SR 273 Pedestrian & Bicycle Road Safety Audit

New Castle County, Delaware

**Prepared for:
Delaware Department of Transportation**

**By
Urban Engineers**

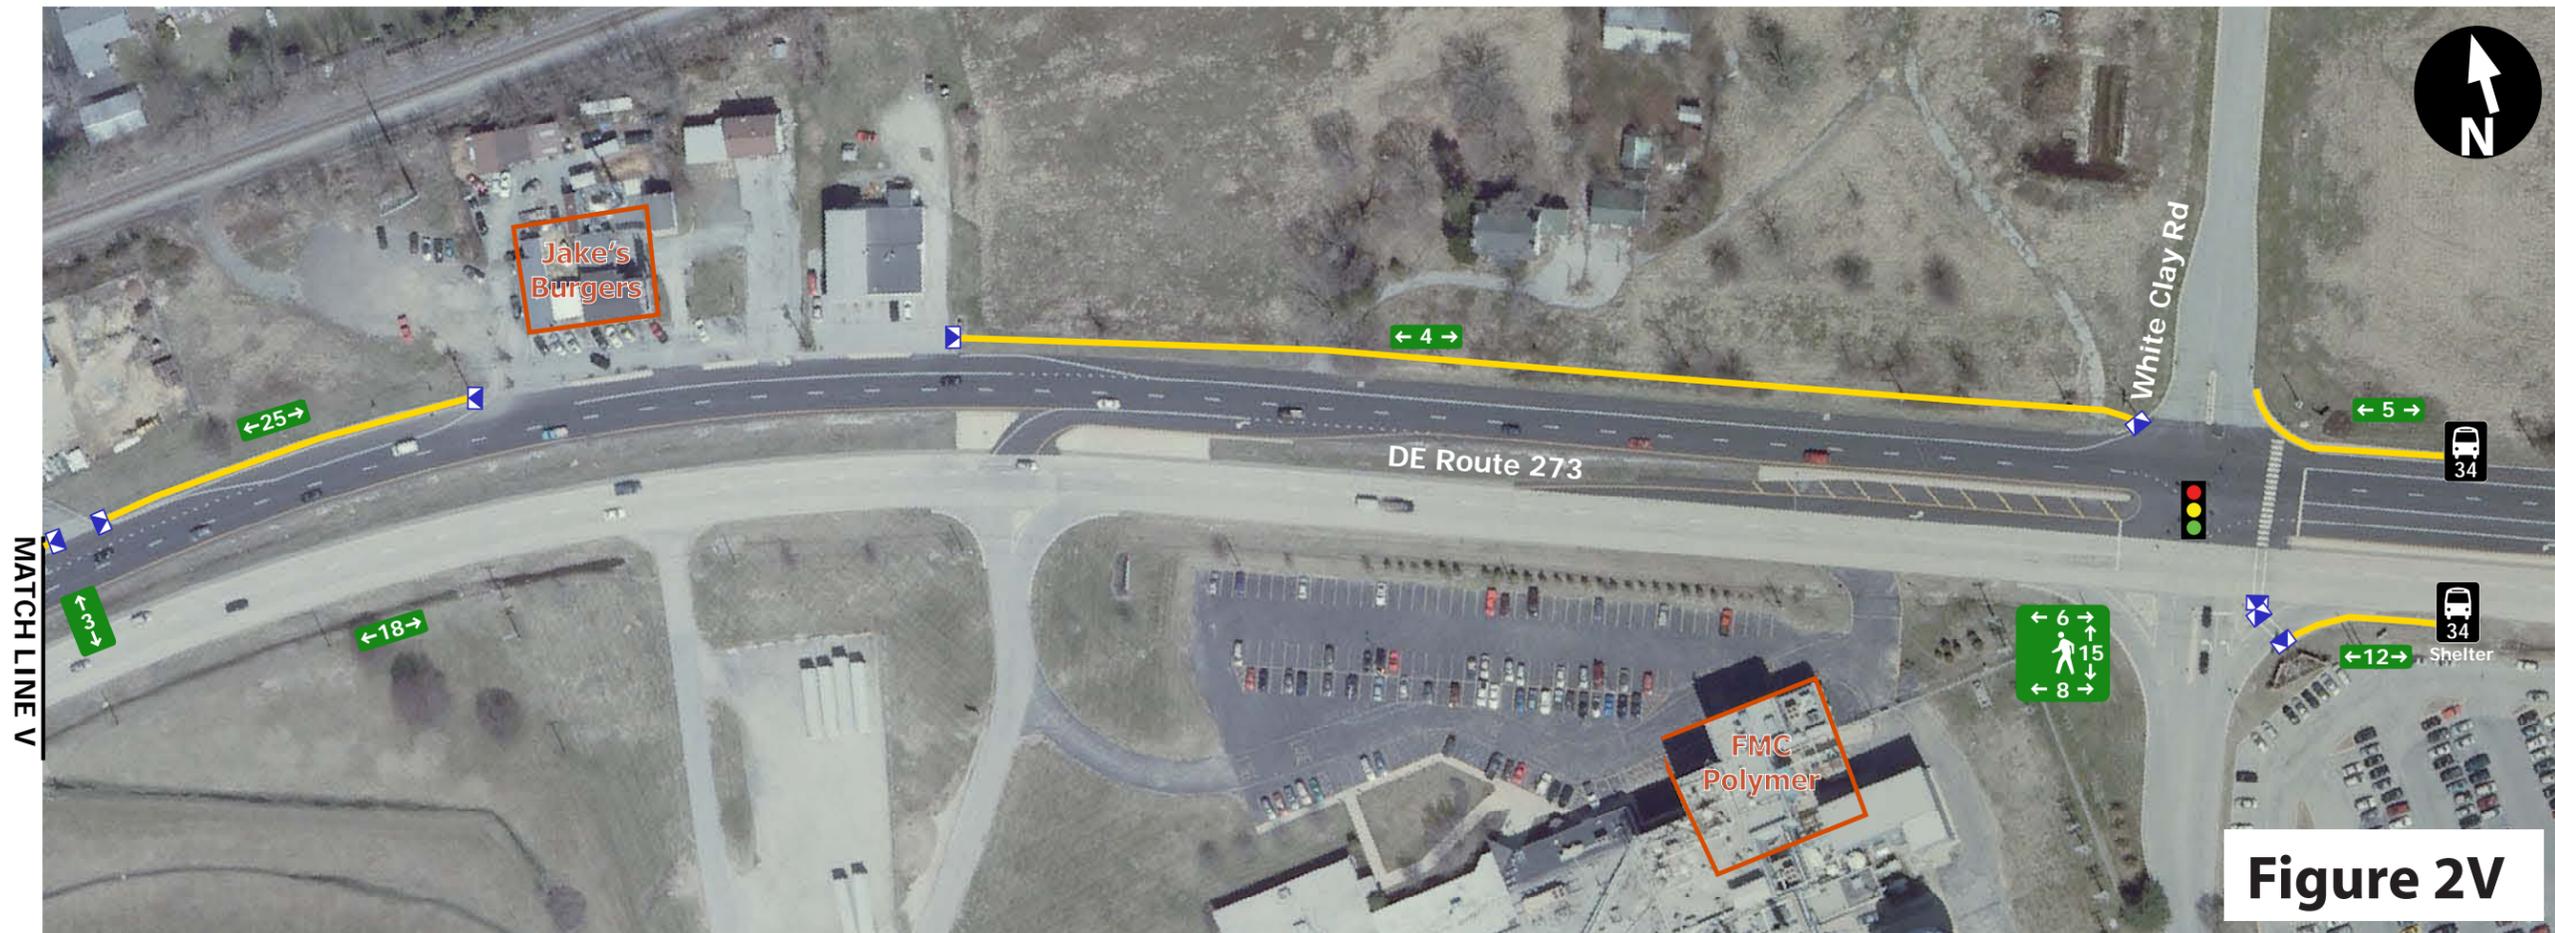
Figure 2V

Continuing west, pedestrian volumes increase between Jake's Burgers and Alexander's Home and Garden with 25 pedestrians observed walking along the north side of SR 273 and 18 along the south side, as shown in **Figure 2V**. Many of the pedestrians along the north side of the road appeared to be going to Jake's Burgers. This establishment was popular on Saturdays as well, with 21 pedestrian recorded along the north side of the road, many of whom also went to Jake's. Two (2) pedestrians were recorded during an average weekday and five (5) on Saturday crossing SR 273 at the marked, unsignalized crossing just east of Alexander's home garden (**Figure 2W**).

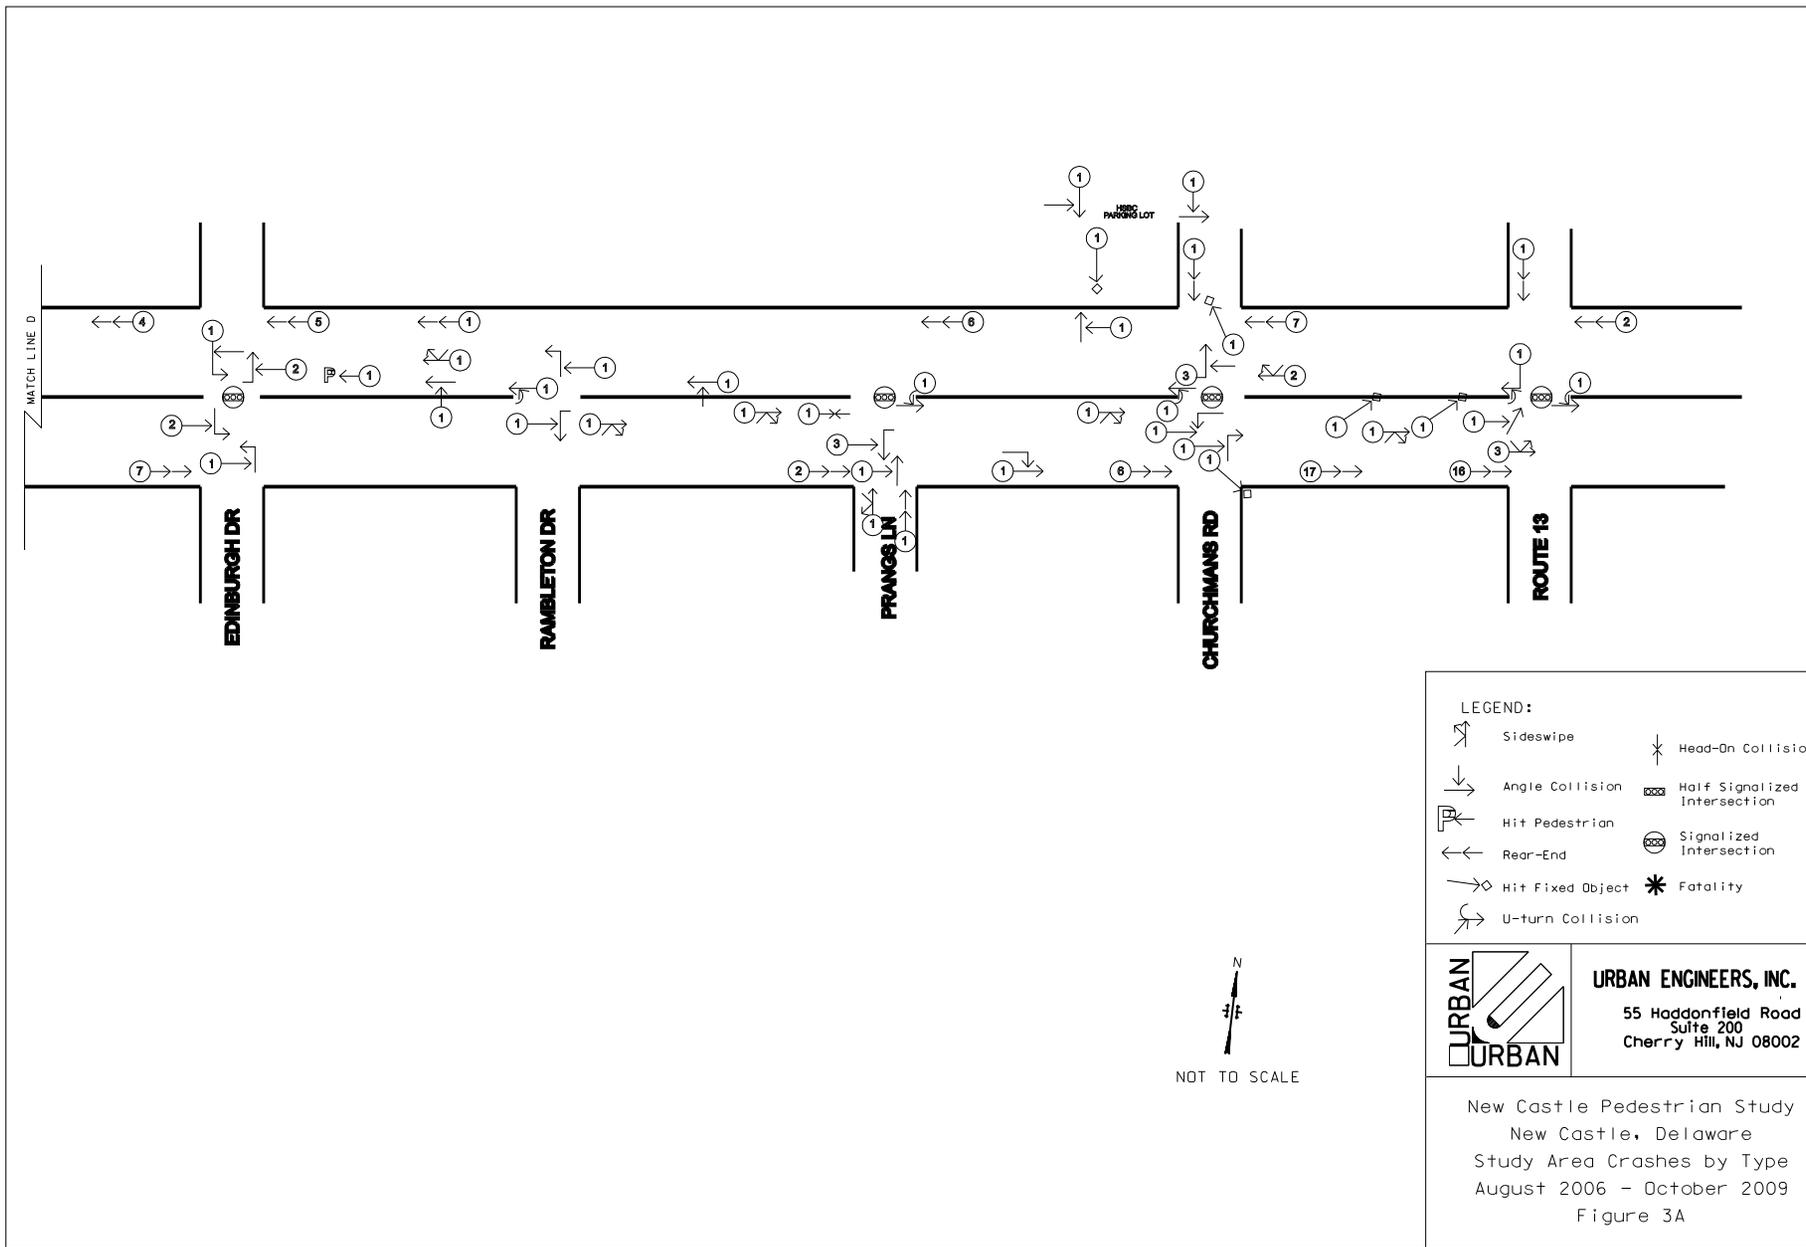
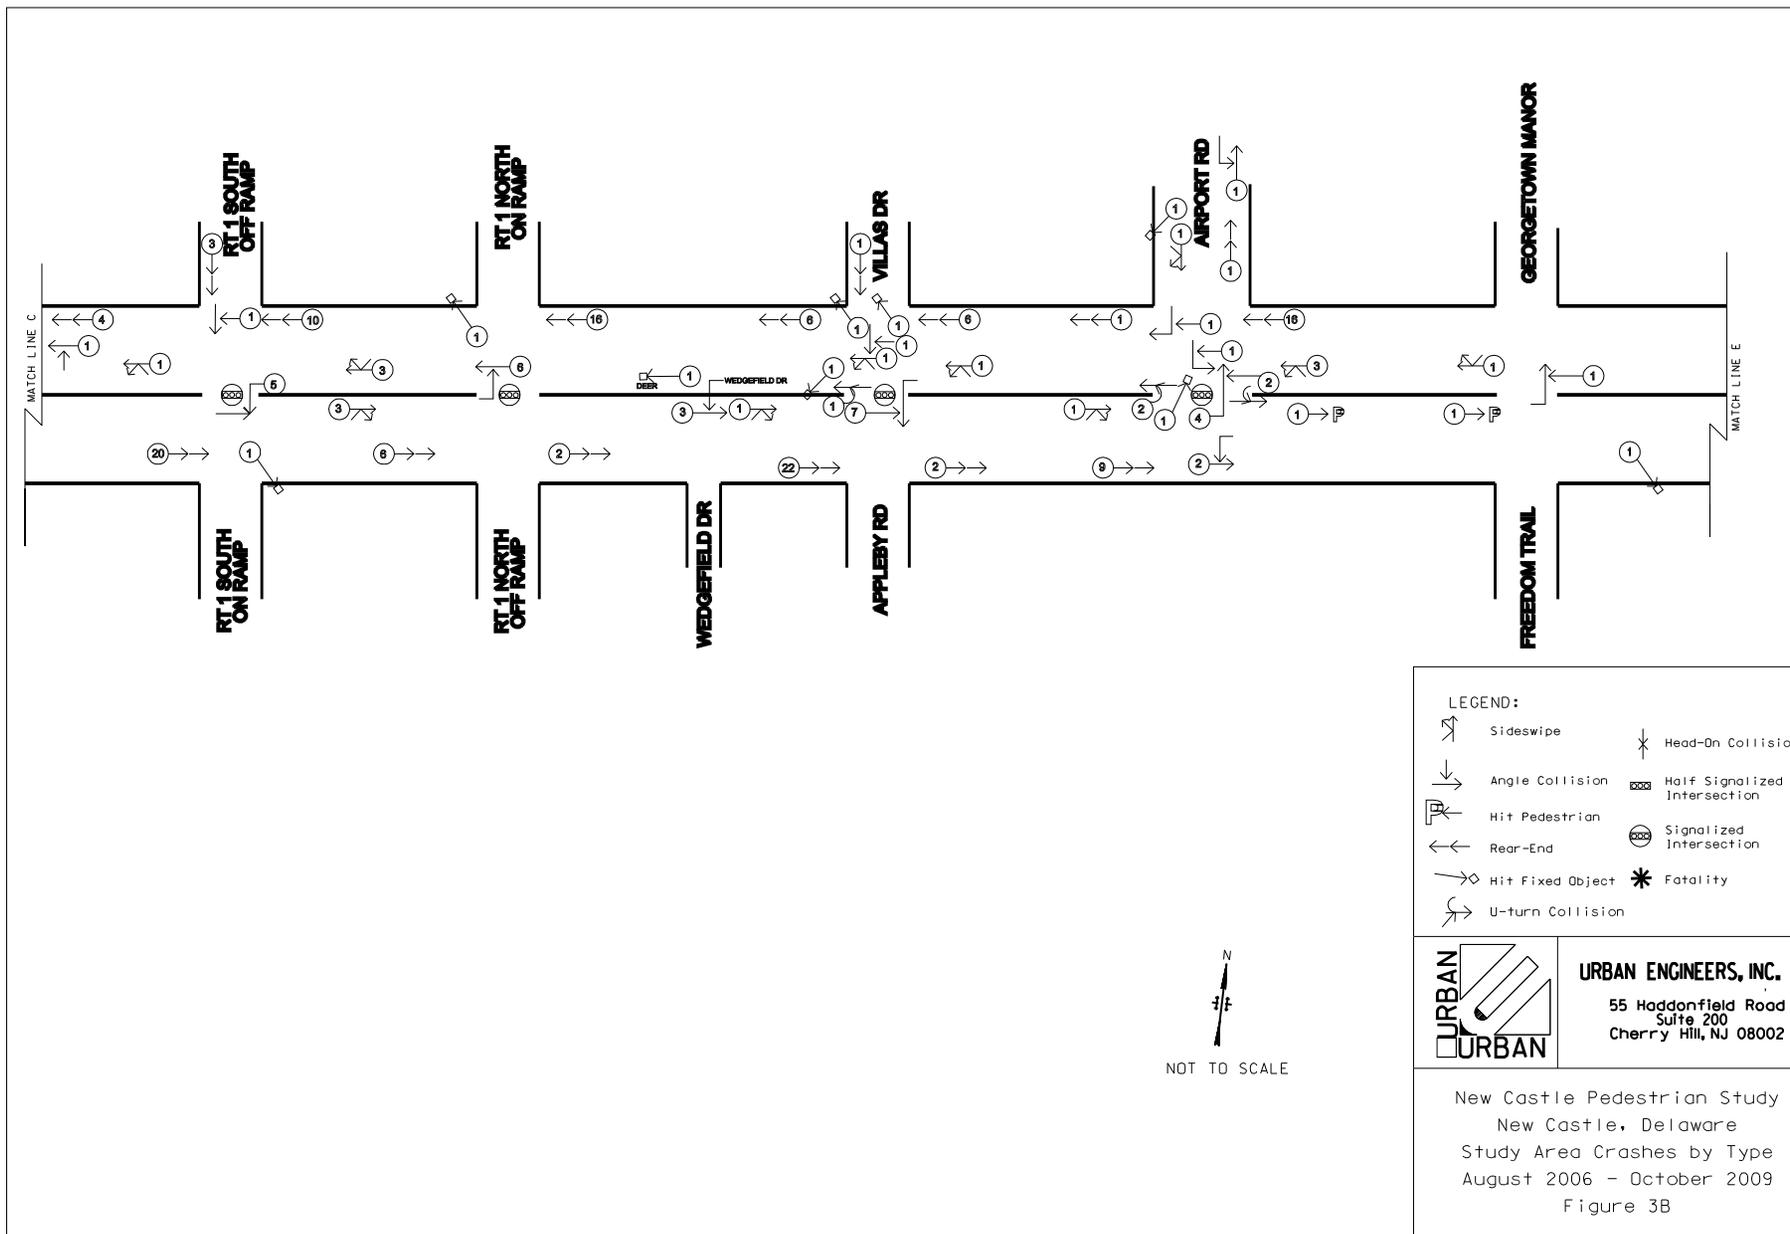
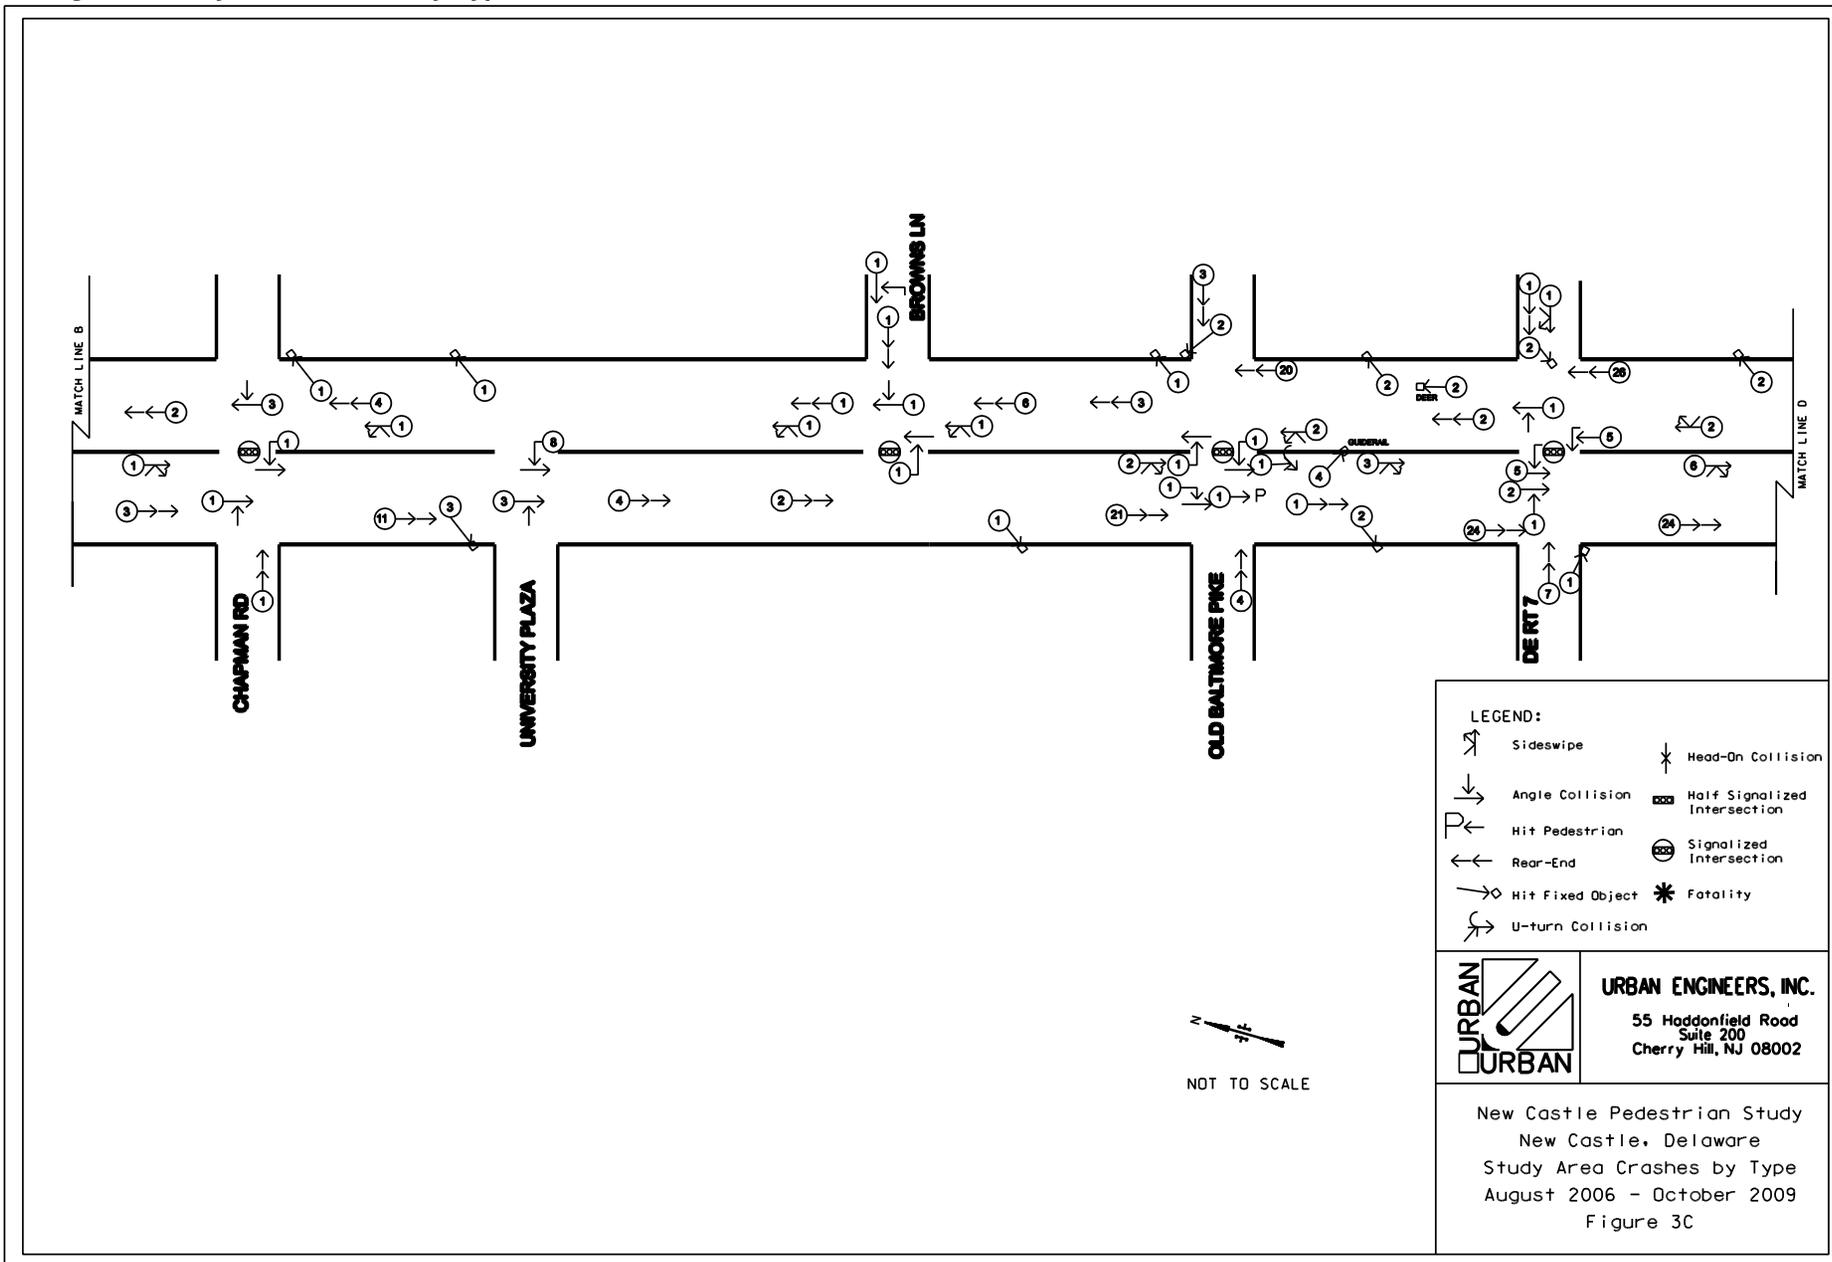
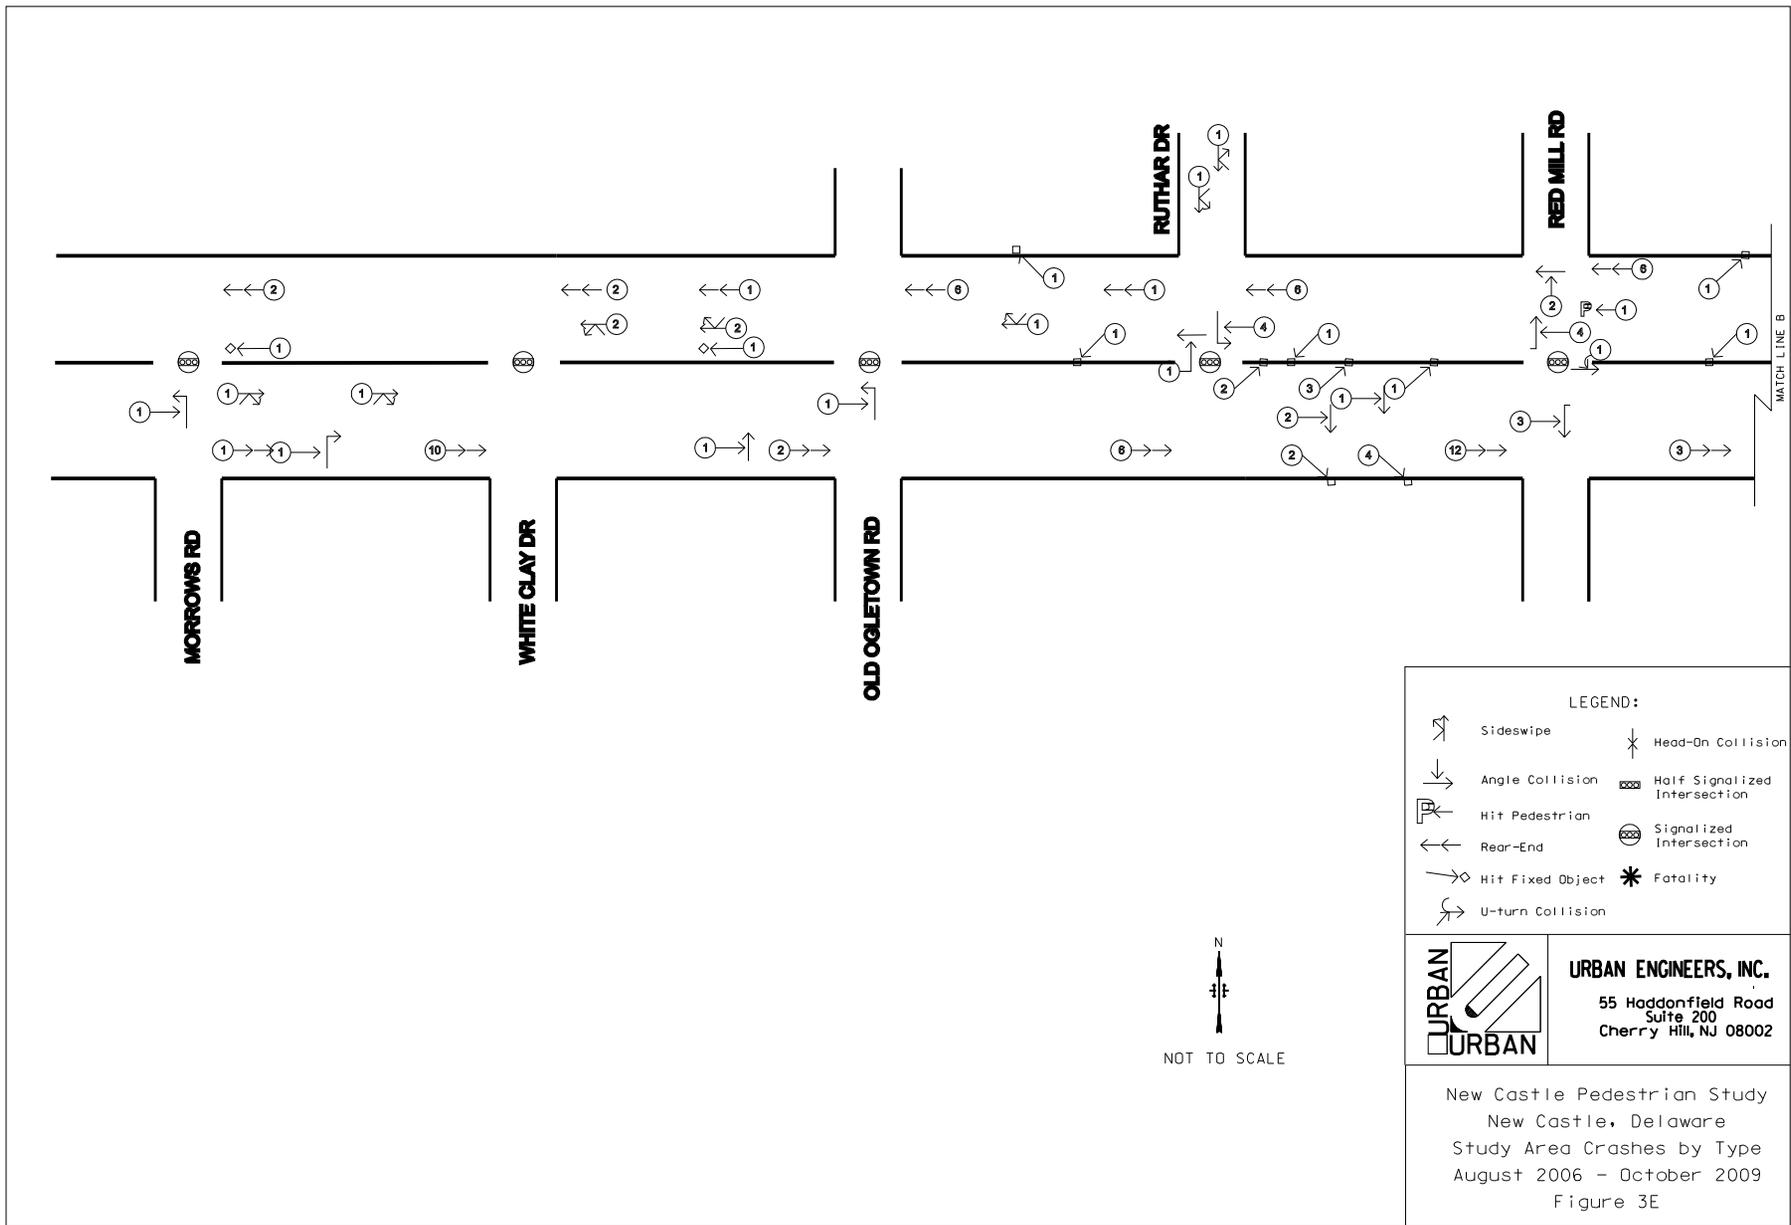
Figure 3 Study Area Crashes by Type

Reported crashes were summarized by multiple contributing factor categories. One of these categories was weather conditions. Of the 898 total crashes during the study period, 181 (20%) were reported as having wet roadway conditions. These crash types seemed to be most prevalent in sections of the corridor where higher speeds and/or congestion could be expected, such as the I-95 interchange ramps, between the I-95 and DE 4 ramps at Brownleaf Road and Harmony Road, at DE 7, at Appleby Road where the corridor context shifts, and approaching US 13. The crash types in these conditions were typically rear-end or hit fixed object (run off the road) collisions.

The crashes that were reported with dark-unlit roadway conditions within the study area total 62 (7%) during the same study period. Dark-unlit crash areas included at or near Brownleaf Road, Old Baltimore Pike, and Red Mill Road (this location has numerous overhead lights). The most common crash type in these lighting conditions was rear-end collisions.

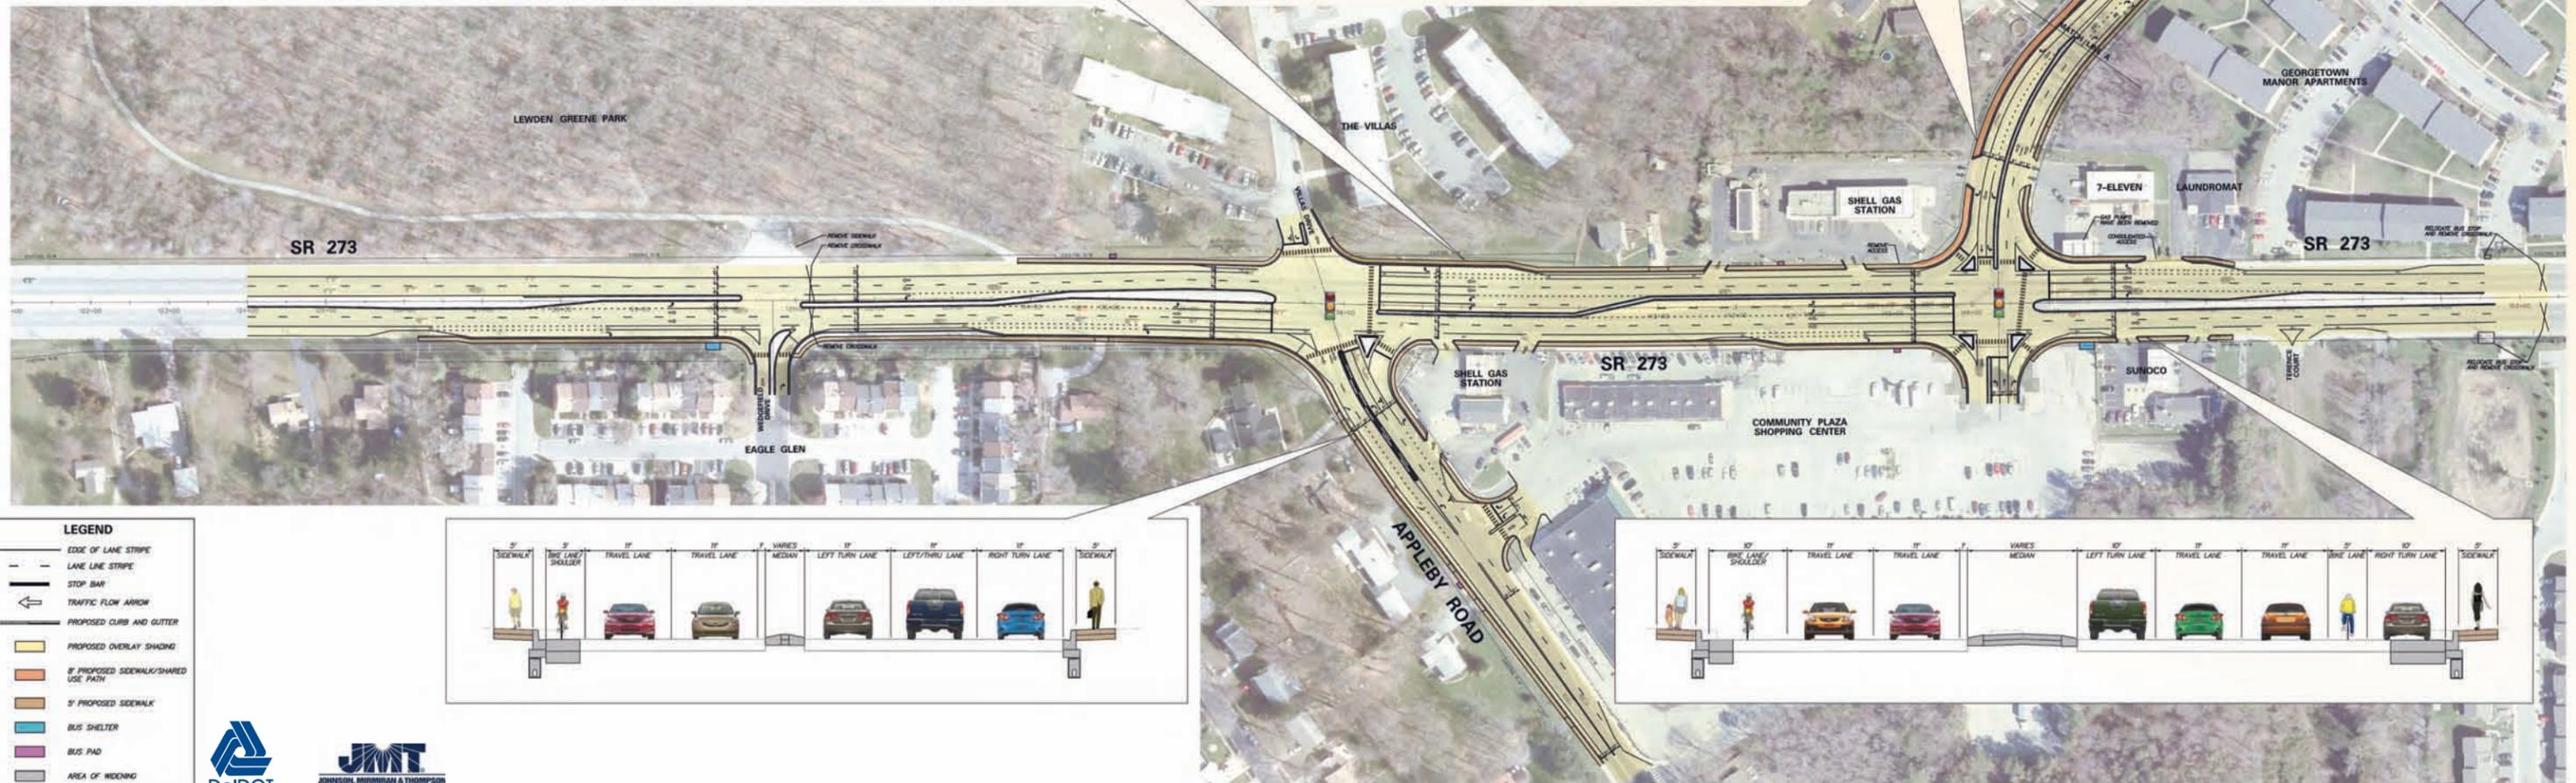
Alternative 1

APPLEBY RD. TO AIRPORT RD.

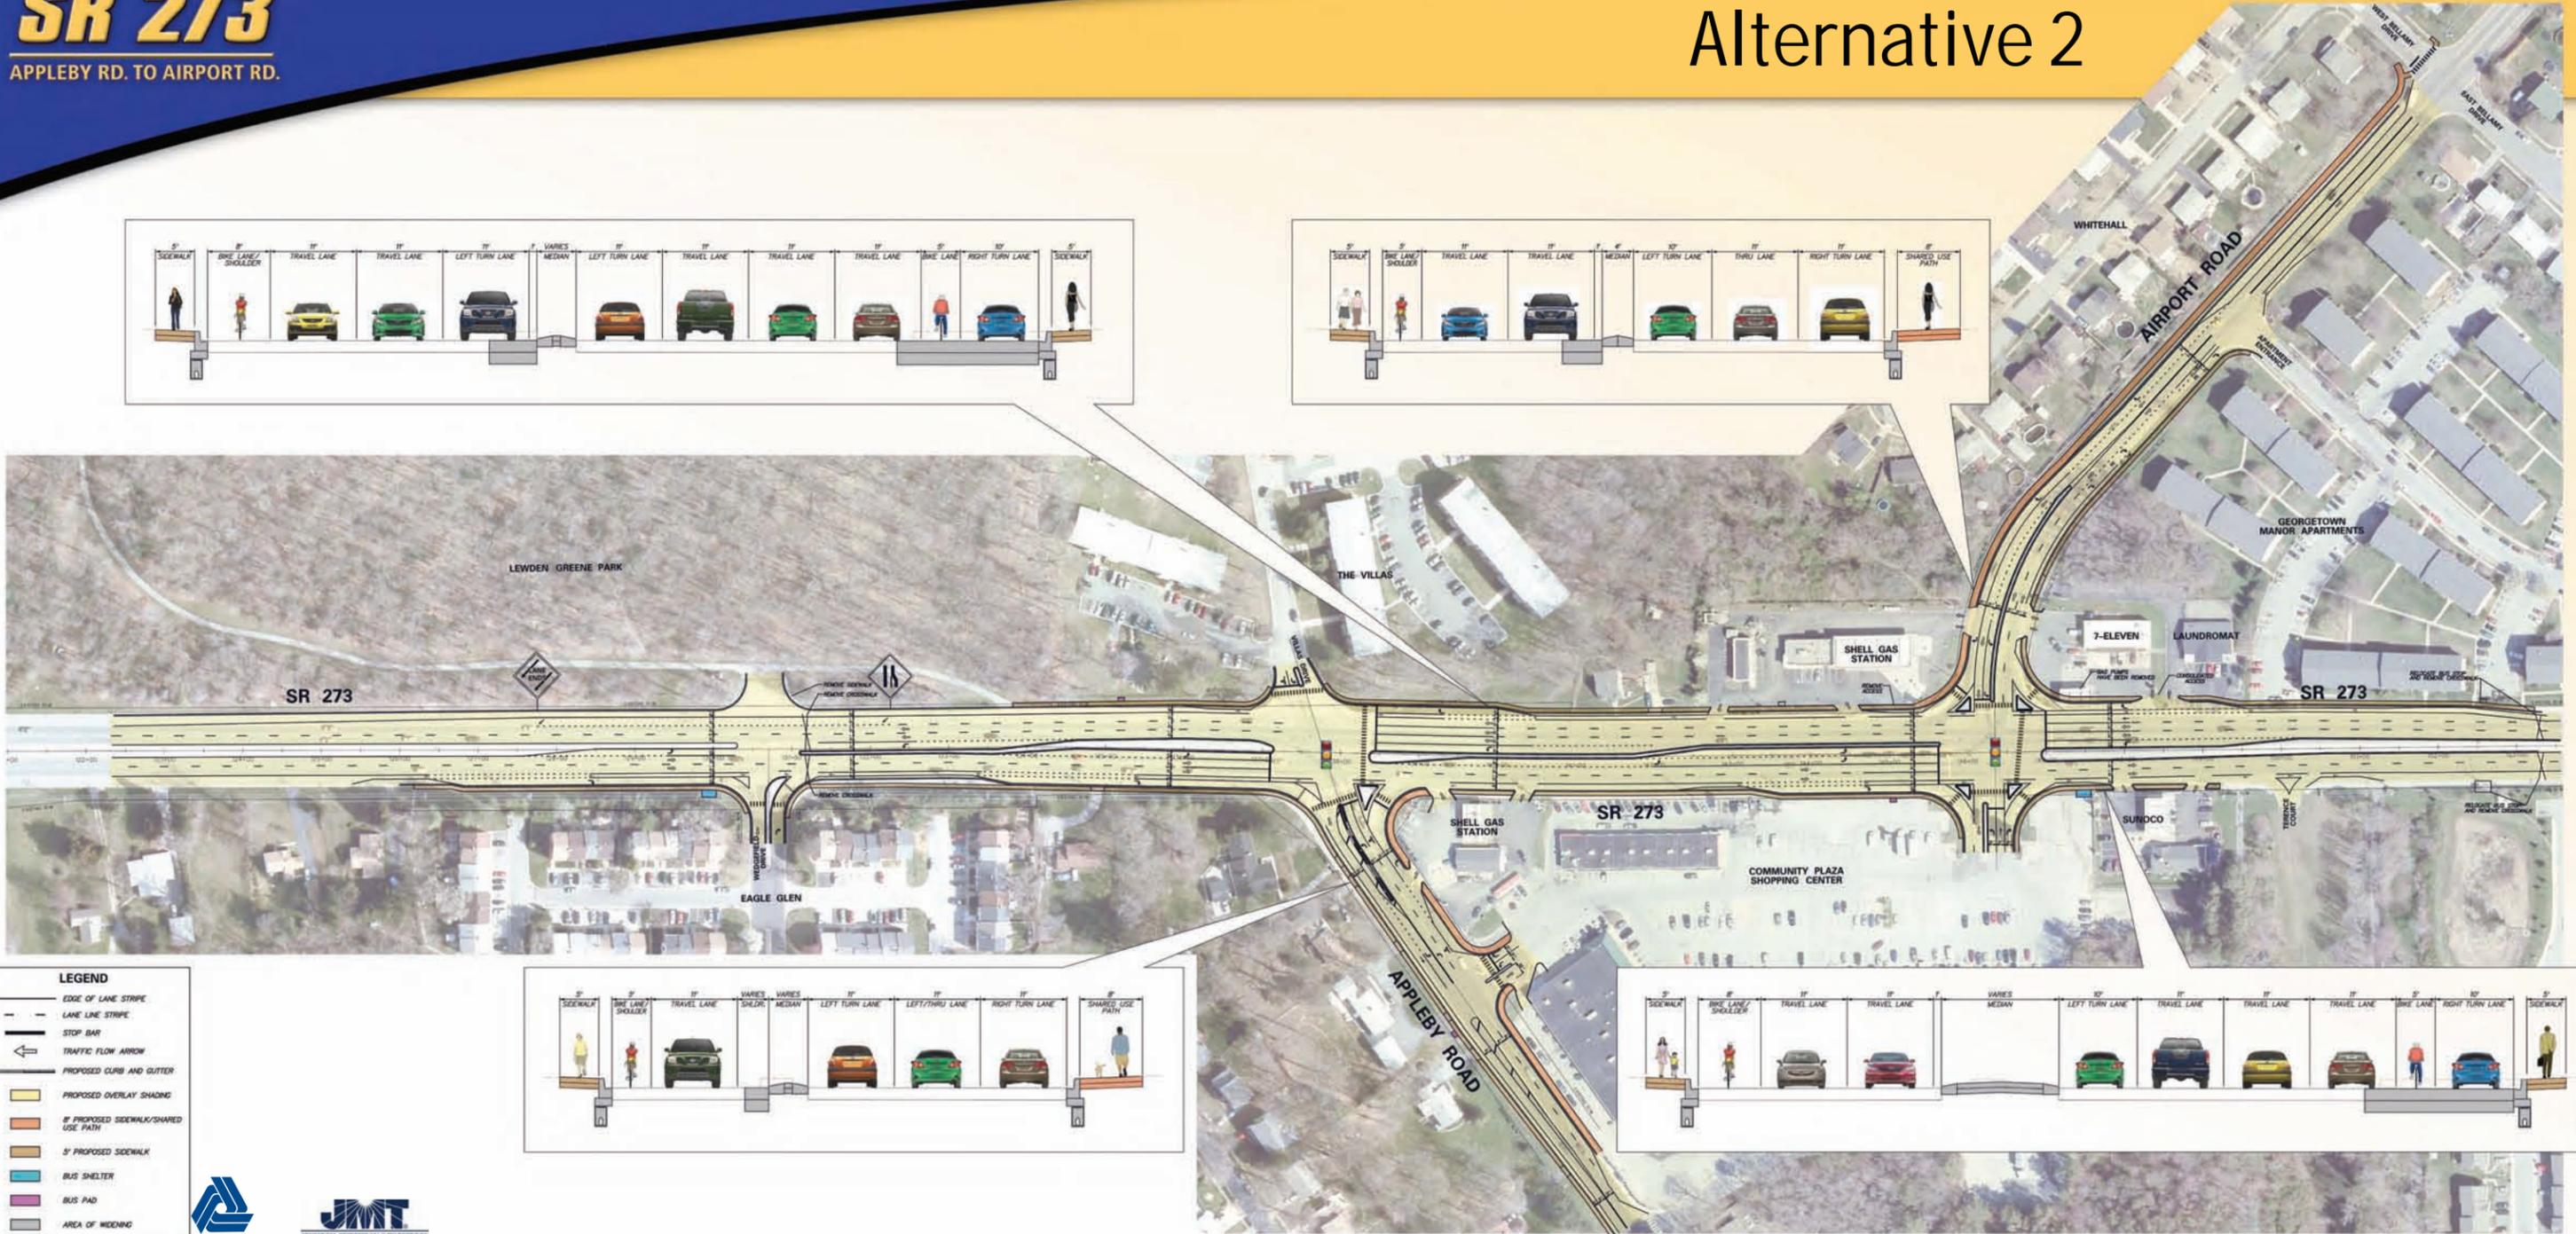
Alternative 2

APPLEBY RD. TO AIRPORT RD.

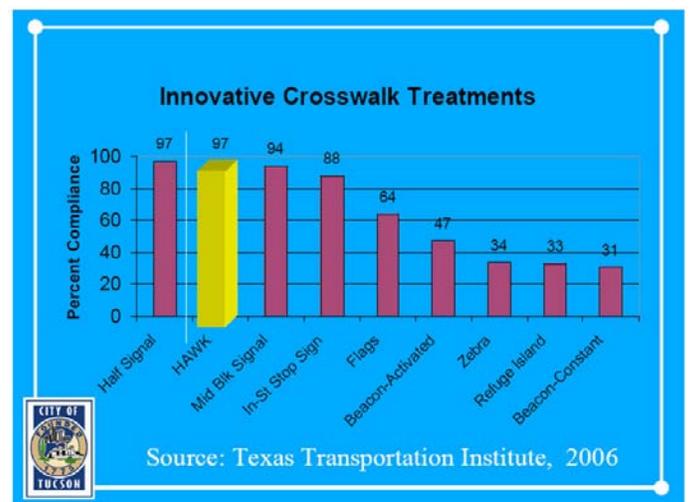
The chart above is based on the results of a study performed by the Texas Transportation Institute on different crosswalk treatments and their compliance in the city of Tucson, Arizona. From this study, it was concluded that the HAWK beacon was one of the most

effective traffic control devices for pedestrian crossings with a 97% driver compliance rate. The study was updated in 2009 and in addition to the compliance rates, a 28% reduction in all crashes and a 58% reduction in pedestrian crashes was found at HAWK beacon locations.

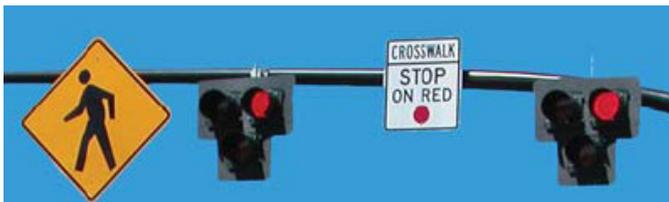
MUTCD Figure 4F-3. Sequence for a Pedestrian Hybrid Beacon

According to Mark Luszcz, DeIDOT's Assistant Chief Traffic Engineer: "The HAWK is expected to provide a reasonably safe pedestrian crossing, while disrupting vehicular traffic flow less than a normal traffic signal. This is accomplished by allowing vehicles to proceed, with caution, during the pedestrian clearance interval. Although the research has shown that drivers understand and generally obey the SOLID RED indication, public education will still be important in explaining the purpose and operations of this new traffic control device."
