**SAFETY AND TRAFFIC REVIEW OF  
PROPOSED RODNEY SQUARE TO  
SHIPLEY STREET  
BUS SERVICE CHANGE**

November 2011

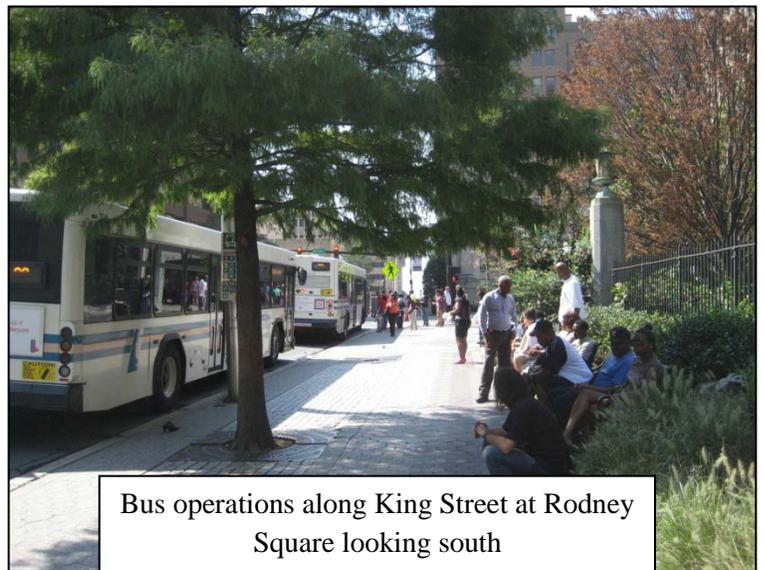
Bus operations along King Street at Rodney Square looking south

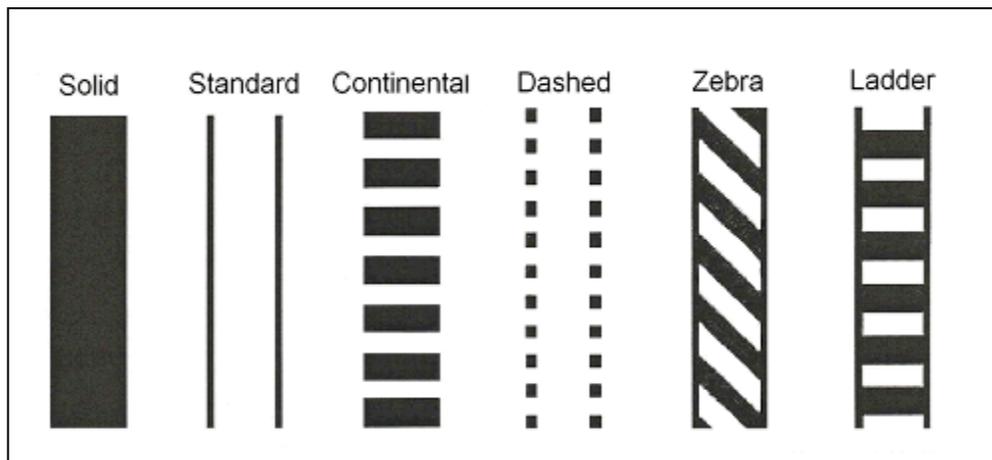
As part of the data collection effort detailed in Table 2, several crosswalk types were noted within the study area. The figure below denotes the difference between a “continental” striped crosswalk that is found throughout downtown Wilmington, and a “standard” striped crosswalk that may be used at locations with lower pedestrian and/or vehicular volumes.

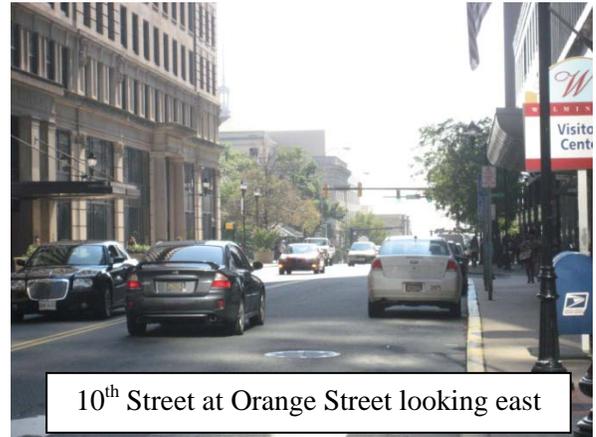
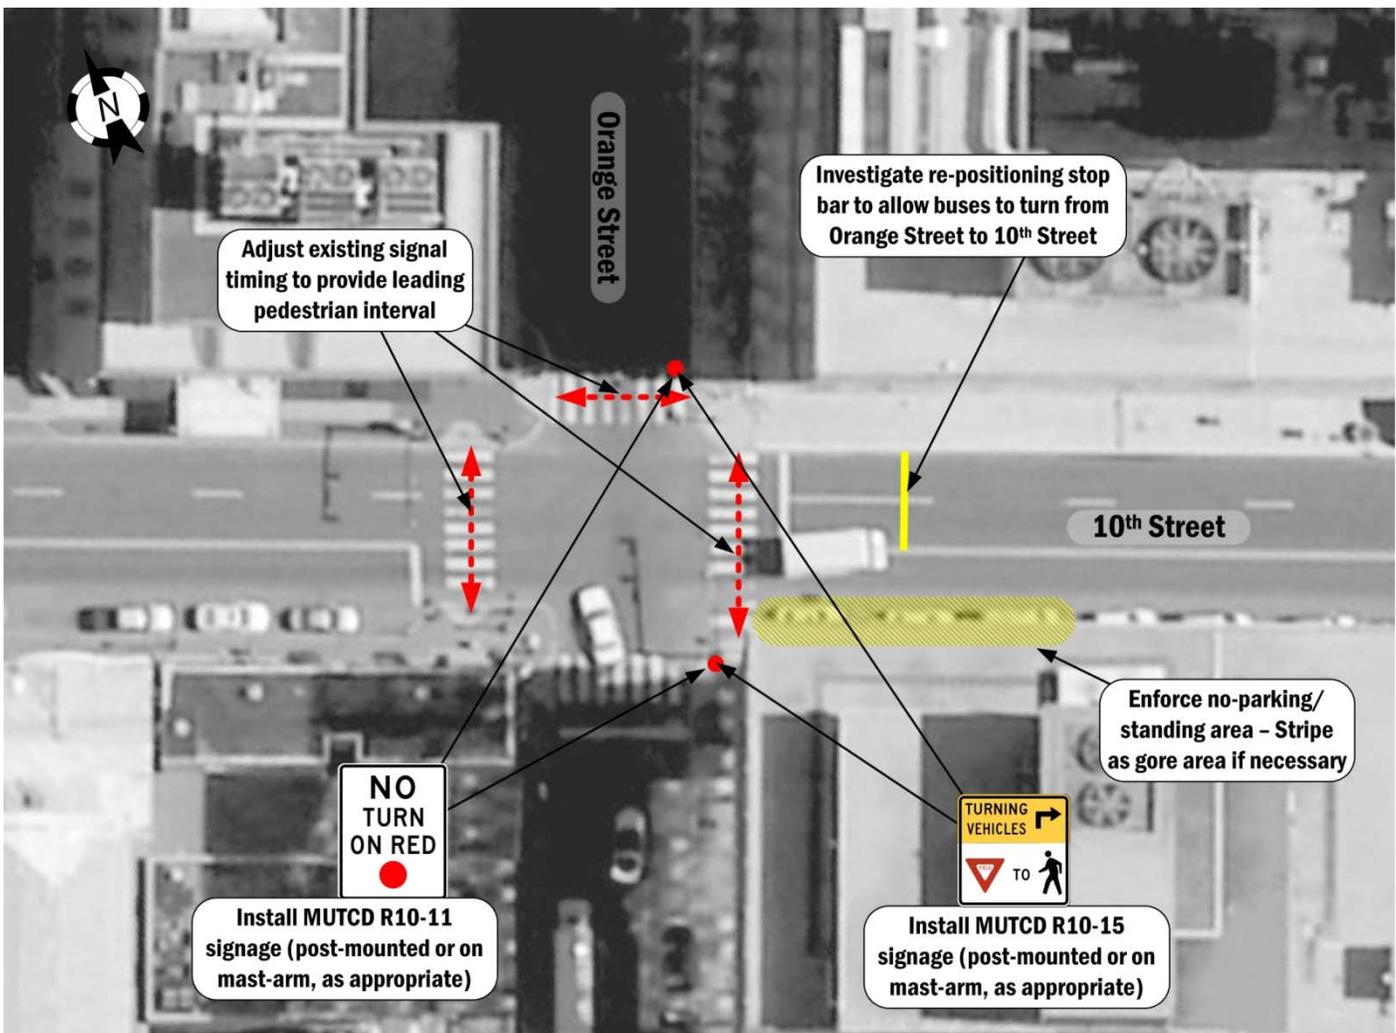
A review of pedestrian conditions at the signalized intersection of 10<sup>th</sup> and Orange Streets indicated above average pedestrian accommodations, including pedestrian-scaled lighting and crosswalks with high-visibility continental striping. Given the expected increase in turning movements for northbound buses destined to the proposed Shipley Street route, several improvements are recommended. To reinforce the parking prohibition along 10<sup>th</sup> Street eastbound east of Orange Street, a gore area should be painted to fully allow buses to make this turn without impeding traffic. Along Orange Street northbound approaching 10<sup>th</sup> Street, “Turning Vehicles Yield to Pedestrians” signage (MUTCD R10-15) should be installed.

A review of bus operations using AutoTURN at this intersection indicate that some encroachment may be necessary for buses to turn from Orange Street to 10<sup>th</sup> Street. From Orange Street, a turning bus slightly encroaches on the other travel lane and there is some front overhang crossing the yellow line on 10th Street. This was the best path without hitting the curb line. One solution for this is to pull back the stop bar on the westbound 10th Street approach to allow for this movement. The bus clears the parking lane along 10th Street approximately 70 feet from the Orange St curb line.

Similarly, “No Turn on Red” signage (MUTCD R10-11) should be installed, preventing vehicles from turning right to 10<sup>th</sup> Street from Orange Street northbound during a red signal phase. Further, a leading pedestrian interval should be investigated at this intersection, given the high number of projected pedestrian and turning vehicle conflicts at this location.

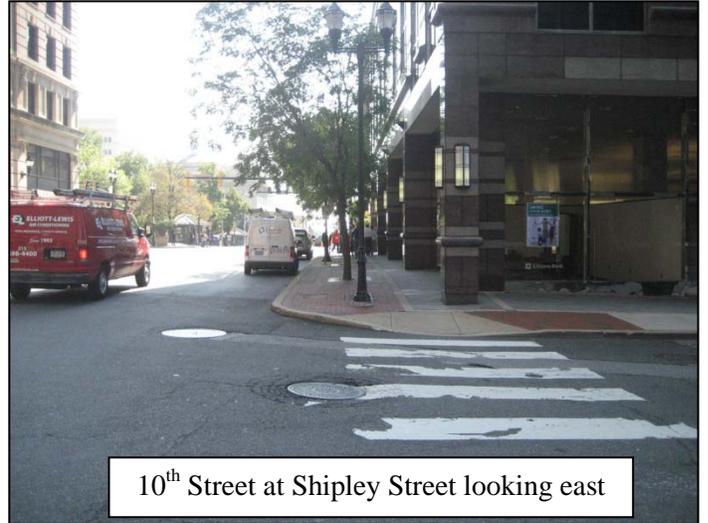
The non-signalized intersection of 10<sup>th</sup> and Shipley Streets currently provides a continental striped crosswalk along the southern leg of the intersection across Shipley Street. In order to provide increased turning space for buses traveling to the proposed Shipley Street route, two parking spaces located directly west of Shipley Street along 10<sup>th</sup> Street eastbound should be removed. To reinforce the parking prohibition along 10<sup>th</sup> Street, a gore area should be painted to fully allow buses to make this turn without impeding traffic. The removal of parking will also provide increased visibility for pedestrians traveling eastbound across the Shipley Street crosswalk. Along 10<sup>th</sup> Street eastbound approaching Shipley Street, “Turning Vehicles Yield to Pedestrians” signage (MUTCD R10-15) should be installed. On-pavement “Yield to Pedestrians” striping should be investigated as well.

10<sup>th</sup> Street at Shipley Street looking east

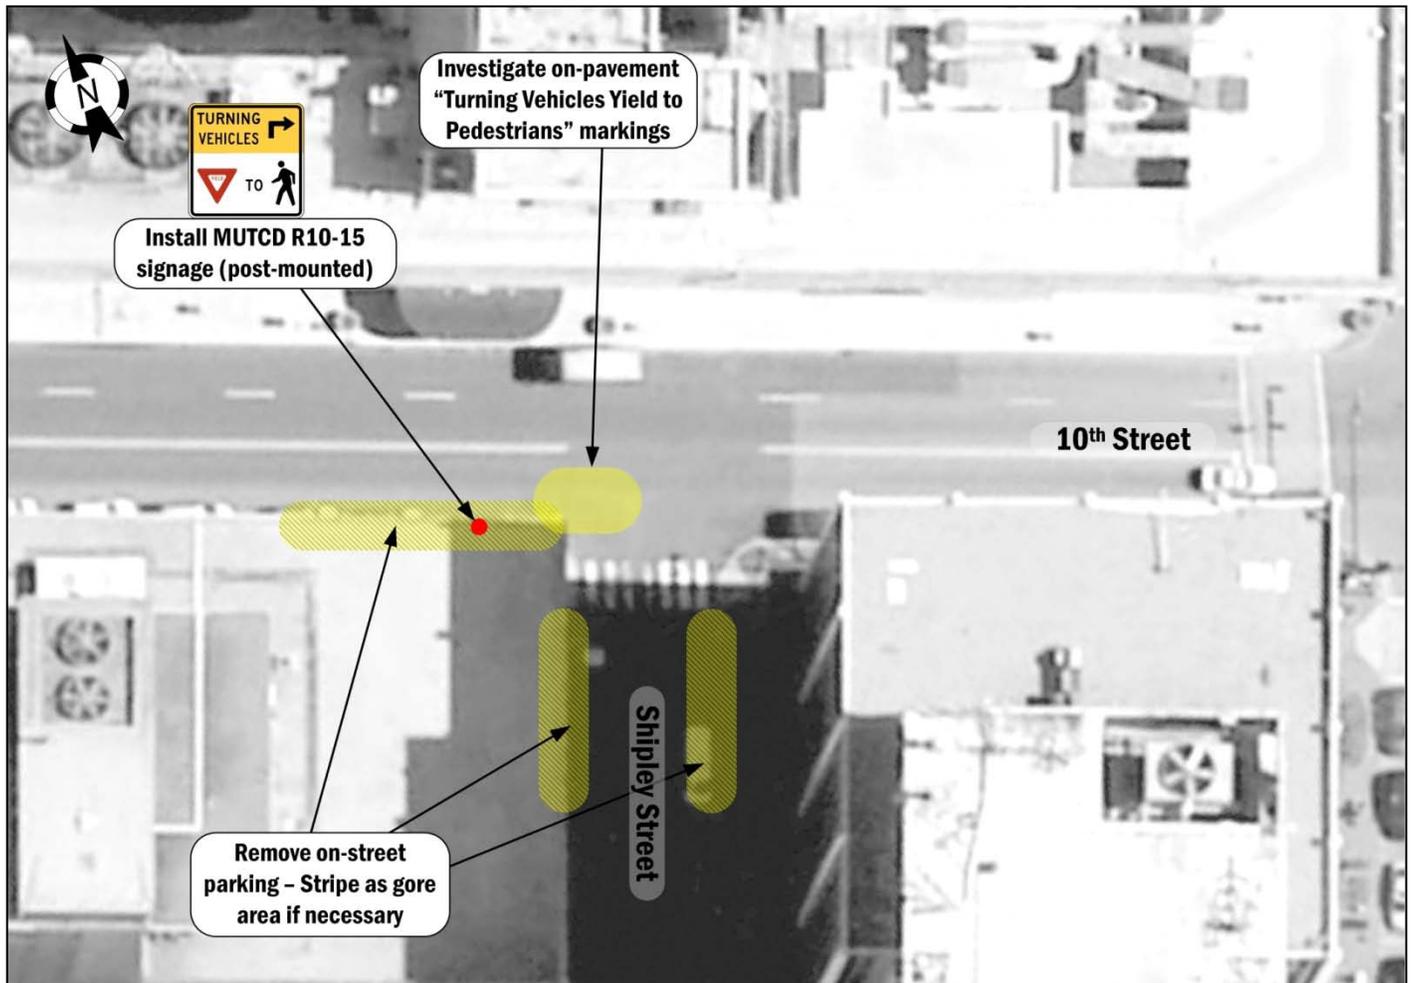
A review of bus operations using AutoTURN at this intersection indicate that some encroachment may be necessary for buses to turn from 10<sup>th</sup> Street to Shipley Street. The turn from 10<sup>th</sup> Street eastbound onto Shipley Street forces a bus to slightly encroach onto oncoming traffic to allow for a larger radius to make the turn. The bus will also require the removal of parking along Shipley Street for a minimum of 75 feet from the 10<sup>th</sup> Street curb line.

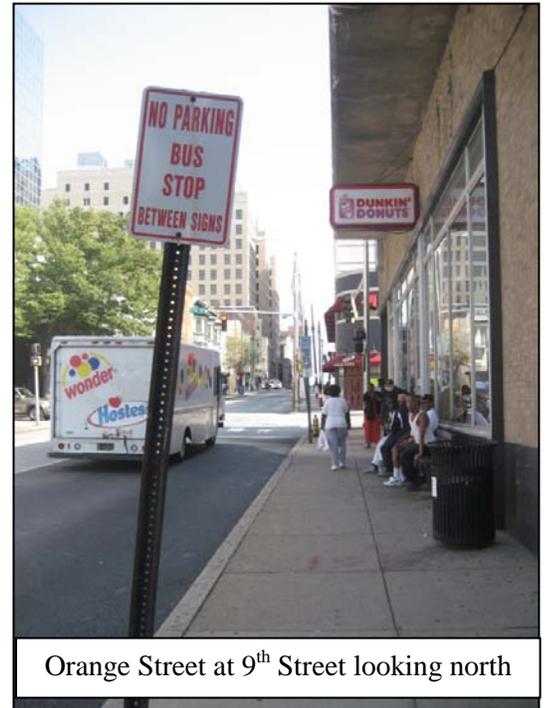
A review of pedestrian conditions at the signalized intersection of 9<sup>th</sup> and Orange Streets indicated adequate pedestrian accommodations, including crosswalks with standard striping and pedestrian signal heads with countdown timers. Given the expected increase in turning movements for buses destined to the proposed Shipley Street route via 9<sup>th</sup> Street, several improvements are recommended. To reinforce the parking prohibition along 9<sup>th</sup> Street eastbound east of Orange Street, a gore area should be painted to fully allow buses to make this turn without impeding traffic. Along Orange Street northbound approaching 9<sup>th</sup> Street, “Turning Vehicles Yield to Pedestrians” signage (MUTCD R10-15) should be installed. Similarly, “No Turn on Red” signage (MUTCD R10-11) should be installed, preventing vehicles from turning right to 9<sup>th</sup> Street from Orange Street northbound during a red signal phase. A leading pedestrian interval should be investigated at this intersection, given the high number of projected pedestrian and turning vehicle conflicts at this location. Finally, the existing bus stop located on Orange Street just south of 9<sup>th</sup> Street should be relocated further south to allow buses turning onto 9<sup>th</sup> Street additional space to pull out from the curb prior to making the turn.

Orange Street at 9<sup>th</sup> Street looking north

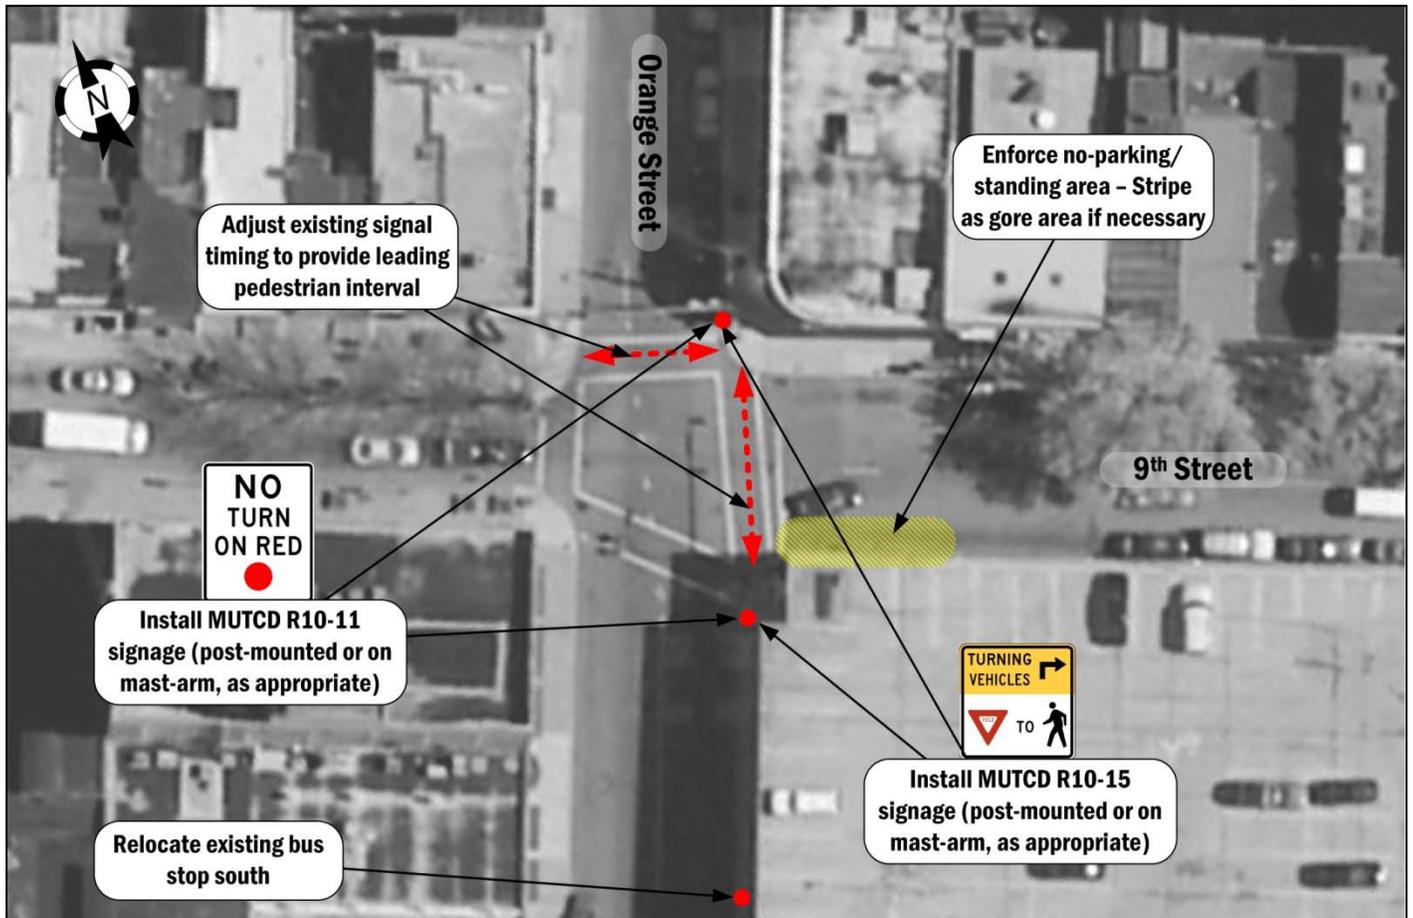
A review of bus operations using AutoTURN at this intersection indicate that some encroachment may be necessary for buses to turn from Orange Street to 9<sup>th</sup> Street. From Orange Street, a turning bus slightly encroaches on the left travel lane of 9<sup>th</sup> Street.

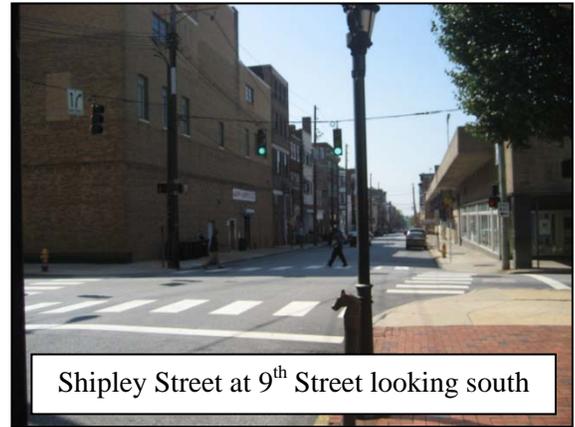
A review of pedestrian conditions at the signalized intersection of 9<sup>th</sup> and Shipley Streets indicated adequate pedestrian accommodations, including crosswalks with high-visibility continental striping and pedestrian signal heads with countdown timers. Given the expected increase in turning movements for buses along the proposed Shipley Street route, several improvements are recommended. To reinforce the parking prohibition along 9<sup>th</sup> Street eastbound west of Shipley Street, a gore area should be painted to fully allow buses to make this turn without impeding traffic. Similar gore areas should be painted on Shipley Street southbound beyond the existing crosswalk south of 9<sup>th</sup> Street. Along 9<sup>th</sup> Street eastbound approaching Shipley Street, “Turning Vehicles Yield to Pedestrians” signage (MUTCD R10-15) should be installed. Similarly, “No Turn on Red” signage (MUTCD R10-11) should be installed, preventing vehicles from turning right onto Shipley Street from 9<sup>th</sup> Street northbound during a red signal phase. Further, a leading pedestrian interval should be investigated at this intersection, given the high number of projected pedestrian and turning vehicle conflicts at this location.

Shipley Street at 9<sup>th</sup> Street looking south

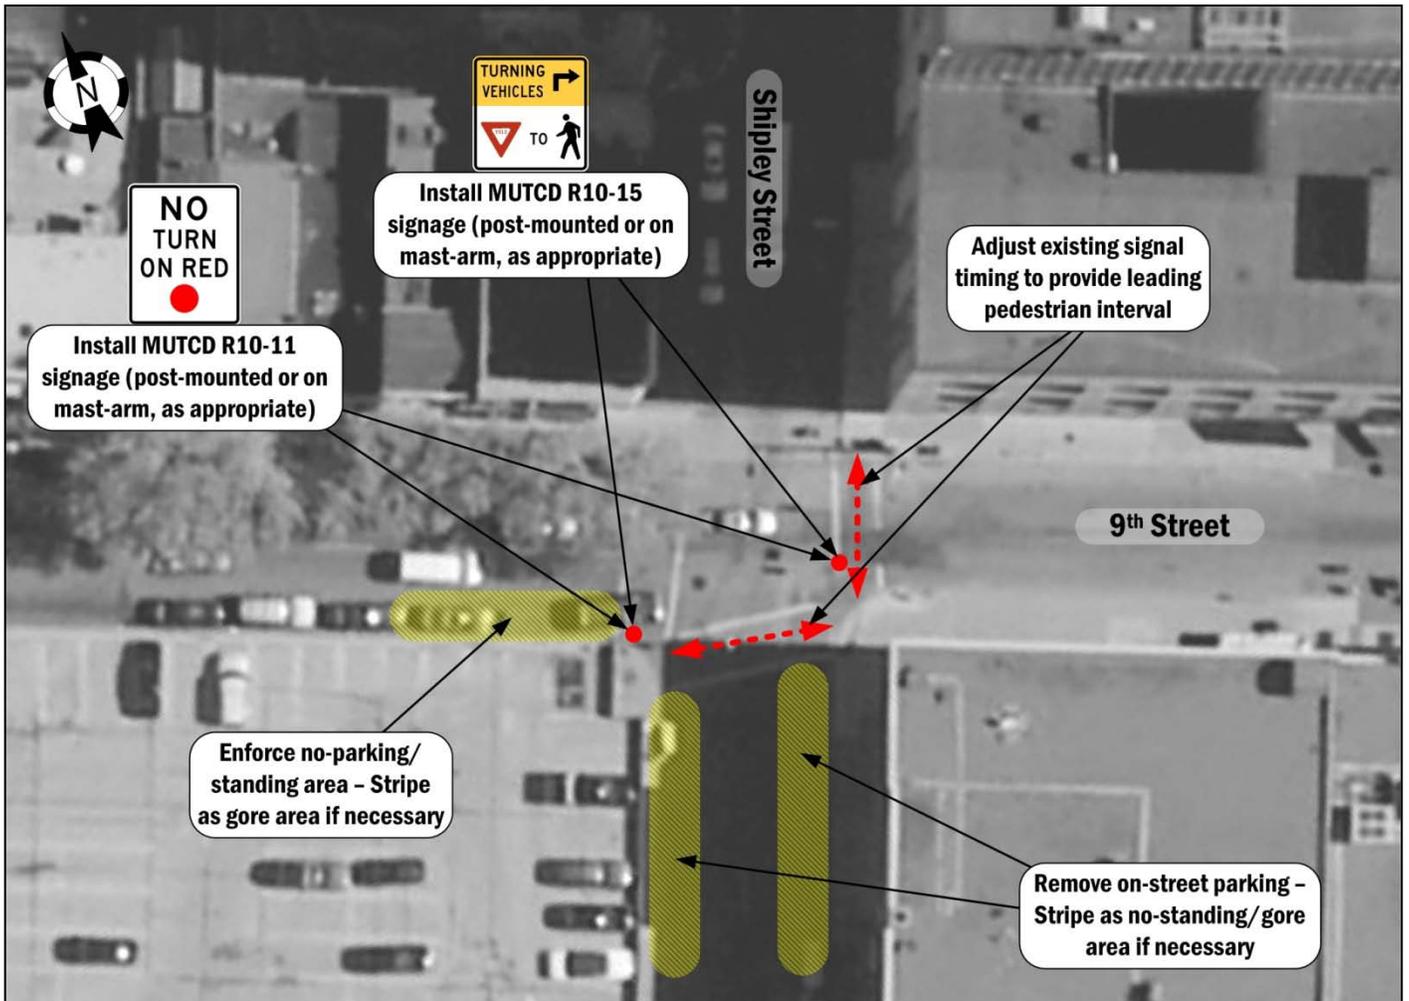
A review of bus operations using AutoTURN at this intersection indicates that no encroachment will occur into another travel lane for buses to turn from 9<sup>th</sup> Street to Shipley Street. As noted above, this will require the removal and enforcement of proposed no-parking areas along 9<sup>th</sup> Street and Shipley Street.

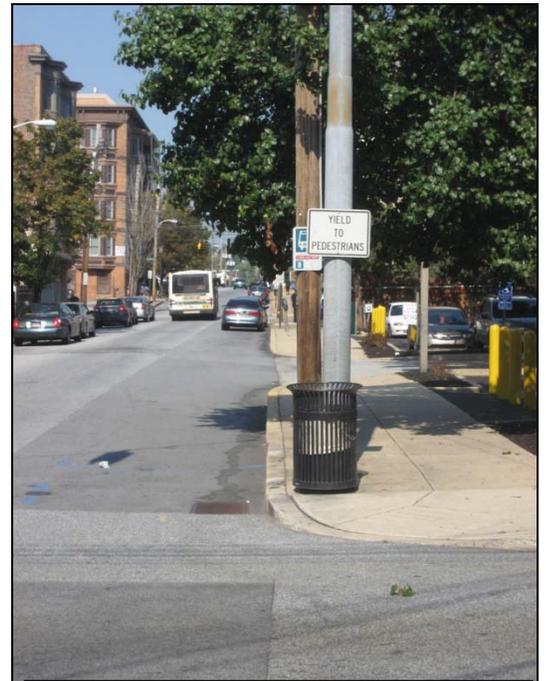
The signalized intersection of 8<sup>th</sup> and Orange Streets has several pedestrian deficiencies that limit the circulation of non-motorized traffic through this intersection. While observed pedestrian traffic at this intersection was significant, crosswalks are not installed for any of the crossings at this intersection. Further, pedestrians standing on the northwestern corner of the intersection cannot see any signal faces indicating when it is safe for them to cross. In order to improve pedestrian circulation at this intersection for the proposed Shipley Street route, crosswalks should be striped on all four approaches, and pedestrian signal heads should be installed for the northern crossing of Orange Street, at a minimum.

8<sup>th</sup> Street at Orange Street looking west

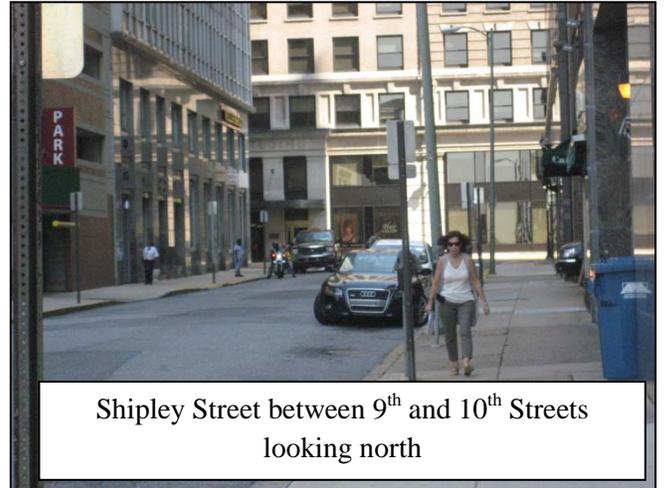
Shipley Street between 9<sup>th</sup> and 10<sup>th</sup> Streets looking north

In order to provide an overflow area for buses using the proposed Shipley Street location south of 9<sup>th</sup> Street, parking should be removed along the western curb, to be replaced with a 10-foot wide striped shoulder/gore area and signage indicating the location as a no parking area. This area can also serve as a potential overflow/staging area for buses during peak periods. Parking along the eastern curb can be maintained along with a single travel lane as exists in the current condition.

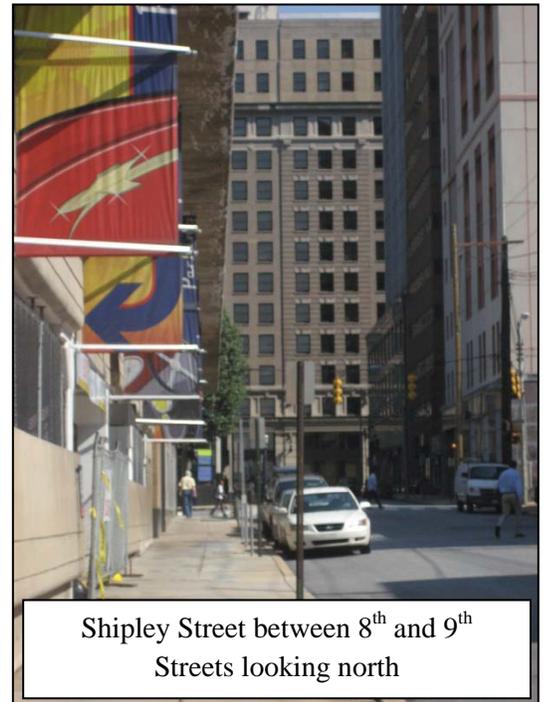
Shipley Street between 8<sup>th</sup> and 9<sup>th</sup> Streets looking north

To provide an adequate staging area for buses along Shipley Street, parking should be removed along the western curb, to be replaced with a 12-foot wide striped shoulder/gore area and signage indicating the location as a bus stop area. In order to maintain Shipley Street as a service street for Market Street businesses, parking along the eastern curb should be removed, to be replaced with a 12-foot wide striped shoulder/gore area and signage indicating the location as a loading zone/short-term (15-minute) parking area, to be determined based on cooperative input from adjacent business owners. The removal of parking along both curbs would allow for a single 12-foot travel lane along this block of Shipley Street.

To improve conditions for transit users, a shelter and/or benches should be installed along the western sidewalk of Shipley Street beneath the overhang attached to the former parking garage. Any use of the area beneath the overhang will require a review of the structural condition of the overhang area, as a visual review of the structure indicates it is in a state of disrepair. Pedestrian access along the eastern sidewalk of Shipley Street can be improved by removing and/or consolidating trash receptacles throughout this area. This would likely require a significant level of cooperation amongst the City, DTC, DeIDOT, and local business owners.
