**NEW CASTLE COUNTY MS4
Permit No. DE 0051071**

**JOINT ANNUAL REPORT FOR CALENDAR YEAR
2010**

**Volume 2 of 2
DeIDOT Report and Appendices**

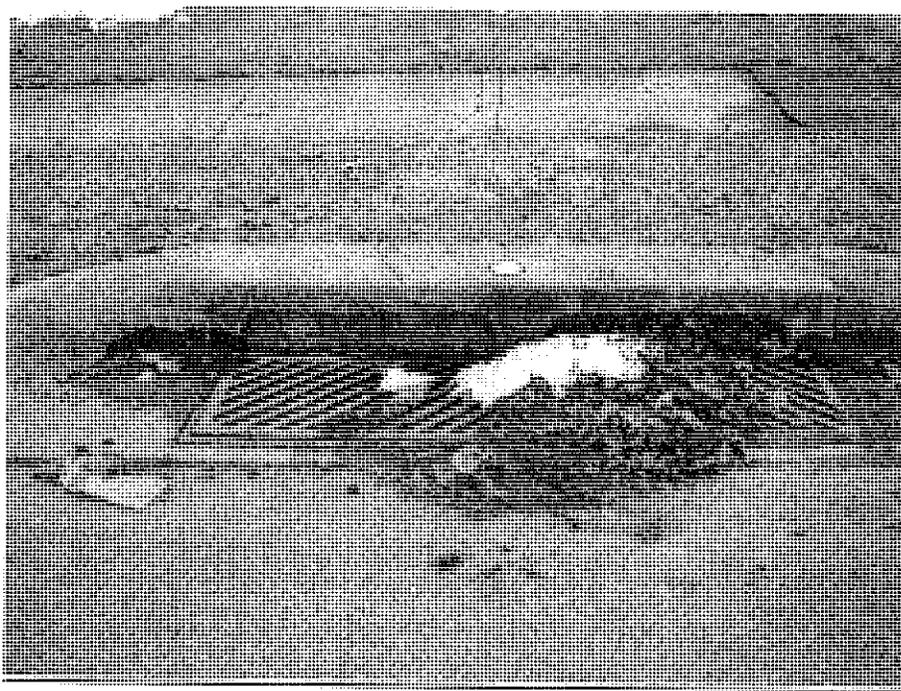
Figure 2. Structure View

Upon inspection of the catch basin on March 2, 2010 it was noted that the basin was 75 percent full of leaves. The leaves appear to be blocking flow in the catch basin since the pipe is not visible. Pictures were taken of the PID and other catch basins in the area were inspected. The other basins in the immediate area appear to be clear of leaves and debris.

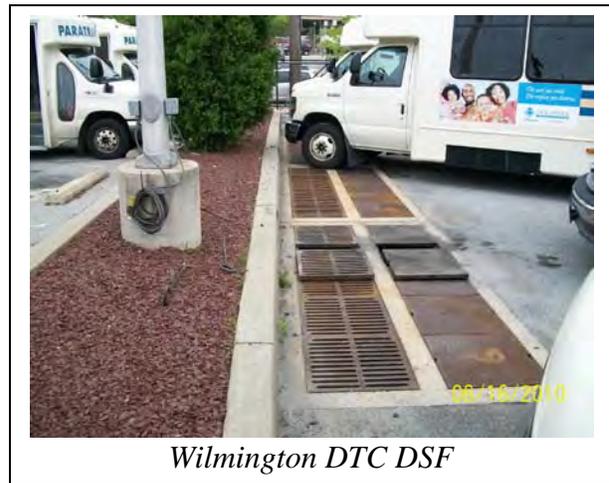
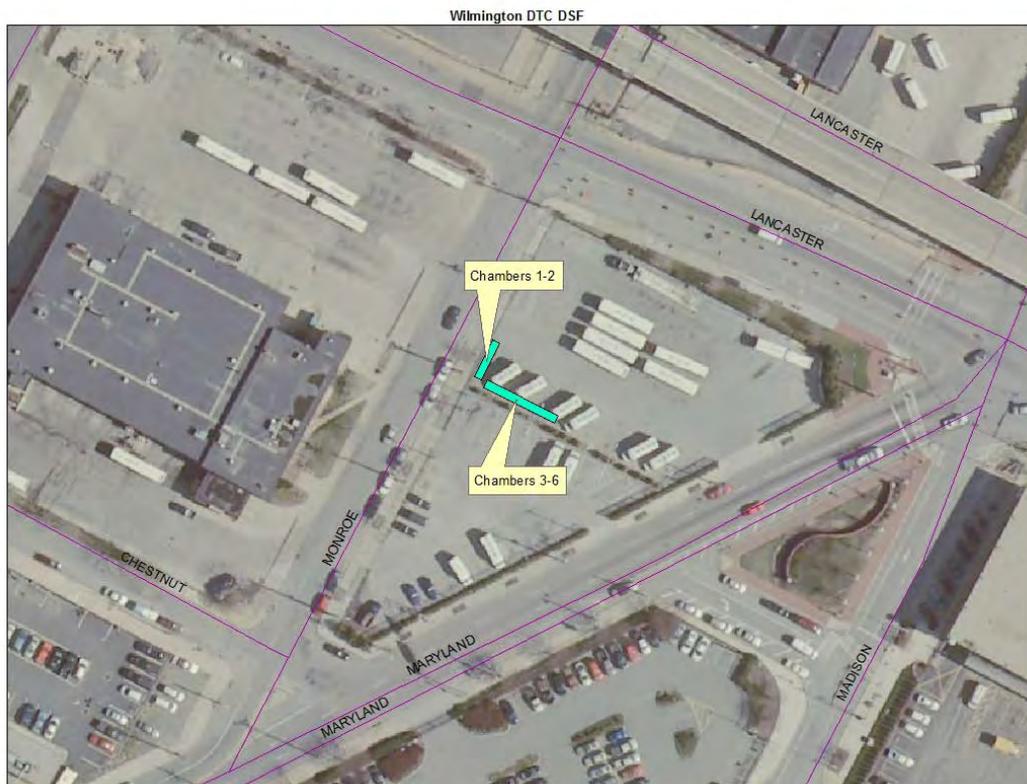
Caller contact information: 1354 Field Crew Subdivision: Minquadales East
County: New Castle
ADC Map No./Grid: 13-D5

Outfall / inlet ID# : 16374

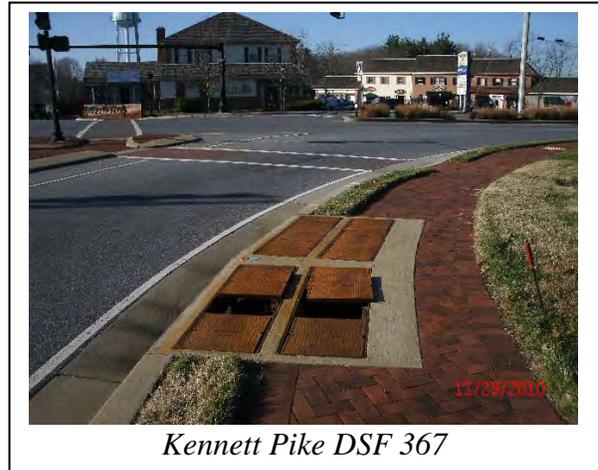
The purpose of this Memorandum is to summarize the investigation of a potential illicit discharge (PID) in the community of Minquadale East, located at 920 Hazeldell Avenue.

DATE: April 12, 2010

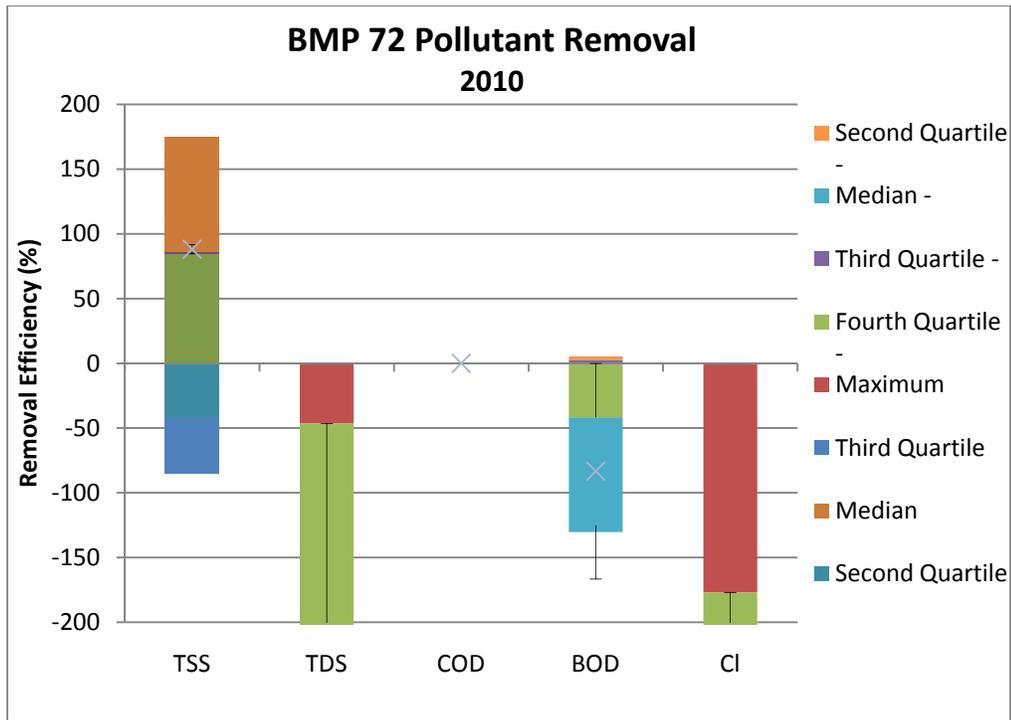
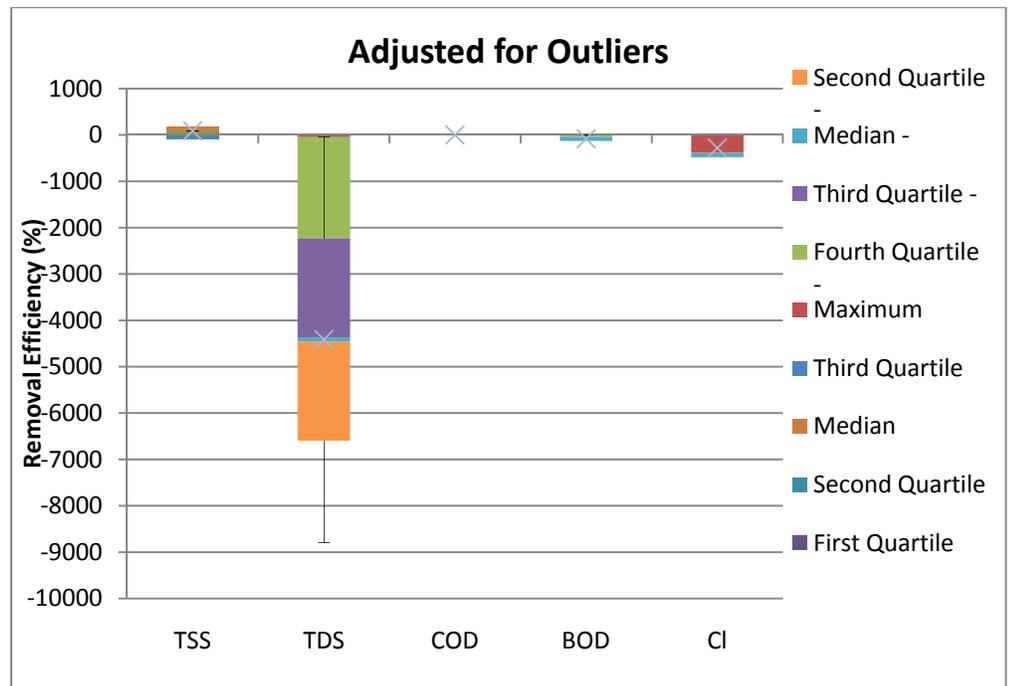
Removal Efficiency Statistical Data					
	Total Suspended Solids (TSS)	Total Dissolved Solids (TDS)	Chemical Oxygen Demand (COD)	Biological Oxygen Demand (BOD)	Chloride (Cl)
Count	2	2	2	2	2
Min	84.62	-8780	ND	-166.67	-384.16
25th	86.3825	-6596.61	ND	-125.003	-332.35
Median	88.145	-4413.22	ND	-83.335	-280.54
75th	89.9075	-2229.82	ND	-41.6675	-228.73
Max	91.67	-46.43	ND	0	-176.92
Mean	88.145	-4413.22	ND	-83.335	-280.54
SD	4.985103	6175.567	ND	117.8535	146.5408

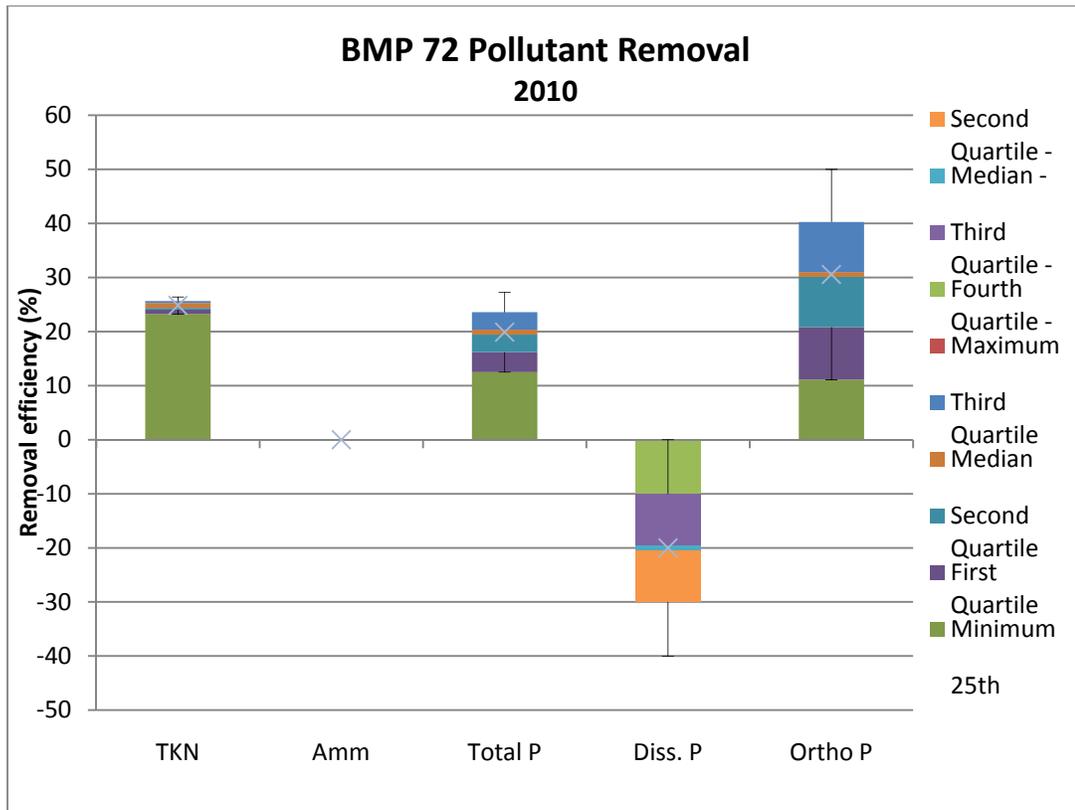
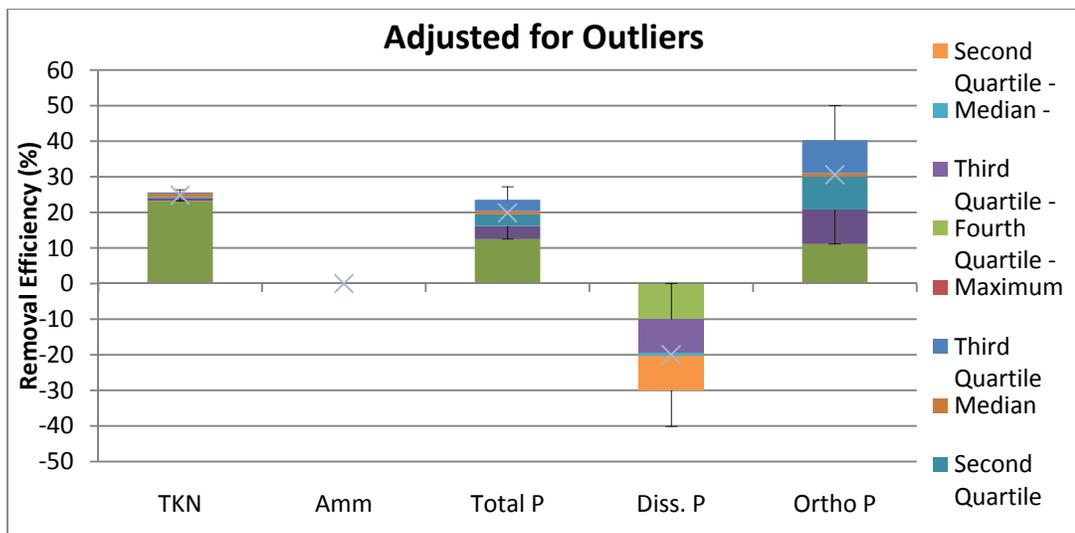
Removal Efficiency Statistical Data					
	Total Kjeldahl (TKN)	Ammonia	Total Phosphorus	Dissolved Phosphorus	Ortho Phosphate
Count	2	2	2	2	2
Min	23.26	ND	12.5	-40	11.11
25th	24.05	ND	16.1925	-30	20.8325
Median	24.84	ND	19.885	-20	30.555
75th	25.63	ND	23.5775	-10	40.2775
Max	26.42	ND	27.27	0	50
Mean	24.84	ND	19.885	-20	30.555
SD	2.234457	ND	10.44397	28.28427	27.49938

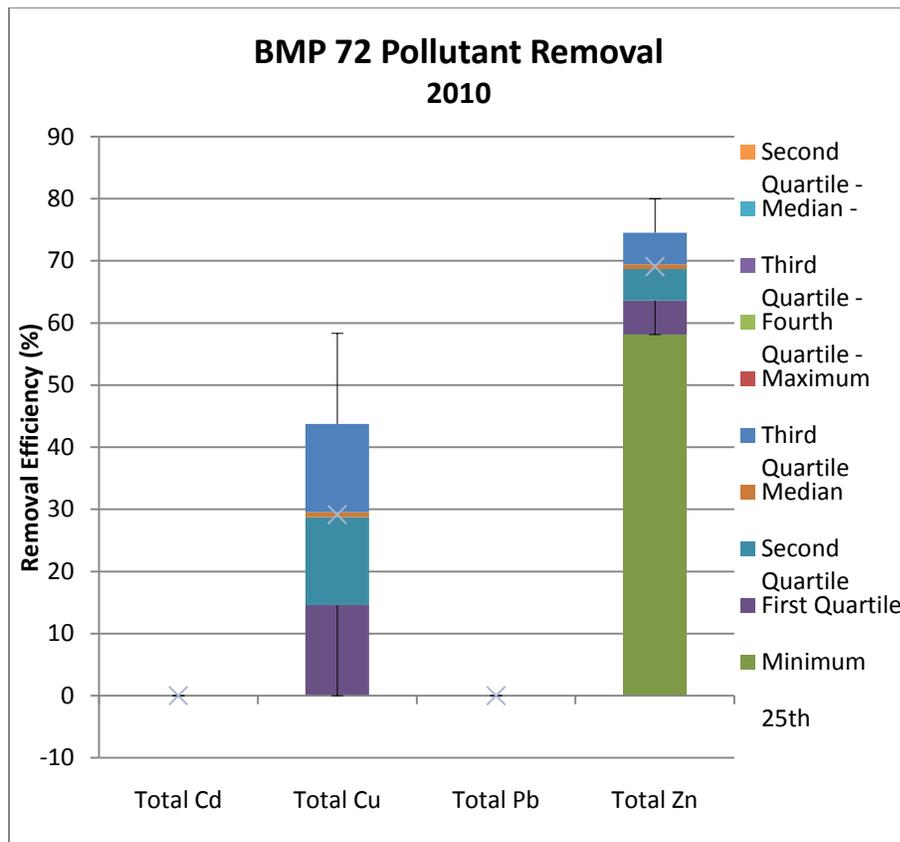
Removal Efficiency Statistical Data				
	Total Cadmium (Cd)	Total Copper (Cu)	Total Lead (Pb)	Total Zinc (Zn)
Count	2	2	2	2
Min	ND	0	ND	58.14
25th	ND	14.5825	ND	63.605
Median	ND	29.165	ND	69.07
75th	ND	43.7475	ND	74.535
Max	ND	58.33	ND	80
Mean	ND	29.165	ND	69.07
SD	ND	41.24554	ND	15.45735

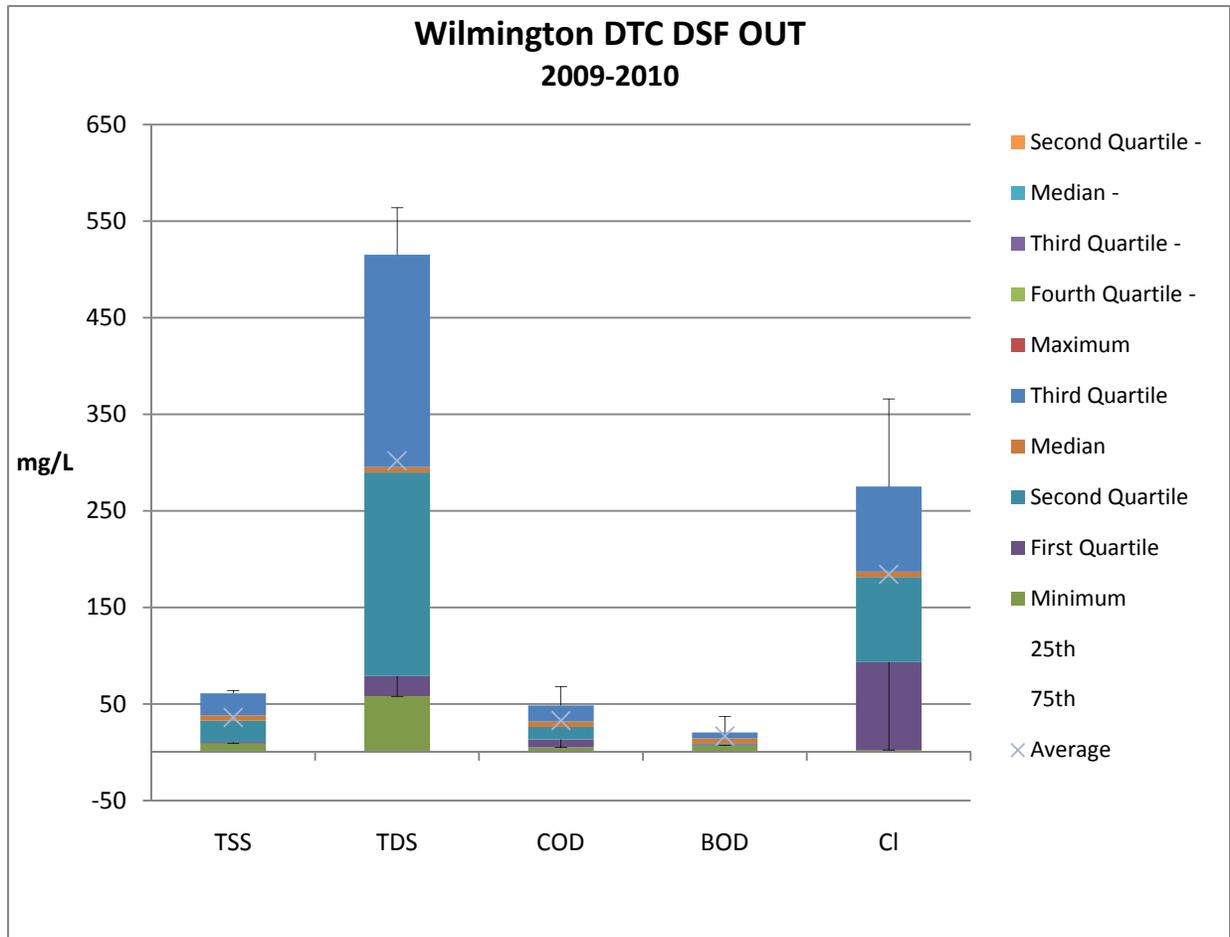
Statistical Data (2009-2010)					
	Total Suspended Solids (TSS)	Total Dissolved Solids (TDS)	Chemical Oxygen Demand (COD)	Biological Oxygen Demand (BOD)	Chloride (Cl)
Count	4	4	4	4	2
Min	9	58	5	7	2.48
25th	10.5	79	13.25	7.75	93.36
Median	35.5	292.5	29	11.5	184.24
75th	61	515.25	48.5	20.5	275.12
Max	64	564	68	37	366
Mean	36	301.75	32.75	16.75	184.24
SD	30.07768	266.8612	28.15878	13.96126	257.0475

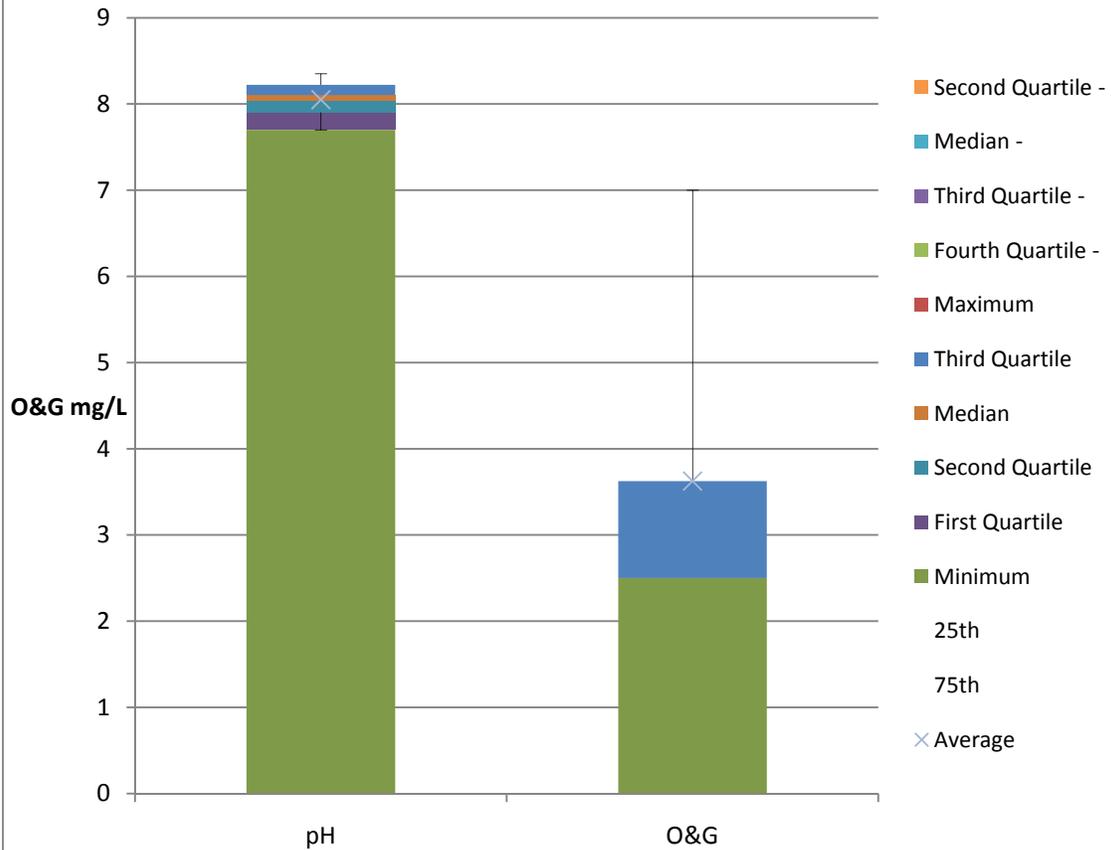
Statistical Data (2009-2010)		
	pH	Oil & Grease (O&G)
Count	4	4
Min	7.7	2.5
25th	7.9025	2.5
Median	8.075	2.5
75th	8.2225	3.625
Max	8.35	7
Mean	8.05	3.625
SD	0.280357	2.25

Laboratory Data (2009-2010)		
Date	pH	Oil & Grease (O&G)
12/09/09	7.7	7
01/25/10	8.35	ND
02/23/10	8.18	ND
12/01/10	7.97	ND

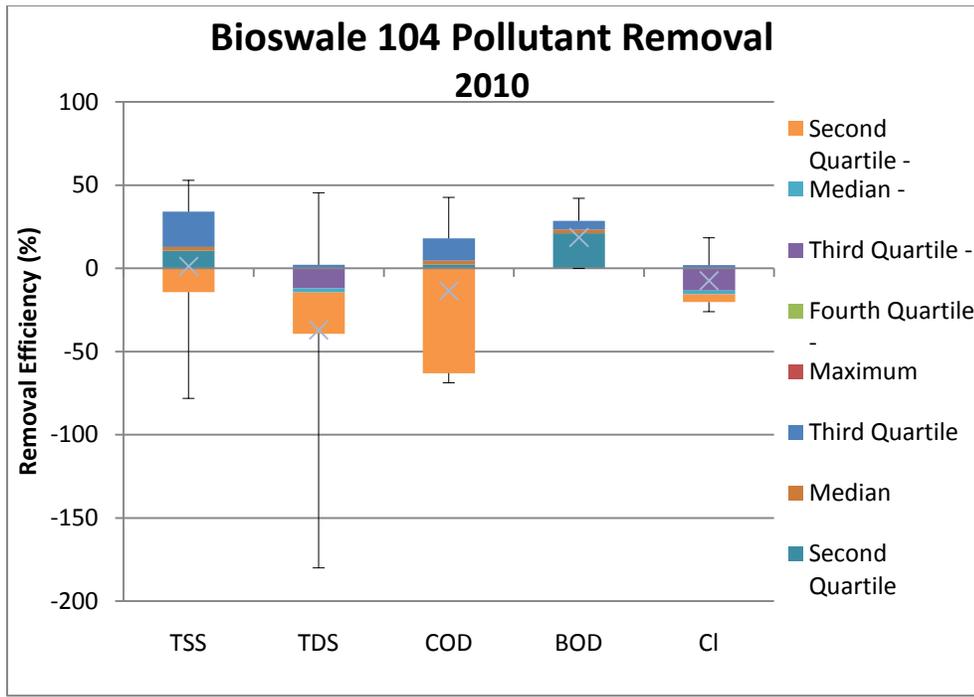
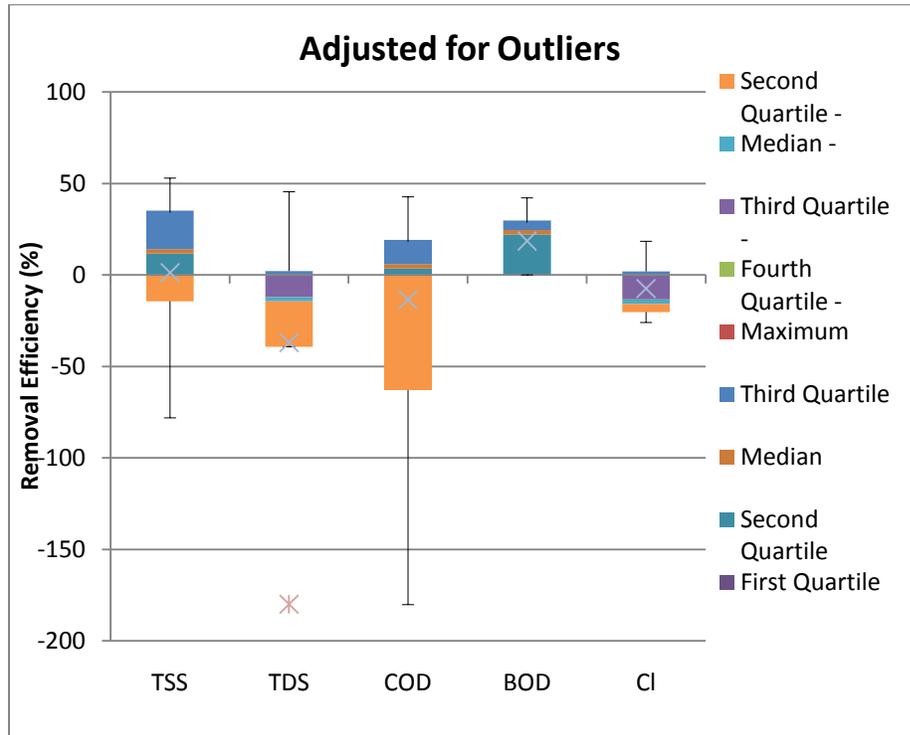
Removal Efficiency Statistical Data					
	Total Suspended Solids (TSS)	Total Dissolved Solids (TDS)	Chemical Oxygen Demand (COD)	Biological Oxygen Demand (BOD)	Chloride (Cl)
Count	5.00	5.00	5.00	5.00	3.00
Min	-78.13	-180.00	-68.75	0.00	-26.01
25th	-14.29	-39.24	-62.96	0.00	-20.27
Median	11.76	-13.21	3.57	22.22	-14.53
75th	34.04	2.13	18.06	28.57	1.93
Max	52.92	45.45	42.67	42.11	18.38
Mean	1.26	-36.97	-13.48	18.58	-7.39
SD	50.99	85.66	49.85	18.42	23.04

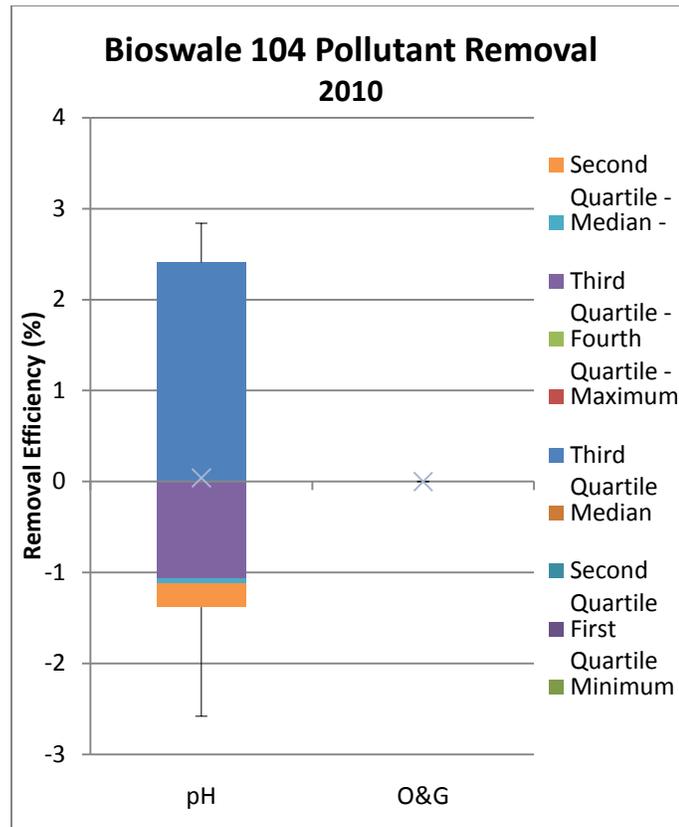
Removal Efficiency Statistical Data		
	pH	Oil & Grease (O&G)
Count	5.00	5.00
Min	-2.58	ND
25th	-1.38	ND
Median	-1.09	ND
75th	2.41	ND
Max	2.84	ND
Mean	0.04	ND
SD	2.43	ND

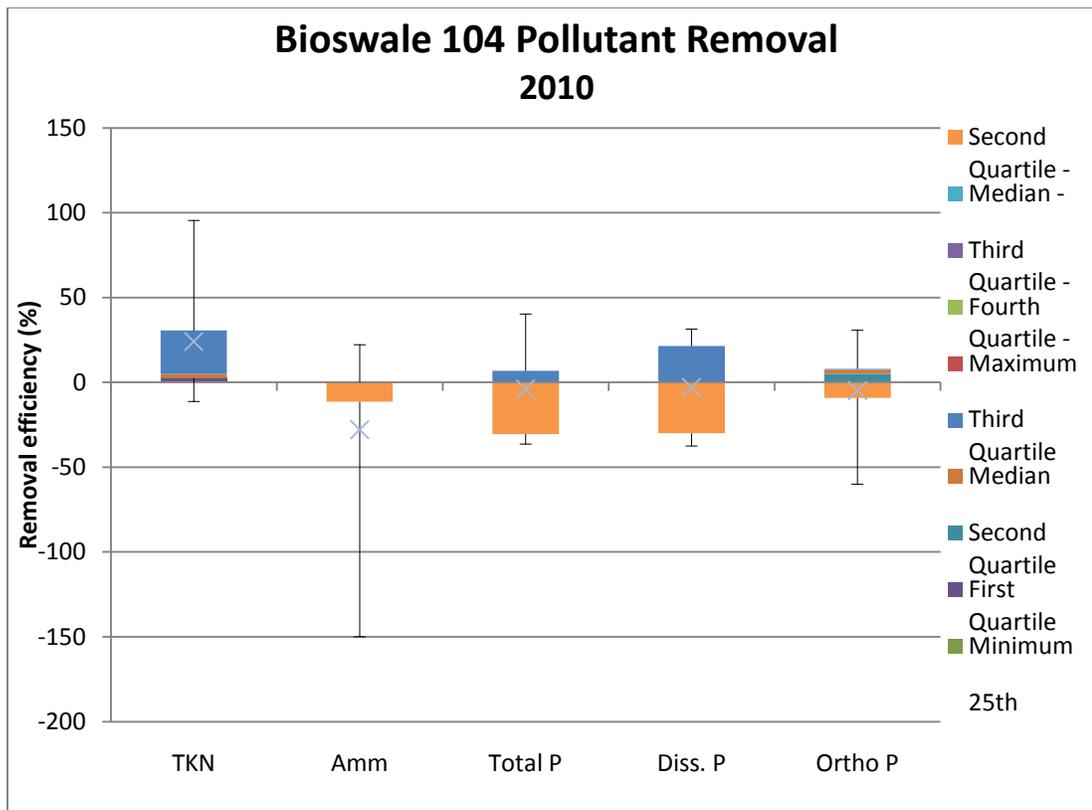
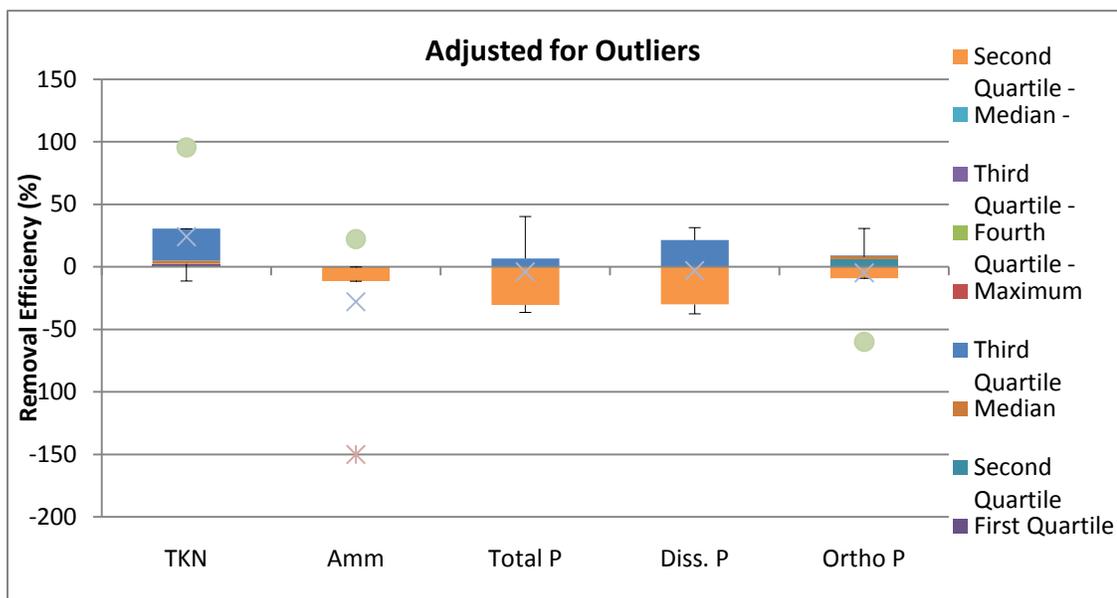
Removal Efficiency Statistical Data					
	Total Kjeldahl (TKN)	Ammonia	Total Phosphorus	Dissolved Phosphorus	Ortho Phosphate
Count	5.00	5.00	5.00	5.00	5.00
Min	-11.25	-150.00	-36.36	-37.50	-60.00
25th	2.46	-11.43	-30.43	-30.00	-9.09
Median	3.51	0.00	0.00	0.00	6.25
75th	30.51	0.00	6.82	21.43	8.00
Max	95.48	22.22	40.32	31.43	30.77
Mean	24.14	-27.84	-3.93	-2.93	-4.81
SD	42.66	69.37	31.00	30.46	33.97

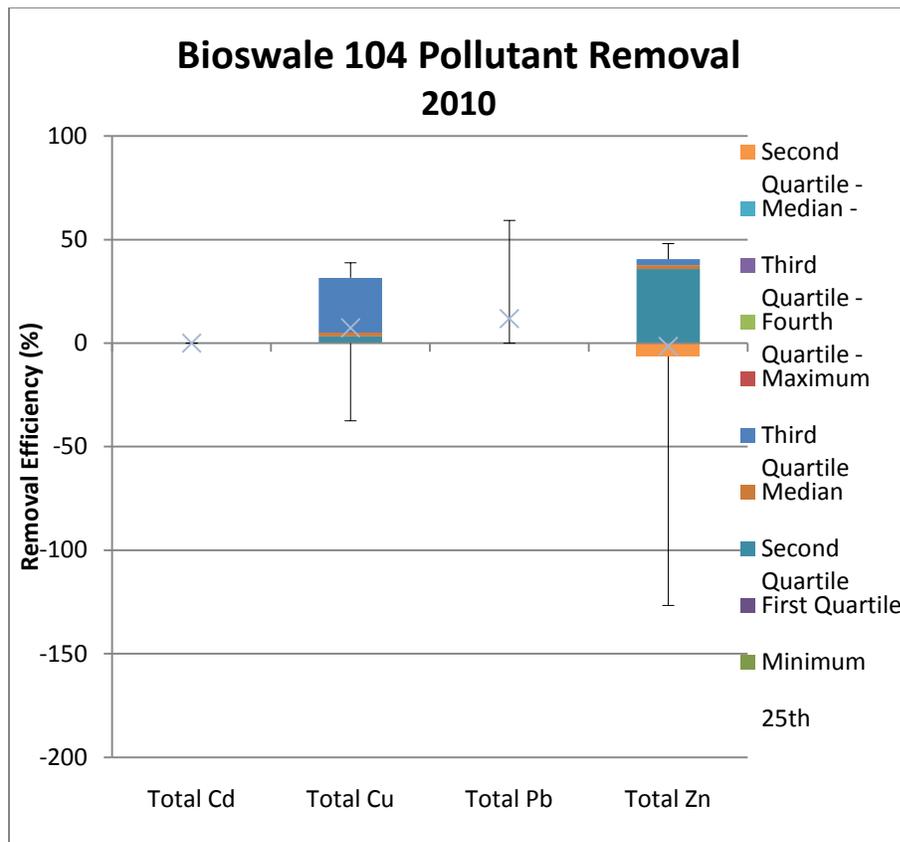
Removal Efficiency Statistical Data				
	Total Cadmium (Cd)	Total Copper (Cu)	Total Lead (Pb)	Total Zinc (Zn)
Count	5.00	5.00	5.00	5.00
Min	ND	-37.50	0.00	-126.67
25th	ND	0.00	0.00	-6.38
Median	ND	4.17	0.00	36.76
75th	ND	31.58	0.00	40.54
Max	ND	38.81	59.26	48.08
Mean	ND	7.41	11.85	-1.53
SD	ND	30.22	26.50	73.11

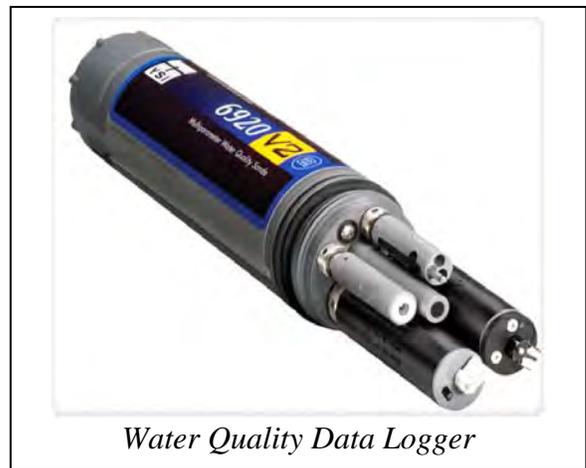
Water Quality Data Logger

KCI installed and maintains the monitoring equipment at both locations, in addition to continually evaluating the water quality data. The upstream and downstream solar powered YSI water quality data loggers are equipped to monitor the following parameters: dissolved oxygen, turbidity, pH, temperature, and conductivity.

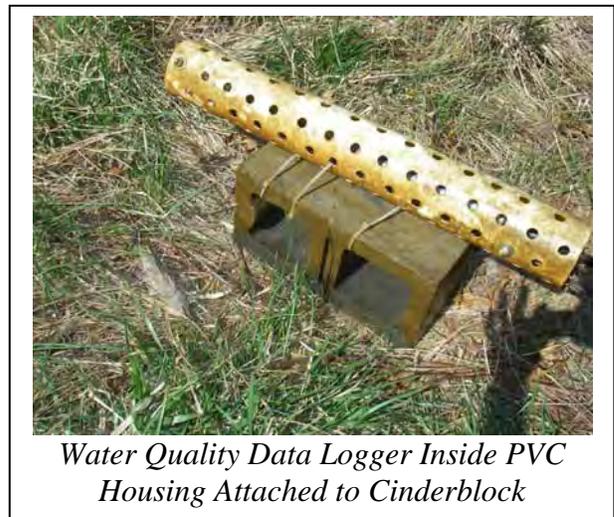
Water Quality Data Logger Inside PVC Housing Attached to Cinderblock

The water quality data loggers are each hard wired to a separate docking station by a long cable protected by a 1.25 inch electrical conduit buried in the ground. The docking stations are each equipped with a 20 watt solar panel, antenna and EcoNet Data Logger/Transmitter that transfers real-time data to an EcoNet Data Acquisition System, which can be viewed through the YSI EcoNet Website on the internet. EcoNet provides automated data reports, and real time alarming and alerting when parameters exceed user-defined thresholds. KCI monitors the data collected from the water quality loggers and prepares weekly memorandums summarizing data observations. DelDOT is notified of unusual parameter levels or other equipment issues.

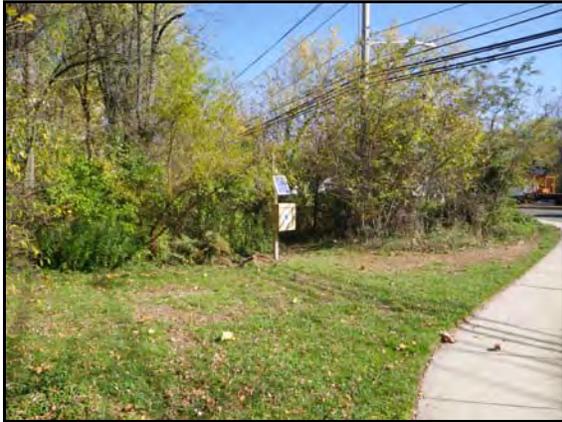
*Christina River: Elkton Road
Upstream Docking Station*

Continuous stream monitoring equipment was installed on the westbound (upstream) and eastbound (downstream) sides of the Elkton Road overpass of the Christina River in New Castle County (See Location Map next page). Installation was completed in December 2010. The purpose of the monitoring is to evaluate water quality during the Elkton Road construction project. The project includes pavement reconstruction; additional turn lanes at the intersection of Elkton Road and Casho Mill and Apple Roads; reducing Elkton Road between Apple Road and Delaware Avenue from four to two lanes with a two-way center turn lane and a landscaped median just south of Amstel Avenue Intersection; new sidewalks and curb ramps; bike lanes; and utility improvements. The project's estimated completion date is September 2012.

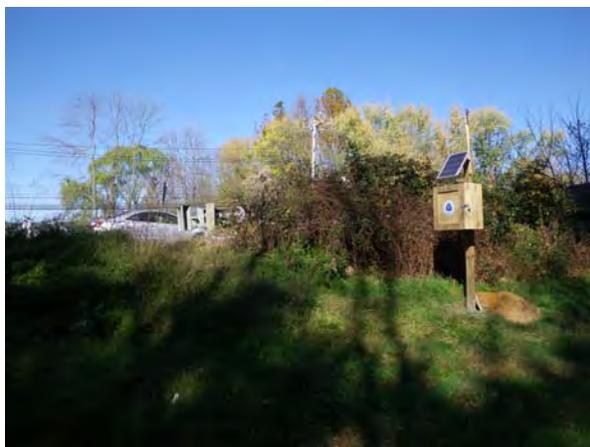
*Christina River: Elkton Road
Downstream Docking Station*
