**ADA Compliance  
Inspection Application**

### Curb Ramp, Type 1A (Retrofit)

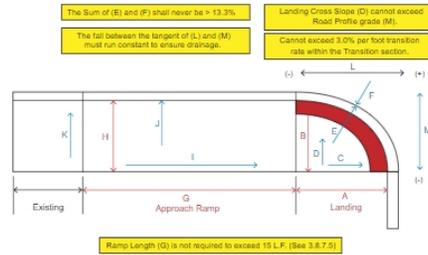
#### Grading

A (in) 0

B (in) 0

C (%) 0

D (%) 0

E (%) 0

F (%) 0

G (ft) 0

H (in) 0

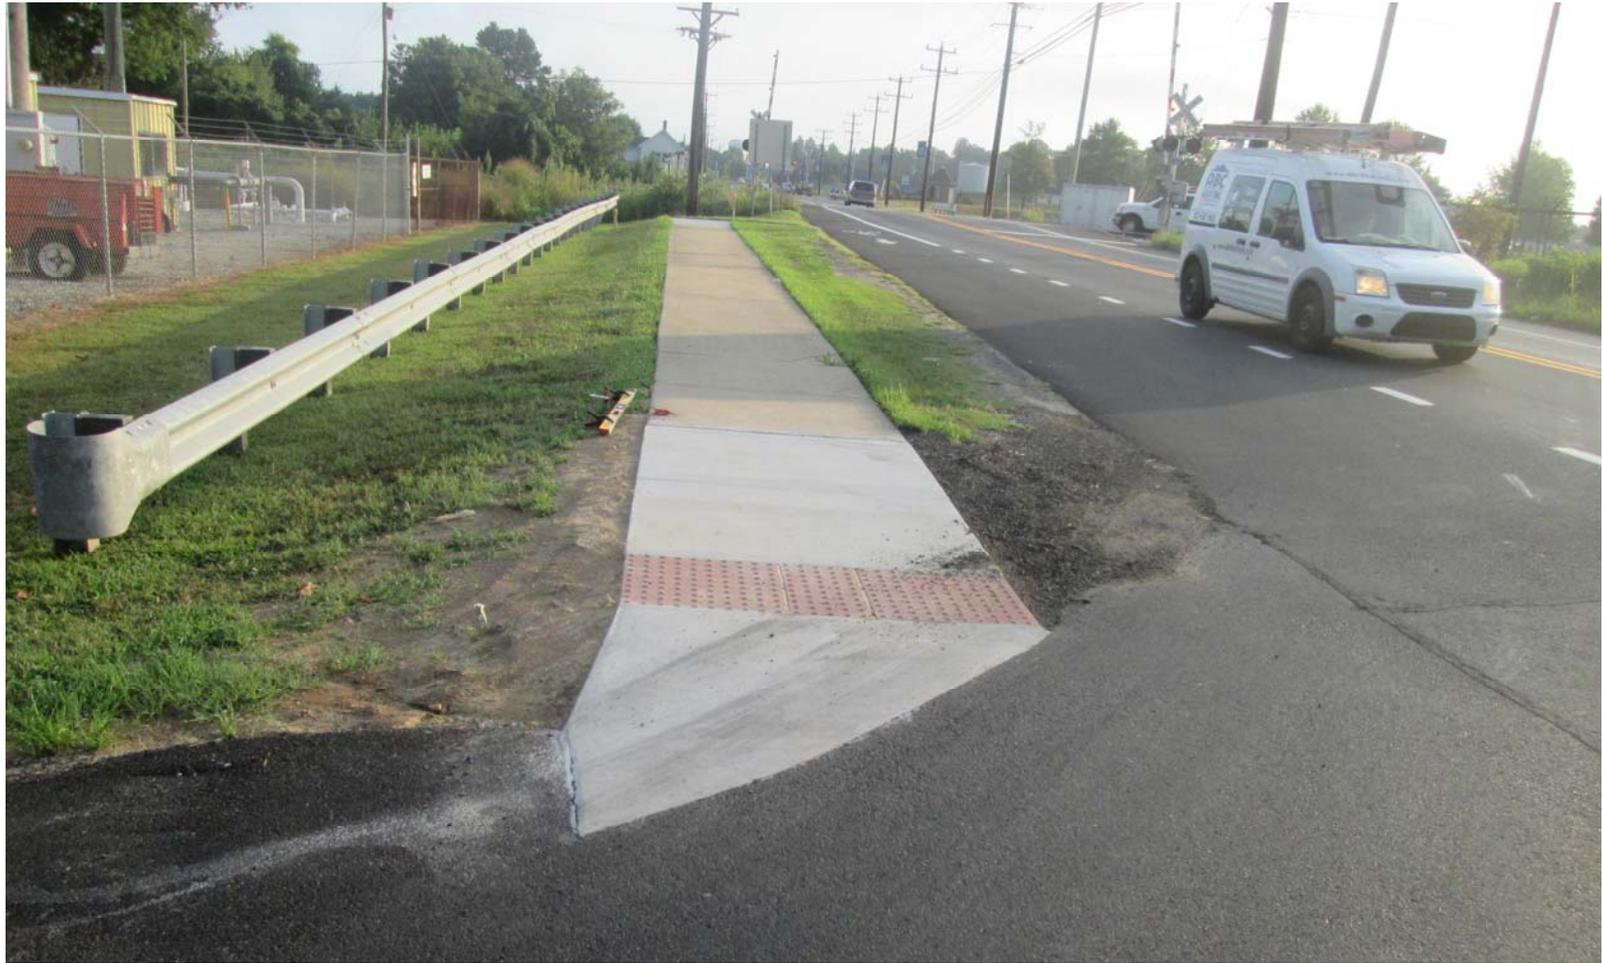
## Other Things that will cause ADA Failure

The Slope on the Street Side of the Gutter MUST be no more than 5%

The Slope on the Sidewalk Side of the Gutter MUST be no more than 8.3%
