# BR 1-366 on Chesapeake City Road: DelDOT's First GRS-IBS Bridge

Presenter:

Barry Benton, P.E.

Assistant Director, Bridge

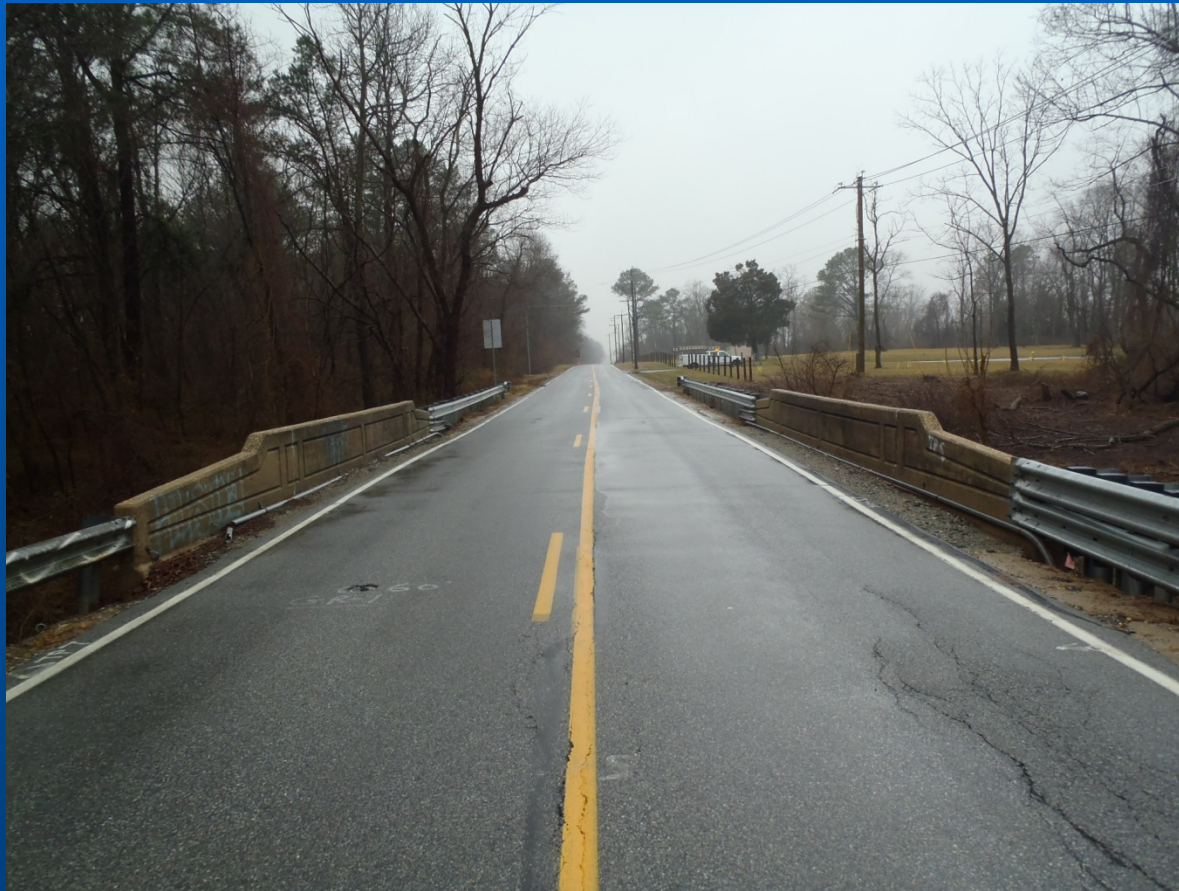
East Approach

- **Constructed in 1935.**
- **29' span, concrete encased steel beams on masonry abutments.**
- **Curb to curb width was 24.5'.**
- **Structurally Deficient (Superstructure NBI 3) and Functionally Obsolete.**

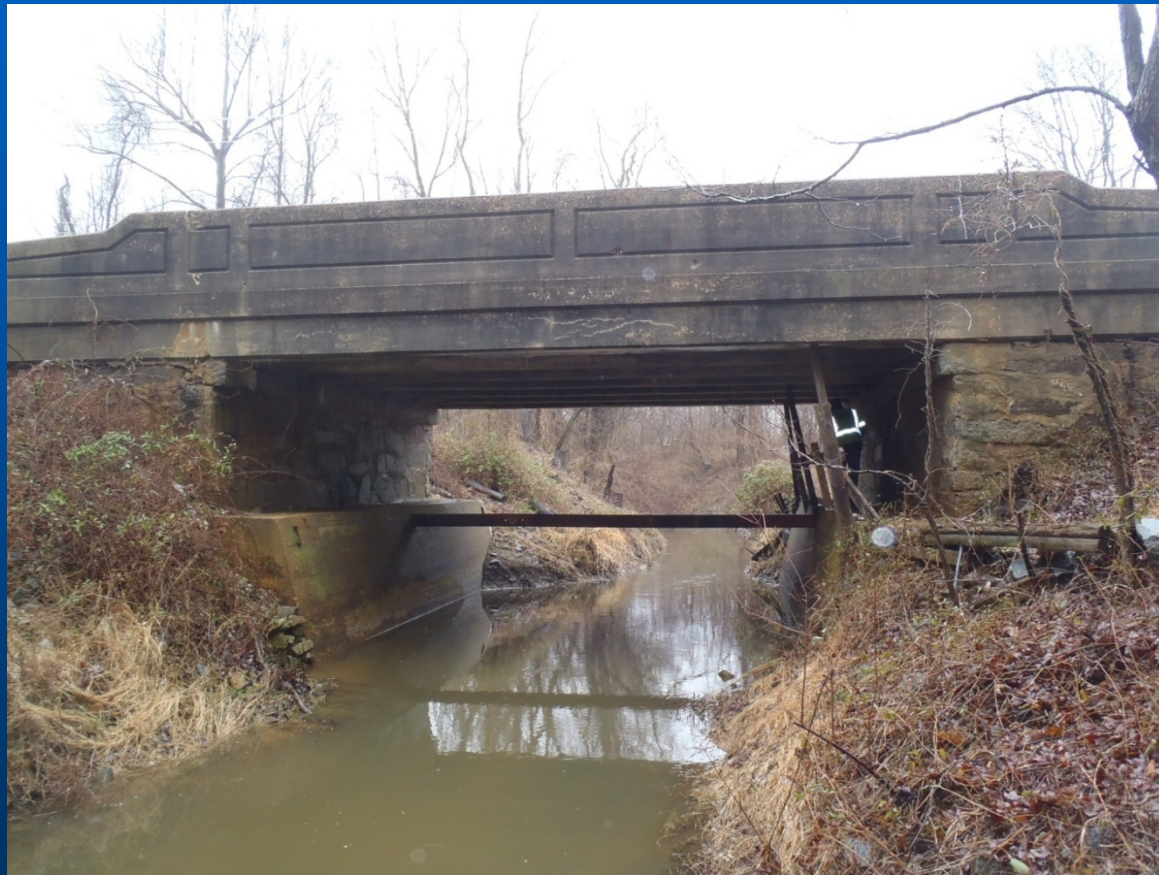
South Elevation

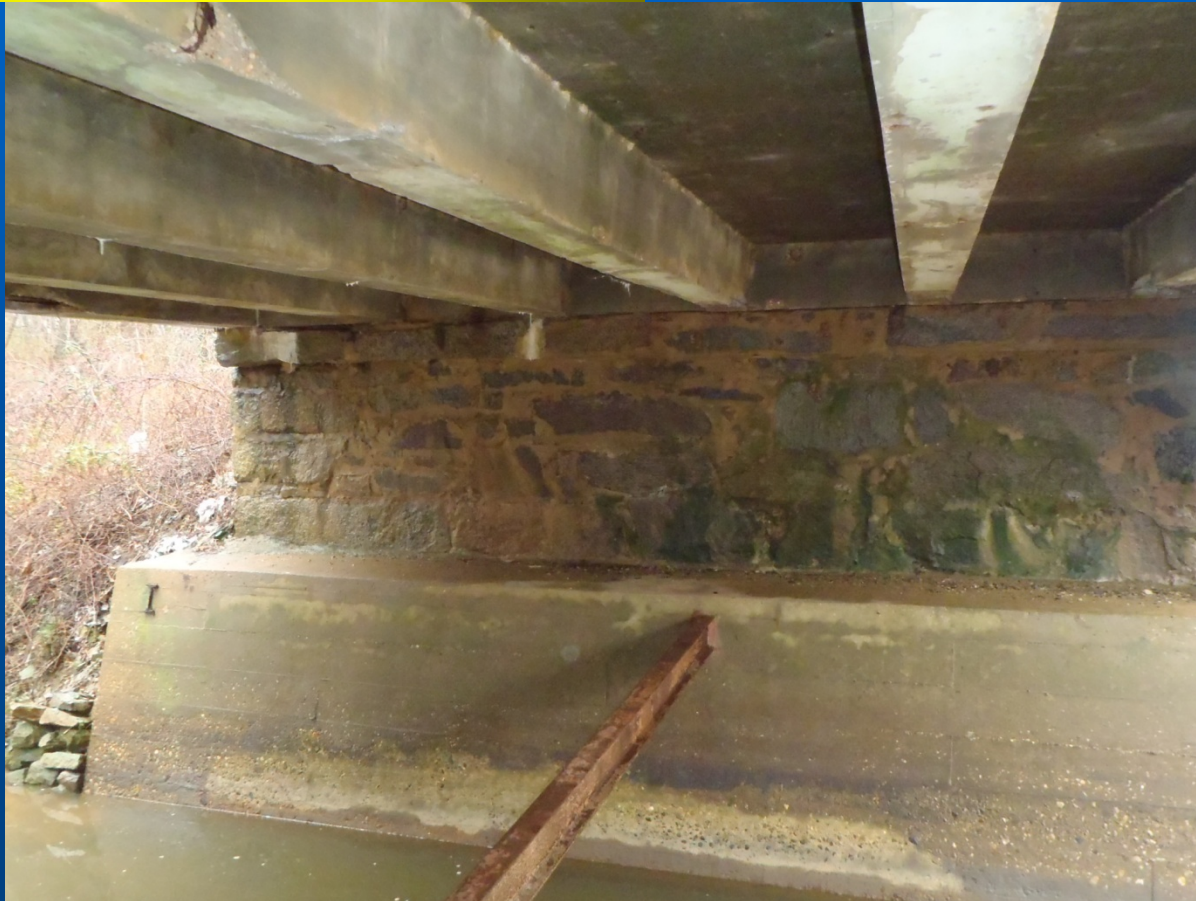
General View West Abutment

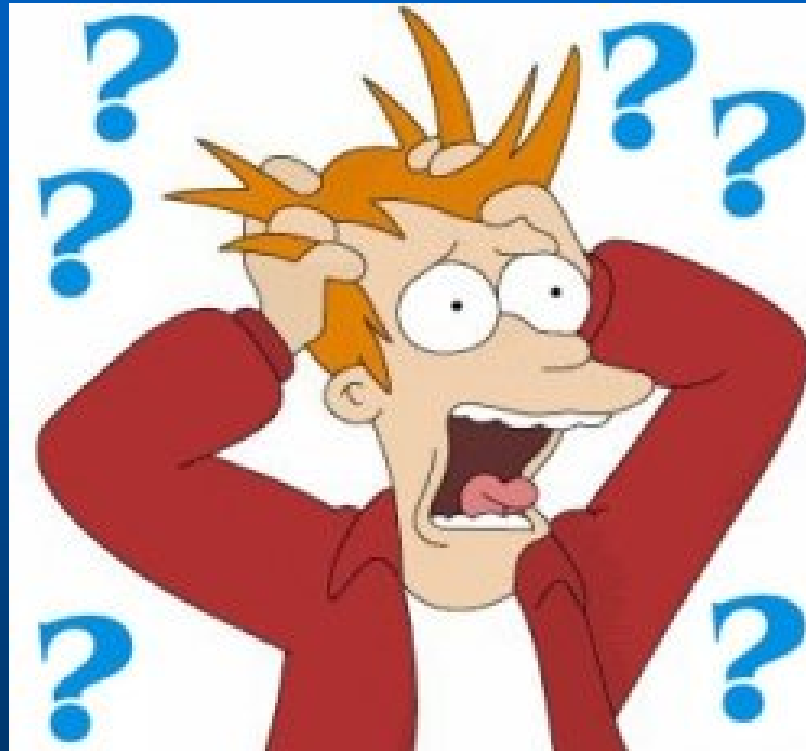
# Structure Selection

- Based on the need to complete the construction quickly, the boring results, and the H&H analysis, a small structure was the best option.
- Typically a precast concrete frame would be the selected structure type.
- However, Every Day Counts!
- GRS-IBS abutment bridge selected.

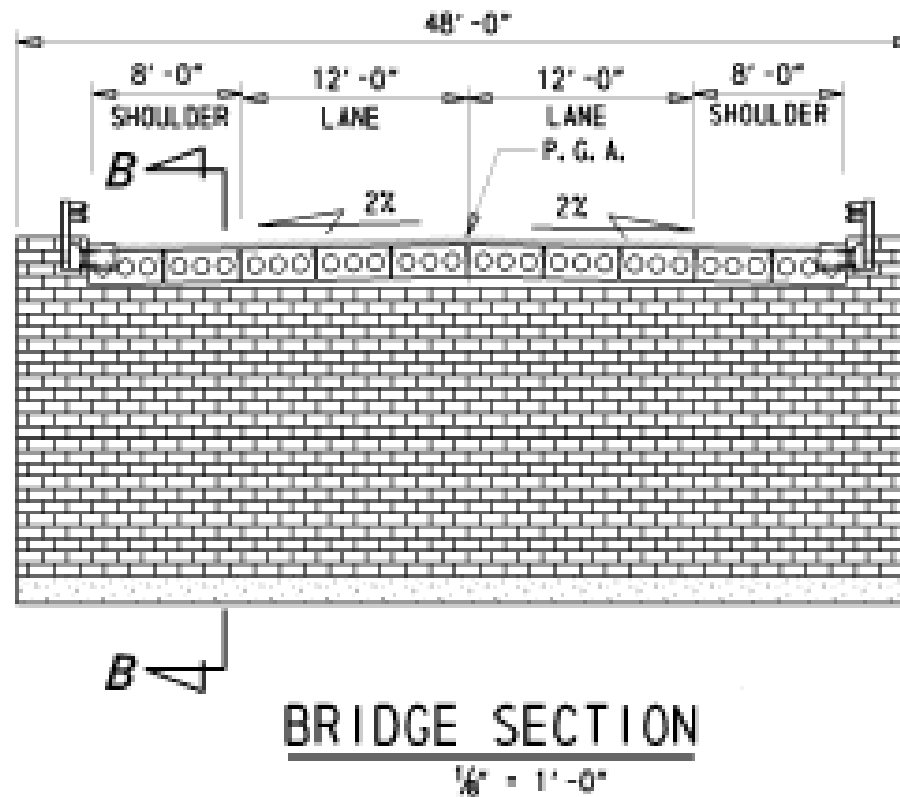
- The backfill is extremely important.
- FHWA recommends either a well graded or an open graded material.
- For this project, the open graded material was used.
- A #89 stone was specified. We ended up using a select #8 stone.

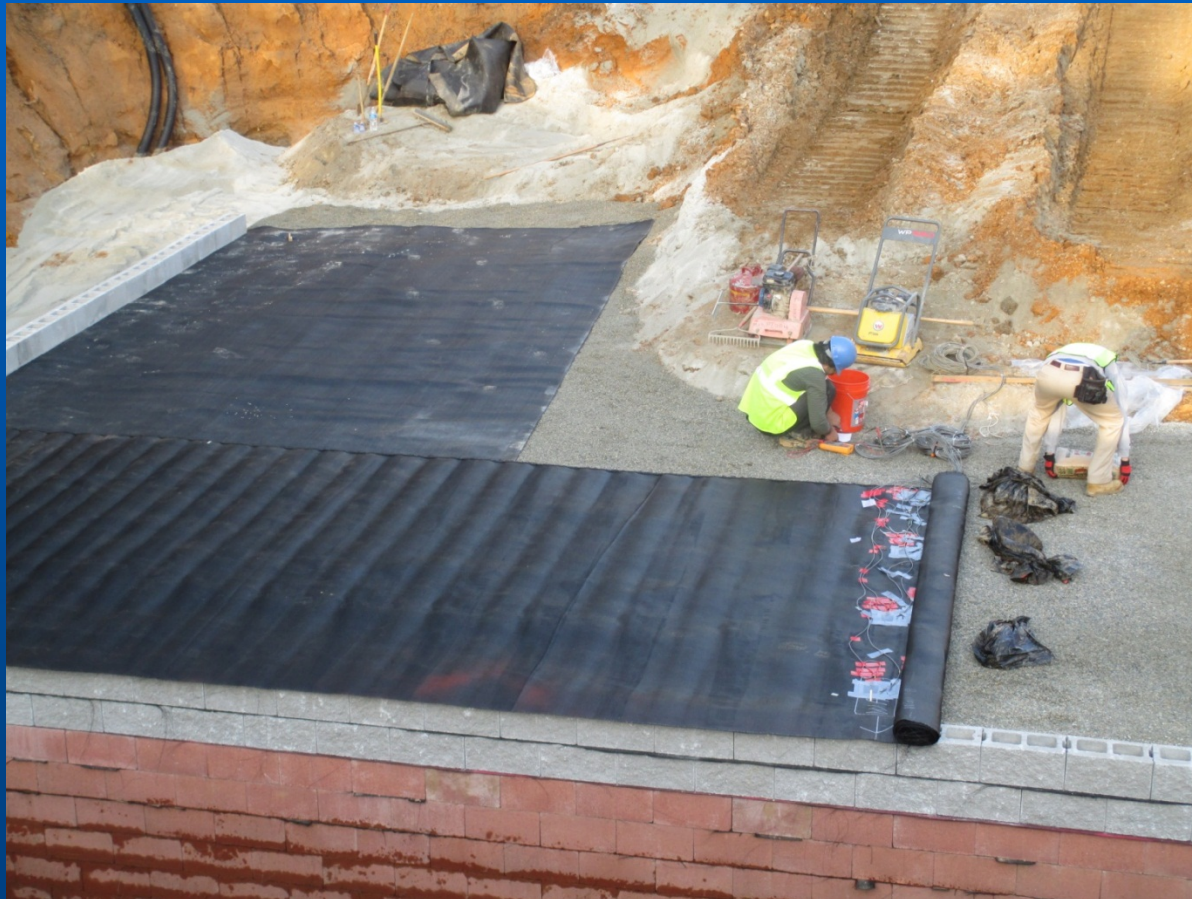
# Research Component

- We have worked with Dr. Chris Meehan and his staff from the University of Delaware throughout the project.
- The University verified the design of the GRS abutment components.
- They also developed an instrumentation plan to accompany their research.

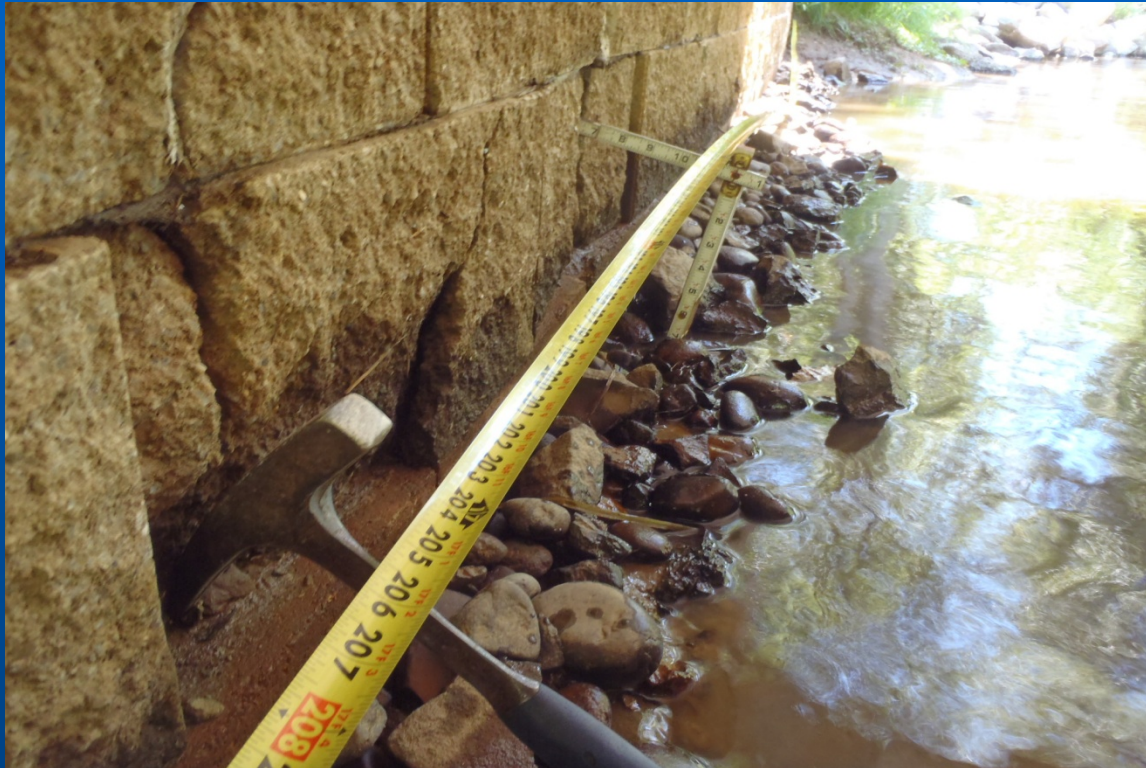
**East Abutment with Broken Blocks (Looking South)**

- **First course of block is vital. Must be straight, level and plumb.**
- **The blocks slide easily if the edges are too smooth. Need a batter to allow for some movement.**
- **Allow for learning curve. The second abutment was much better than the first.**
- **Inspectors need to understand how the bridge works.**

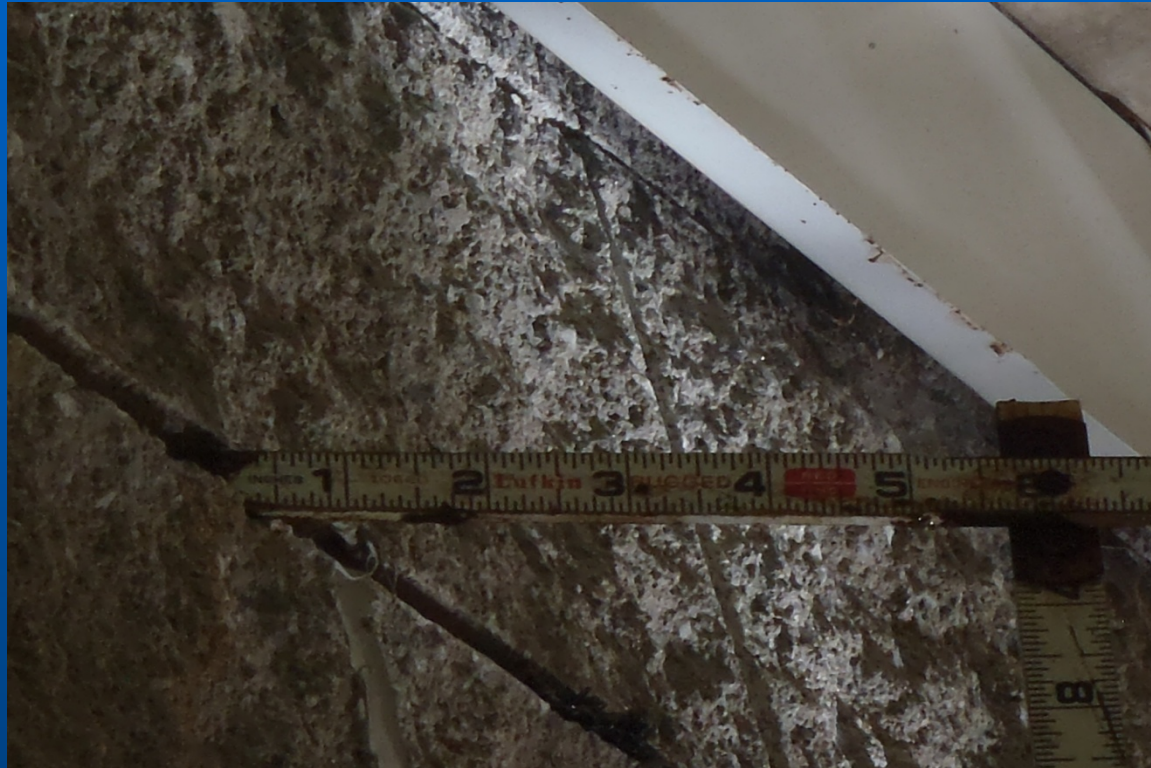
**East Abutment – ¾" Wide Joint Gap in 2nd Row from Top (Looking Up)**

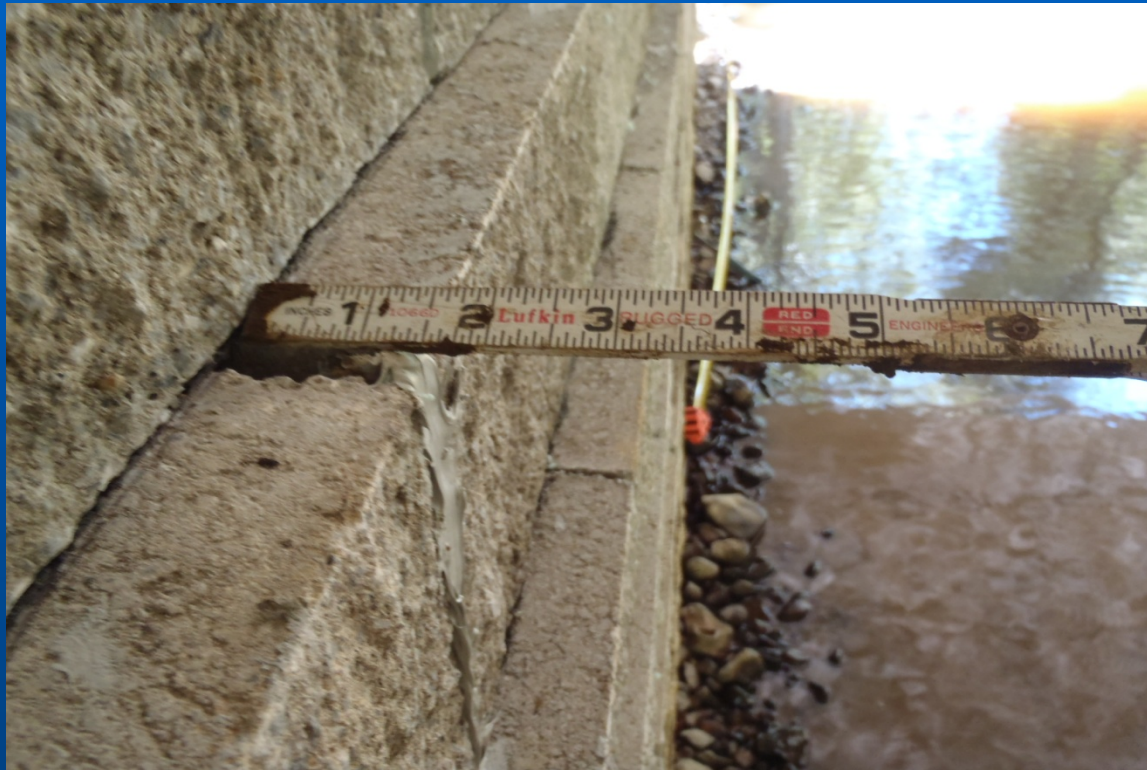
**East Abutment – Uneven Battering or Bulging (~8 Feet Below Girders)**
