Delaware Department
of Transportation

HAWK Pedestrian Signal Compliance Review

May 2020

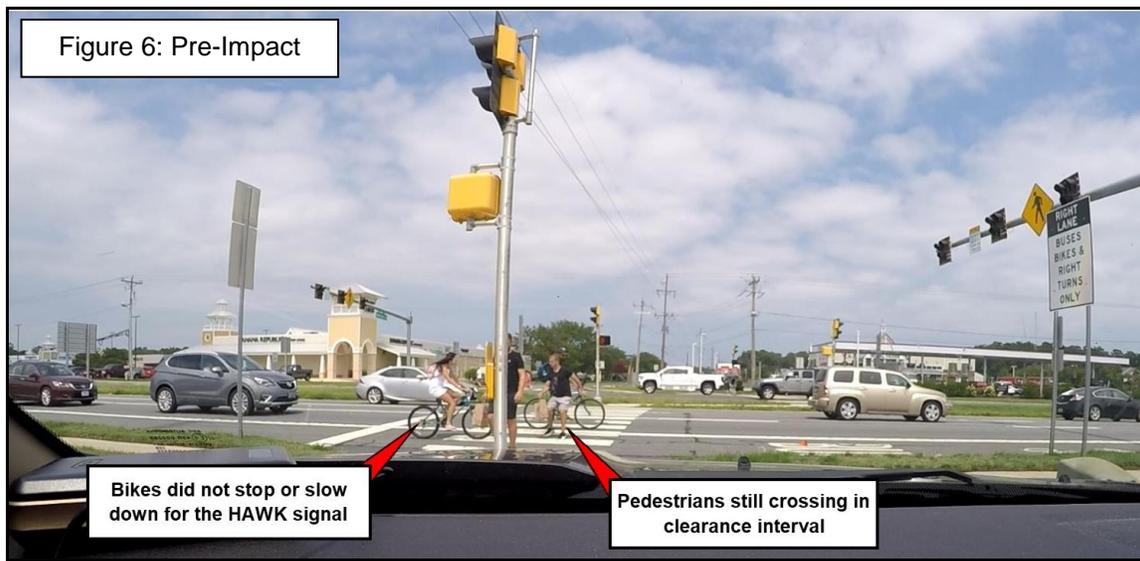
The field observations at SR 1 and Holland Glade Road also revealed conflicts between pedestrians and bicyclists. Bicyclists frequently ignore the HAWK signal and do not stop or slow down for pedestrians, which creates a potential conflict. An example of this is shown in **Figures 6 and 7** when a pedestrian in the crosswalk was struck by a bicyclist. During this incident, two (2) pedestrians were crossing the southbound lanes during the clearance interval. Two (2) bicyclists traveling southbound on SR 1 failed to stop or slow down for the HAWK signal or the pedestrians, which resulted in one of the bicyclists striking the pedestrian.

Figure 6: Bicyclists failed to stop for the SR 1 and Holland Glade Road HAWK Signal

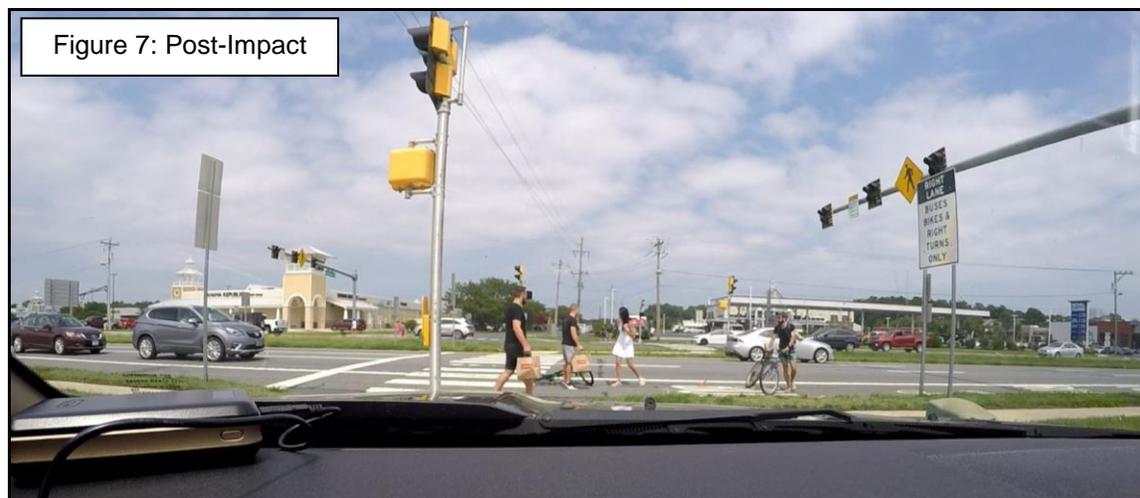
Figure 7: The bicyclist struck the pedestrian

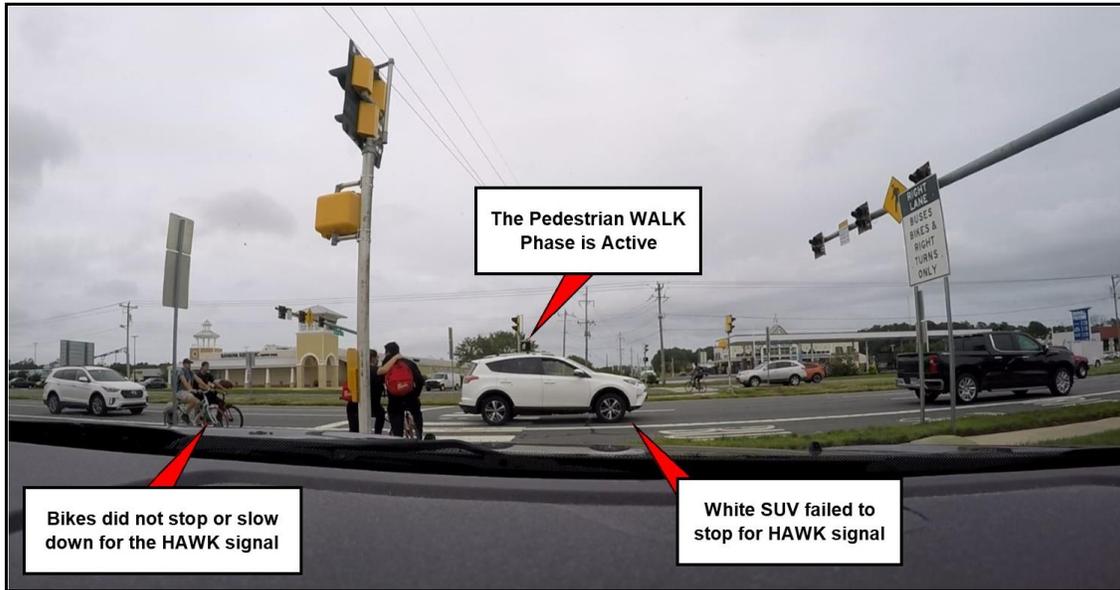
Figure 8 shows the importance of checking for oncoming traffic even if the pedestrians have the WALK phase. In this image, the pedestrians have the WALK phase, but the white SUV ran the red light and the bicycles did not slow down or stop for the HAWK signal.

Figure 8: Examples of conflicts at SR 1 and Holland Glade Road HAWK Signal

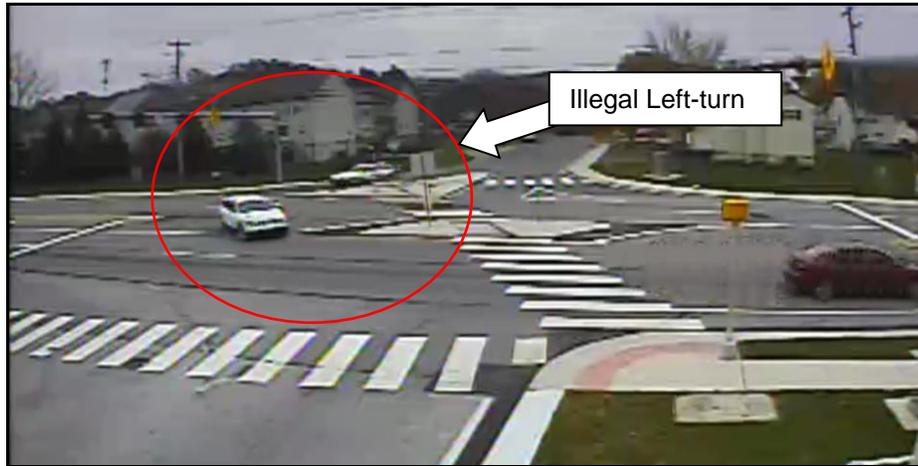
Field observations at this site revealed a safety concern associated with the installation of a HAWK signal at a four (4) leg intersection with channelized movements. Specifically, there are large channelizing islands on the north and south legs to prevent vehicles from turning left onto SR 273 from the minor street approaches. However, during the field observations, vehicles were observed using the gap in traffic created by the HAWK signal to illegally drive around the islands to turn left onto SR 273 (see **Figure 10**). This action by the motorists creates a safety hazard for pedestrians using the crosswalk during the WALK phase.

Figure 10: Vehicle turning left from Freedom Trail
