**SR 1, Dewey Beach
Anchor Way to Bayard Avenue
Pedestrian Access Routes (PAR):
ADA Assessment**

April 2019

Delaware Department of Transportation

Agreement No. 1789, Task 1

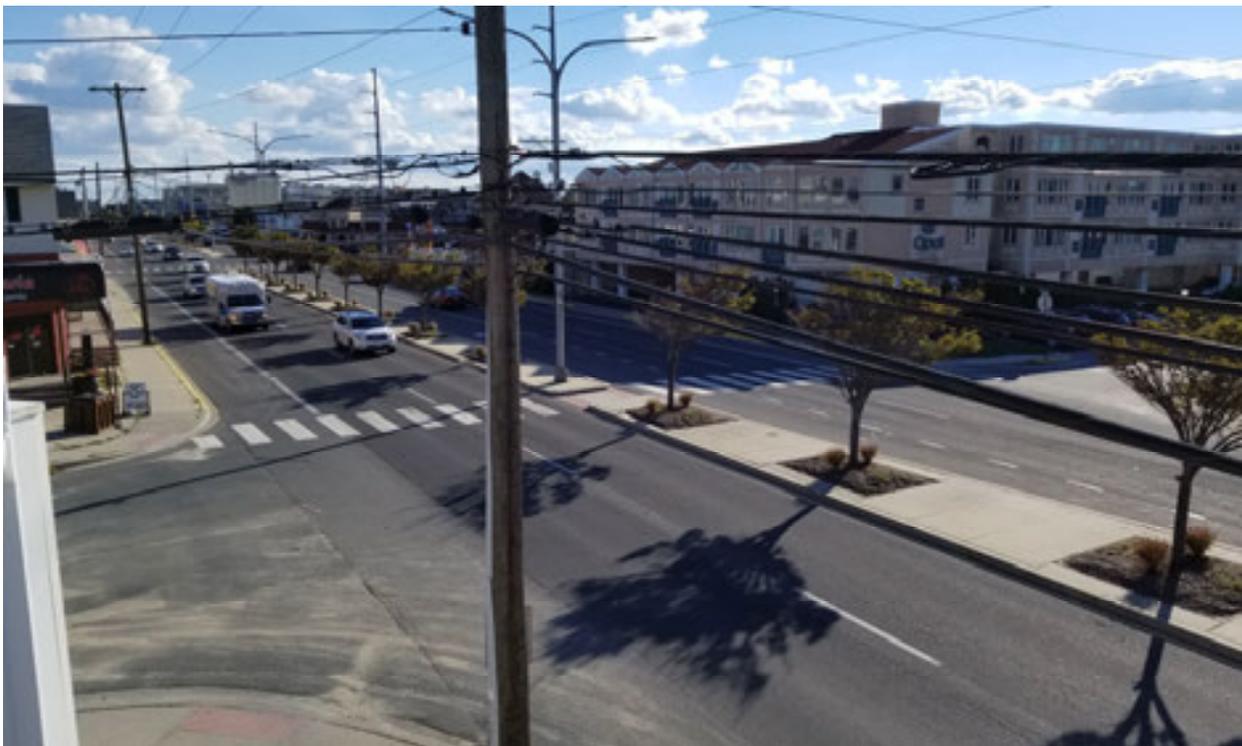
Photo 1: Looking southwest at the intersection of SR 1 and McKinley Avenue

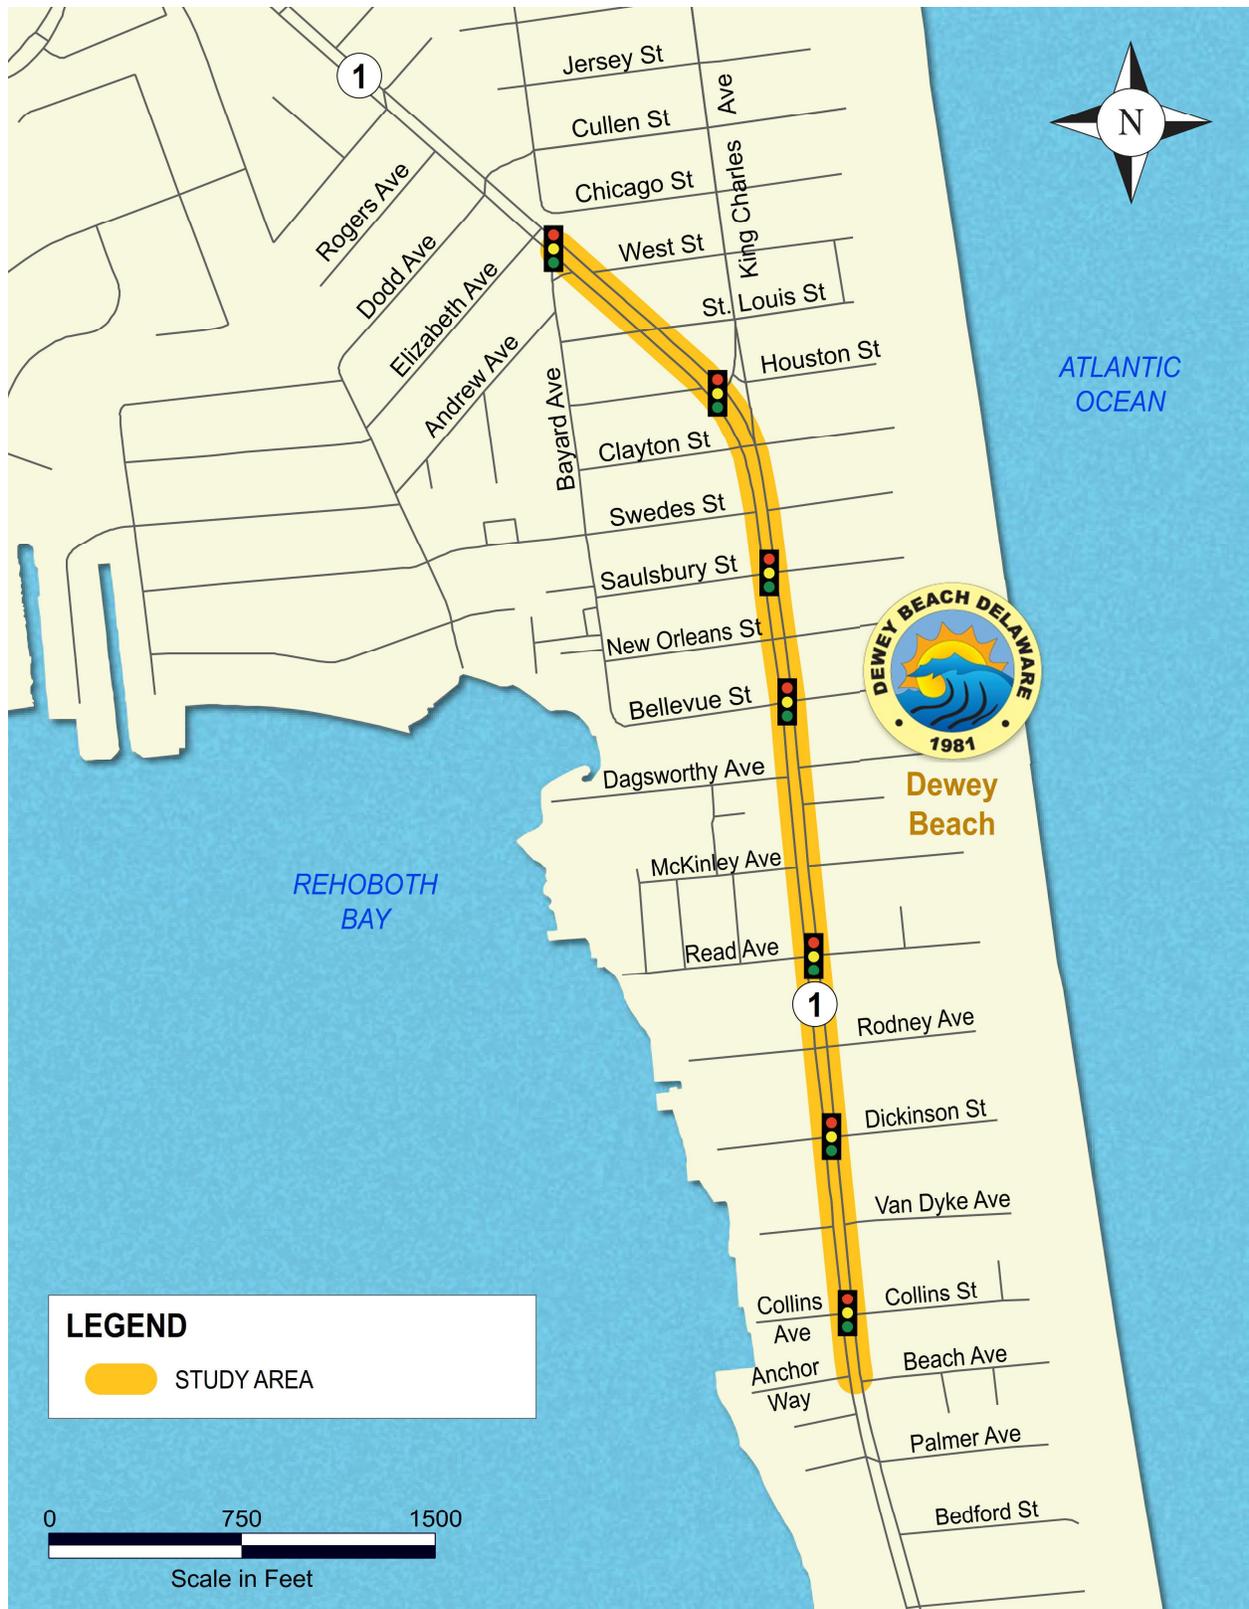
Figure 1: Study area

The study area for the pedestrian facilities assessment is along SR 1 from Anchor Way to Bayard Avenue in the Town of Dewey Beach, Sussex County. Figure 1 on the next page highlights the limits of the study area.

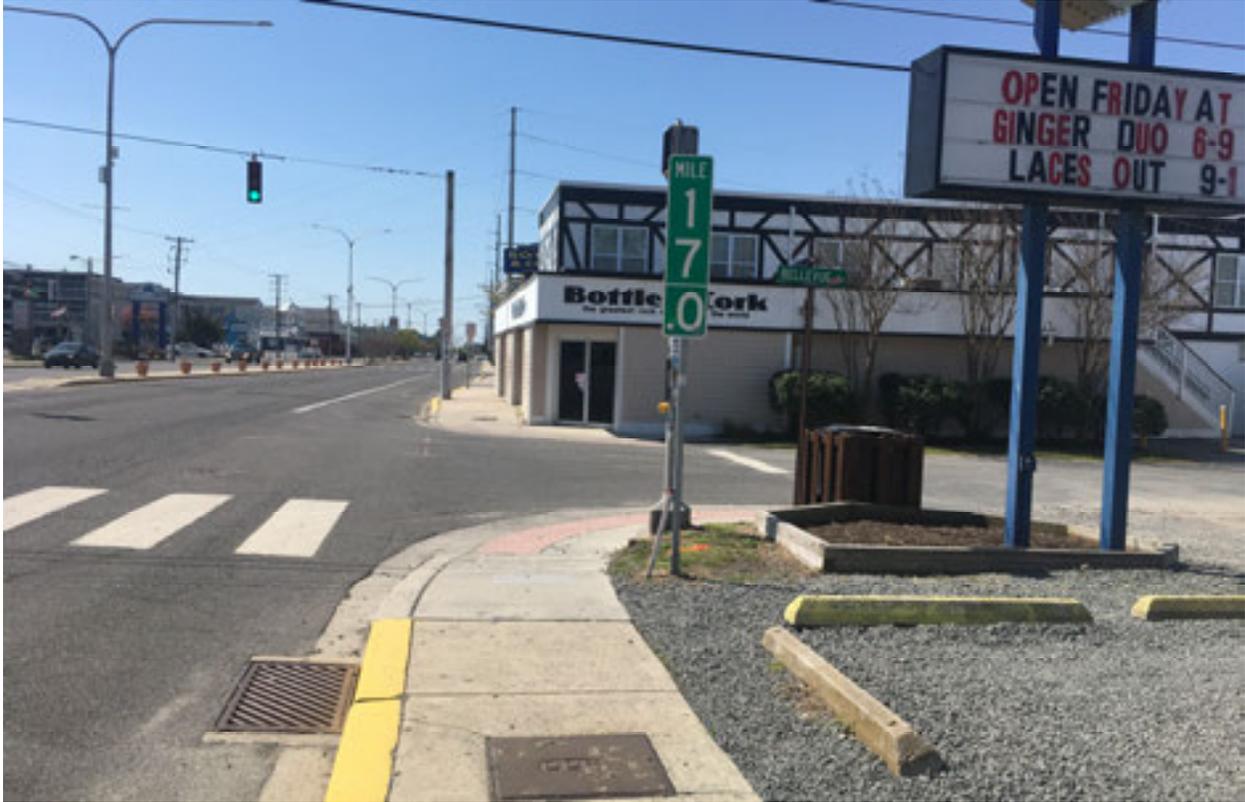
Photo 2: Looking south at the intersection of SR 1 at Bellevue Street

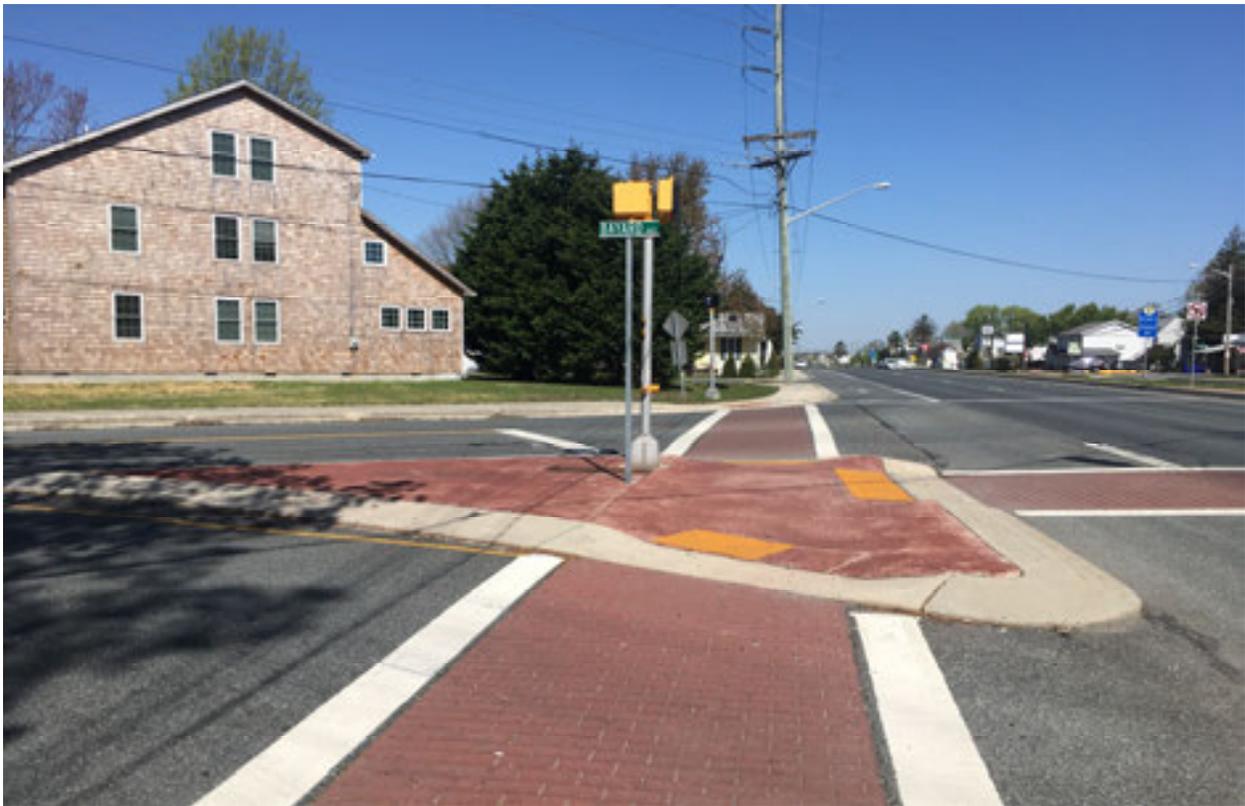
Photo 3: Looking north at the intersection of SR 1 at Bayard Avenue

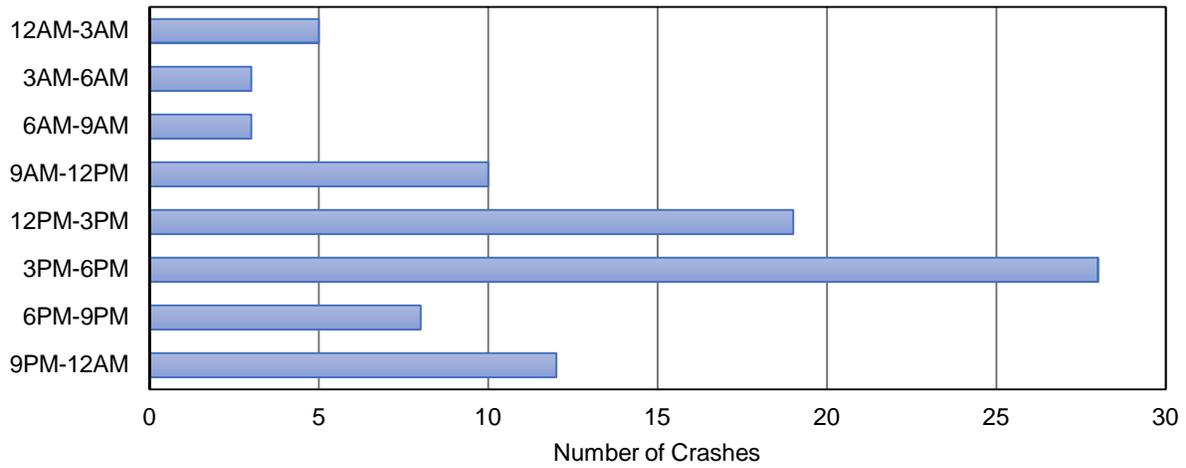
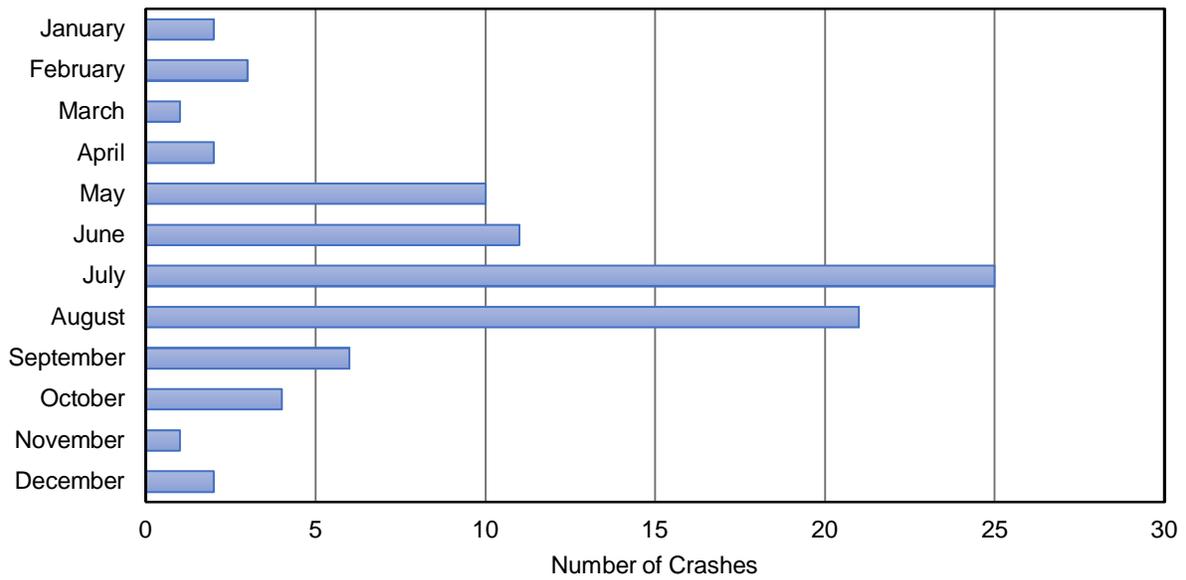
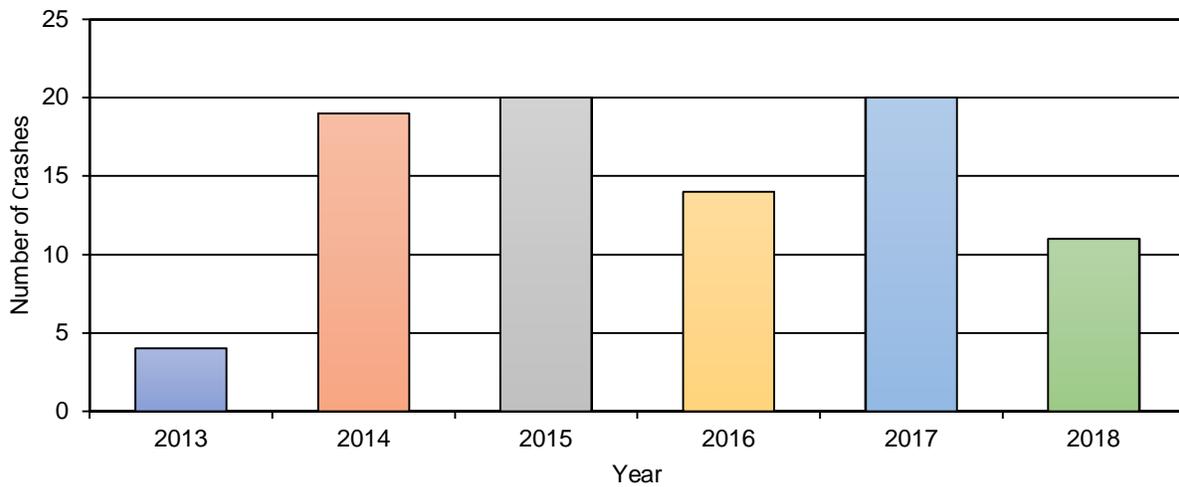
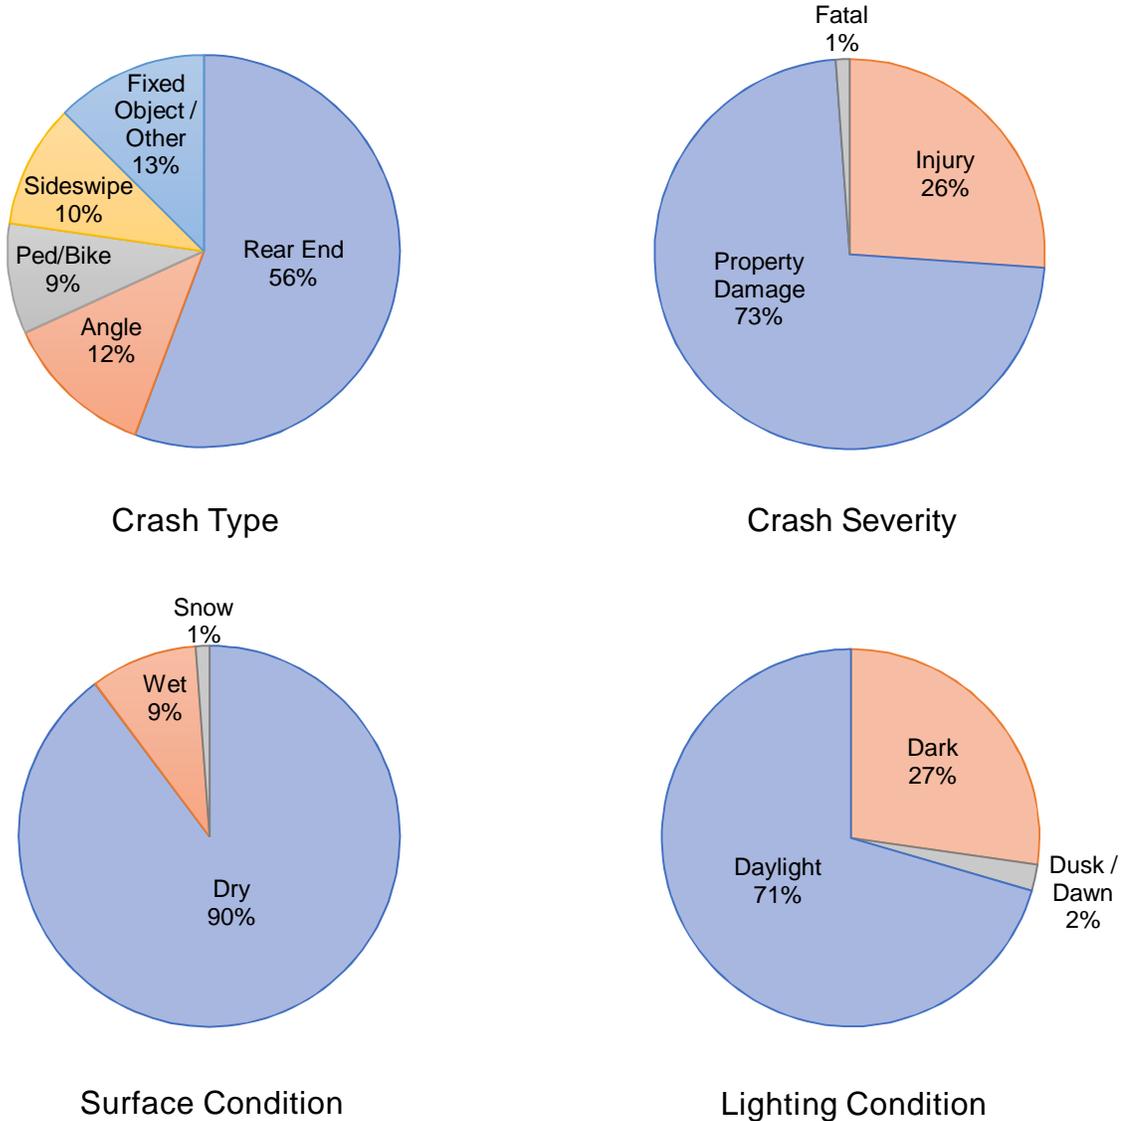
FIGURE 2
Crash Data Summary

Crash reports were reviewed for a five-year period from September 2013 to August 2018. A total of 88 crashes were reported within the one-mile section of SR 1 from Anchor Way to Bayard Avenue. A categorical summary of the crashes by time of day, month, year, type, severity, surface condition, and lighting condition is shown in **Figure 2**. Additional crash data is also summarized below.

- 18 crashes (26 percent) involved a personal injury
- 49 crashes (57 percent) were rear end crashes
- 65 crashes (74 percent) occurred between Memorial Day and Labor Day
- Eight crashes (9 percent) involved pedestrians or bicyclists, including two pedestrian fatalities
- 10 crashes (11 percent) were alcohol related
- 47 crashes (53 percent) occurred between 12:00 PM and 6:00 PM
- 24 crashes (27 percent) occurred at night in lighted and unlighted conditions
- 73 crashes (83 percent) occurred during clear weather conditions

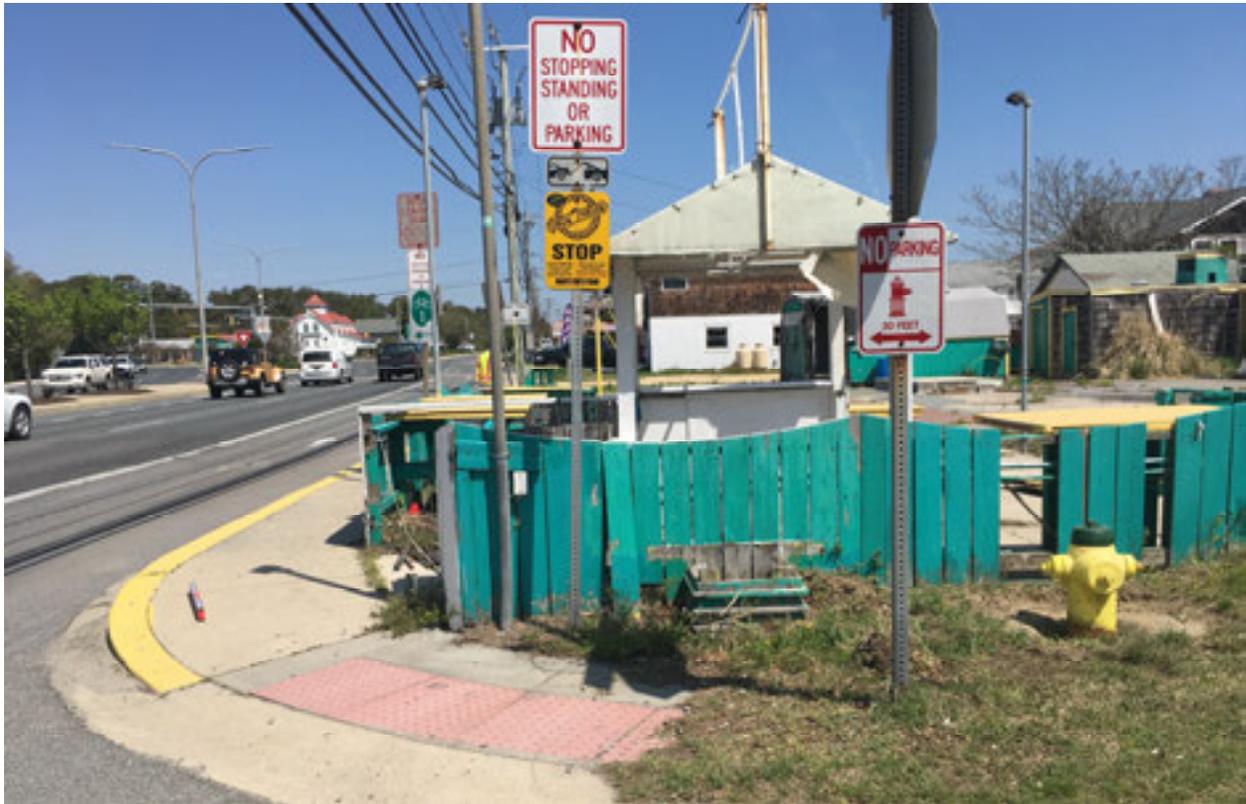
Photo 4: Looking north at the Jolly Trolley stop at Swedes Street

6. Coordinate with the Town of Dewey Beach and the Jolly Trolley to confirm the locations of the trolley stops. Construct ADA compliant loading zones at all stops. Right of way acquisition will likely be required.

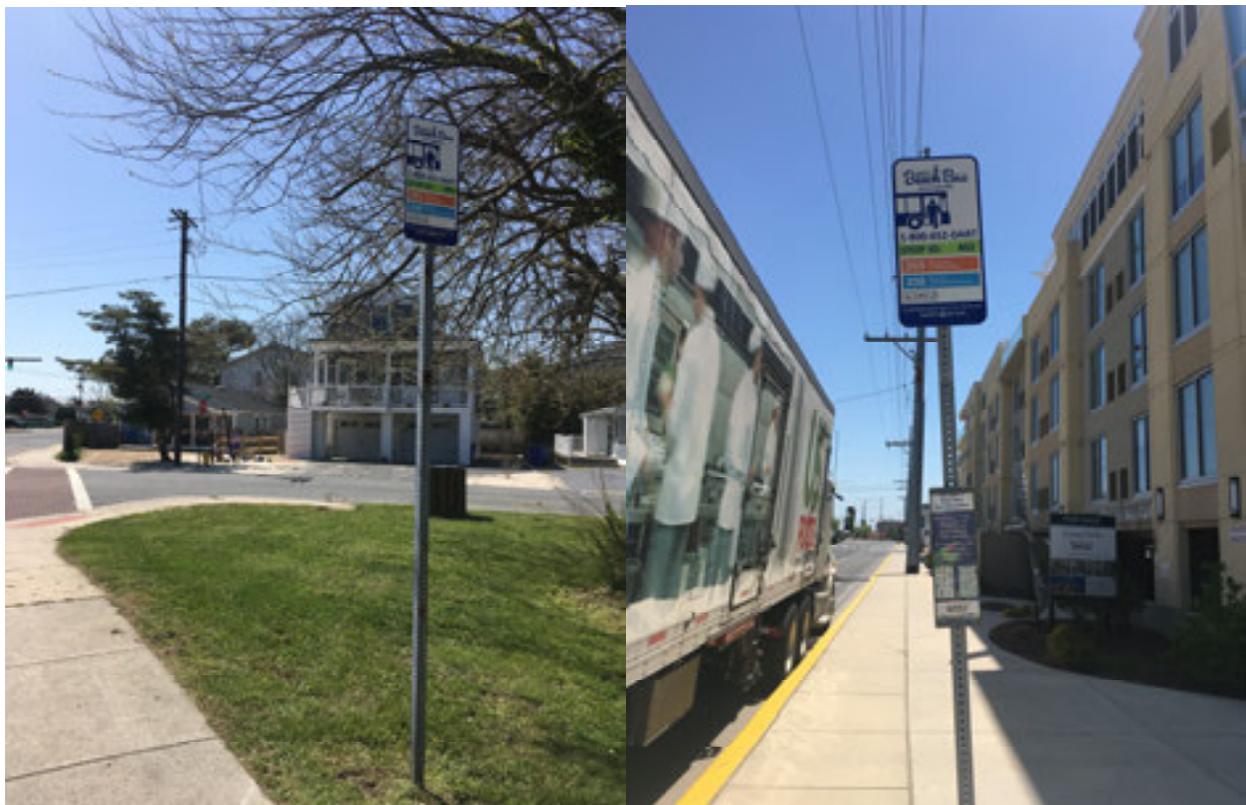
Photos 5 and 6: Looking at the DART Beach Bus stops near Houston St and Dickinson St

5. Coordinate with Delaware Transit Corporation to confirm the location of the four bus stops. Relocate the stops as directed by DTC while accounting for available right of way. Construct ADA compliant bus loading zones at all bus stops. Right of way acquisition will likely be required.

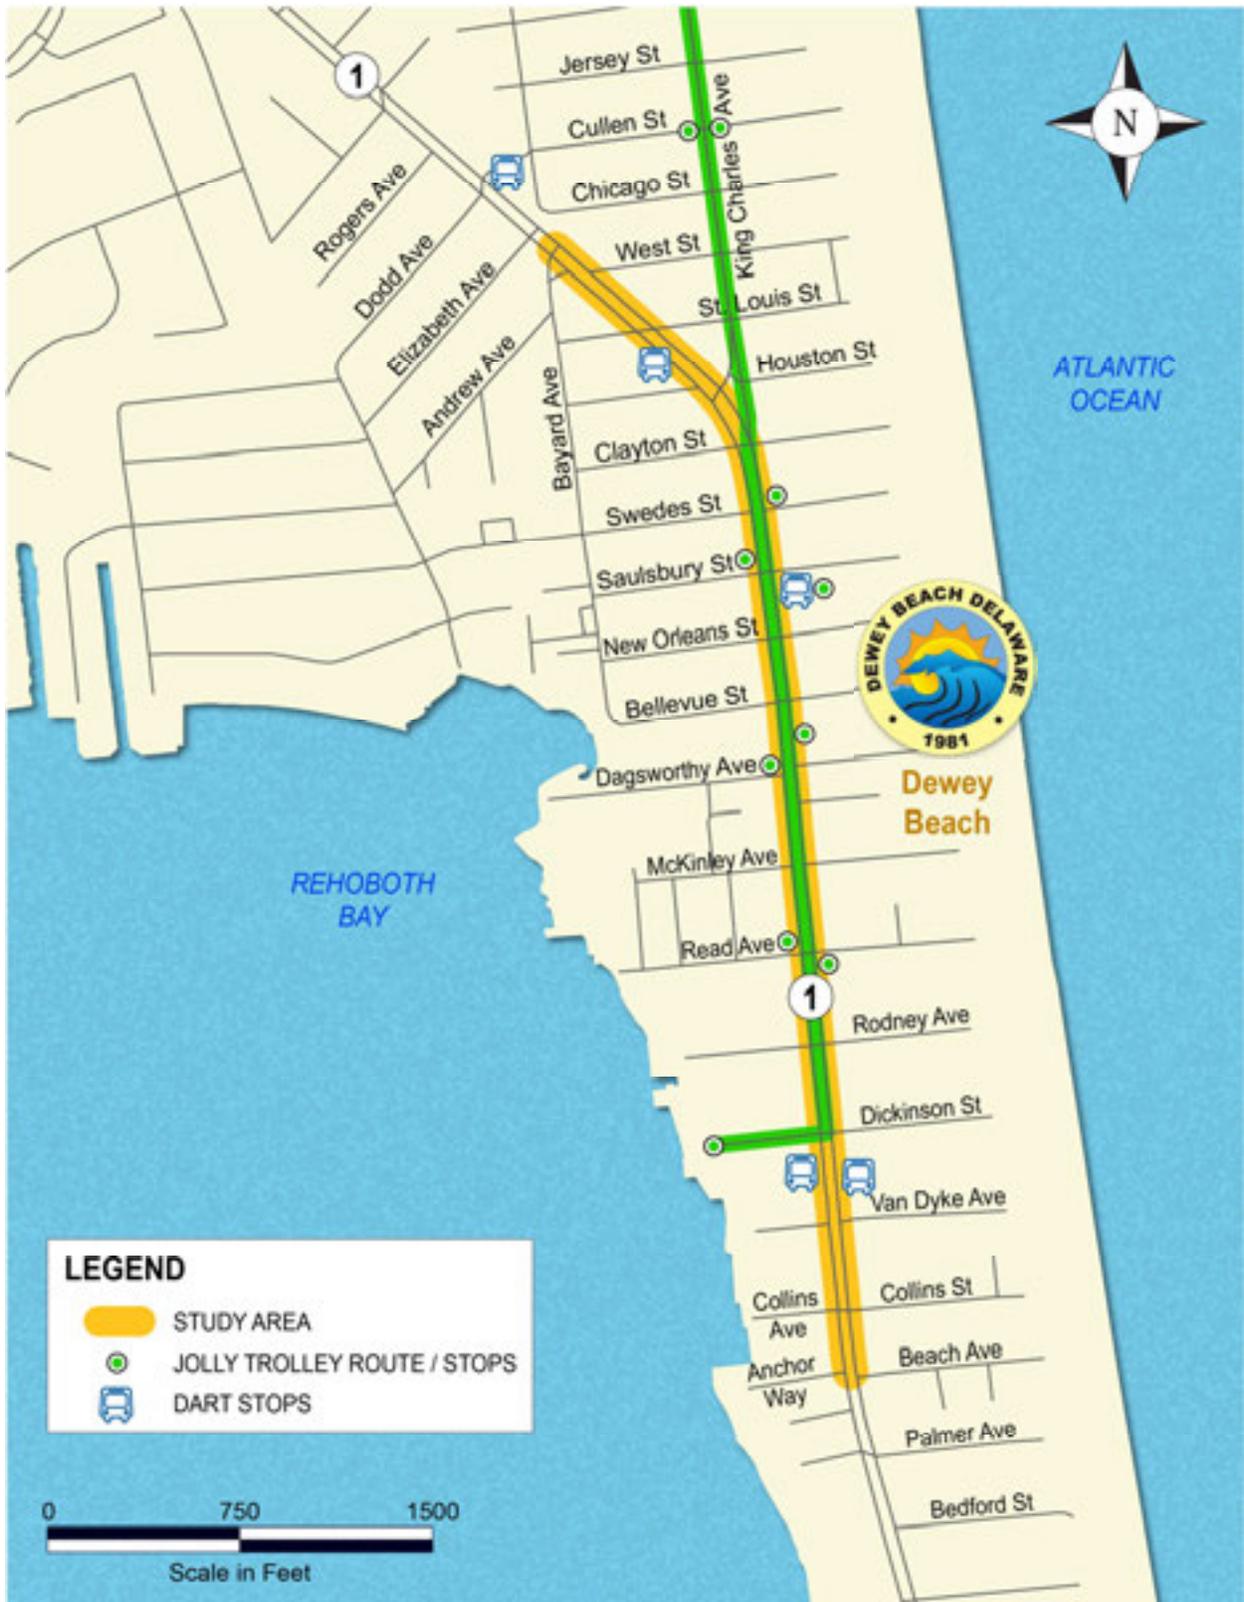
Figure 2: Transit stops within study area

Since 1970, the Jolly Trolley, a privately owned and operated shuttle service, has provided seasonal service between Rehoboth Beach and Dewey Beach. The shuttle operates daily from 8:00 AM to 2:00 AM from Memorial Day to Labor Day. The Jolly Trolley has seven stops along SR 1 within the study limits as noted in Table 2. Ridership numbers are not available; however, Table 2 provides a stop location summary. Figure 2 shows the locations of both DART and Jolly Trolley stops.

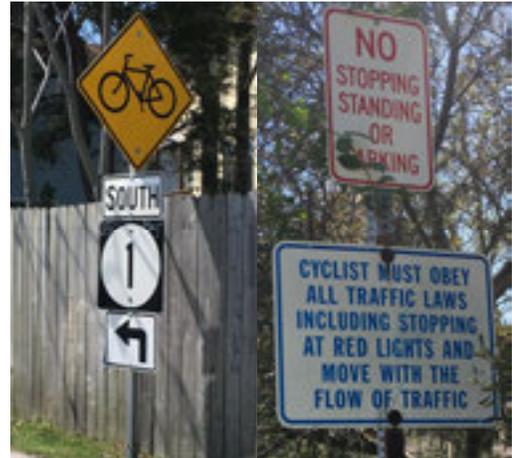
Photo 7: Looking at bicyclists traveling southbound in the SR 1 northbound shoulder

With shoulder widths of 10 feet, trucks block bicycle access when parking in the loading zones. Figure 3 depicts the officially designated loading zone areas; however, trucks were regularly observed utilizing the shoulder at unposted locations as well. Additionally, some loading zones signs were posted with a begin point, but with no end point posted.

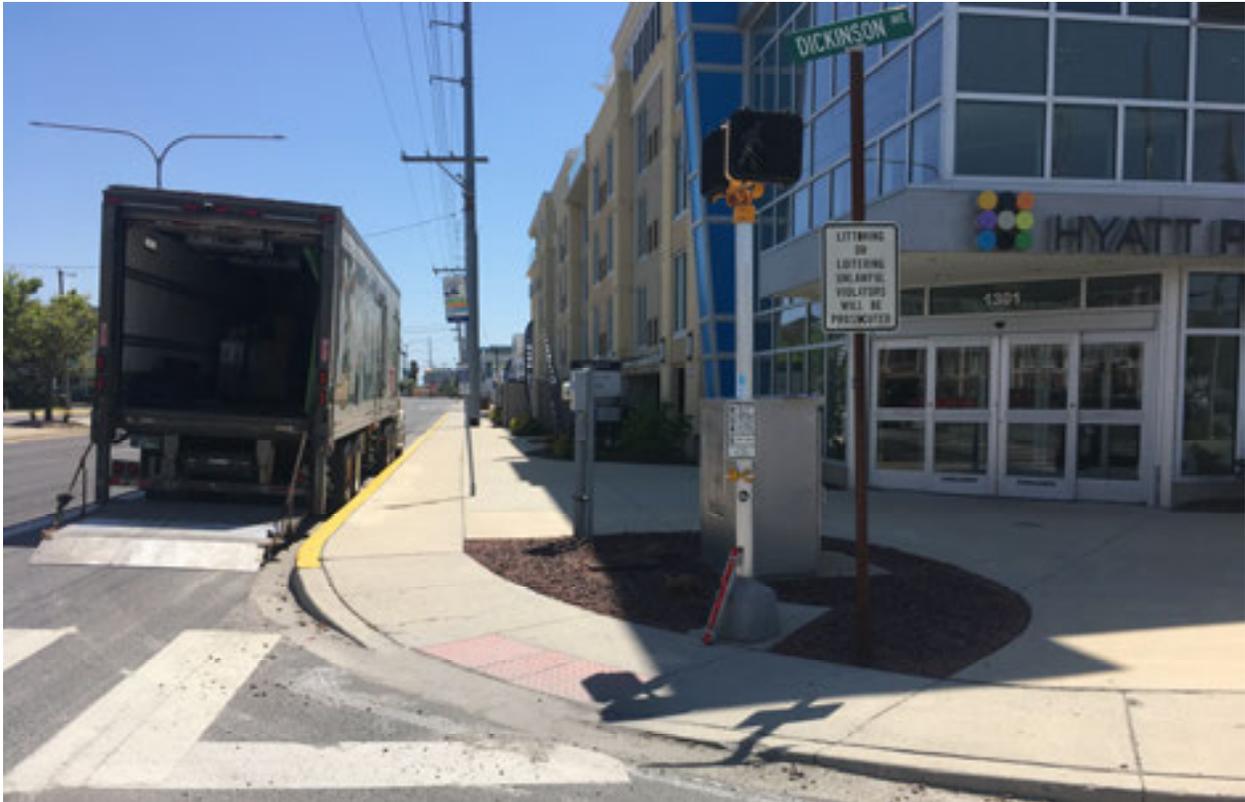
Photo 8: Looking at delivery truck parked illegally in the SR 1 southbound shoulder

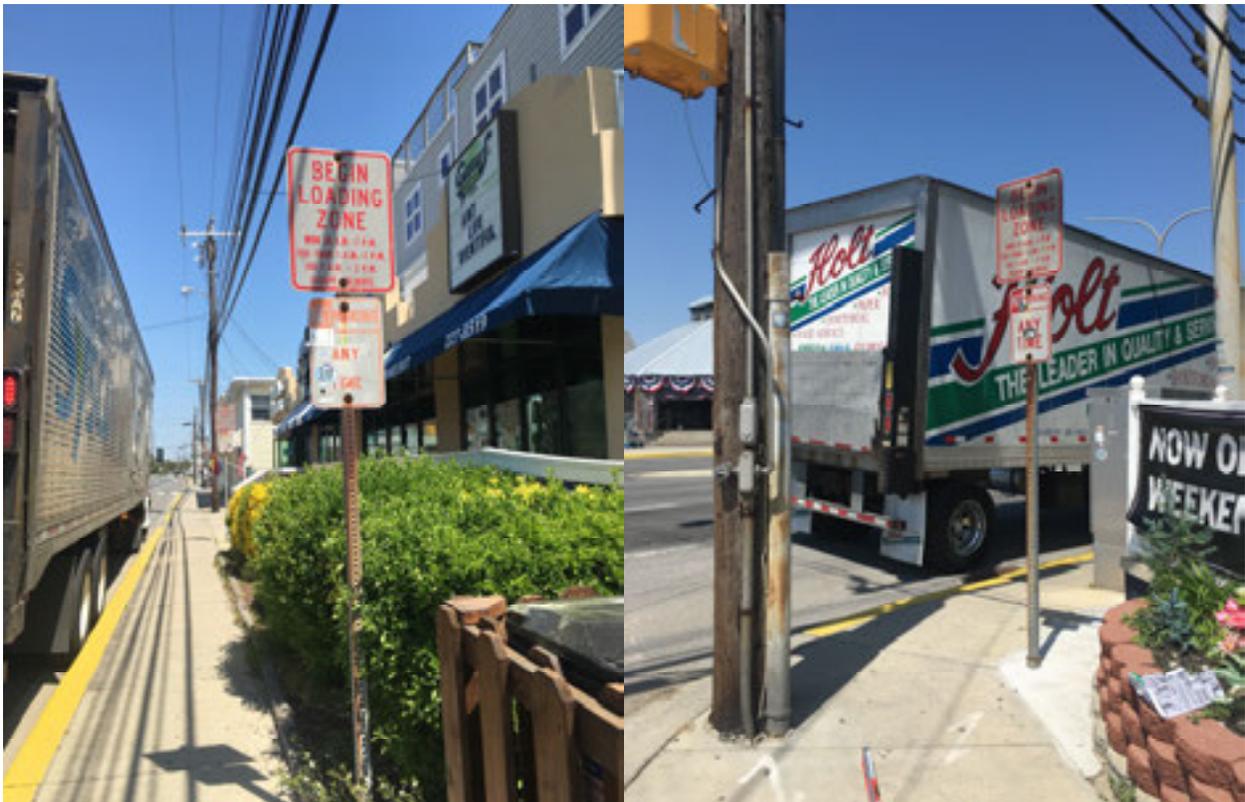
Photo 9 and 10: Looking at delivery trucks parking in designated loading zones

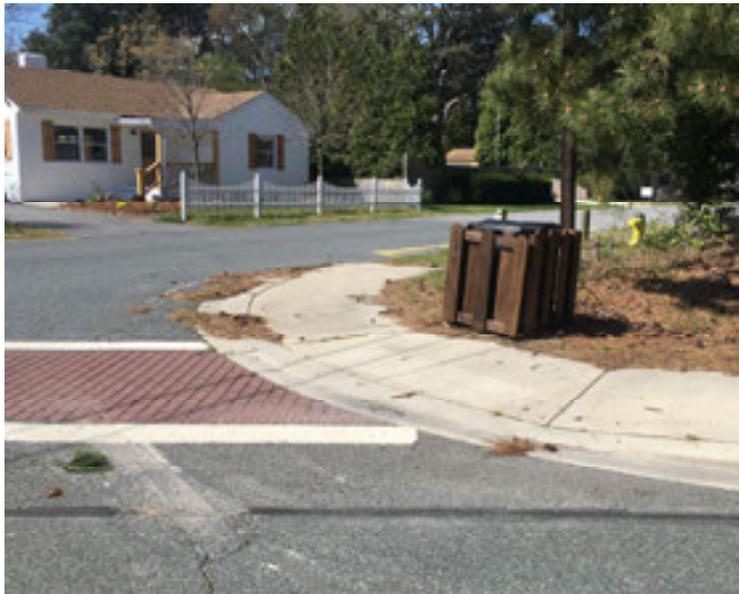
1. Several existing curb ramps did not meet ADA standards due to existing geometrics or lack of detectable warning surfaces.

A total of 21 non-compliant curb ramps were recorded within the study area. Most of these curb ramps will be reconstructed under future pavement rehabilitation projects in 2019 and 2020. (Contract T201706301 and T201706302). Under pavement and rehabilitation contracts, the curb ramps will be reconstructed to meet ADA standards to the maximum extent feasible; however, some deficiencies will remain until a comprehensive capital project is initiated in the future to address items such as the utility pole obstructions, insufficient sidewalk width, and steep cross slopes.

Photo 11: Northwest corner curb ramp at SR 1 and St. Louis Street with no truncated domes

1. Reconstruct the non-compliant curb ramps under the pavement and rehabilitation contracts T201706301 and T201706302. Upgrade pedestrian signal equipment to achieve ADA compliance to the maximum extent feasible given the scope of the project. Reassess any remaining non-compliant conditions after completion of the work.
2. Coordinate with the Town of Dewey and local businesses to relocate the existing trash bins to outside the sidewalk PAR.
3. Coordinate with the Town of Dewey and DeIDOT Traffic to relocate/repost traffic signs compliant heights.
4. Coordinate with DeIDOT Traffic and the Town of Dewey regarding the installation of Rectangular Rapid Flash Beacons (RRFB) at the seven existing unsignalized intersections along SR 1 between King Charles Avenue and Collins Street. DeIDOT is currently developing preliminary design plans for RRFB installation at all seven locations.

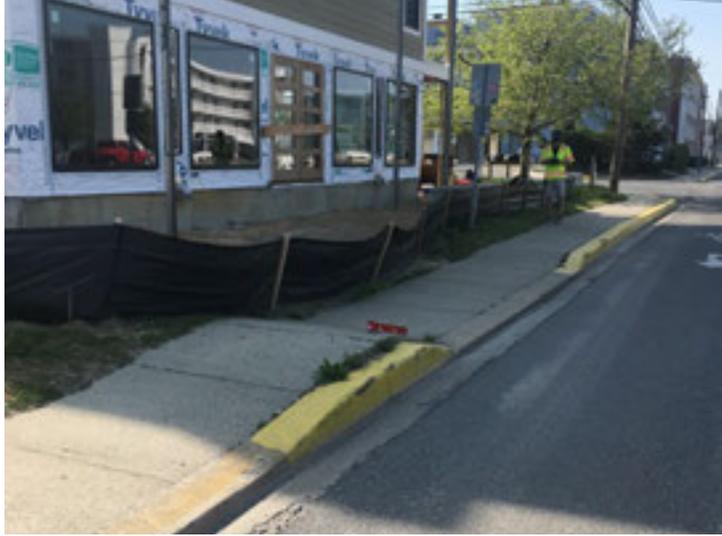
- Existing driveways create longitudinal slopes and cross slopes that do not meet ADA standards.

A total of 34 non-compliant driveway aprons were recorded within the study area. Some of these driveways are associated with loading zone locations for adjacent businesses. Locations of the non-compliant driveways are highlighted to be reconstructed in the proposed concept improvement plans

Photo 12: Non-compliant driveway slopes at the northeast corner of SR 1 at Rodney Street

- Relocate all aerial utilities underground to eliminate the pole obstructions in the PAR.
8. Evaluate each driveway apron and develop conceptual alternatives to mitigate non-compliant cross slopes, which include:

- Confirm with the Town of Dewey Beach the need and limits of each loading zone and investigate if the driveway is permitted. If not, remove the depressed curb and reconstruct the curb and sidewalk.
- If there is no structure or building immediately adjacent to the sidewalk, reconstruct the sidewalk and tie back into the existing driveway. If the sidewalk is wide enough, it may be desirable to route the PAR behind the driveway apron. Easements will be required.
- If structures are immediately behind the sidewalk, obtain detailed field survey to determine options. If the driveway does not serve vehicles and only provides access as a loading zone, it may be feasible to steepen the apron enough to reconstruct the sidewalk without affecting the building.

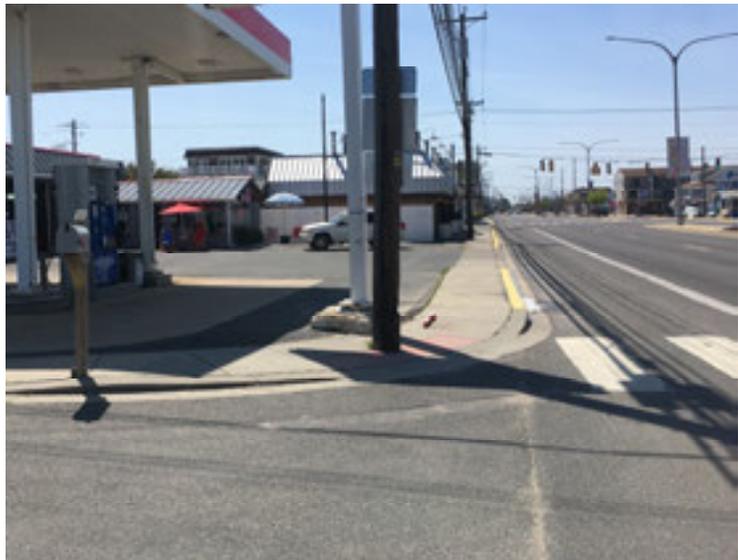
- Fixed objects, such as utility poles, signal cabinets and sign posts are located within the accessible route and create non-compliant pinch points.

Photo 13: Southwest corner curb ramp at SR 1 and Swedes Street with a utility pole in the landing area

7. Evaluate each utility pole pinch-point and develop conceptual alternatives to mitigate these pinch-points, which include:
 - Construct a sidewalk extension into the roadway adjacent to the existing pole.

- Relocate the pole to an area with a wider sidewalk or to an area where a sidewalk extension can be constructed. Depending on the spacing between the adjacent poles and on the aerial connections to the side street poles, evaluate if removing a pole completely is an option. This solution may result in additional pole placement on the side streets or replacement of the adjacent poles to accommodate the longer spacing.

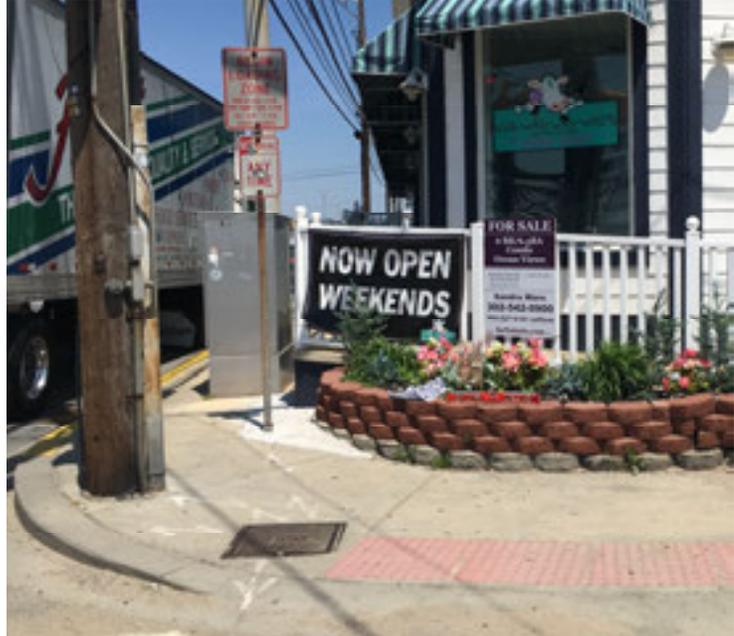
A total of 28 pinch points and protruding objects were recorded within the study area and can be categorized as follows:

- 12 utility poles
- 10 signs
- Four privately owned features, including trash bins and a mailbox
- Two traffic signal equipment features, including a signal pole and signal cabinet

Photo 14: Example of multiple obstructions within the PAR on the northeast corner of SR 1 at Bellevue Street

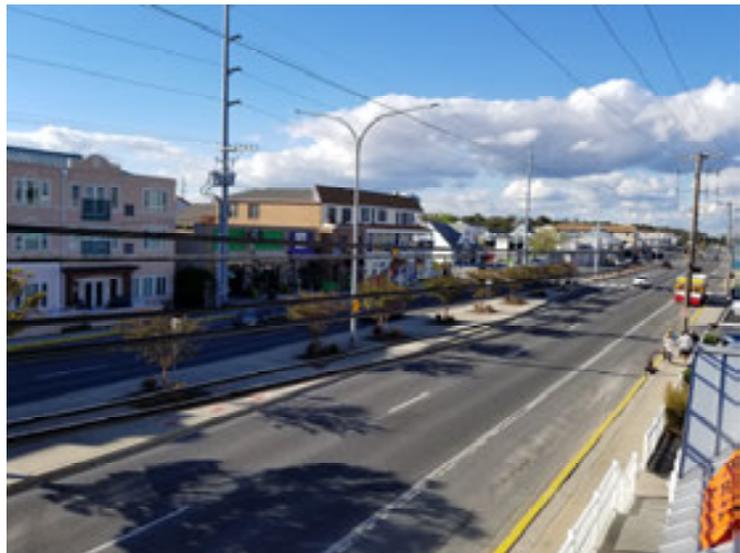
Existing street lighting is located along a majority of SR 1 within the study area. Between Anchor Way and Houston Street there are 21 light poles with two fixtures on each pole located within the median. These fixtures, along with ambient light from adjacent businesses along SR 1 provide sufficient lighting along the corridor.

Photo 15: Looking north at the existing light poles in the SR 1 median
