LANCASTER PIKE
PEDESTRIAN IMPROVEMENTS
(PEDESTRIAN ACCESS ROUTE AND
SAFETY AUDIT PROJECT)
WEST COURT DRIVE TO NORTH DUPONT ROAD

CONTRACT NO. T201601103
AGREEMENT 1710 – TASK 3

PROJECT DDOT1604

April 22, 2016

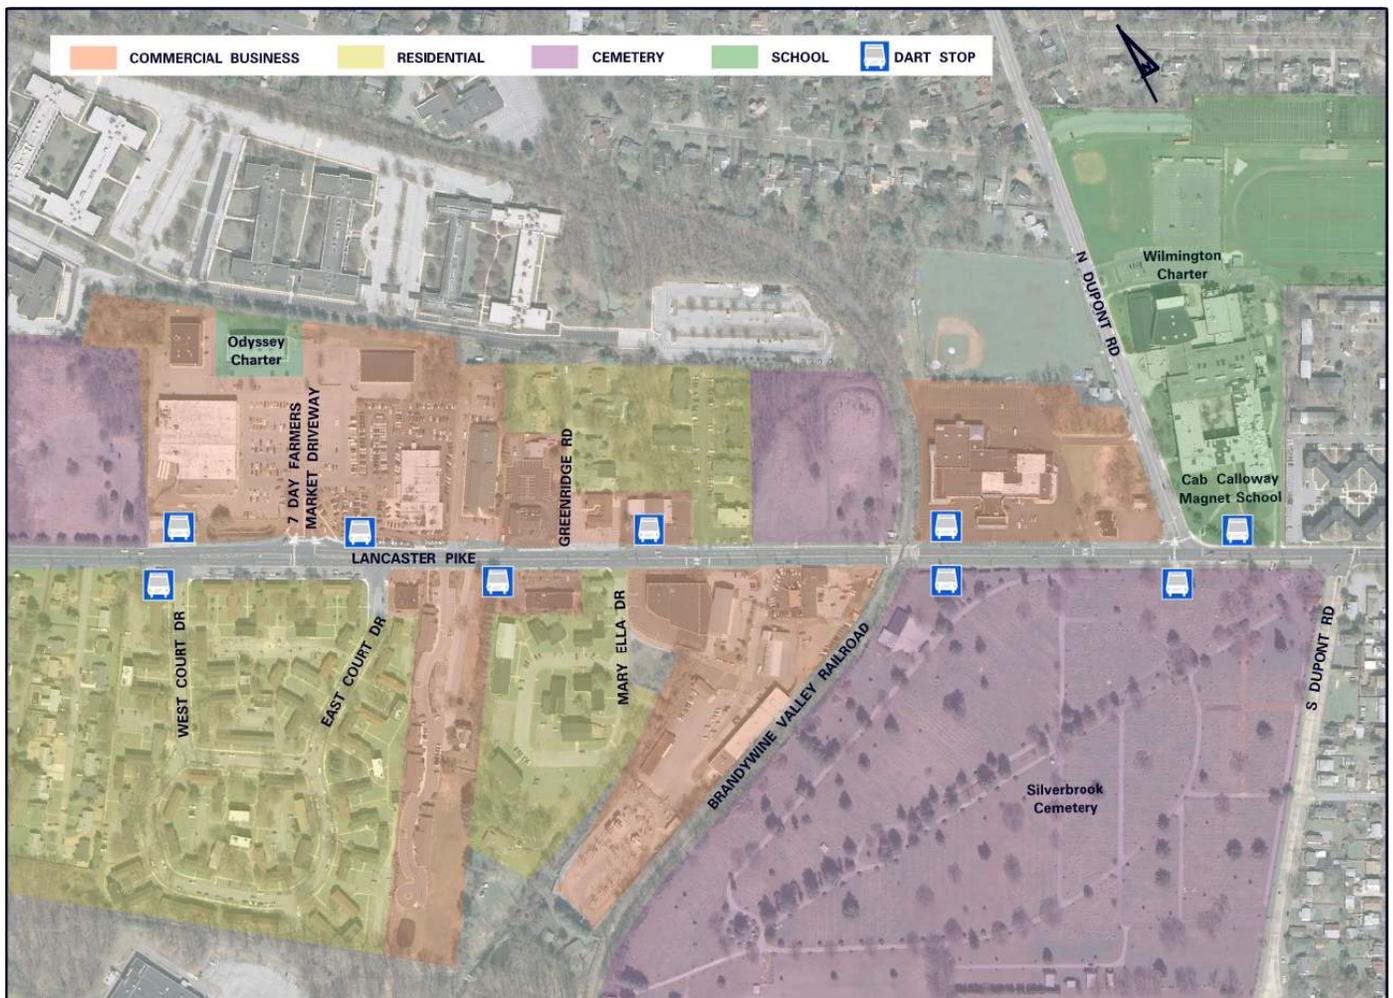
Figure 2: Land Use Map

Land uses along the corridor include residential, commercial and institutional. The Cab Calloway Magnet School and the Wilmington Charter are located in the northeast quadrant of the intersection of Lancaster Pike (SR 48) and North Dupont Road. The Odyssey (K-2) Charter is located in the west side of the corridor limits. Figure 2 shows the existing land uses within the study area.

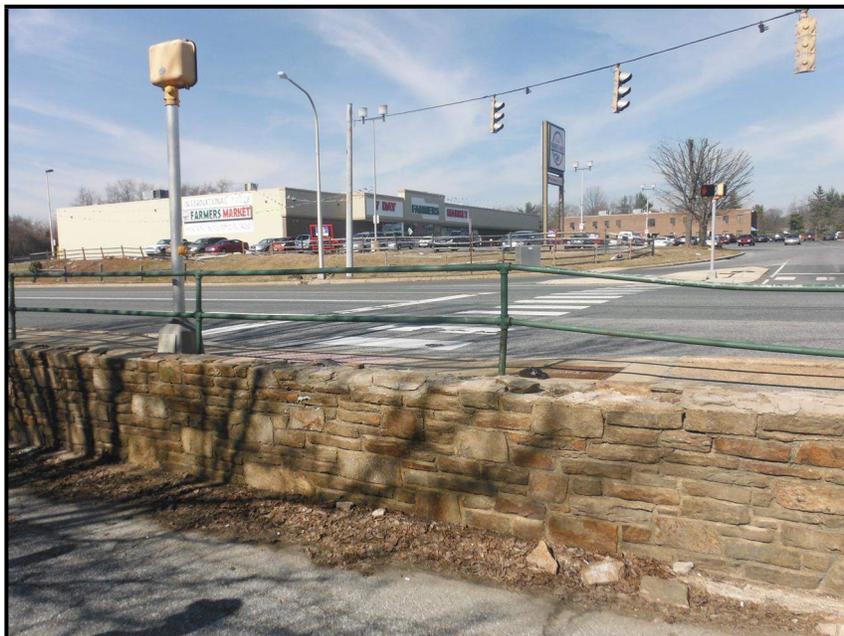
Photo 1: Signalized pedestrian crossing at 7 Day Farmers Market Intersection

- Replace existing 6' wide crosswalk pavement markings with 10' wide crosswalks at both signalized intersections.
- Install DE MUTCD compliant pushbutton signs at the intersection of Lancaster Pike (SR 48) and the 7 Day Farmers Market commercial driveway.

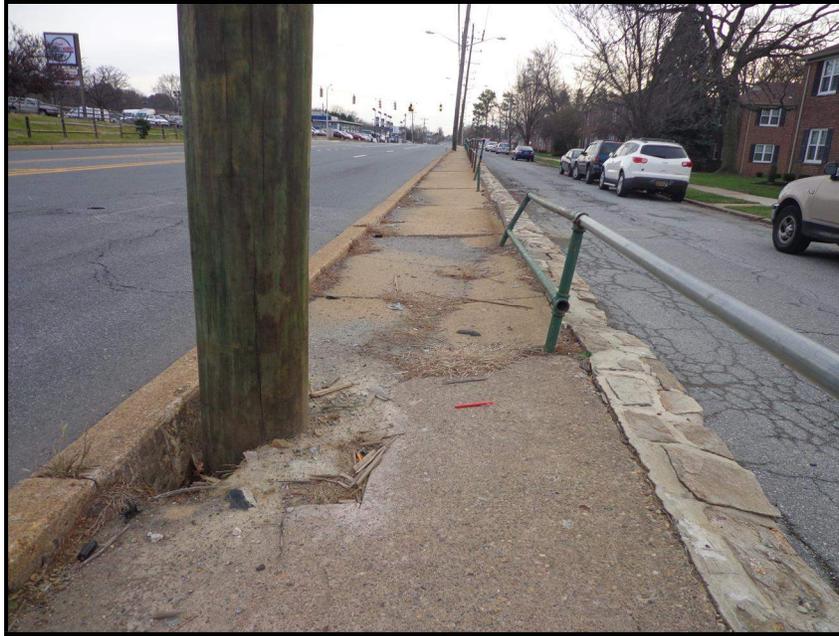
Photo 2: Existing sidewalk /retaining wall between West and East Court Drive

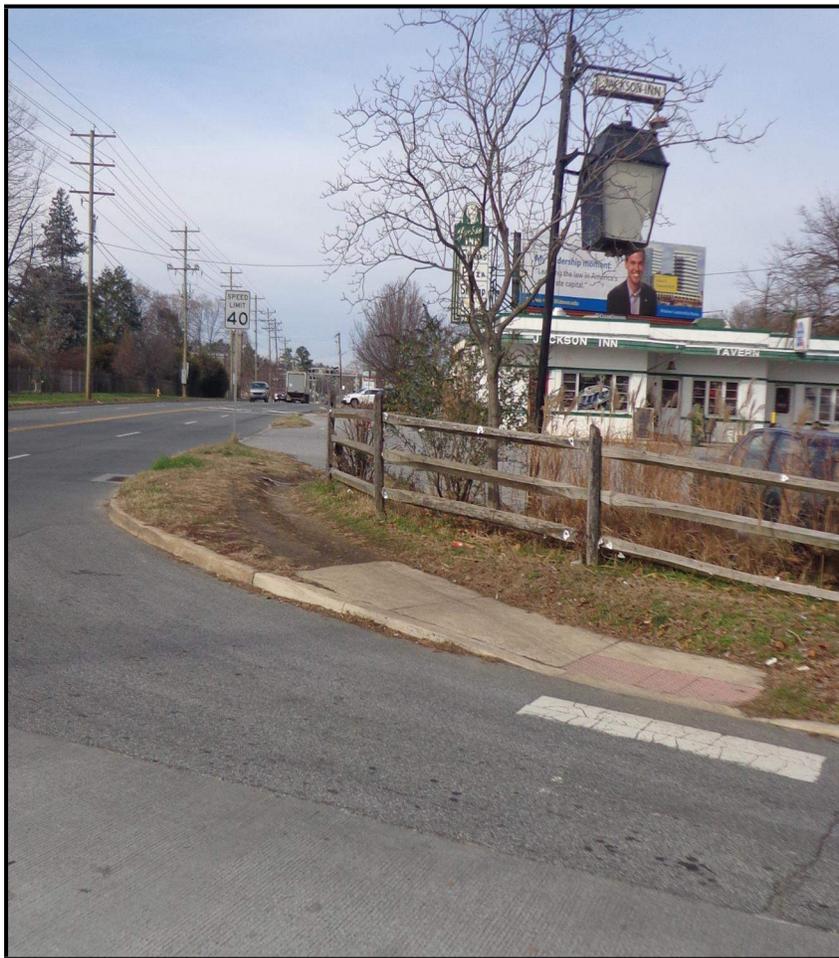
Photo 3: Missing sidewalk west of North Dupont Road – North side

- Construct sidewalk and ADA compliant curb ramps along the north side of Lancaster Pike (SR 48) from West Court Drive to North Dupont Road to tie into existing sidewalk to provide connectivity along this side of the roadway.

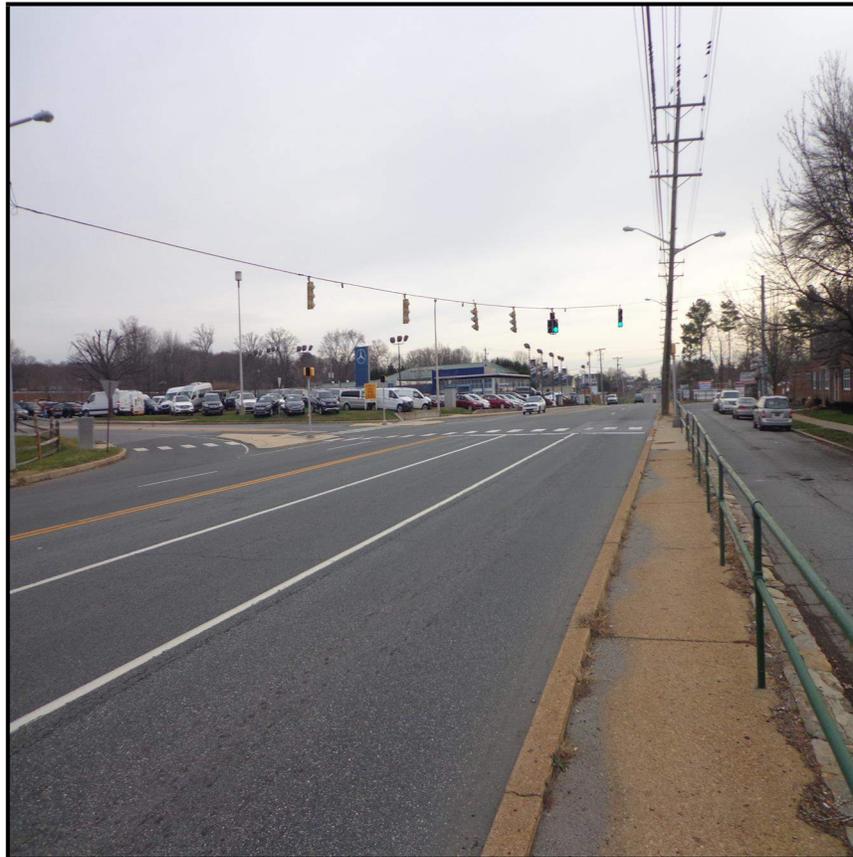
It is also a “T” intersection with signalized pedestrian crossings for both Lancaster Pike (SR 48) and the commercial driveway. This intersection provides an eastbound left-turn lane for traffic entering the commercial site. There are pedestrian crosswalks and signal heads across the north and west approaches of the intersection. This intersection has push-button activated pedestrian signals with countdown displays. The pedestrian crossing signs should be replaced with new signs that meet the DE MUTCD standards for signal pedestrian signs.

Photo 4: Signalized intersection at 7 Day Farmers Market commercial driveway

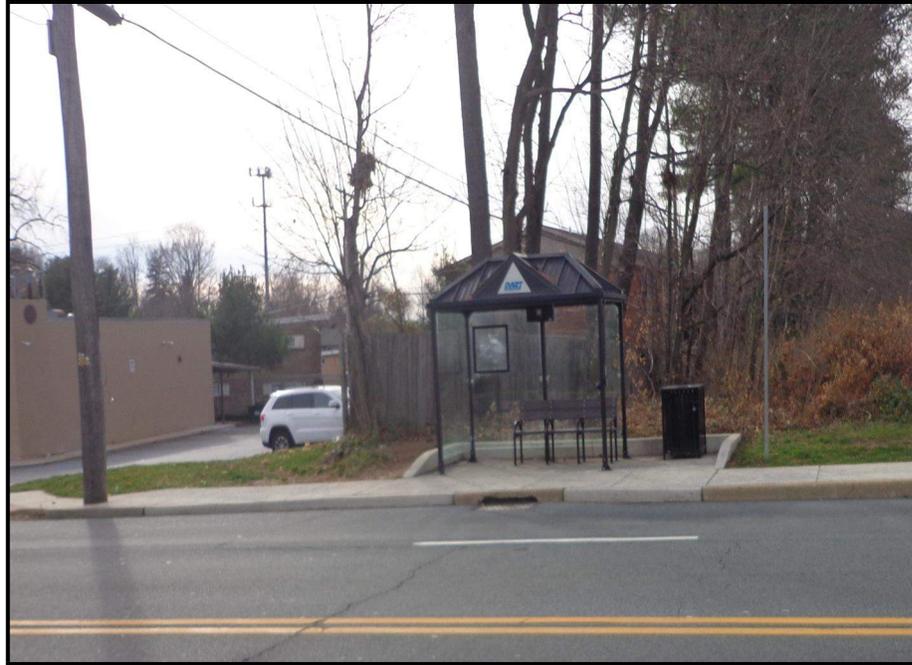
Photo 5: Bus stop shelter west of Mary Ella Drive - South side, eastbound direction

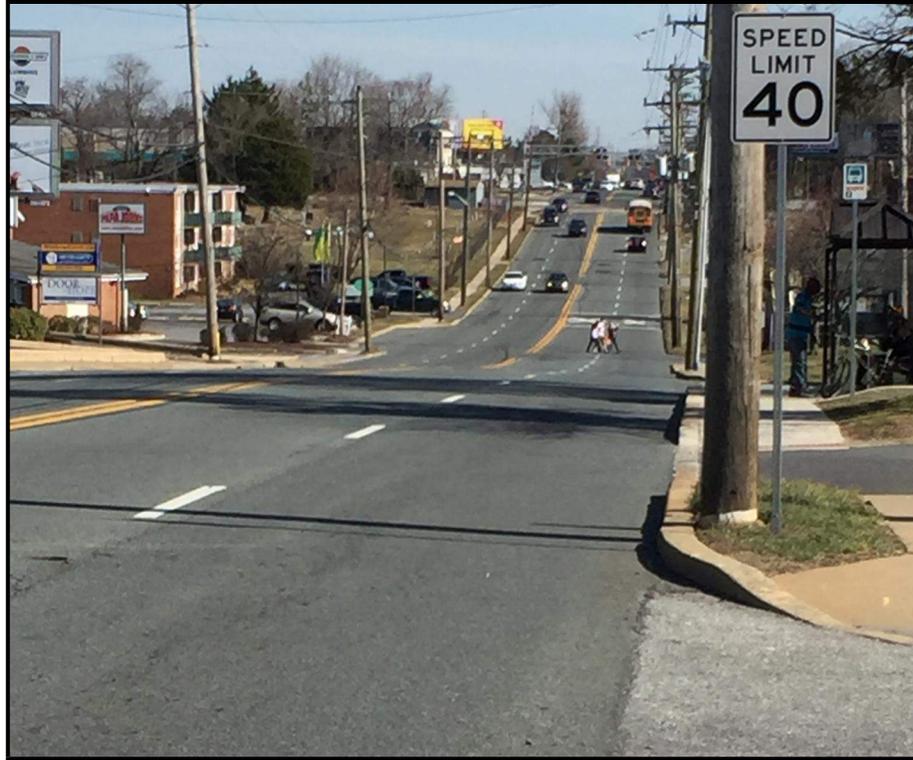
- Approximately 20 pedestrians were observed crossing at midblock locations at or around Mary Ella Drive between 1:30 and 2:15 PM. Due to the traffic volumes, pedestrians were observed performing two-stage crossings, waiting at the middle of the roadway (double-yellow pavement markings) before completing the crossing. This behavior can be explained due to the close proximity of the residential and commercial land uses. Pedestrians cross the roadway at this location to access the retail venues and then go back to their residences. In addition, there is a bus stop located on the north side of the roadway, east of the Mary Ella Drive (See Photos 6 and 7). Bus riders were observed getting off the bus and crossing at that location to access the residential areas on the south side of the roadway.

Photo 6: Pedestrian midblock crossing at Mary Ella Drive

- Provide a midblock crossing west of Mary Ella Drive. Pedestrians wishing to continue east will cross the roadway at this location to continue on the north side of Lancaster Pike (SR 48). A review of the NCHRP Report 562 "Improving Pedestrian Safety at Unsignalized Crossings" indicates a circular red indication (signal or beacon) would be needed at this location to provide for a safe crossing of pedestrians. See Appendix C for analysis worksheet.

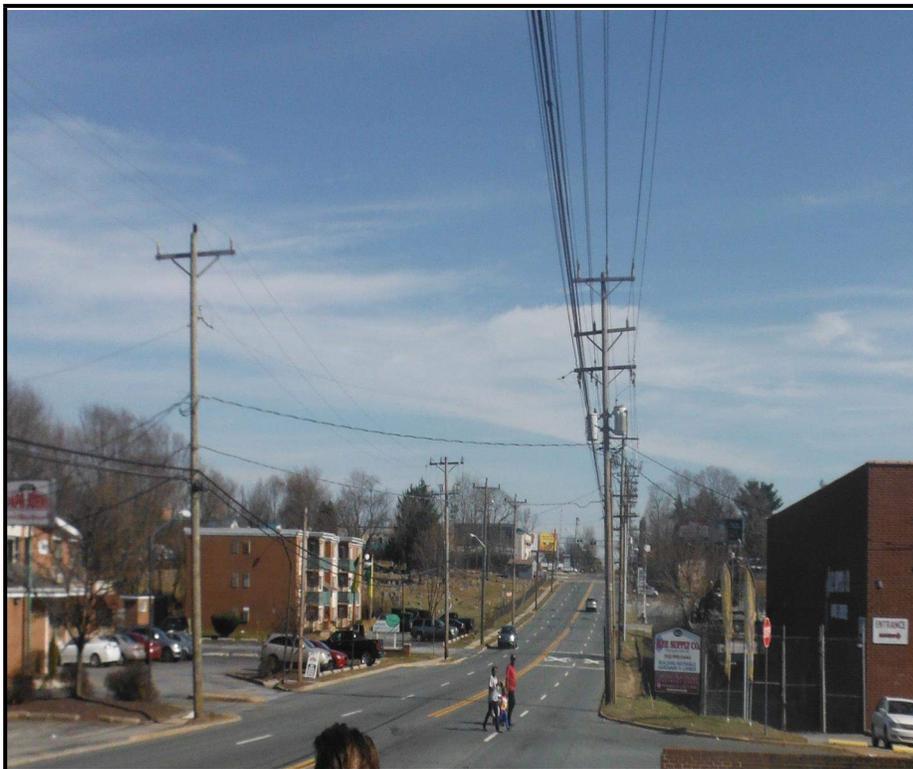
Photo 7: Pedestrian midblock crossing east of Mary Ella Drive

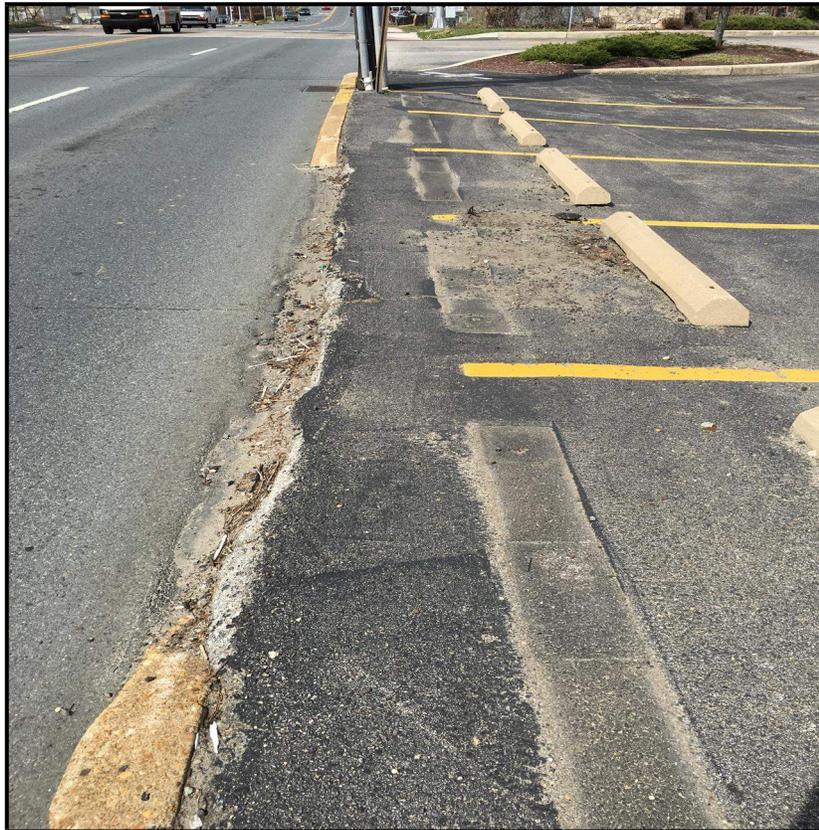
Photo 8: Existing sidewalk east of the railroad tracks

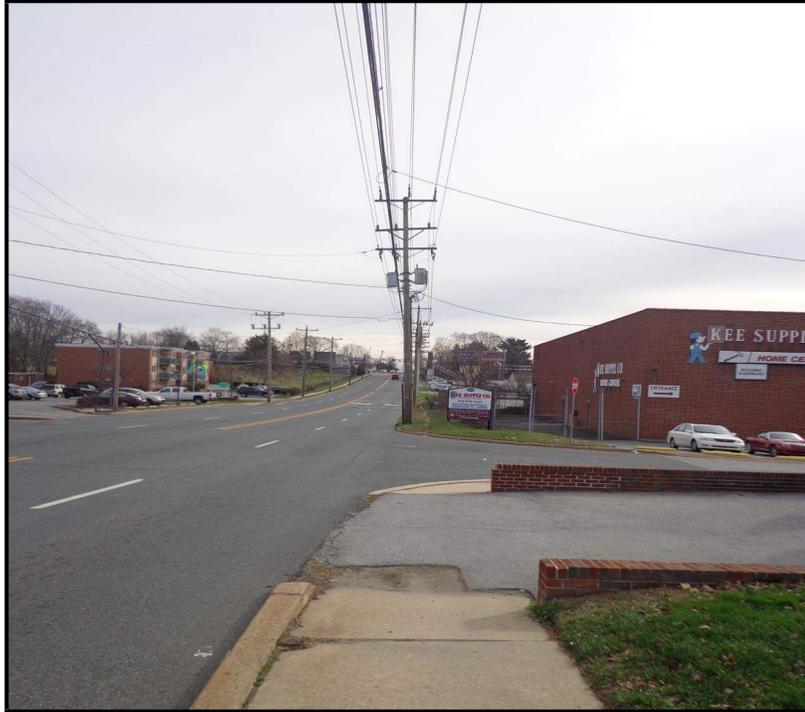
Photo 9: Sidewalk ends east of the Mary Ella Drive

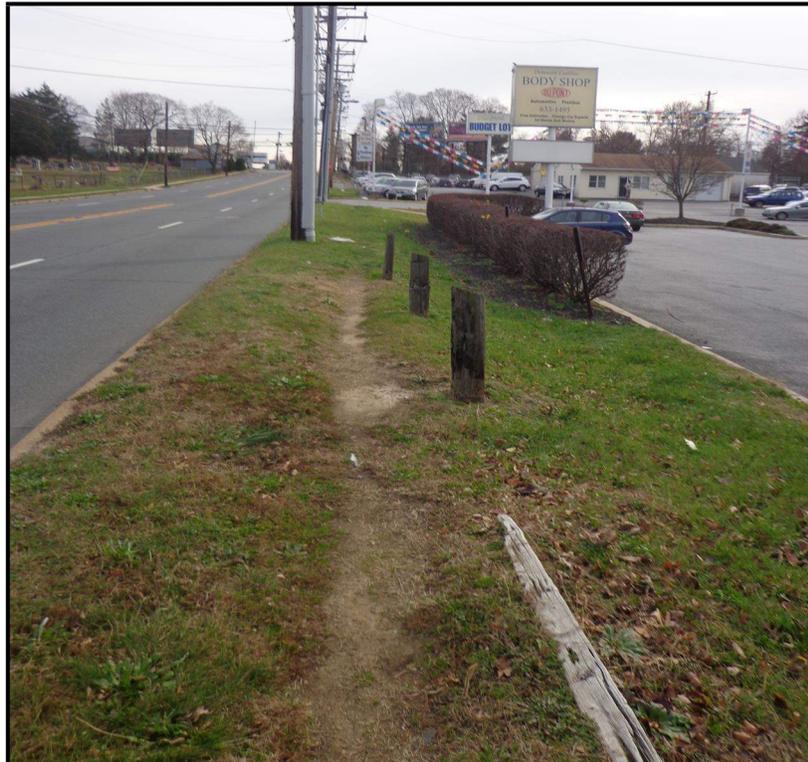
- Two pedestrians were observed walking along a goat path on the south side of Lancaster Pike (SR 48) connecting from Mary Ella Drive to the existing bus stop located approximately 850 feet east of the intersection.

Photo 10: Goat path from Mary Ella Drive to Barbara Road

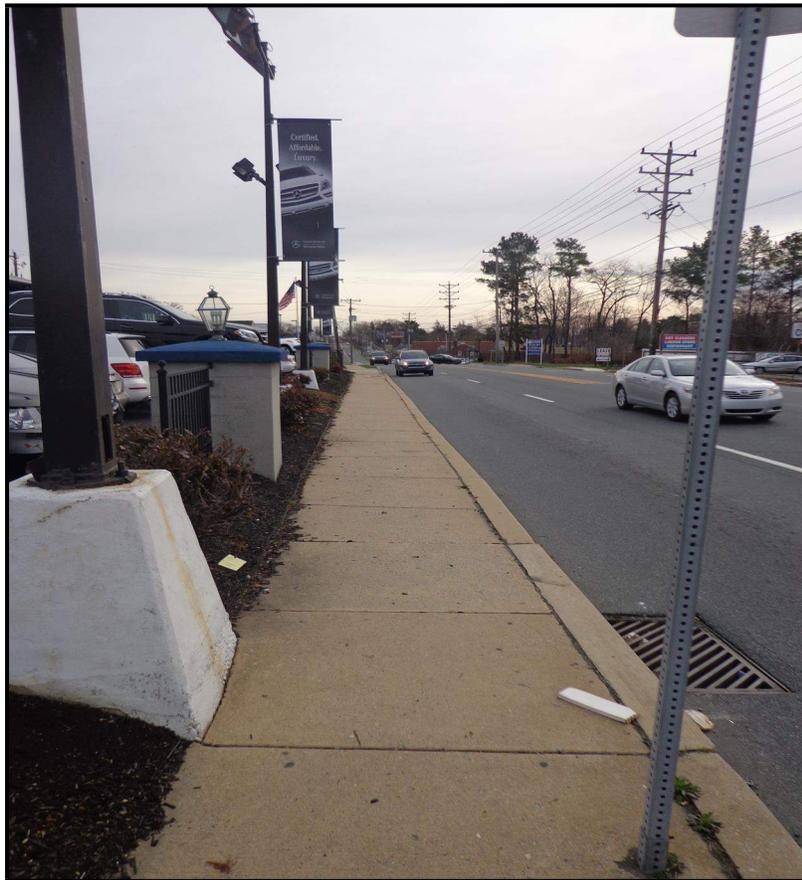
Five transit stops are located on the north side of Lancaster Pike (SR 48). Only the bus stop located at North Dupont Road meets ADA standards. The other four stops do not provide the required concrete pad for boarding /alighting, therefore they do not meet the ADA requirements.

Photo 11: Bus stop does not meet the minimum pad area requirements / East Court Drive

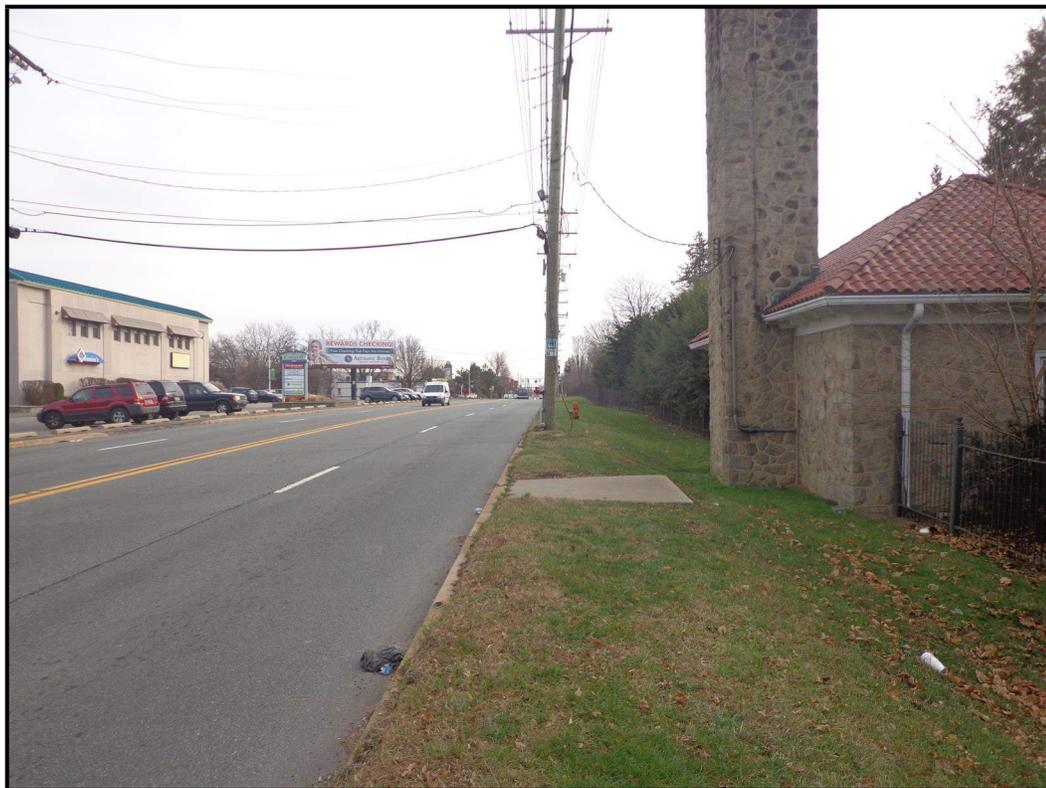
The fourth bus stop (OP Cannery) located east of the railroad crossing is disconnected from the existing sidewalk to the west. To access this stop pedestrians use a goat path along the south side of Lancaster Pike (SR 48) or cross Lancaster Pike (SR 48) at this midblock location.

Photo 12: Bus stop is disconnected from the sidewalk network

- With the approval from DTC and in coordination with DART, remove existing bus stop (OP Cannery) located east of the railroad tracks, on the south side of Lancaster Pike (SR 48).
- Construct sidewalk and ADA compliant curb ramps along the south side of Lancaster Pike (SR 48) from Mary Ella Drive to Barbara Road to provide connectivity to the commercial /light industrial buildings located east of Barbara Road. East of Barbara Road, construct a fence on the south side of Lancaster Pike (SR 48) to discourage pedestrian walking along the south side of the roadway from Barbara Road to the east.

- Construct sidewalk and ADA compliant curb ramps along the south side of Lancaster Pike (SR 48) from Mary Ella Drive to the existing bus stop located east of the railroad crossing. Coordination with the Brandywine Valley Railroad will be required to construct pedestrian crossing on the south side of Lancaster Pike (SR 48). In addition, coordination with property owners along the south side of Lancaster Pike (SR 48) from Barbara Drive to the railroad will be required due to potential ROW impacts.

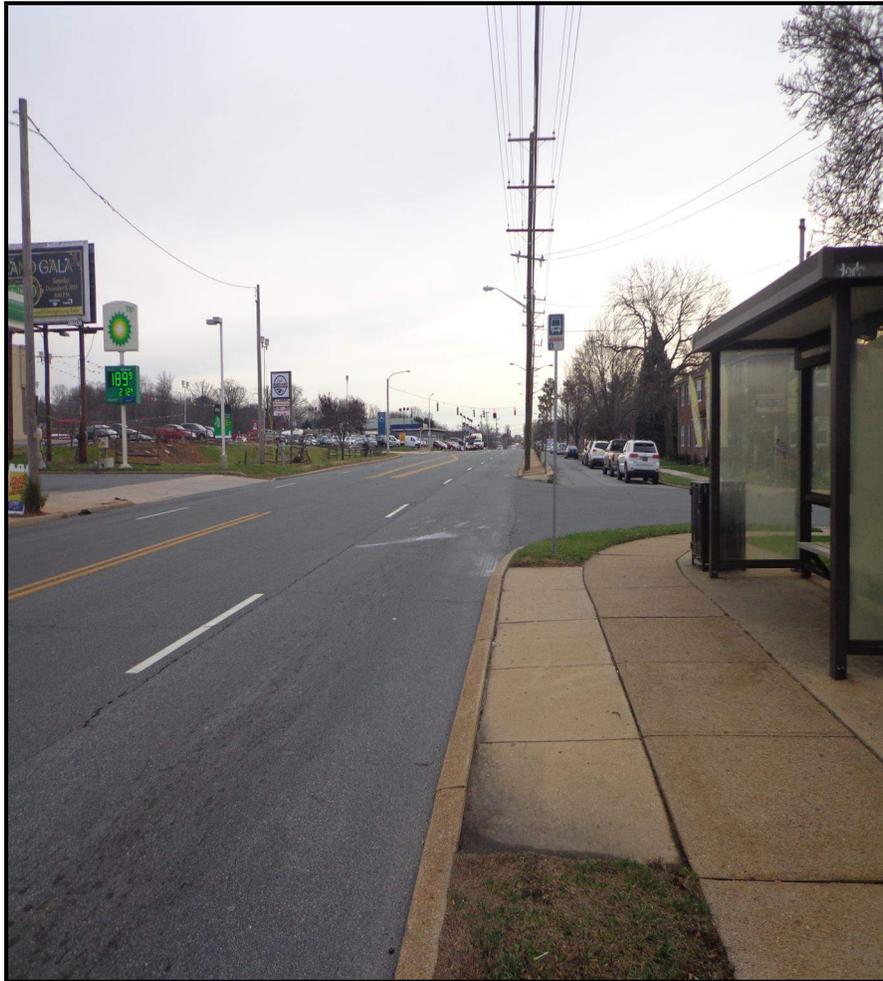
Photo 13: Unlit bus stop shelter

- Relocate railroad crossing pavement markings and add required warning signs east and west of the railroad tracks.
- Perform a lighting evaluation and install lighting along Lancaster Pike (SR 48), particularly at the bus stop locations and the pedestrian crosswalk located at North Dupont Road.

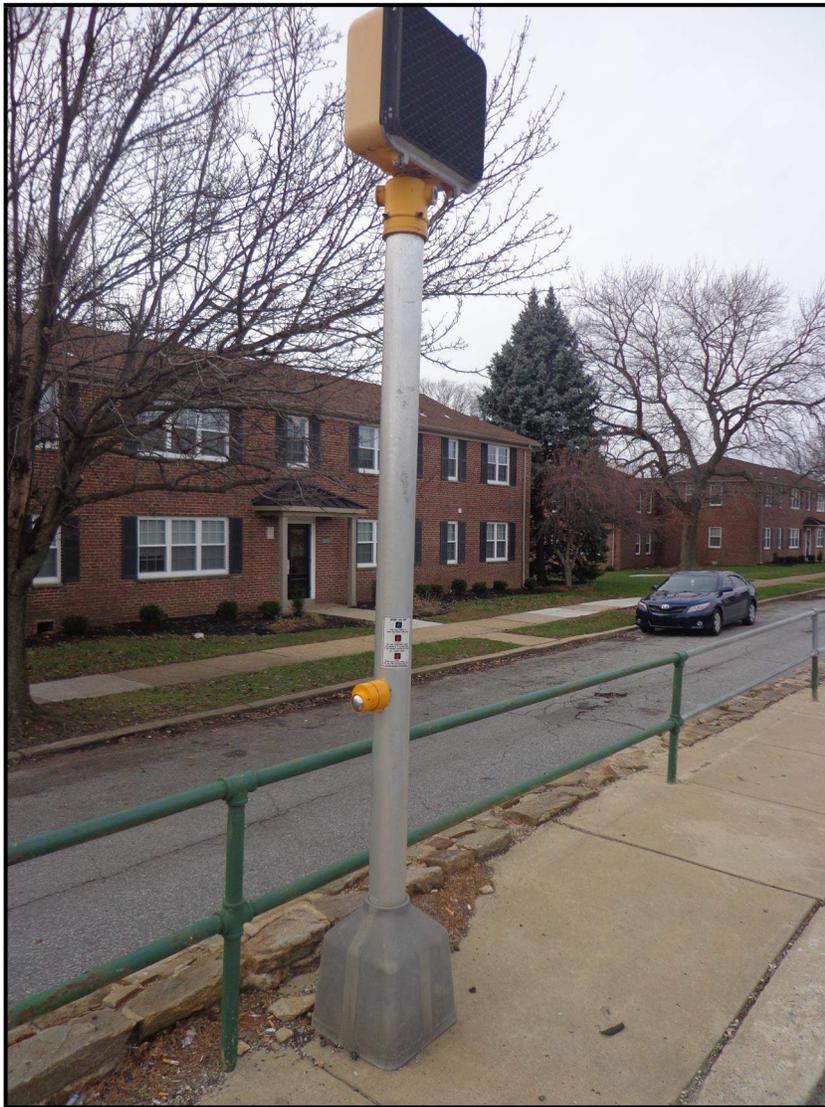
Pedestrian pushbuttons were tested in March 2016 to identify deficiencies. All of the pushbuttons were operating adequately. Likewise, pedestrian pushbutton signs were inventoried. Signage deficiencies were detected at the intersection with the 7 Day Farmers Market commercial driveway. All the pushbutton signs at this intersection need to be replaced with DE MUTCD compliant signs.

Photo 14: Pedestrian pole and pushbutton sign at 7 Day Farmers Market Commercial driveway intersection

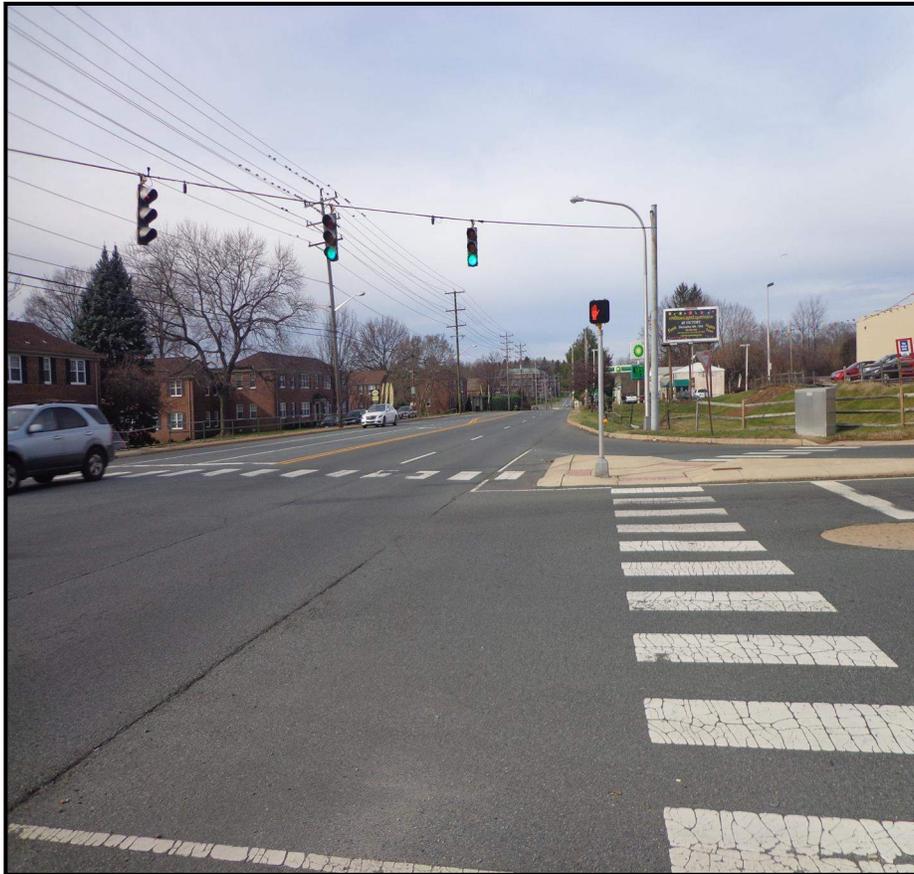
Signing and pavement markings were assessed along the Lancaster Pike (SR 48) study area. Pavement marking deficiencies were detected at various locations, including the existing pedestrian crosswalks, and missing stop bars at roadways controlled by stop signs. Existing 6-foot wide pedestrian crosswalks do not meet the guidance provided in the DE MUTCD for roadways with speed limit of 40 mph or higher. Existing crosswalks should be replaced with 10-foot wide crosswalks.

Photo 15: Crosswalk pavement markings at 7 Day Farmers Market commercial driveway intersection
