# DELAWARE STATE POLICE COLLISION RECONSTRUCTION UNIT

**TROOP 2 - New Castle County**

### LET'S LOOK AT A CASE...

• Tuesday December 27, 2022 8:54 PM

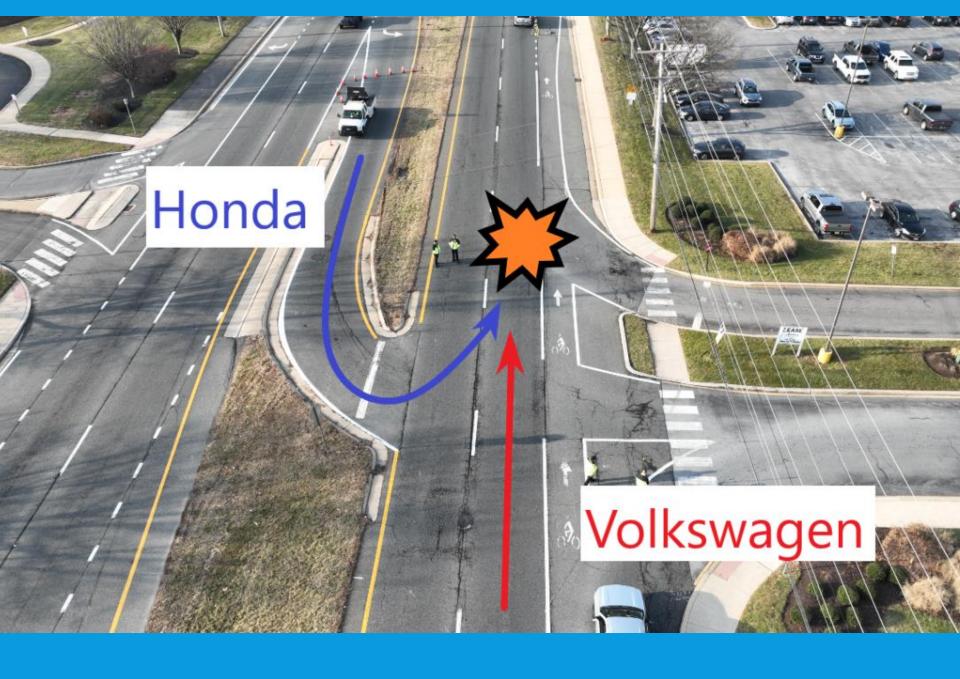
Ogletown Stanton Rd (DE SR 4) westbound west of Harmony Rd, Newark DE

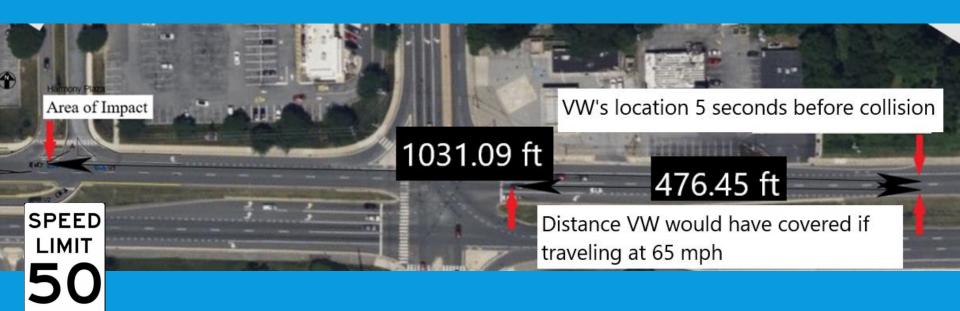
#### TIME AND DISTANCE ANALYSIS
