Technical Memorandum

Project: Pavement and Rehabilitation Design Services

RE: Memorial Drive Before and After Study

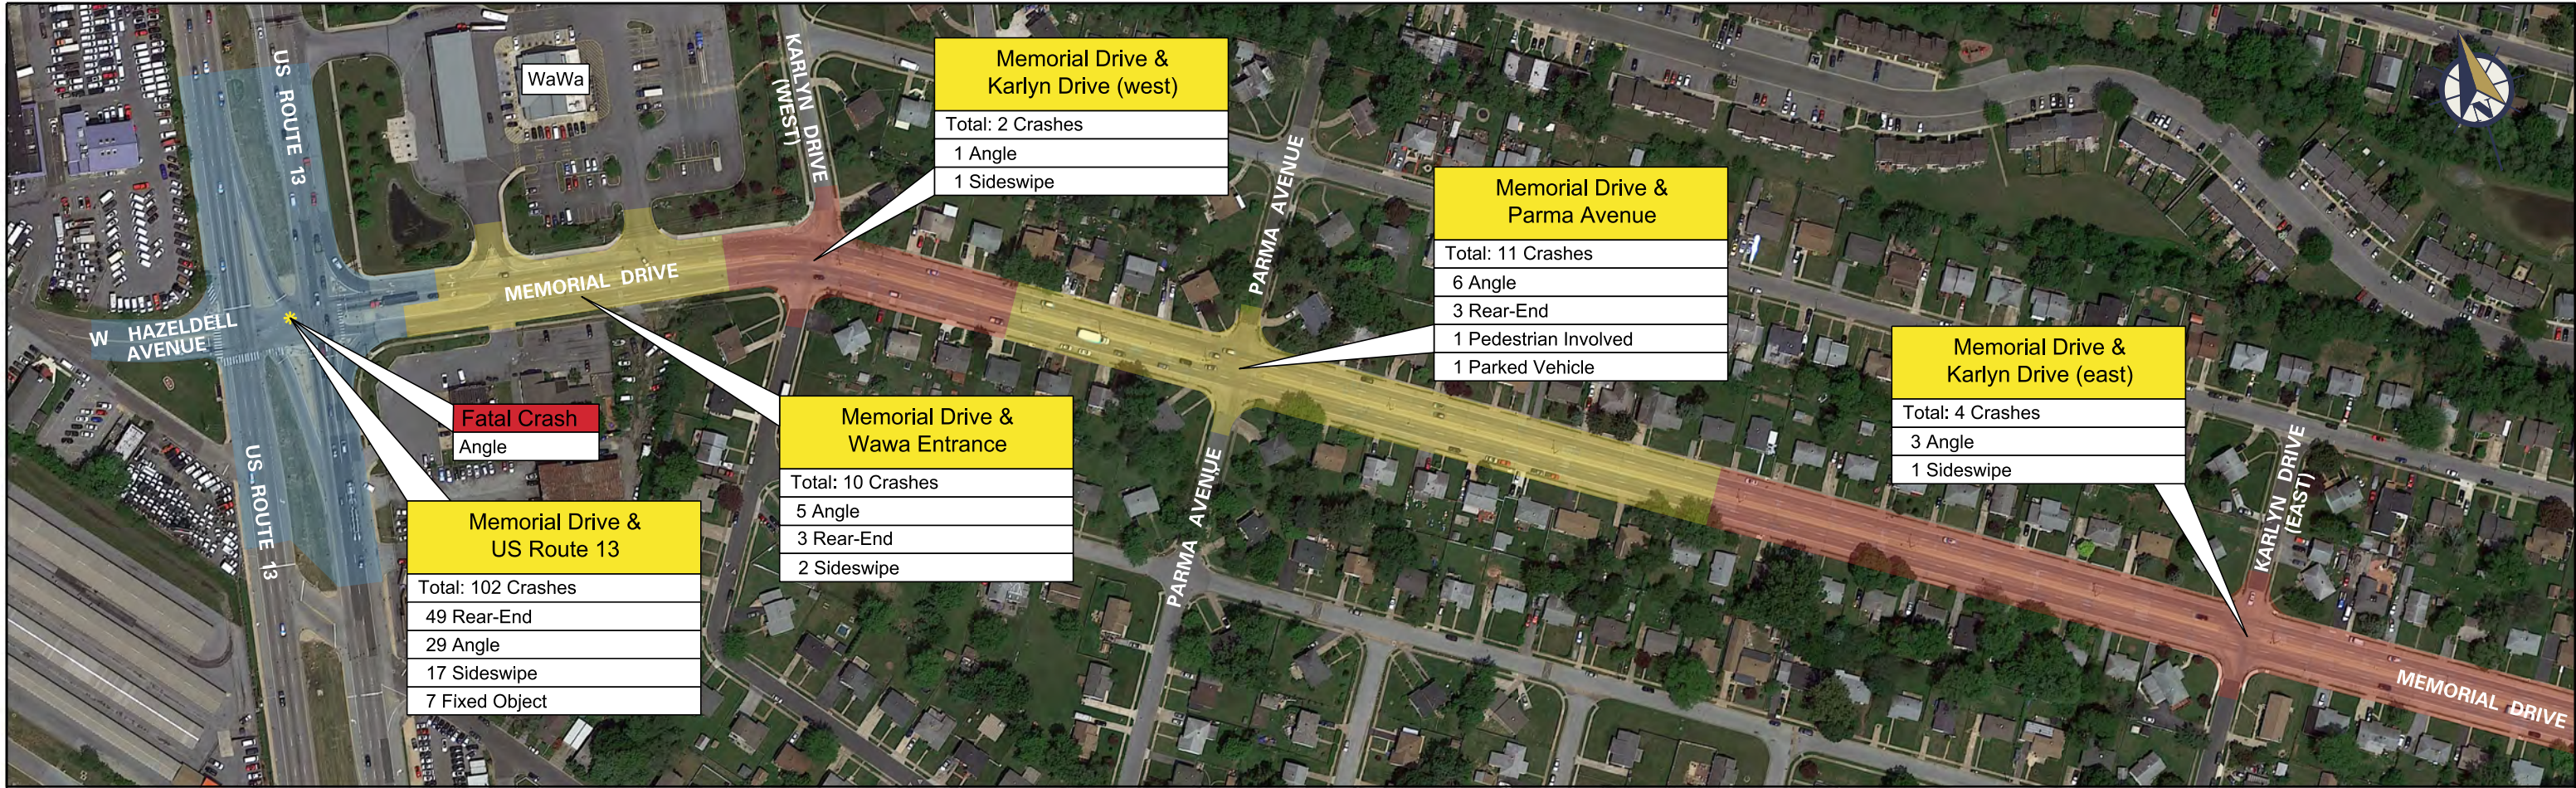
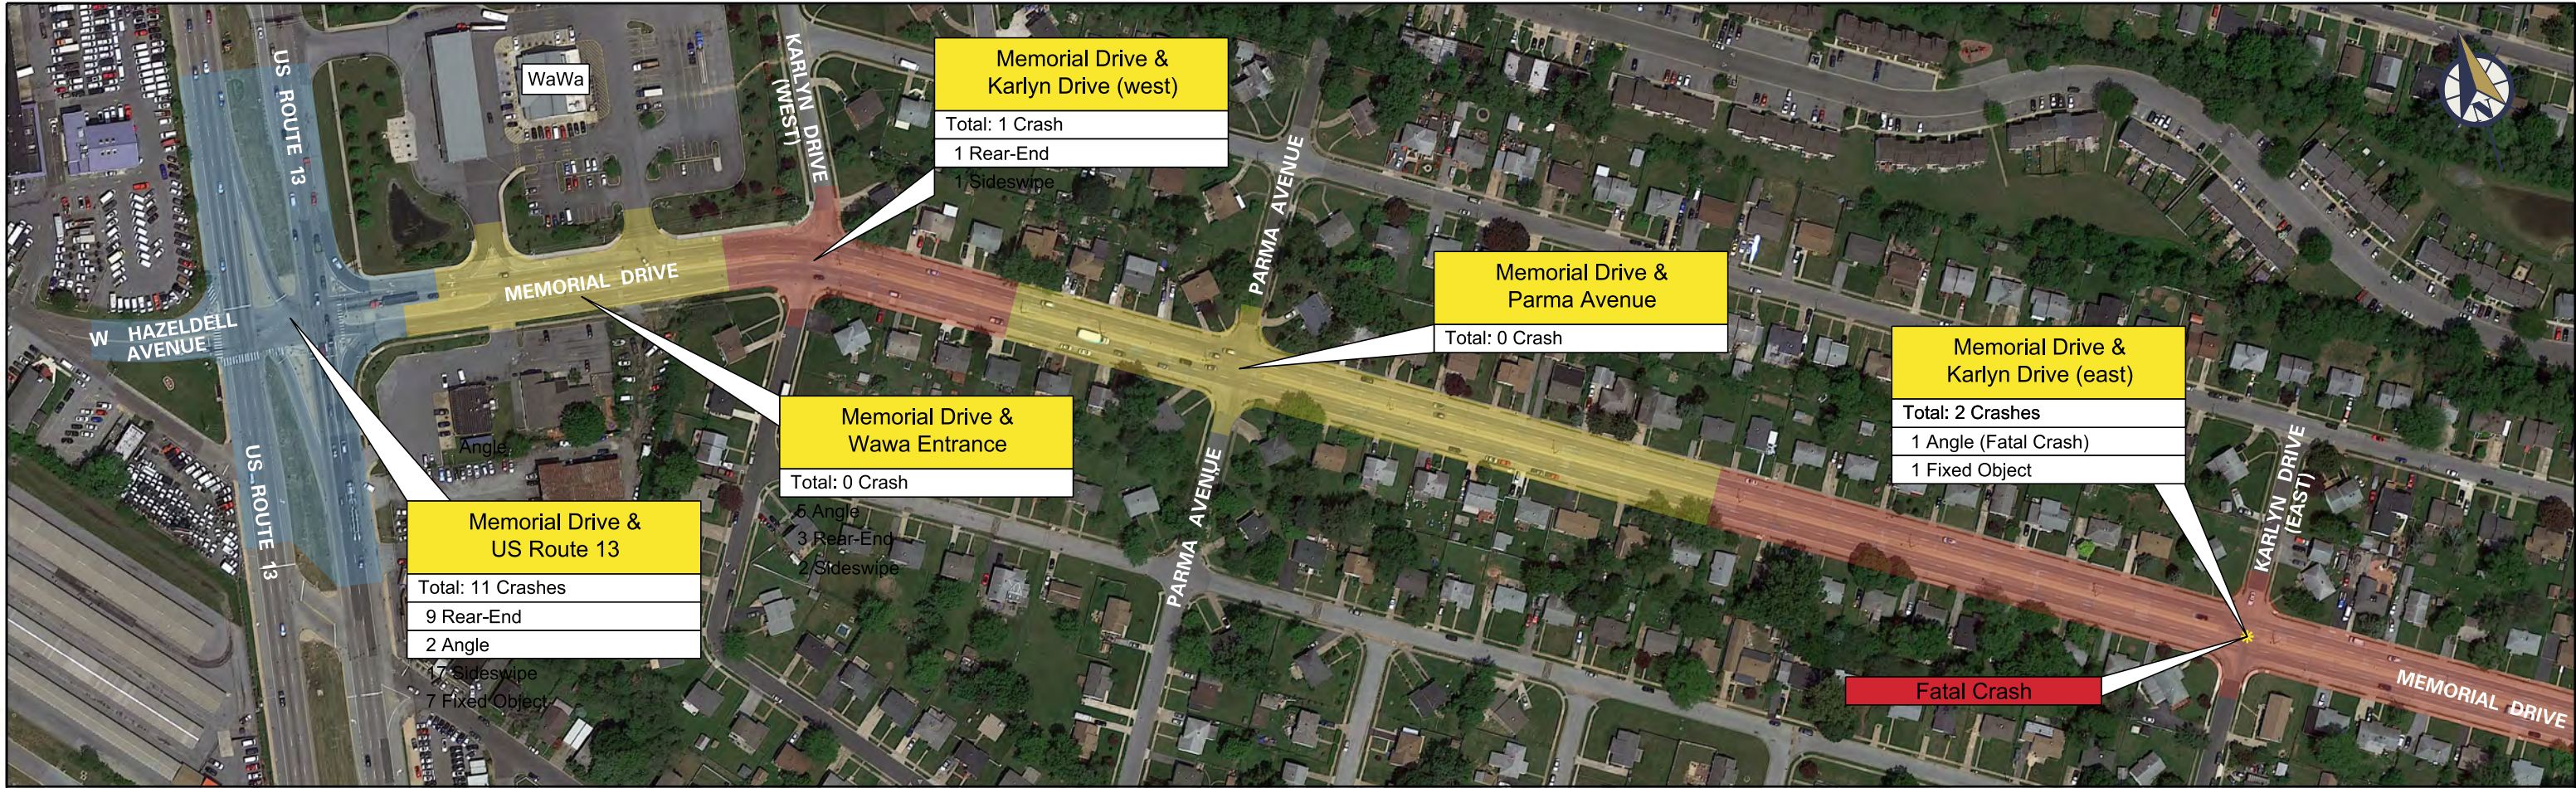
For the crash evaluation after implementation of the road diet JMT reviewed crash data from October 2019 to February 2020. As summarized on Figure 2, a total of 23 crashes during the four-month study period were reported. Out of the 23 crashes, 6 crashes occurred in the study area from the Wawa Entrance to Lind Avenue and one was a fatal crash which involved a southbound vehicle at the Karlyn Drive (east) intersection who failed to yield to right-of-way with a vehicle travelling westbound on Memorial Drive.
