# **First State National Historical Park Pedestrian Safety Analysis**

**DRAFT Report**

**July 2019**

National Park Service

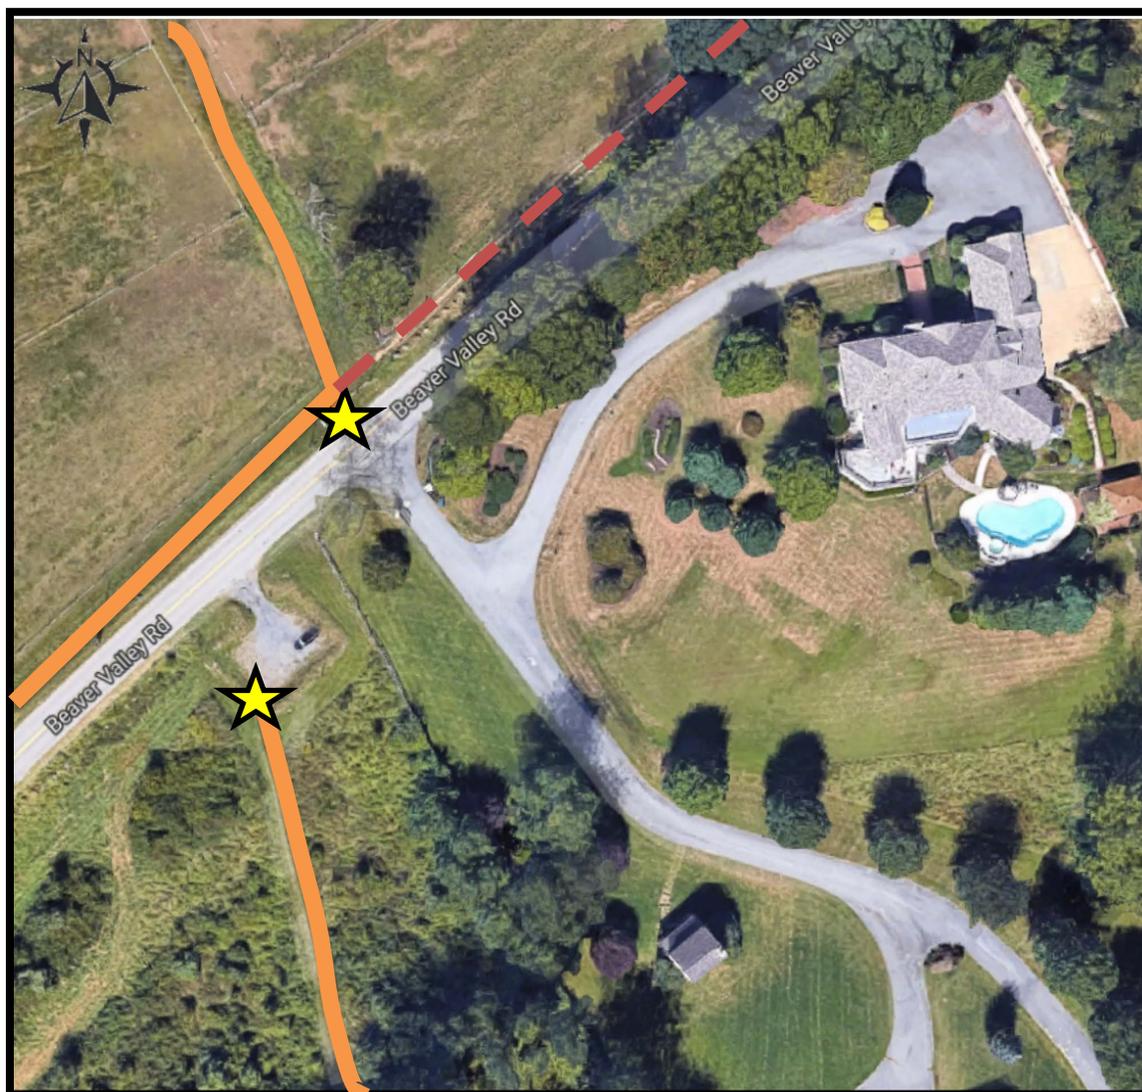
*Figure 5. Site 1 - Beaver Valley Road Crossing*

There are two trailheads on this site. The map in Figure 5 shows the north and south trailheads. The northern trailhead (39.843928 N, 75.555433 W) faces a private driveway, so it is important to keep trail users from accidentally entering the private property. The south trailhead (39.843520 N, 75.555599W) currently ends at the southwest end of a gravel parking lot. The path indicated by the red dashed line is not currently part of the NPS trail system, however may be part of a NPS trail expansion in the future. This site is located in Delaware County, Pennsylvania.

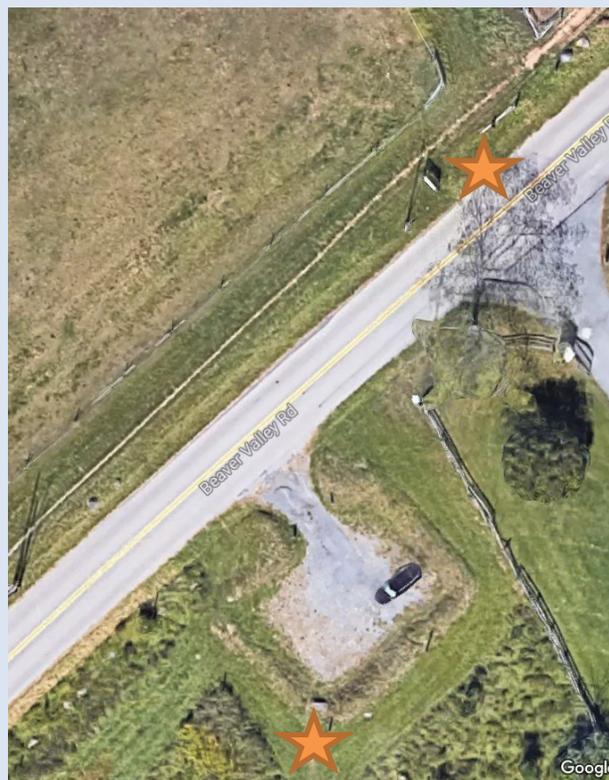
*Figure 6. Site 1 - Trailheads Map View*

*1. The two trailheads are not connected and cross a 20 foot 7-inch-wide uncontrolled active route known as Beaver Valley Road.*

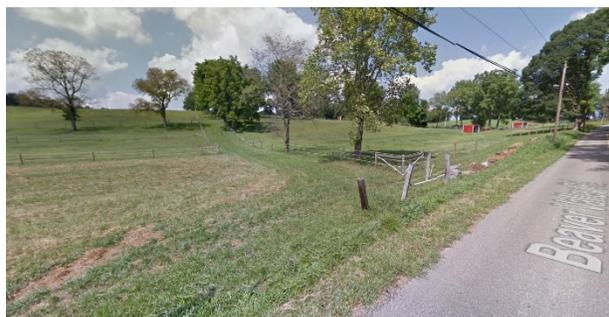
*Figure 7. Site 1 - North Trailhead*

*2. The north trailhead is a grassed path that intersects Beaver Valley Road and is currently aligned with a private driveway. There is no crosswalk pavement marking or advance warning signage, see Figure 7.*

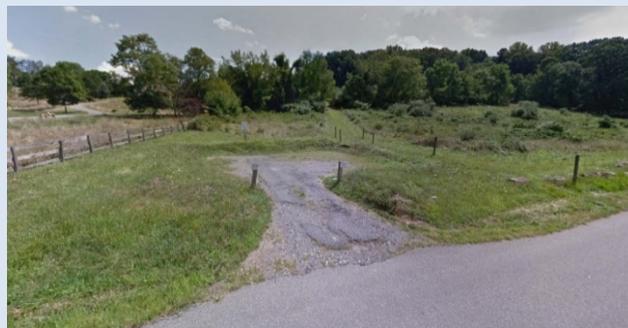
**Figure 8. Site 1 - South Trailhead**

3. The south trailhead ends at the southern corner of a gravel parking area that fronts Beaver Valley Road, see Figure 8. There is no crosswalk pavement marking or advance warning signage at this location.

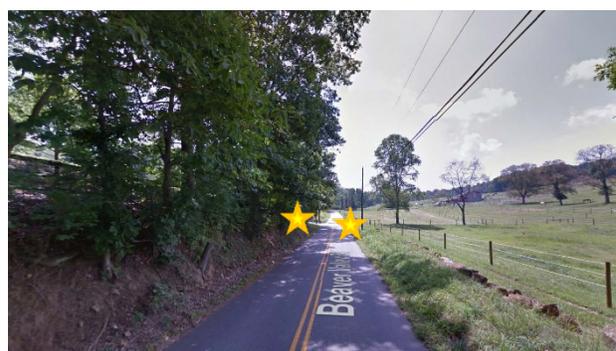
**Figure 9. Southwest Bound Approach to Trailheads**

4. Driving southwest bound towards the trailheads, lateral visibility to the left is limited. The visibility is limited due to the horizontal curve and vegetation. Figure 9 shows the view of the trailheads from approximately 200 feet facing southwest.

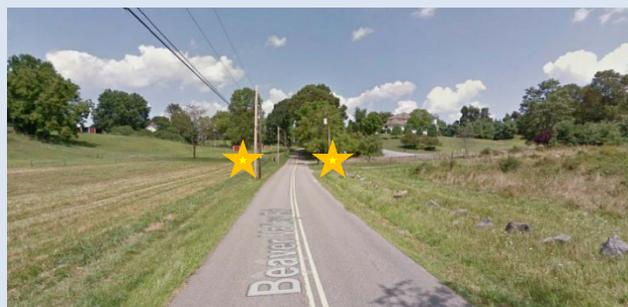
**Figure 10. Northeast Bound Approach to Trailheads**

5. Lateral visibility for drivers headed northeast can potentially be limited due to the vegetation. Figure 10 shows the northeast approach from approximately 200 feet from the north trailhead.

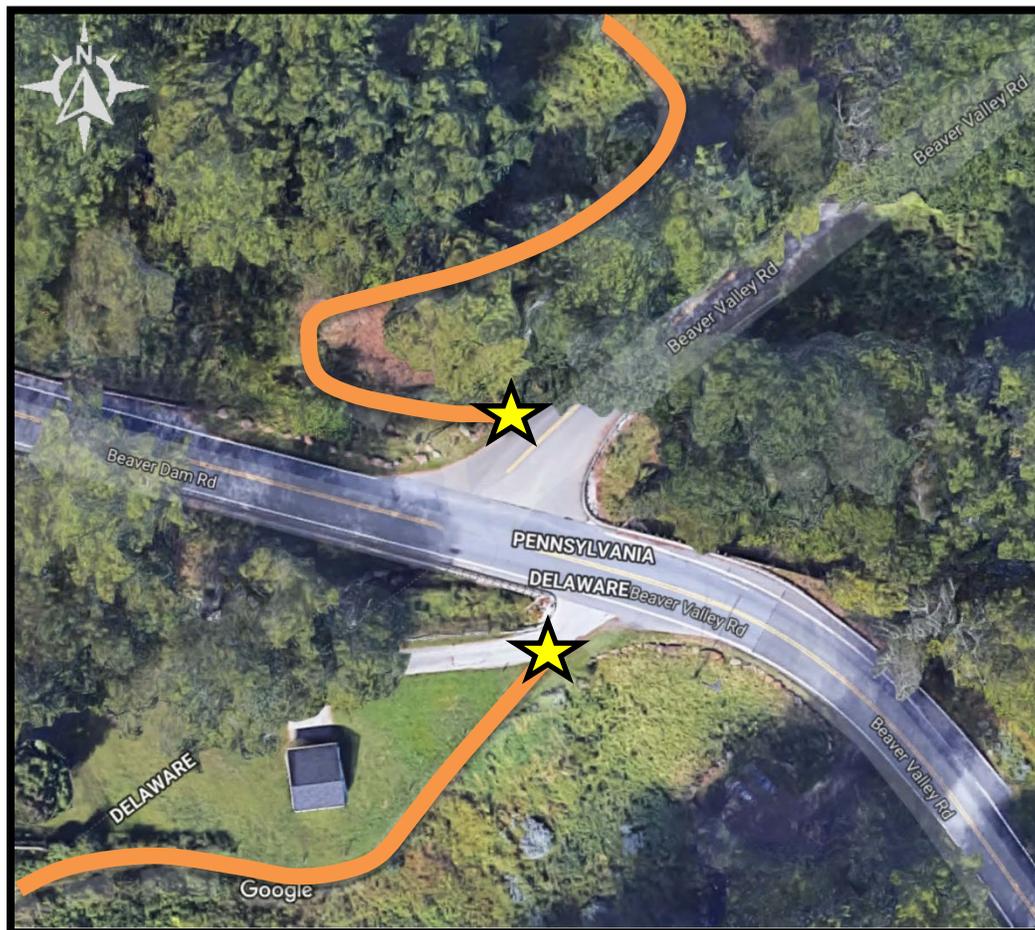
*Figure 11. Site 2 - Beaver Valley Road and Beaver Dam Road Intersection*

There are two trailheads on this site. The map in Figure 11 shows the west (39.839325 N, 75.564890 W) and south (39.839120 N, 75.564730 W) trailheads located on an angled t-intersection. This eastern portion of this site lies in New Castle County, Delaware and the western portion lies in Delaware County, Pennsylvania.

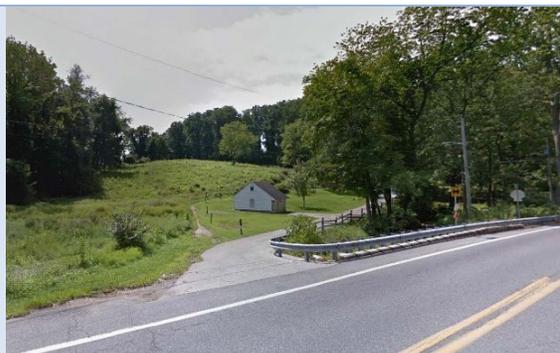
*Figure 12. Site 2 – South Trailhead and Driveway*

1. The south trailhead crosses a residential driveway as shown in Figure 12. This property is owned by NPS, but is leased out. Video footage showed people cutting through the driveway to cross Beaver Valley Road and drivers cutting diagonally to and from the driveway.

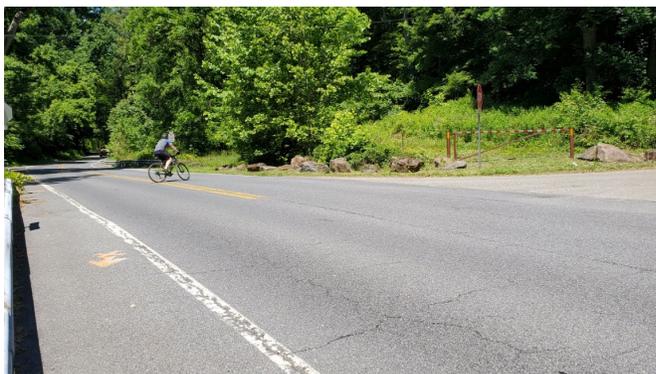
*Figure 13. Site 2 - Cyclist Rider Behavior*

2. In the video study, there were various trail crossing maneuvers across the unprotected, stop-controlled, 3-leg intersection. Pedestrians and cyclists were seen cutting diagonally due to the trail ending on opposite ends, from northeast to southwest. This route has a width of 24 feet 5 inches with 2 feet 6 inches of shoulder on both sides.

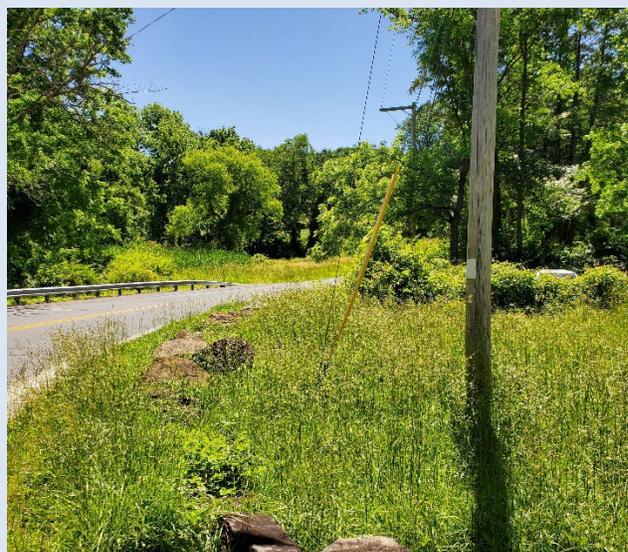
*Figure 14. Site 2 - Lateral Sight Distance from South Trailhead*

3. NB Beaver Valley Road's crossing sight distance is obstructed by horizontal curve and vegetation.

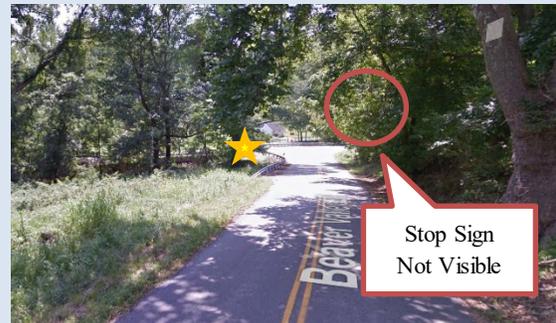
**Figure 16. Site 2 - Facing SW (200 Feet from Trailhead Crossing)**

5. SW Beaver Valley Road's stop sign is obstructed by vegetation as shown in Figure 16.

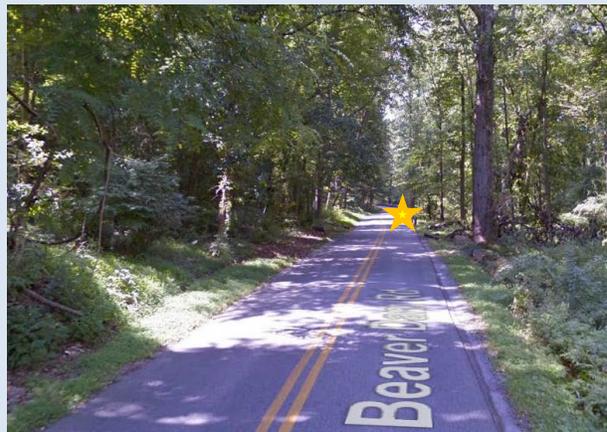
Figure 18. Site 3 - North Trailhead Facing West (200 Feet Away)

1. There is a lack of connectivity between the two trailheads. The approximate road width is about, edge of pavement to edge of pavement.

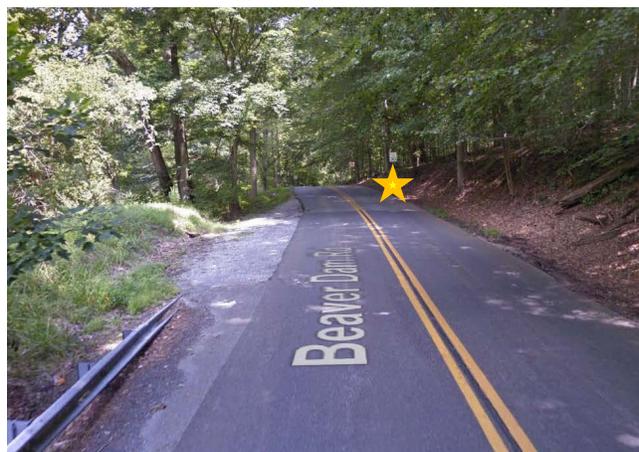
Figure 19. Site 3 - South Trailhead Facing Northeast (200 Feet Away)

2. There are no advance warning signs, lighting, or pavement markings to indicate trail crossings.

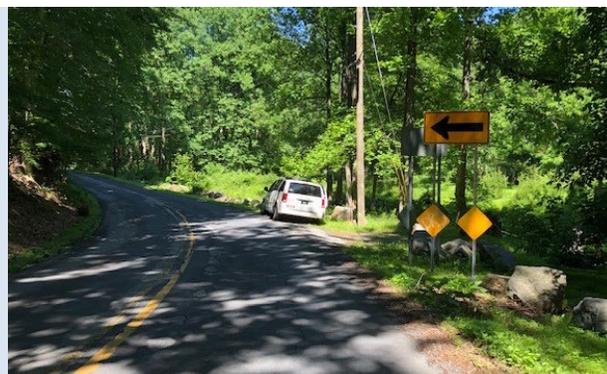
Figure 20. Site 3 - Facing North Trailhead

3. Limited sight distance from north trailhead.

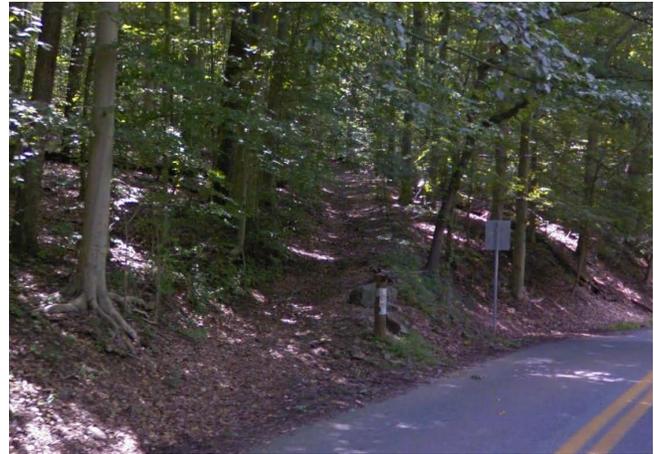
*Figure 21. Site 3 - Facing South Trailhead*

4. *The south trailhead is on a steep slope with limited sight distance, see Figure 21.*

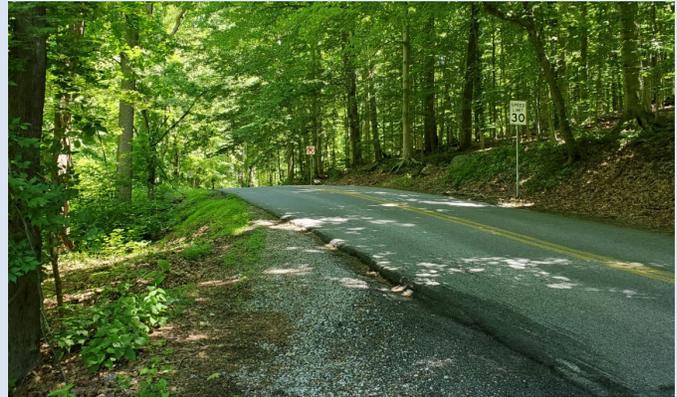
*Figure 22. Site 3 - Steep Roadsides*

5. *Roadsides in this general area are steep as shown in Figure 22.*

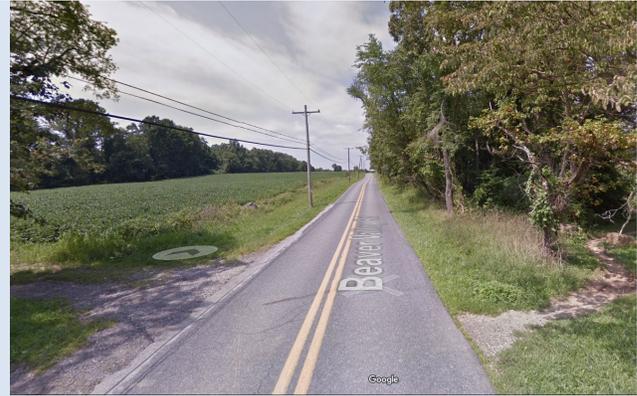
**Figure 24. Site 4 - Facing West at Trail Crossing**

1. This is a 16 foot 11-inch-wide, (edge of pavement to edge of pavement) uncontrolled trail crossing on an active route. Heavy traffic was observed in the video study. Many drivers seemed to be speeding in the video footage.

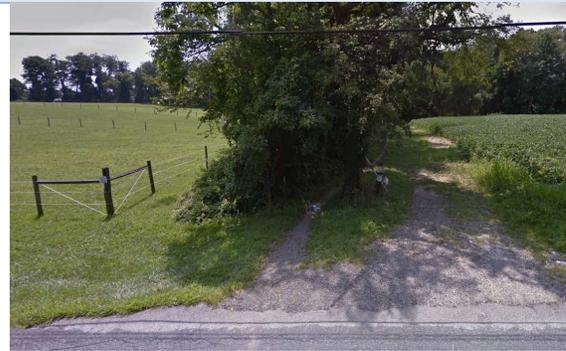
**Figure 25. Site 4 - Facing South Trailhead**

2. There is a farm access road adjacent to the south trailhead, see Figure 25.

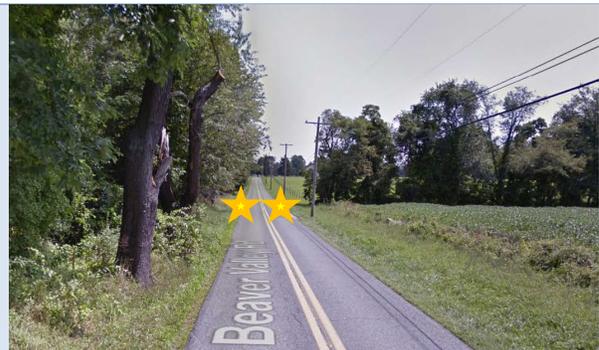
**Figure 26. Site 4 - Facing Southeast from 200 Feet**

3. Viewing the crossing from 200 feet away, facing southeast there is vegetation to the left and farmland to the right as depicted in Figure 26.

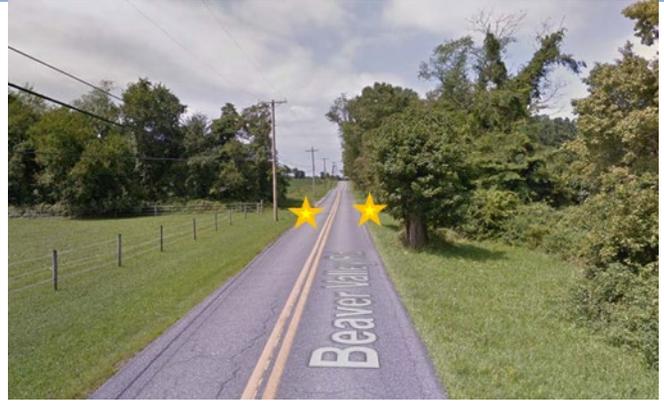
**Figure 27. Site 4 – Facing Northwest from 200 Feet**

4. *The crossing does not have lighting, striping, or advance warning signs from either direction to indicate pedestrian or wildlife crossings. Deer were observed crossing the roadway in the video study.*

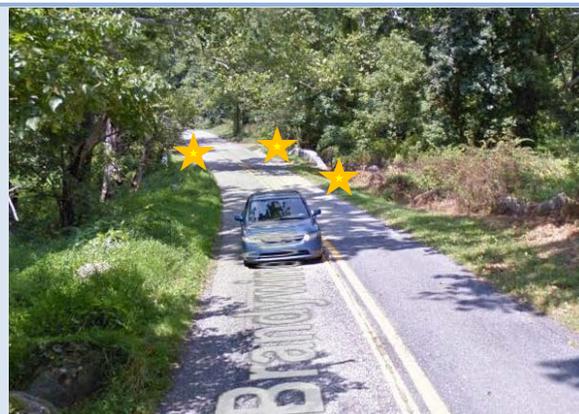
**Figure 29. Sites 5 & 6 - Facing Northwest 200 Feet from Trail Heads**

1. The site 5 trail runs parallel to Brandywine Creek Road and over a rock bridge abutment. This trail is unprotected from an active route.

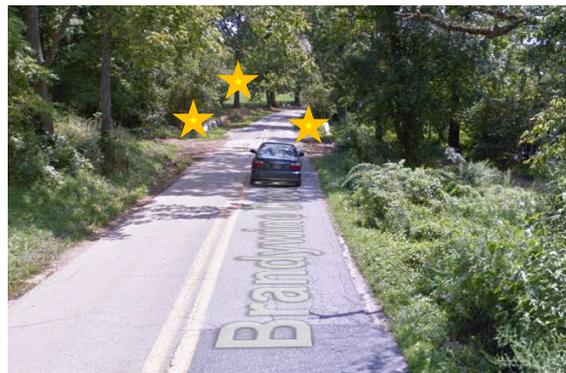
**Figure 30. Sites 5 & 6 - Facing Southeast 200 Feet from Trail Heads**

2. Site 6 trail crosses a 16 foot 8-inch-wide uncontrolled, active route.

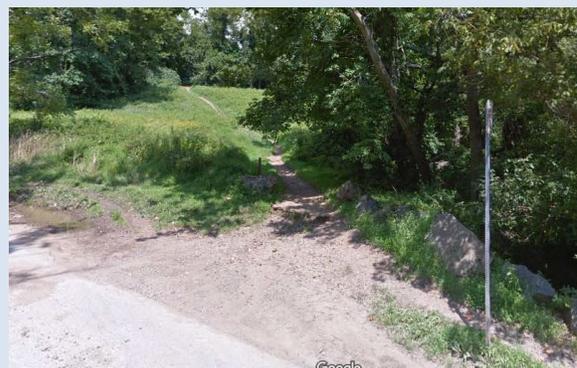
**Figure 31. Site 5 - Trail Head Facing North**

3. Trailheads adjacent to (Figure 31) and right up against stone abutments (Figure 32 and Figure 33). Geo-grid has previously been placed at these locations to stabilize the “shoulder area” and is failing in some areas.

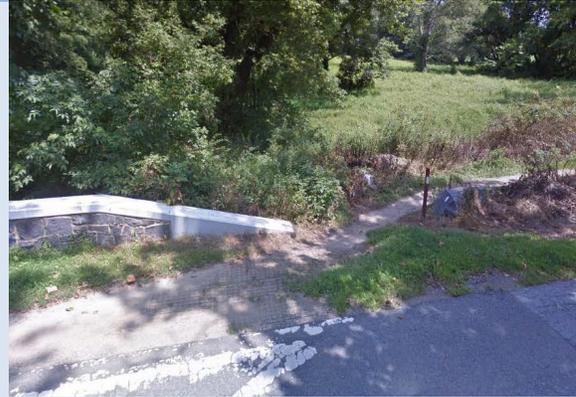
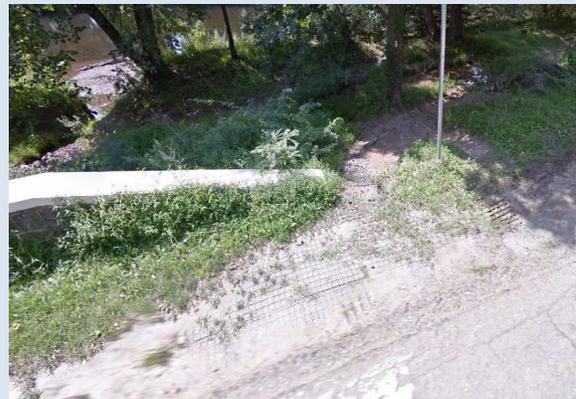
*Figure 32. Site 5 – Trail Head Facing Southeast*

*Figure 33. Site 6 – Trail Head Facing West*

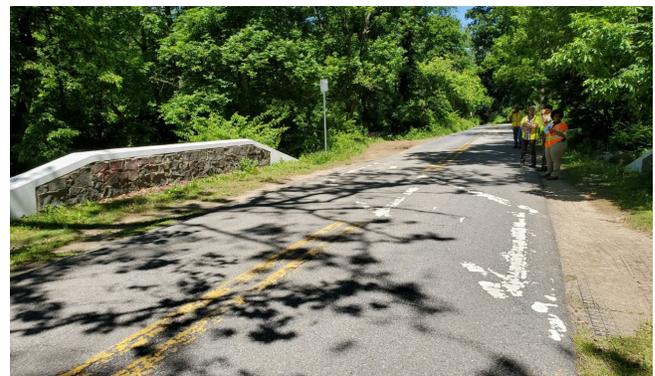
*Figure 34. Site 5 and 6 Existing Crosswalk*

4. The existing crosswalk is faded and difficult to see (Figure 34).

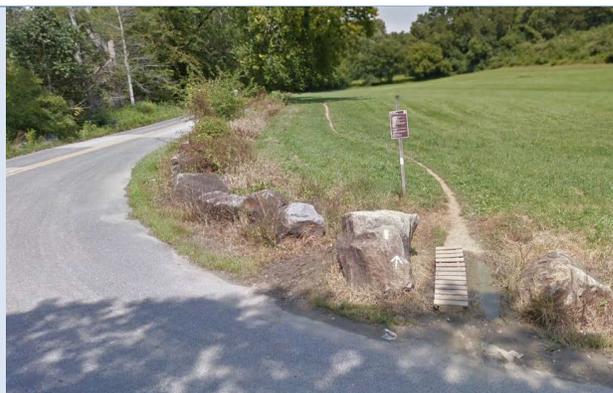
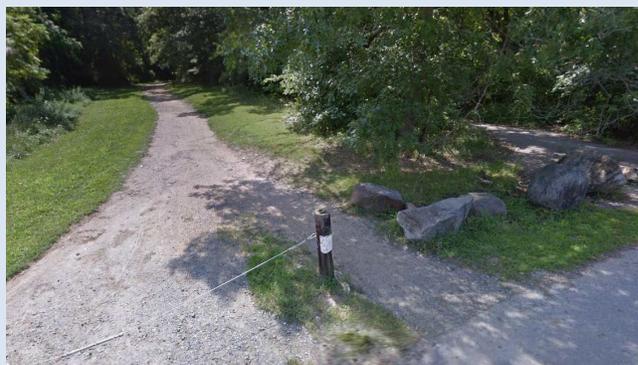
The trail crosses near a critical horizontal curve between Brandywine Creek Road and Ramsey Road, an uncontrolled, active route as shown in Figure 36 and Figure 37. Video study showed various “near misses” between vehicles and pedestrians at this location.

*Figure 36. Site 7 - Facing North Trail Head*

*Figure 37. Site 7 - Facing South Trail Head*

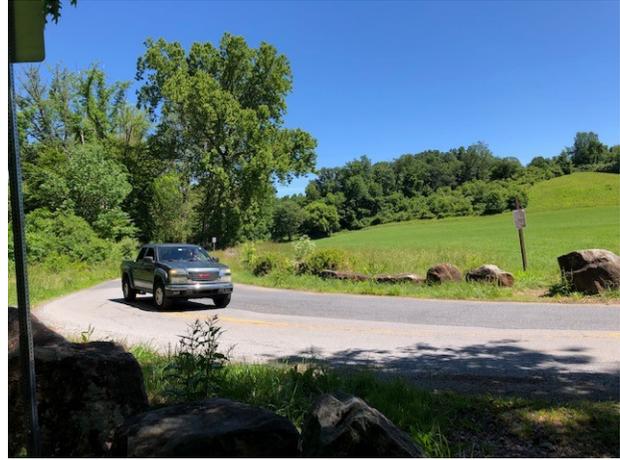
*Figure 39 - Pickup Truck Crossing Centerline*

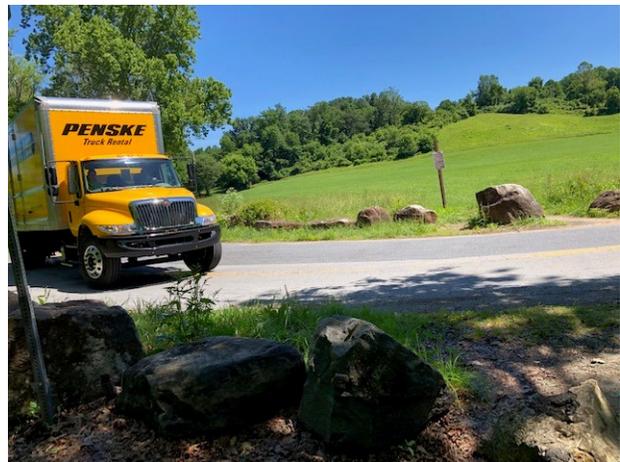
*Figure 40 - Box Truck Crossing Centerline*

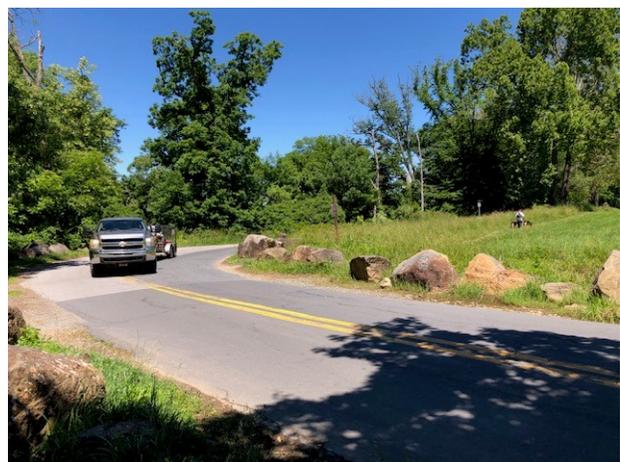
*Figure 41 - Pickup Truck with Trailer Crossing Centerline*

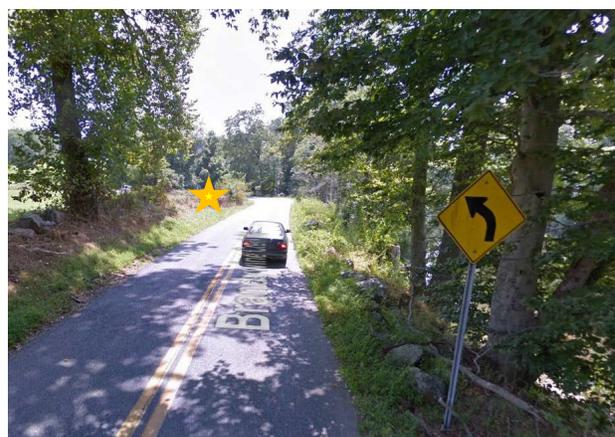
*Figure 44. Site 7 – Facing South 350 Feet from Trail Head Crossing*

4. *Curve signing is inadequate for the tight turn on Brandywine Creek Road to Ramsey Road, see Figure 44.*

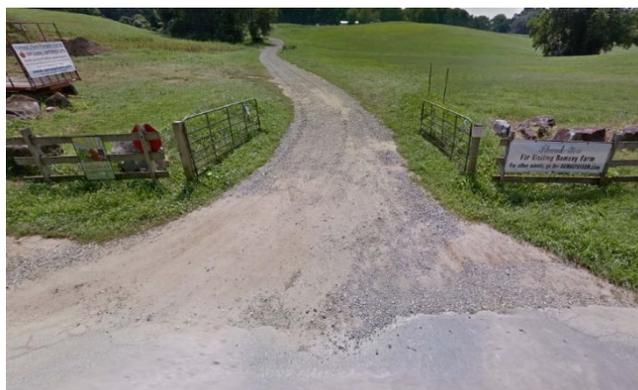
**Figure 47. Site 8 - Facing South Trailhead**

2. The driveway depicted in Figure 47 is used by agricultural land lessee and park visitors. (1/8 mile up the driveway is another trailhead)

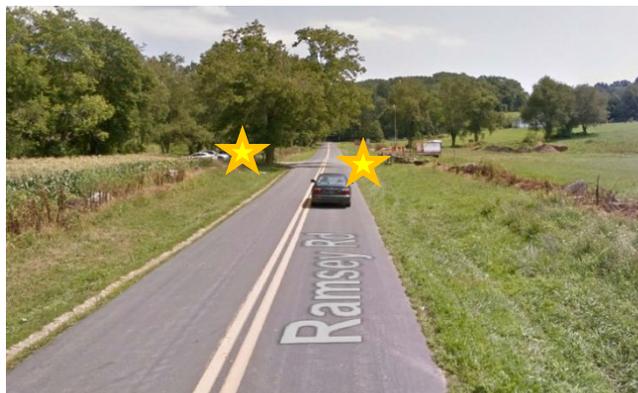
Figure 49. Site 8 – Facing East 200 Feet from South Trail Head

4. There is no advanced warning signals or pavement markings for the trail crossing as shown in Figure 49.

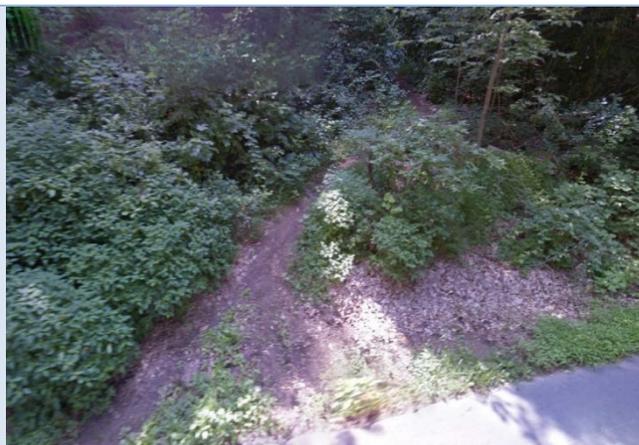
Figure 51. Site 9 - Facing South Trailhead

1. South trailhead is located on the bottom of a slope of a single-track trail. (See Figure 51).

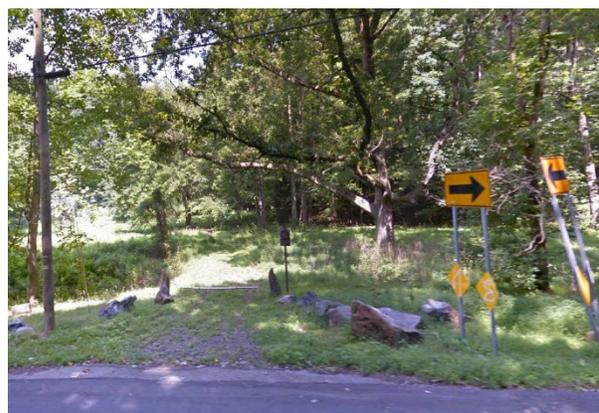
Figure 52. Site 9 - Facing North Trailhead

2. Visitors typically travel from the south trailhead, along the road side and cross the roughly 21-foot wide active route to the unaligned north trailhead, through the cable gate to access this wider trail. (See Figure 52)

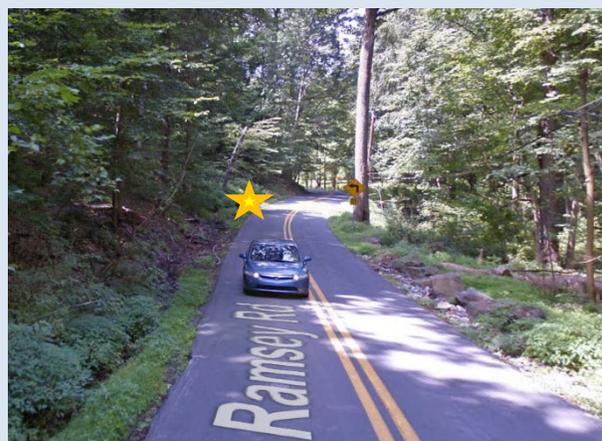
Figure 53. Site 9 – Facing West 200 Feet from North Trail Head

3. Site is considered “high risk” by the NPS due to the limited sight distance for road and trail users.

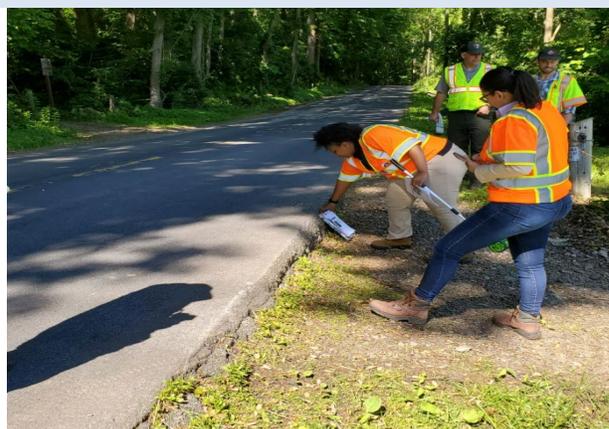
*Figure 57. Road Edge Rutting at North Trailhead*

2. A drop-off of approximately 9 inches was estimated between the road edge and the north trailhead as shown in Figure 57.

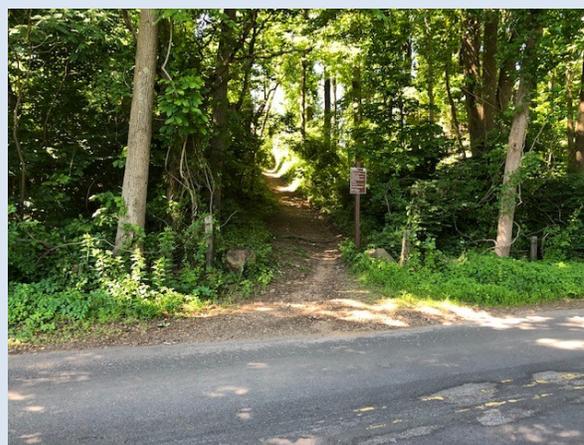
*Figure 58. Site 10 - South Trailhead*

2. Gravel runs into the roadway from the bottom of the steep slope of the south trailhead as seen in Figure 58 and Figure 59.

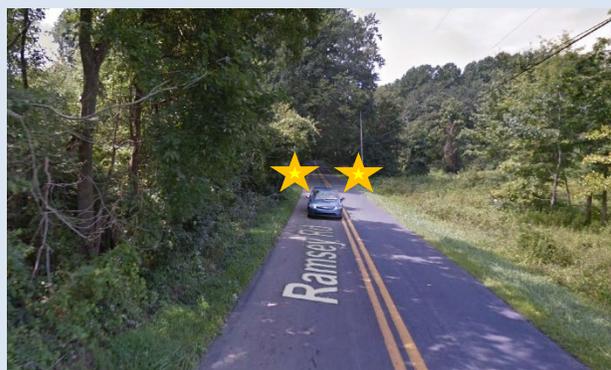
**Figure 61. Site 10 – Facing West 200 Feet from Trail Head Crossing**

*4. When cyclists use the roadway, vehicles will drive around them into opposing traffic; video shows “near misses” with vehicles.*

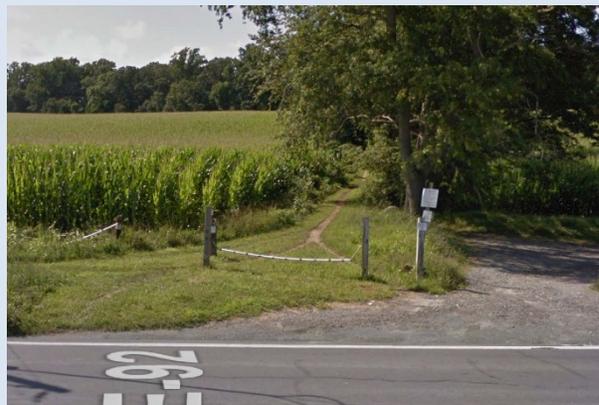
**Figure 63. Site 11 - Facing Northwest Trail Head**

1. Trail crossing maneuvers are located on 3-way intersection. Woodlawn Rd is stop-controlled and DE-92, Thompson's Bridge Road, is uncontrolled. NPS stated that this intersection has a high incidence of left-turning movement crashes.

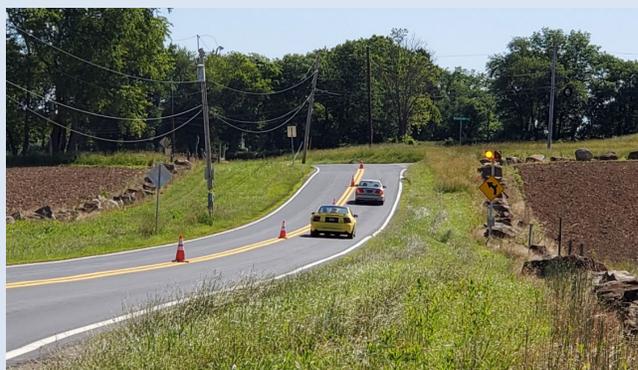
**Figure 67. Approaching Site 11 from Eastbound DE-92**

3. Existing warning sign with flashing beacon going eastbound along DE-92 shown in Figure 67. Otherwise, there is no other advanced warning signals for trail or pedestrian crossings at the intersection.

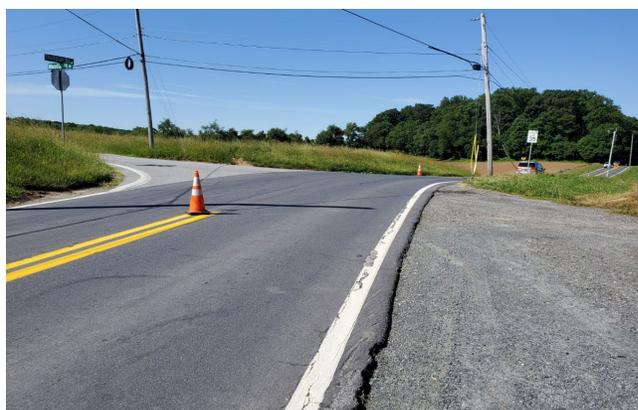
**Figure 68. Site 11 Intersection Westbound DE-92**

4. Existing sight distance challenges due to horizontal and vertical curves and roadside vegetation.

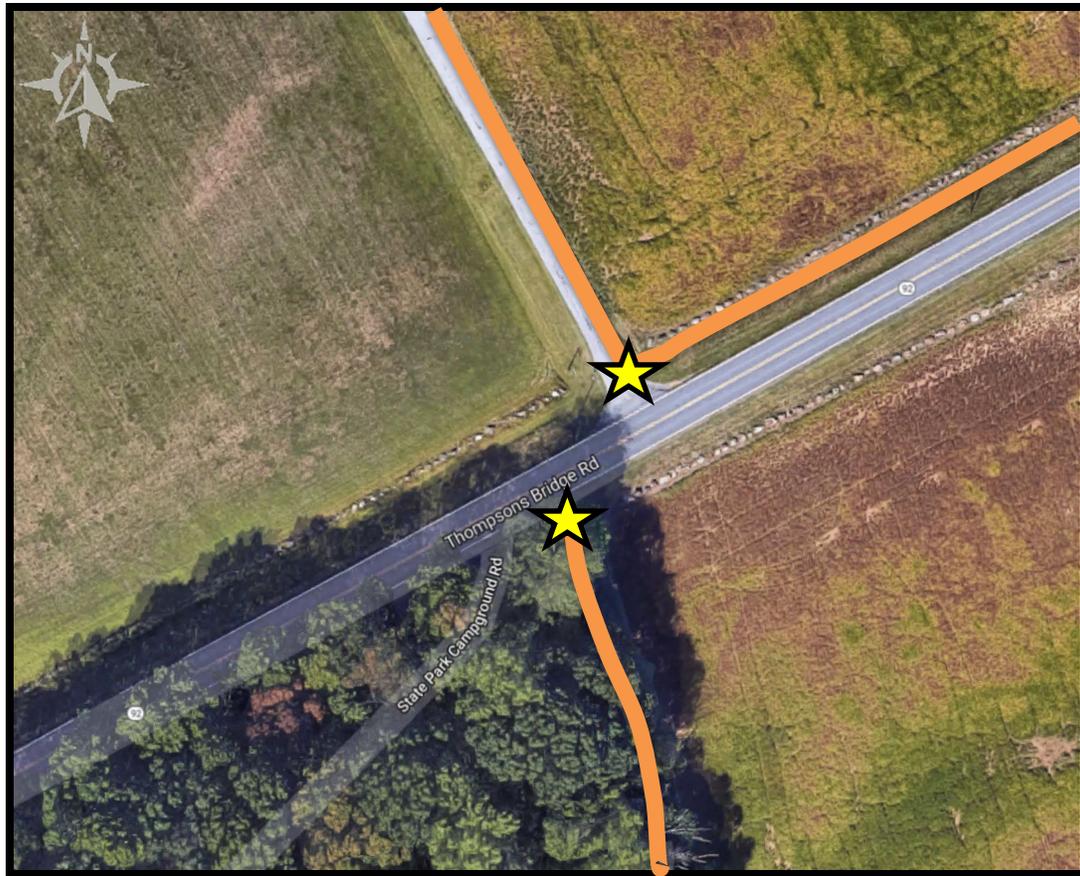
*Figure 69. Site 12 - Thompsons Bridge Road*

The trailheads, northern (39.824005 N, 75.559357W) and southern (39.823816 N, 75.559443W) are located in site 12, near a park access road and agriculture lands as depicted in Figure 69.

1. The north trail runs along DE-92, Thompson Bridge Road between the pavement and boulders, Figure 69. The trailhead ends at a driveway to a farm as shown in Figure 70.

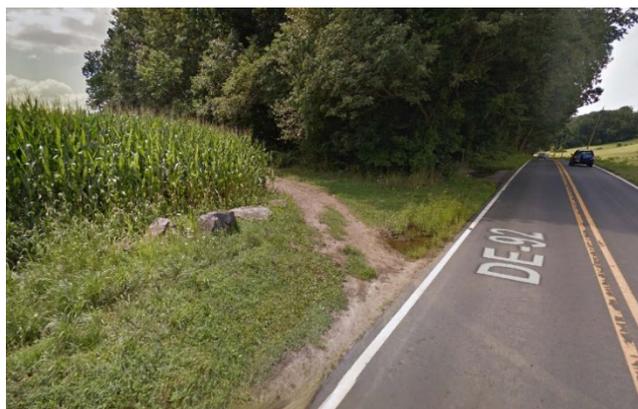
**Figure 71. Site 12 - Facing South Trailhead**

2. The south trailhead is located at the bottom of a slope and experiences sight distance difficulties due to high vegetation on either side making it difficult for drivers to see trail users, especially for drivers headed uphill northbound.

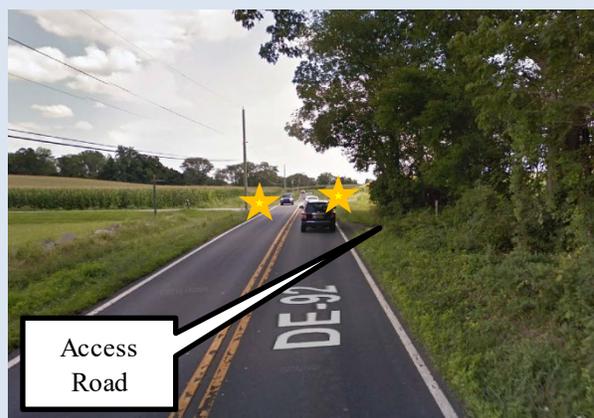
**Figure 72. Site 12 - Facing NE 200 Feet from Trailheads**

3. The access road, that enters the road at an acute angle and is located further south on DE-92 also has sight distance issues as shown in Figure 72.

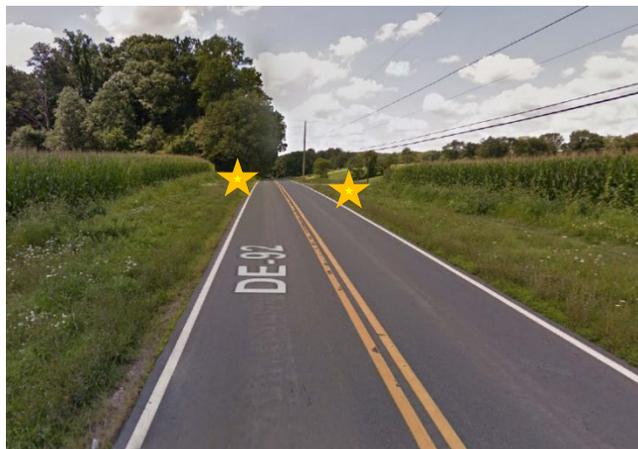
*Figure 73. Site 12 – Facing SW 200 Feet from Trail Heads*

4. The trail crosses a 22 foot 1 inch wide uncontrolled, unsigned, and unmarked active route. In the video study, pedestrians were observed walking down the trail, then turning to walk along the street.

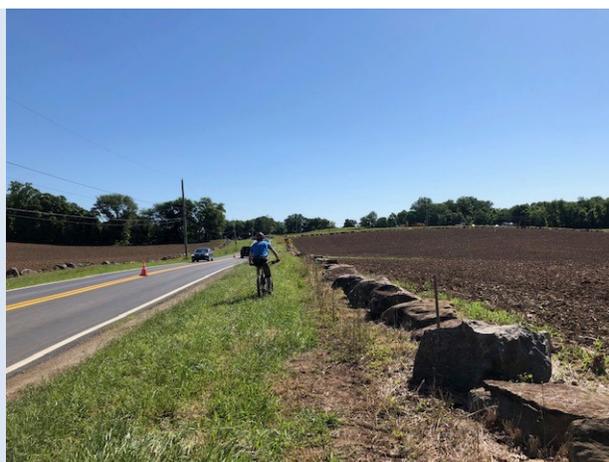
5. Video footage also showed cyclists riding along the unpaved shoulder, off the road, and then crossing the roadway onto the trail.

*Figure 74. Road User Mix Along DE-92*

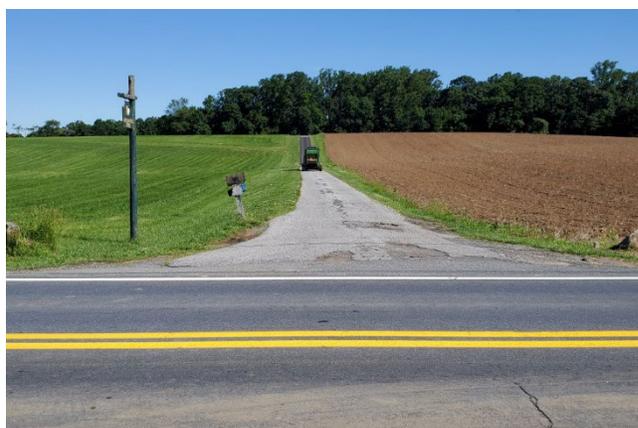
6. Farm equipment was observed on the roadway. The north trail runs along a farm driveway.

*Figure 75. Site 12 - North Trail Shares Farm Driveway*

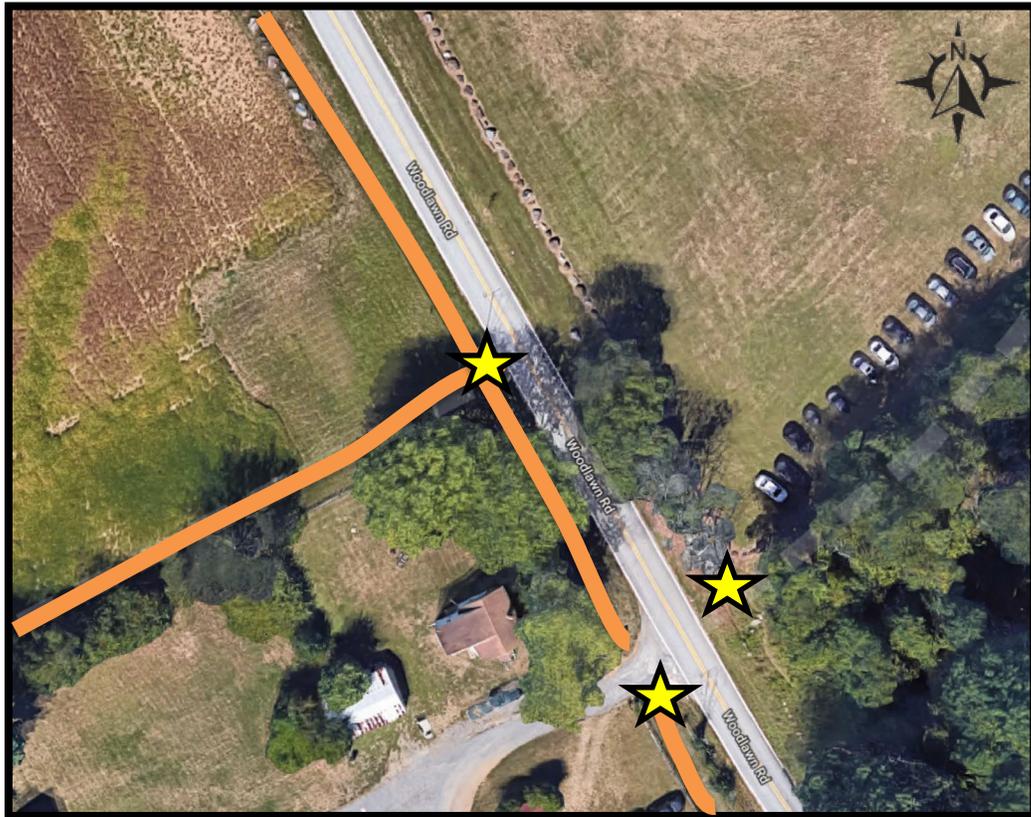
*Figure 76. Site 13 - Woodlawn Road Crossing*

Site 13 contains three trailheads that cross Woodlawn Road as shown in Figure 76. The northwest trailhead (39.823384 N, 75.556101 W) and southwest trailhead (39.823030 N, 75.555881 W) is an active trail, and the northeast trailhead (39.823129 N, 75.555777 W) leads to a dead-end trail. This site is located in New Castle County, Delaware.

Recommendations: Delineate/ Realign trails Discontinuity between southern trails along Woodlawn Road. Trimming Vegetation (Facing NW 200 feet from trailheads). The estimated costs for these improvements are \$17,000. Please see the detailed estimate in Appendix A for a cost breakdown.

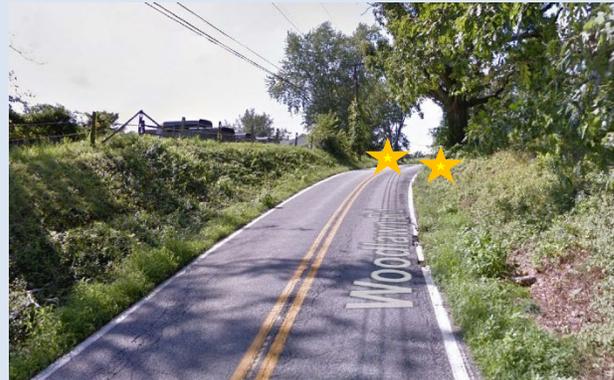
**Figure 77. Site 13 – Facing NW 200 Feet from North Trailhead**

1. East and South trailhead crossings experience sight distance obstructions by vegetation and the horizontal and vertical curve. Drivers are going up a steep grade when heading north on Woodlawn Road (Figure 77).

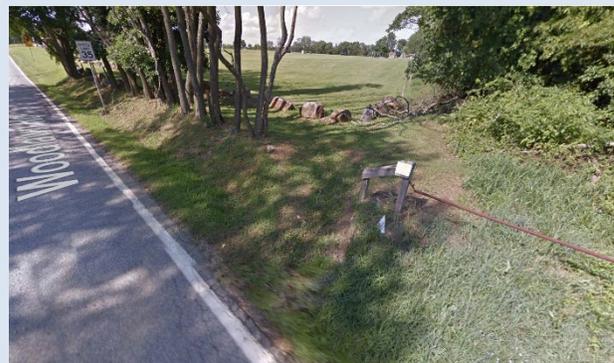
**Figure 79. Site 13 - Facing Eastern Trailhead  
(maintained by New Castle County)**

2. The eastern trail crossing is part of a recreational facility (same as shown in Site 11) and is maintained by New Castle County. There is currently no trail from this location.

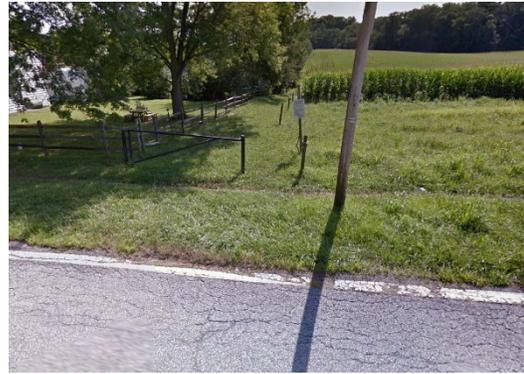
**Figure 80. Site 13 - Facing Northern Trailhead**

3. *The northern trailhead leads to trails along Woodlawn Road and meets the trail from Site 12.*

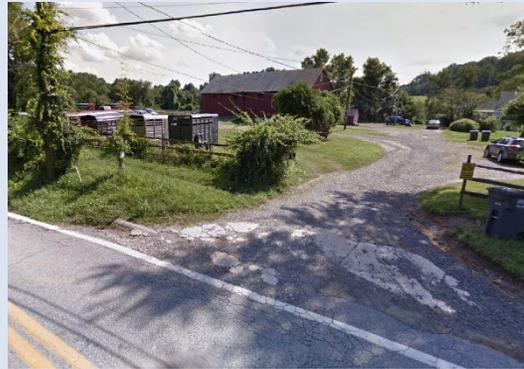
**Figure 81. Site 13 – Facing Southern Trailhead**

4. *The southern trailhead is adjacent to a driveway to a local business for kayak and other recreational rentals.*

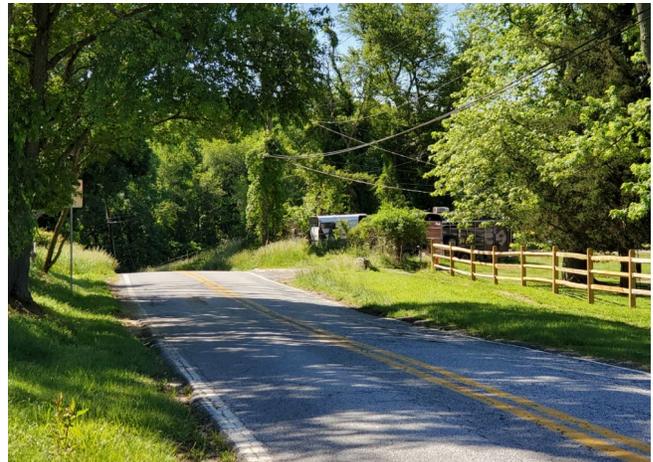
**Figure 82. Driveway at Southern Trailhead**

3. *The trail crossings are across a 17 foot 8-inch-wide uncontrolled, active route. NPS reports many accidents at this location.*

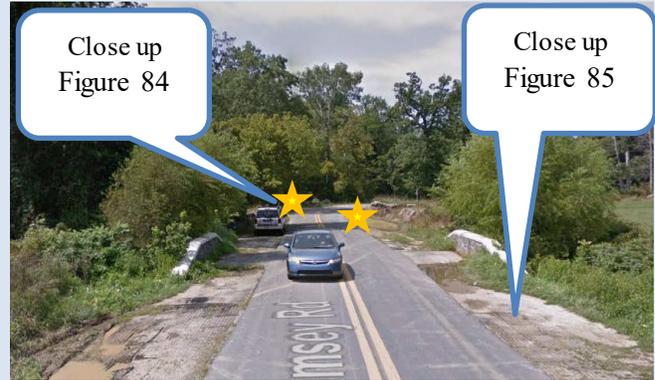
*Figure 83. Site 7 – Facing West 200 Feet from Trail Head Crossing*

1. The sides of the roadway along Ramsey Road are used for parking when the closest parking lot is full leaving only one lane available for traffic. The video also shows many instances of pedestrians and cyclists using the road or “shoulder area” instead of the trail. This area has previously been stabilized using a plastic geo-grid system that is failing in some locations. The grids shift or come out, and some spots experience ponding. See Figure 83 through Figure 85.

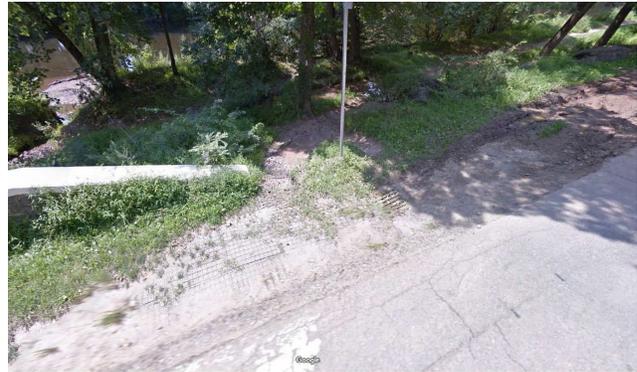
***Figure 86 - Brandywine Creek Roadside (Site 6)***

*2. Along the roadside near Sites 5 and 6 on Brandywine Creek Road, there are sections with geogrid material.*

Recommendations: Stabilize the roadside with concrete grid pavers. These pavers provide both safety and aesthetic benefits by providing a stable roadside with a natural look once the turf is established. The image shows a typical detail used in an application in a Coordinated Technology Implementation Program (CTIP) preliminary project on Blue Ridge Parkway. The estimated costs for these improvements are \$72,000. Please see the detailed estimate in Appendix A for a cost breakdown.

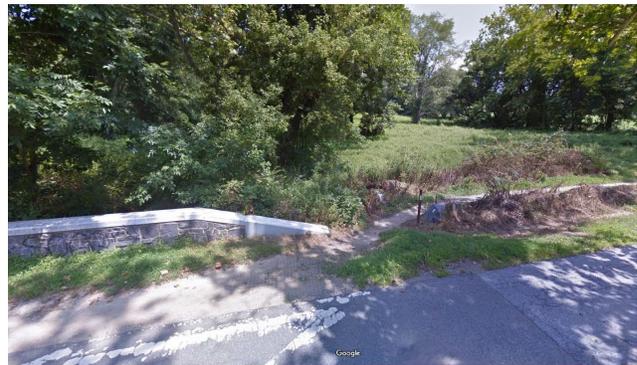
***Figure 87 - Brandywine Creek Roadside (Site 5)***

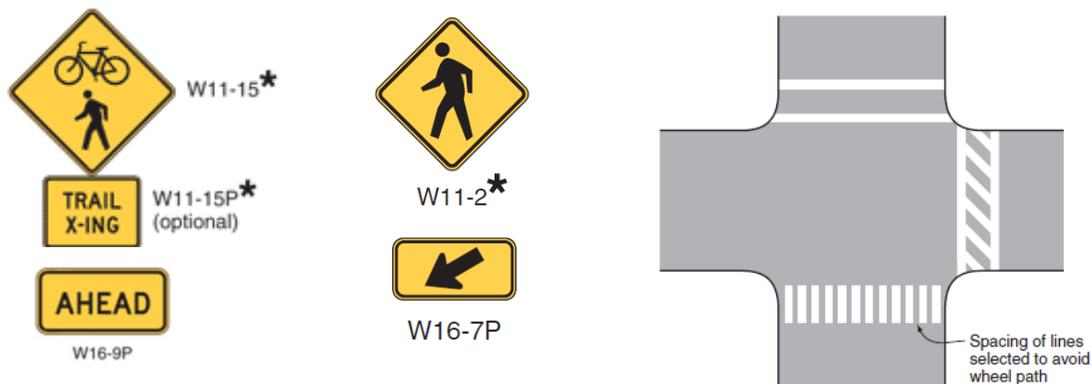
The following are safety recommendations that can be implemented in the short-term. Most consist of pavement markings, trail head stabilization, and signage. The most common signs and markings are shown in Figure 88. The safety recommendations are listed below and listed by site number. Please note, where Pedestrian (W11-2) signs are proposed, Trail Crossing (W11-15a) or the combined Bicycle and Pedestrian (W11-15) sign can be used instead. Also, where “PED XING” pavement markings are proposed, “TRAIL XING” can be used instead. These improvements will allow trail users to easily locate the trails (trailhead improvements) and road users will be able to anticipate and see the trail crossing (advance warning signs and pavement markings).

**Figure 88. Advance Warning Signage and Crosswalks**

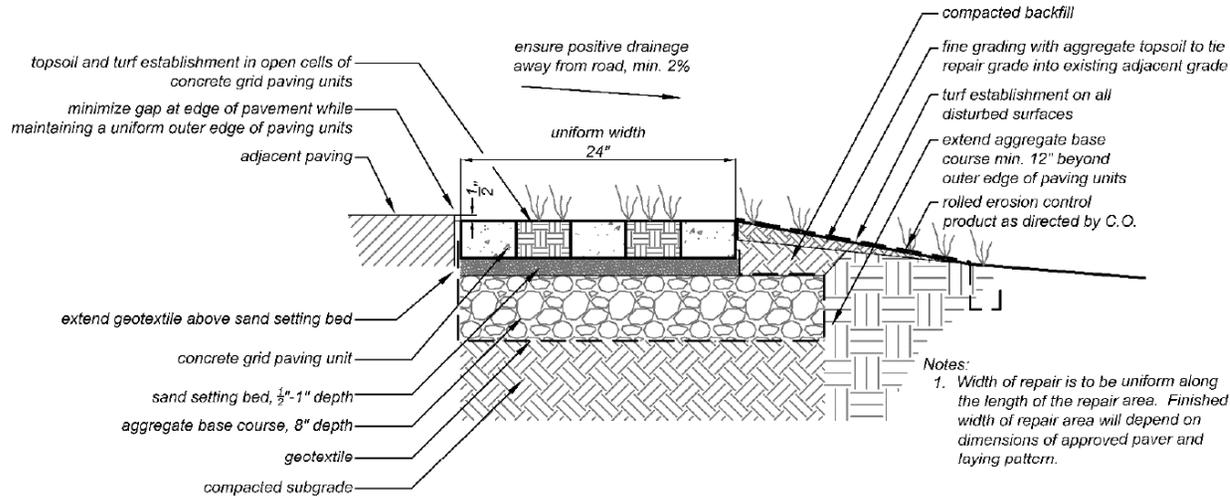
*Figure 89 - Concrete Grid Detail from Blue Ridge Parkway CTIP Project*

**DETAIL - TYPE A RUT REPAIR, CONCRETE GRID PAVING UNIT**  
 NOT TO SCALE
