## LEIPSIC RIVER BRIDGE CROSSING AREA

The Leipsic River bridge crossing and the results of the underwater archeological investigation conducted there are discussed in this section. The information provided includes a description of the natural setting, bathymetry, and subbottom stratigraphy. An overview of local history is presented with information on documented shipwrecks in the vicinity. The findings of the remote sensing survey and site evaluation work are also provided with recommendations concerning further work.

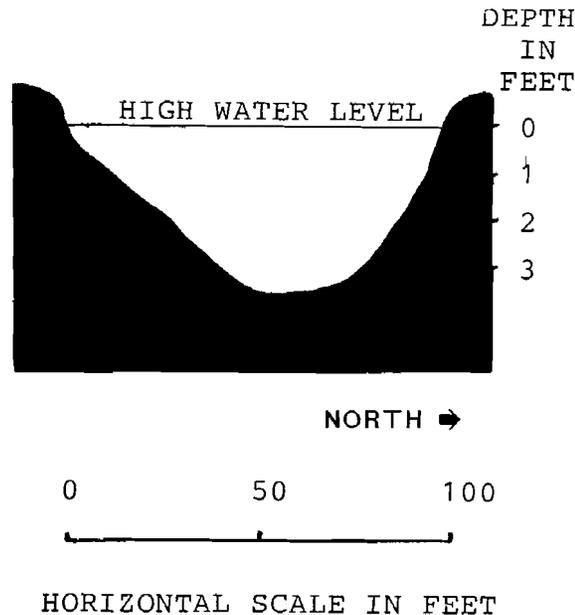
**FIGURE 127**  
**Bathymetric Cross Section of Leipsic River Bridge Crossing**

Figure 127 is a bathymetric cross section of the project area looking towards the west (upstream). The bathymetric profile shows the river bottom to be quite smooth and nearly flat in cross section. The smooth bottom contours indicate that this part of the river has been subject to heavy siltation during recent times.

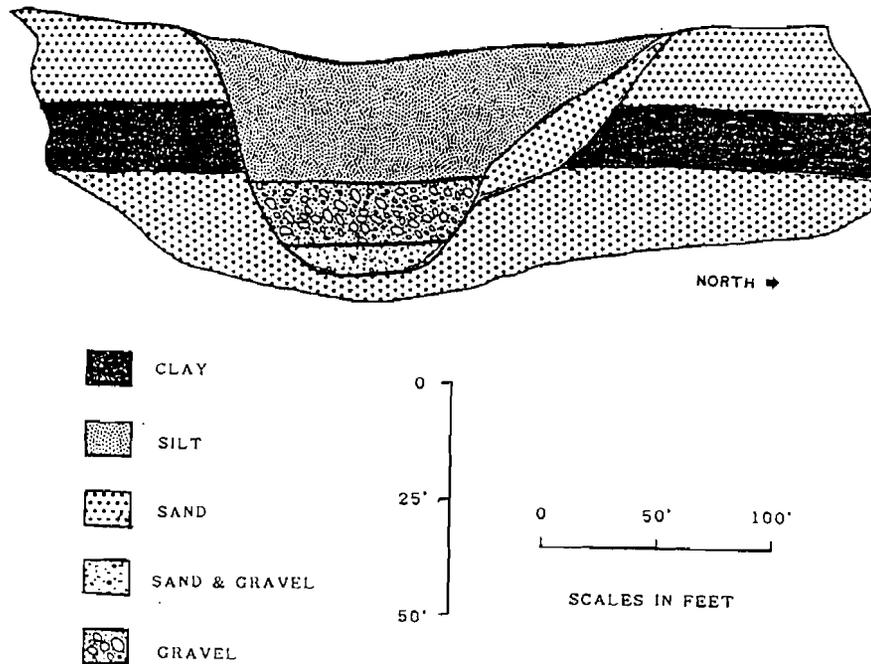
FIGURE 128  
Stratigraphic Profile of Leipsic River Crossing

A cross sectional diagram of the river's subbottom stratigraphy is provided as Figure 128. It has been prepared using information from geotechnical soil borings along the project alignment (Century Engineering, Inc. 1988; Kidde Consultants 1988). This profile is oriented with the view looking upstream (westward); north is to the right.

The subbottom sediment stratigraphy shows evidence of the river's origin as a subaerial stream valley. Features characteristic of such streams are evident. One is a relict stream channel containing gravel and sandy gravel sediments that has been cut deeply by erosion into the natural sand and clay subsoil. Also present is a buried former terrace on the northern side of the ancestral stream valley. The ancestral river's erosional down cutting that formed the ancient valley took place before the river was inundated by rising sea level around 4000 B.C.

Following its inundation, the Pleistocene-early Holocene former river valley began to fill with silty and sandy sediments. About forty feet of sediments have accumulated above the ancestral stream's former channel. This overburden is sufficiently thick to have buried the formerly exposed lower terrace and totally conceal the original subaerial physiography of the ancient stream valley.

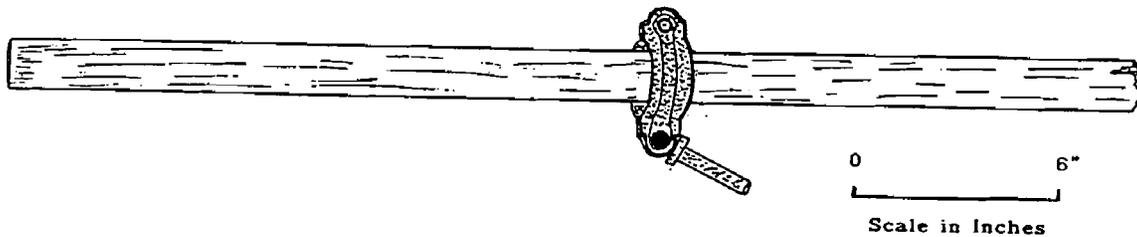
**FIGURE 137**  
**Broken Oar with Iron Clamp-On Oarlock from Site 7A-C-377**

Other artifacts recovered from this location included the broken handle of a wooden oar with a clamp type iron oar lock attached (Figure 137). There were also two lead fishing weights, a fishing hook with nylon line attached, a steel tack, five aluminum beverage cans and can fragments, a fragment of steel wire, and four corroded metal can fragments.

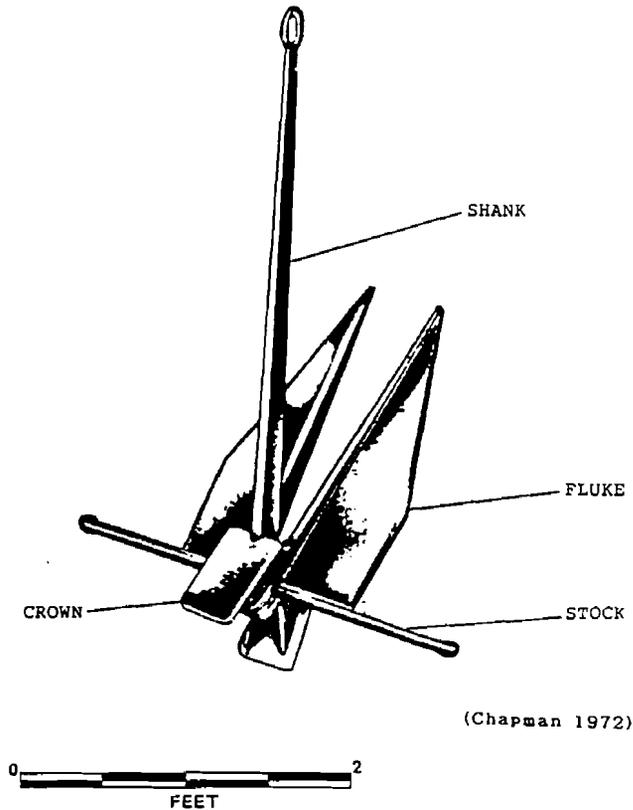
FIGURE 138  
Danforth Type Anchor from Site 7A-C-378

During the Phase I field work, a large steel anchor of the Danforth type was observed resting on the bottom within the limits of Site 7K-C-378. Its location is shown by the small anchor symbol in Figure 136. The Danforth anchor was developed around 1940 and quickly became very popular because of its superior holding power and ease of recovery (Figure 138).

The Danforth anchor at Site 7K-C-378 was recovered and found to weigh seventy pounds. Its size was appropriate for use on a vessel having a length of from 75 to 100 feet. Commercial vessels of that size were commonly used as freight boats along Delaware's rivers during the first half of the 20th century. This anchor appears to be evidence that such vessels navigated this part of Leipsic River as late as the 1940's.

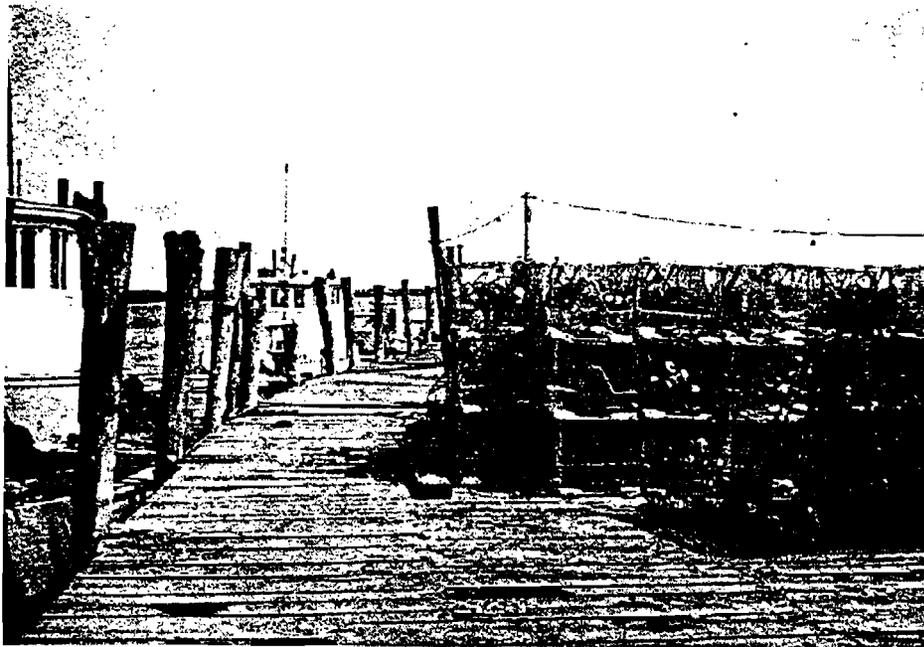
**FIGURE 139**

Evidence of hunting and fishing was also found. This material included a wire mesh crab trap of recent vintage, which was left in place. A photograph of similar crab traps is shown in Figure 139. In addition, there were three lead fishing weights, a shotgun shell casing, and a broken aluminum boat hook. Container type artifacts that were recovered consisted of one aluminum can fragment and ten bottle glass fragments of light blue color.

**Wire Mesh Crab Traps on the Docks at Bower's Beach, Delaware**

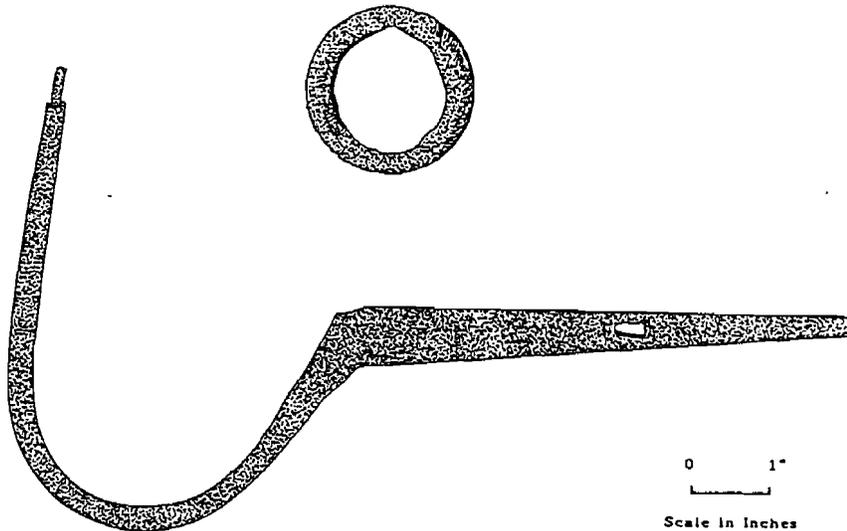
**FIGURE 140**  
**Iron Gaff Hook and Ring from Site 7A-C-378**

Fasteners and other miscellaneous hardware were also found. Artifacts recovered included an iron ring of one inch diameter, a padlock marked "REESE Made in USA", and a U-shaped iron gaff hook (Figure 140). There were also an S-shaped steel hook, a U-shaped steel hook, two iron square nuts, a large steel bolt with a thick cotter type pin attached at one end, and a brass ring.
