ARCHEOLOGY – FINDING AND RECORDING “SMALL THINGS FORGOTTEN”

INTRODUCTION

PROJECT
Replacement of Bridges
3-936 and 3-937 on Road
214 over Cabbage Pond

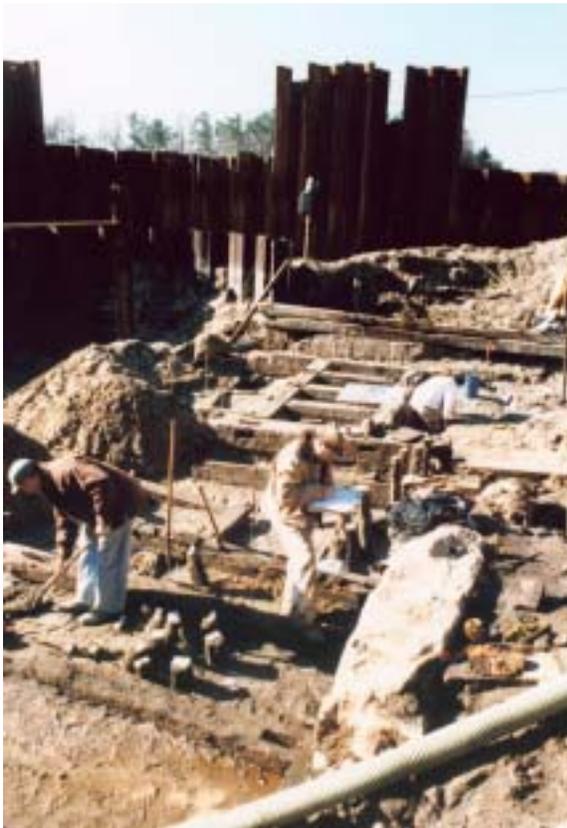
Photo 4-1. Archeologists at work (water power system), Cabbage Pond. Note archeologists (top to bottom), hand-excavating and taking notes – an important part of fieldwork.

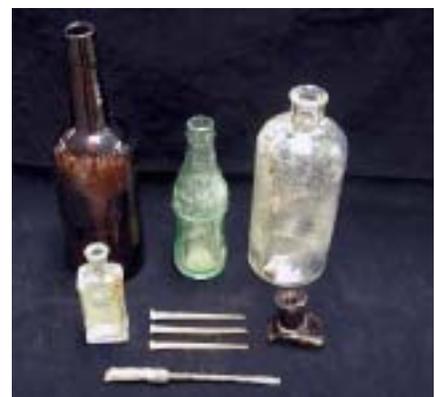
Photo 4-2. Nineteenth- and twentieth-century artifacts from Cabbage Mill (whiskey bottle, Coca-cola bottle, prescription bottles, cut nails, screwdriver).

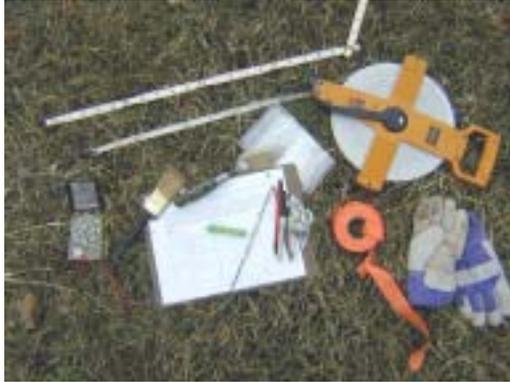
Photo 4-3. Some tools of the trade for survey and hand excavation (compass, paintbrush, flagging tape, tape measure, trowel, pick, plastic artifact bags, permanent marking pens, work gloves)

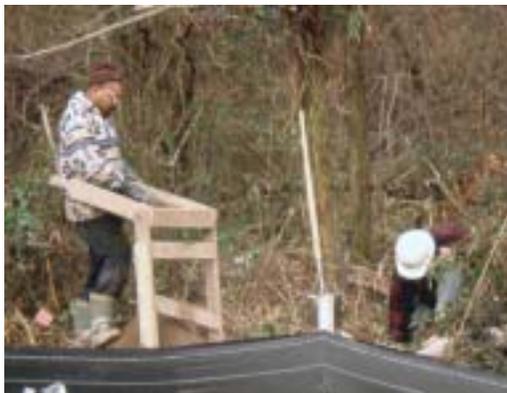
Photo 4-4. Shovel Testing at Cabbage Pond. Archaeologist at left is screening soil through 1/4-inch mesh.

The eastern portion of the site, thought to contain the mill, was flagged in 10x10' grids, then 1-1/2-foot diameter shovel test pits (STPs) were excavated along transects to gather associated artifacts, identify possible features, and complete a visual outline of the mill structure. STPs were excavated in layers, and a record was kept of the STP number, mapped field location, depth, recovered artifacts, and soil attributes. Soil screened through 1/4" hardware mesh recovered artifacts that were sent to the archeological laboratory for processing and analysis. In this

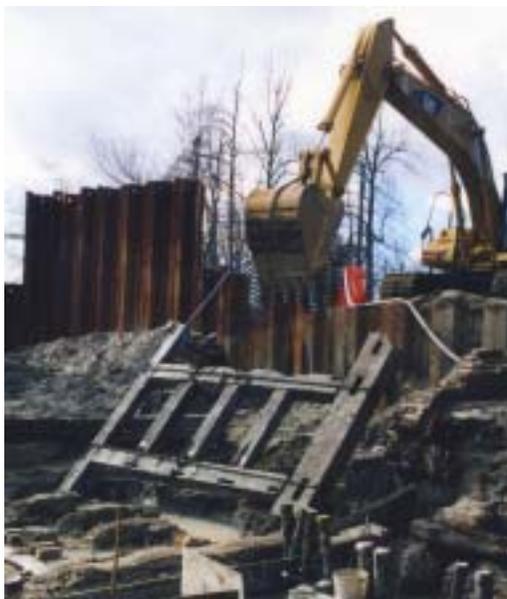
Photo 4-5. The backhoe is used to carefully lift and move heavy mill sections, in this case dismantling Penstock No. 2 from the water power area.

The single course of Penstock No. 2, composed of white oak, tulip poplar, and American chestnut, was dated circa 1824, and may have serviced the earlier waterwheel mill at this location.

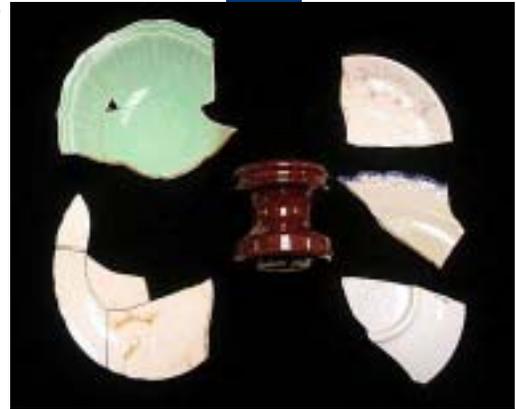
Photo 4-6. Plain and decorated ceramics from Cabbage Mill [plates, saucers, porcelain insulator (center)].

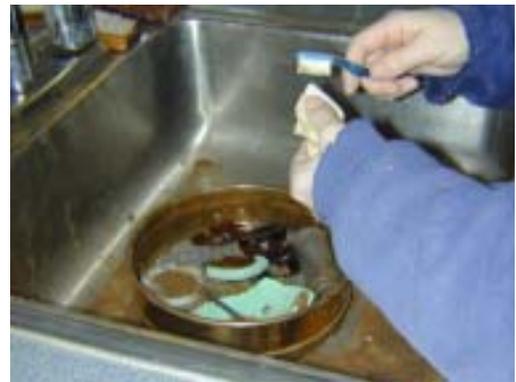
Photo 4-7. Artifacts are carefully washed, removing soil inside and out. A toothbrush works well for gently cleaning fragile or embossed artifacts.

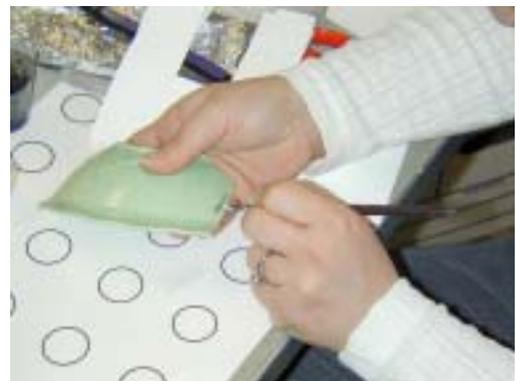
Photo 4-8. A lab technician paints the artifact identification number in tiny but readable print (many times the artifact is as small as a thumbnail or a dime). The number will forever identify the artifact and its location within the site.

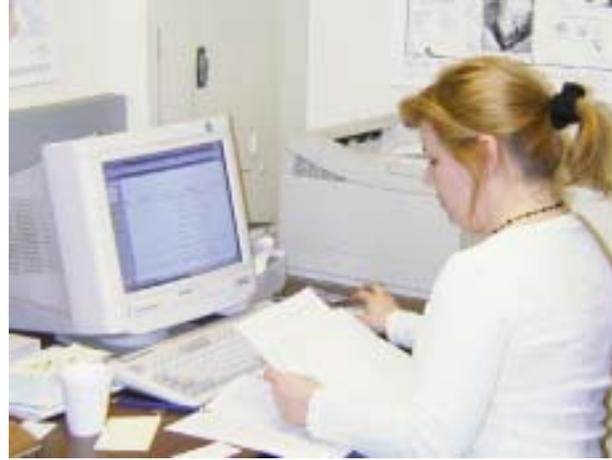
Photo 4-9. Artifact details are entered into a computer database. Later, an artifact catalog is produced for the report and the archives--a complete inventory of artifacts found during the archeology project at Cabbage Mill.

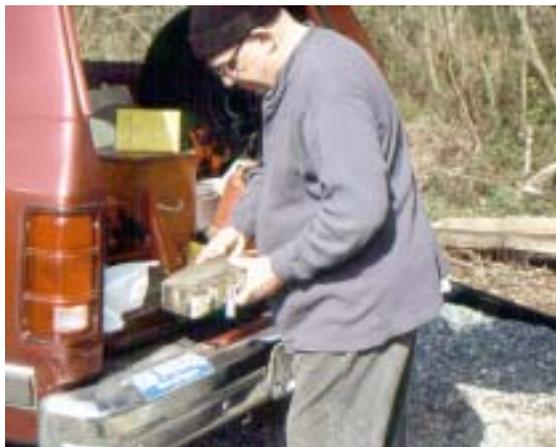
Photo 4-11. Dr. Heikkenen observes a “tree-ring” sample from the mill. The sample, labeled with detailed information providing its specific location within the site, was subsequently taken to the laboratory for analysis.

The single course of Penstock No. 3 was represented by 28 identified hand-hewn timbers, of which 11 were sampled. Composed of white cedar and white oak, this course was dated circa 1703. The recovery of highly desirable and easily worked

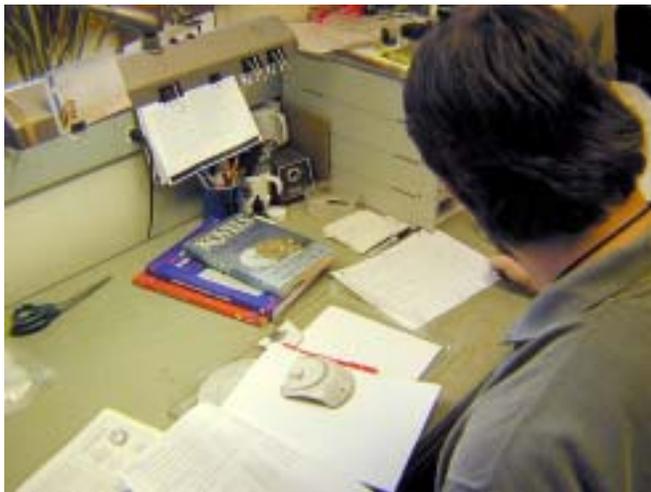
Photo 4-12. Each artifact is logged by number, description, and site location (this is some of the information that is later entered into an artifact catalog database).

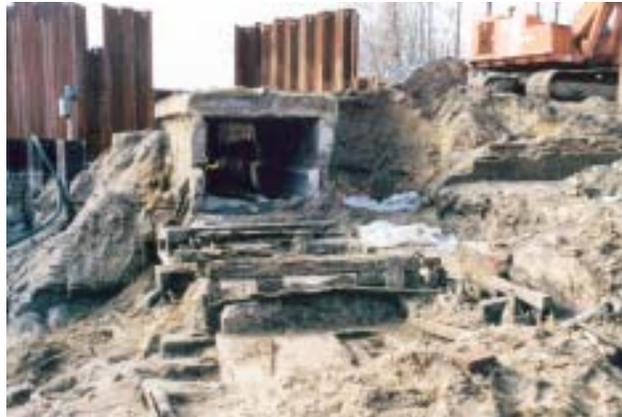
Photo 5-1. View of partially dismantled concrete culvert (below roadway). See upper mill timbers in foreground, and brick foundation to right. View to West.

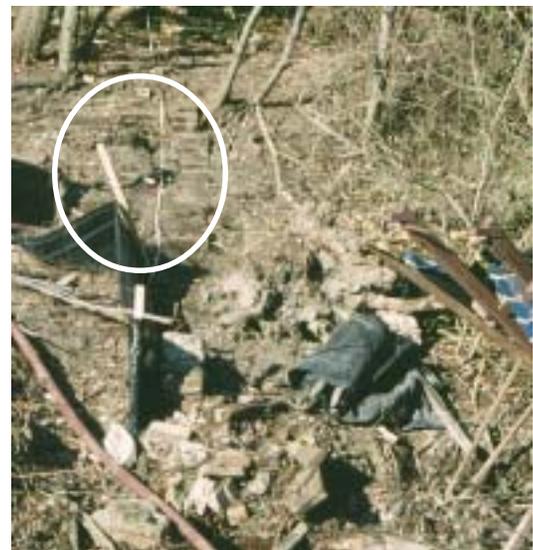
Photo 5-2. View of northeast corner, brick foundation, and silt fence (upper left). It was the installation of this fence that led to discovery of the mill's foundation.

When the field crew arrived in November 1997, their first challenge was to determine whether the site would be damaged by construction by finding the boundaries of the Cabbage Mill. If it had been determined that the mill was not in the path of construction, archeological investigations would likely have ended and the mill would have been preserved in-place. On the first day, however, archeologists sampled the ground surface with a thin, steel probe ("tile probe") and found the foundation beneath Road 214, directly in line with planned road/bridge construction. The foundation, then, became the immediate focus of intensive excavations. For the archeological record, the foundation was labeled "Feature 1."

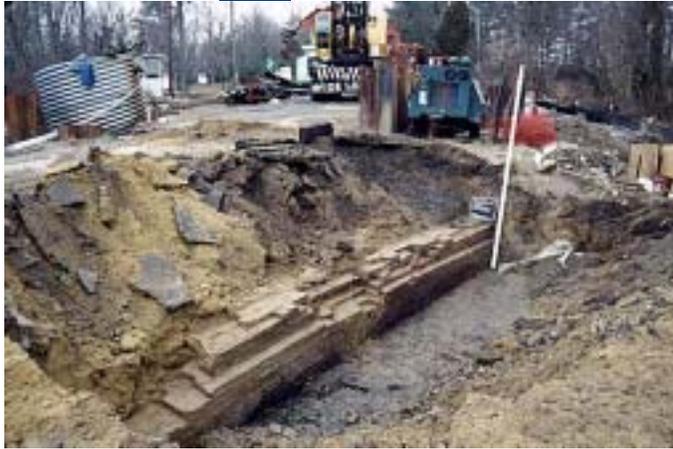
Photo 5-3. West foundation wall to mill, buried under several feet of fill below Road 214. View to North.

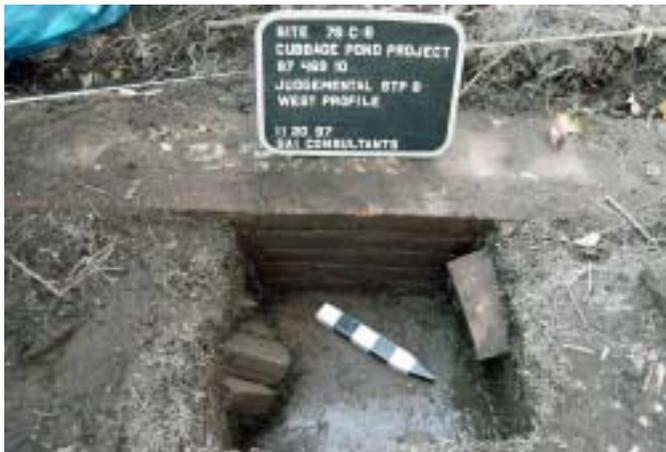
Photo 5-4. Judgmental STP placed along the west foundation wall. Note 5-course brick foundation overlying concrete floor. View to West.

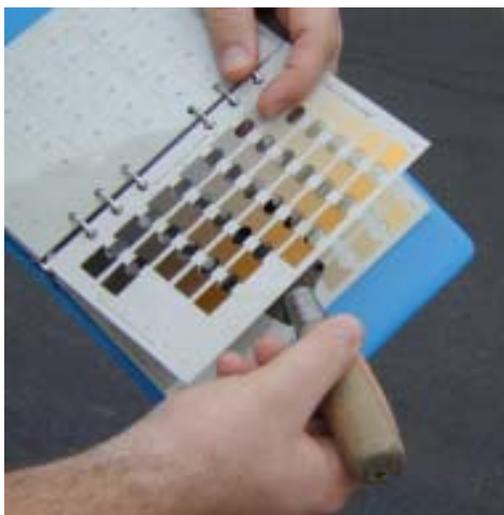
Photo 5-5. Archeologist searches for precise Munsell soil color to accurately identify soil sample.

The archeological standard for soil descriptions is found in a 321-color Munsell soil chart. Much like paint color chips are coded to indicate which colors to mix for the desired effect, the Munsell Chart provides a precise code for each color hue of soil. The Munsell soil color code provides an objective standard for various soil hues that may be encountered at the site; an important aspect of archeological documentation.

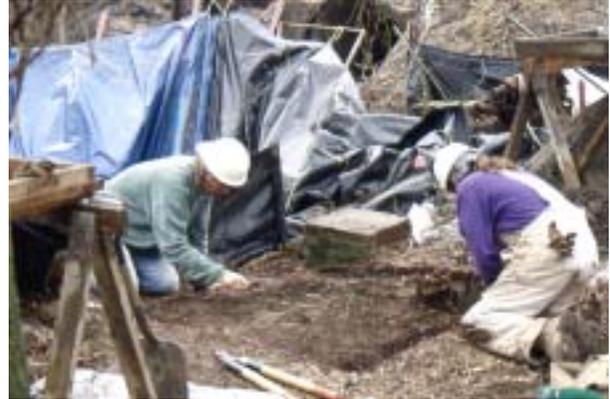
Photo 5-6. Field archeologists use trowels to excavate a Test Unit adjacent to a brick pier addition at Cabbage Mill.

Larger (5x5-foot) excavations called test units (TUs) were placed where smaller STPs indicated there might be deposits related to mill activity or where features (such as the brick foundation or log foundation at Cabbage Mill) had been exposed. A feature usually reflects activity that, with archeological study and analysis, provides a clue to how people lived in the past. In addition to the precise measurements and descriptions recorded for STPs, TUs were photographed both in color and black and white, and sketches of features (called unit profiles) were drawn to scale. The unit profiles and photographs provided a consistent and thorough record of archeological fieldwork. STPs and TUs were backfilled and restored to their original condition, after being recorded.

Three rows of uniformly spaced brick piers were eventually uncovered over a broad area, marking the location of an approximate 16x20-foot lean-to addition. Based on historical and archeological evidence, the lean-to was built by circa 1868, the date of a Kent County Mutual Insurance record that detailed the size of the main mill structure *and* addition. We know from oral history, archival research, and similar mill excavations, that the area containing the addition would likely have housed a short-

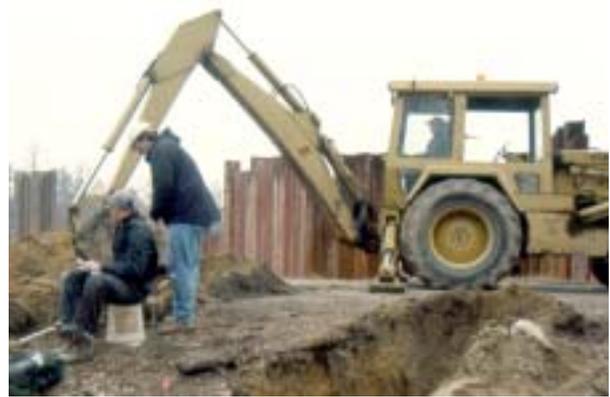
Photo 5-7. Archeologists supervise backhoe trenching to make certain that soil layers are systematically exposed, sampled, and recorded, and that artifacts are recovered, and features are documented prior to their removal.

One or more archeologists supervised mechanical (backhoe) excavation of trenches to assure that important features were not damaged before they were recorded. A backhoe was used to remove up to five feet of recent fill from the modern road construction (overburden). A 50-gallon sample of each layer of soil was screened for artifacts, and color and black and white photos were taken of each mechanical trench and archeological feature. The seven backhoe trenches at Cabbage Pond Mill served to expose the log foundation and uncover timbers associated with the mill's waterpower systems. When a Nor'easter deluged the site, a backhoe helped improve drainage while archeologists and contractors struggled to overcome waterlogged excavations, "running sands," and miserable field conditions.

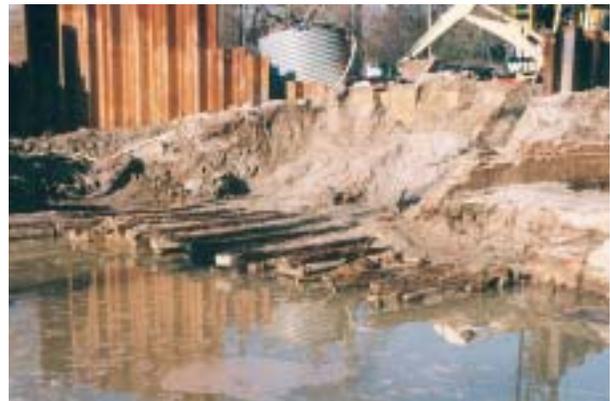
Photo 5-8. The aftermath of a Nor'easter provided archeologists with a realistic sense of the water control problems experienced by Delaware millers. View of penstock and brick foundation. View to Northwest.

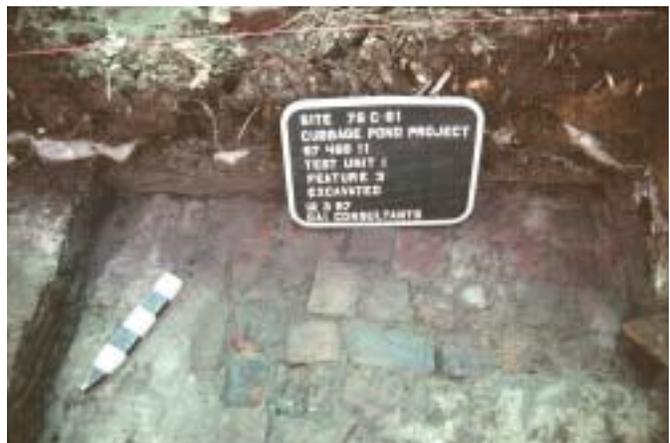
Photo 5.10. View of charred brick floor (Feature 4)--evidence of a fire at the mill, Test Unit 1. (Feature 3 refers to an excavated sandy soil containing a small number of artifacts and charcoal overlying the brick floor.)

Test units inside the 24x40-foot brick foundation identified a 3-inch-thick concrete floor over a shallow layer of burned wood and brick fragments, and an irregularly paved surface of whole and fragmented bricks (several charred). When archeologists removed the brick floor, they identified yet another layer of brick rubble, burned wood, and cut nails. They also found broken plates and dishes (refined white earthenware ceramics) called *sherds*, fragments of pharmaceutical vials and broken window glass (some melted). These burned and charred fragments were physical evidence of the fire referred to in researched documents about the history of the mill. The artifacts dated the concrete floor to after 1875, and the fire to the second half of the 19th century. Fire was a constant concern with these generally wooden mills that contained highly combustible products (i.e., grain dust) and friction-generating equipment.

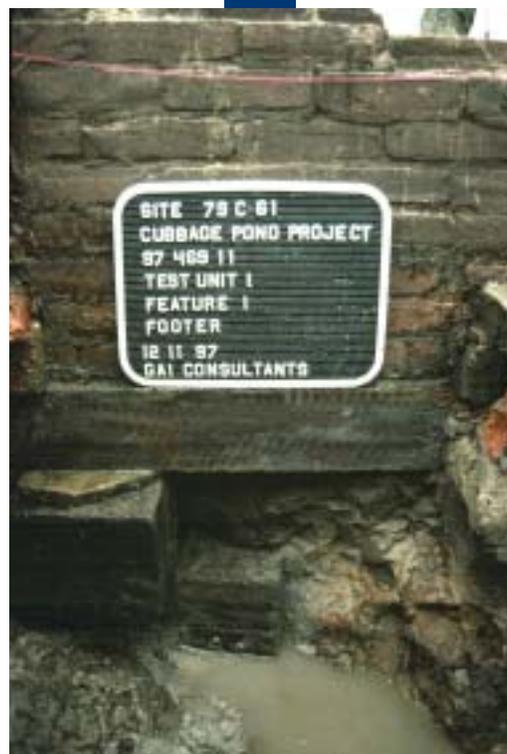
Photo 5-11. Circular-saw-cut footer and wood block underpinning brick foundation--evidence of miller's attempt to offset subsidence due to saturated (sandy) soils.

flats, but it wreaked havoc on the structures, built on saturated soils. Archeologists observed a number of the wooden piers driven into the sandy substrate and surrounded by plank cribbing to intermittently support wooden sills underpinning the brick foundation--a clear attempt to offset building subsidence problems. A review of mill excavations and historical documents indicates similar settling issues at other Delaware area mills, as well as the introduction of water-control features not unlike those at Cabbage Pond.

Evidence for dating foundation improvements was found in the wood footers supporting the brick foundation. Circular saw marks detected on wood footers supporting the brick foundation could be dated to after circa 1850-1860, when circular saws first became available.

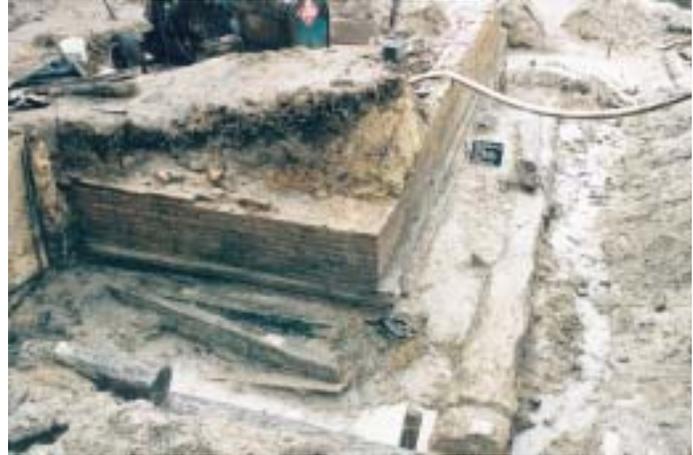
Photo 5-12. Hand-hewn log feature, possibly representing the original mill constructed on site (circa 1770s). Note wooden footings beneath "later" brick foundation. View to South.

During the last days of fieldwork, backhoe trenches revealed a hand-hewn log structure of five vertical courses extending up to 7 feet in height. Given the sheer dimension and characteristics of hand-hewn construction, archeologists surmised that the log walls represented the northern and western walls of an earlier mill foundation--possibly the first mill constructed on the site (late 1770s to early 1780s). Although historical documents in conjunction with dates derived from penstock courses seemed to indicate that the log feature undoubtedly supported a mill building, dendrochronology attempts to determine the age of these specimens lacked an adequate sample for dating purposes.

If the log feature did, indeed, serve as an earlier mill foundation, it is reasonable that the brick foundation that closely parallels the log footprint was built in the same general location to take advantage of the earlier, intact, retaining dam and penstocks adjacent to Cedar Creek. It is also reasonable that the log construction may simply represent the remains of a 19th-century bullwark or retaining wall designed to impede the effects of hydrostatic pressure from the nearby millpond.

Evidence for an earlier timber structure was revealed by a log foundation identified parallel to the north and west walls of the brick structure. The log foundation contained large, hand-hewn, corner-timbered logs, held in place with vertical posts.

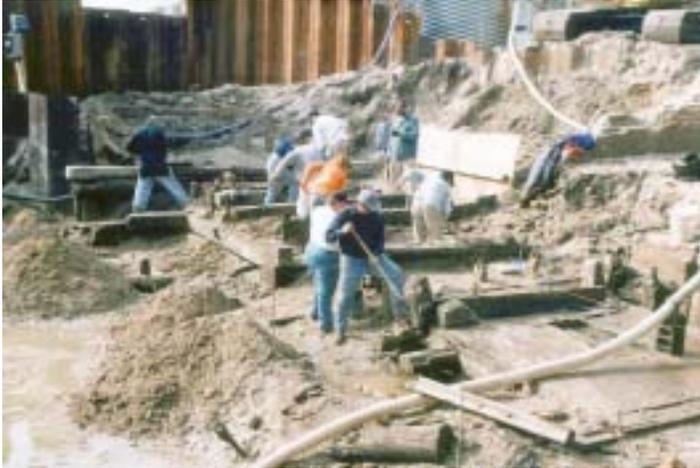
Photo 5-13. The Cabbage Mill Waterpower System. The entire crew pitched in to shovel, trowel, measure, record, and remove the five timber courses exposed under the modern road. The field crew worked 12 hours/day, 6 days a week in the wake of two Nor'easters. View to Northwest.

by one, and stockpiled on site. The sand fill between timbers was hand excavated (trowel and shovel) in collection units, but because artifacts had likely washed-in over time and were not related to the mill, the sand was not screened. A "picture" of the mill began forming as the horizontal position and elevation of each architectural component was carefully recorded, drawn, and photographed.

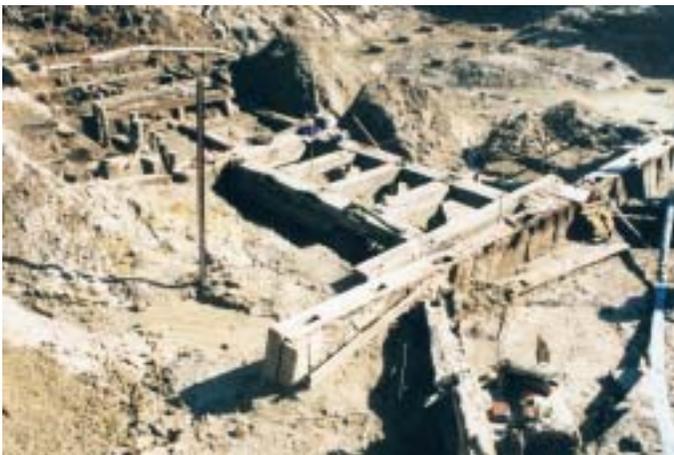
Photo 5-14. View of "second" penstock of mortised and wood-peg crossbeams. Wing wall in foreground to right. Looking Southeast.

Penstocks (also known as flumes) channel water from a dammed pond or stream to a mill's power source (waterwheel or turbine). Three overlapping courses of penstock (mortised beams) were recovered at Cabbage Mill, tree-ring dated in order of recovery to 1881, 1824, and 1703. Although it is unlikely (and undocumented) that a mill was constructed on the site at the turn of the 18th century, it is not unreasonable for William Draper and his successors to have scavenged or recycled from older, ruined structures--on or near the property. Indeed, the number of unused notches and mortises were evidence that the Cabbage Mill penstocks and wheel pit were cobbled together with elements of earlier structures.

1881 - The first course of penstock (about ten 28' oak and poplar mortised beams) appeared to have served as a foundation for the concrete culvert and was surrounded by a series of upright posts that supported vertical cribbing.

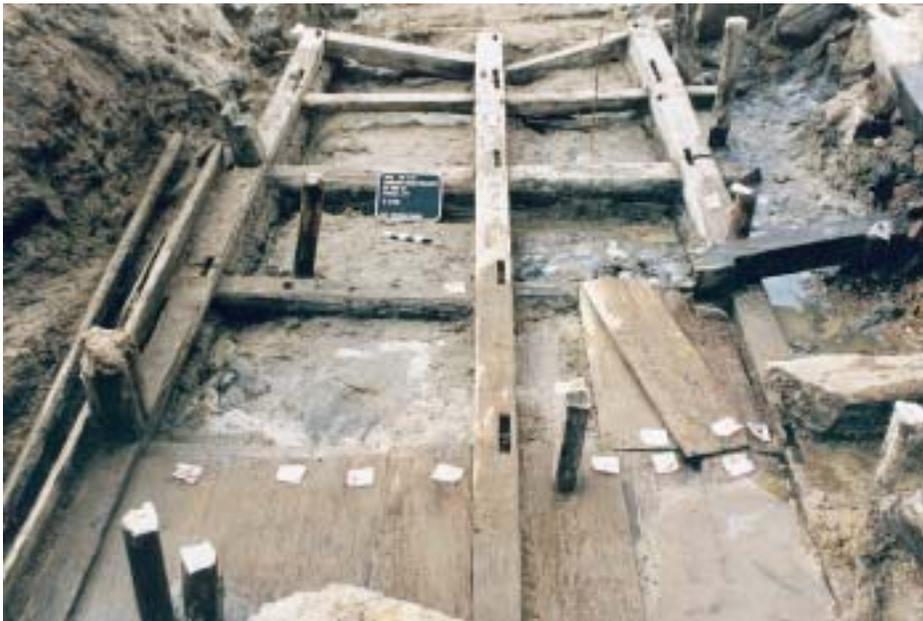
Photo 5-15. View of Cabbage Mill wheel pit. Intact plank flooring in foreground. View to West.

The waterwheel pit contained a lattice of three 9' x 20' beams mortised with six beams about 11' long. The mortised beams were cut atop the north-south braces, indicating that posts or vertical risers were likely secured at these locations. The archeologists surmised that this feature may have supported a tandem or face wheel. The waterwheel pit was probably first built in the last quarter of the 18th century, because by the third quarter of the 19th century, the more efficient and more durable turbine likely replaced waterwheels throughout the region. Historical documents indicate that the waterwheel was probably in service for no more than 60 years.

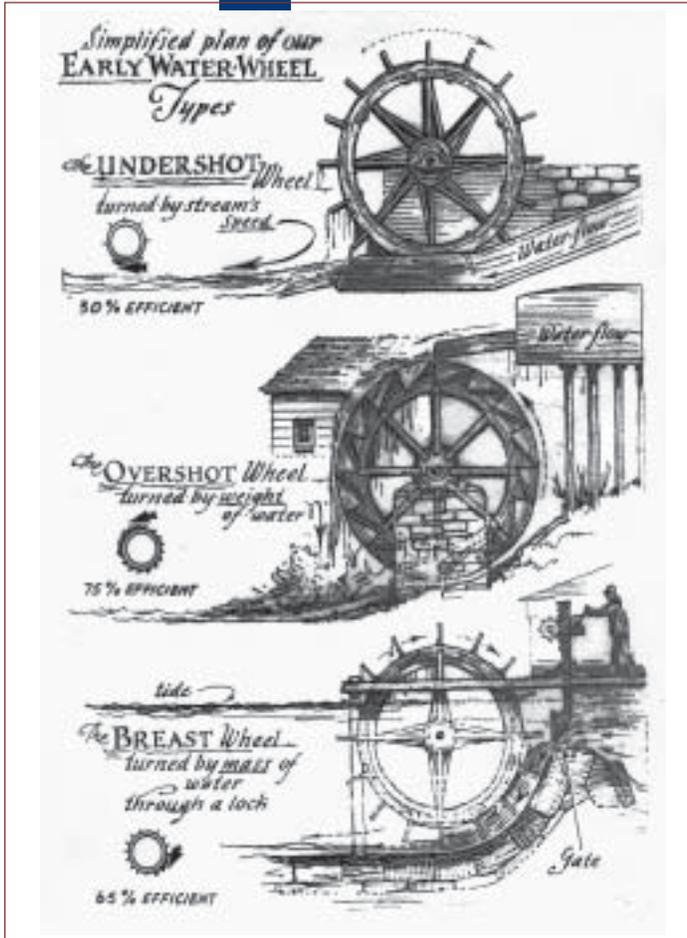
Types of Water Wheels. Credit: “American Yesterday” Volume of Eric Sloan’s America, 1954.

undershot varieties were the least efficient of the water wheel types, so it is not surprising that the waterwheel system was discontinued at Cabbage Mill and replaced with a turbine in the late 19th century when more efficient mechanical technology became available.

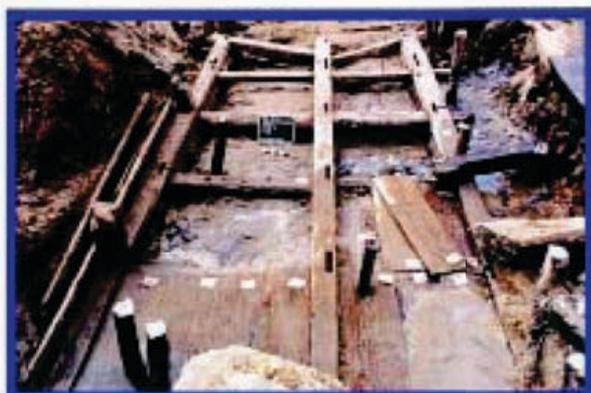
Tandem Wheel Pit,
Cabbage Mill Site. Looking
West. (Photo by GAI
Consultants, Inc.)

Early excavations of the mortared brick foundation uncovered a cement floor overlying two distinct "burn" layers. From a single patent bottle-finish fragment recovered, archeologists were able to date the cement floor to no earlier than the last quarter of the 19th century. Later excavations revealed at least one, possibly two, lower brick floors and, 8 to 12 feet below the current roadbed, several courses of timber. Up to five timber courses spanning more than five vertical feet, were identified and removed. These wooden beams (mortised) and pilings were associated with the mill's water power systems. At least two separate water power systems representing different technologies were identified at the site—a water-wheel system (as represented by a tandem wheel pit) and a turbine system.
