CRS No. N14321

Name: Shallcross Chevrolet

Address: 5221 Summit Bridge Road

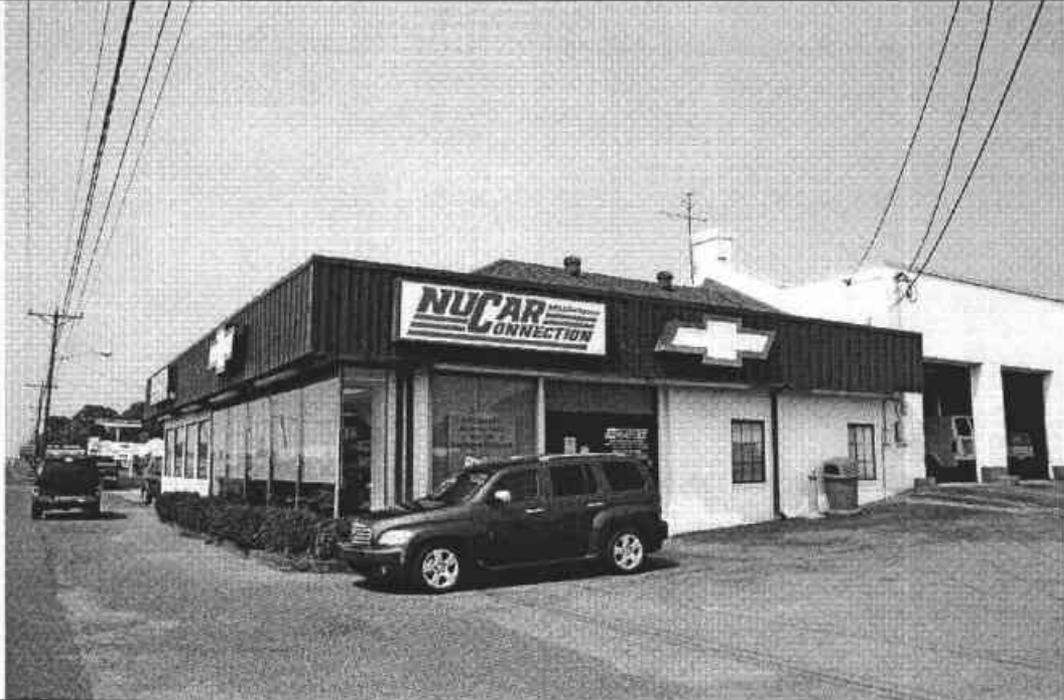
N14321. Photograph 1: Shallcross Chevrolet, showing showroom section, south and west elevations, looking northeast. Note modern encircling pent and modern signage.

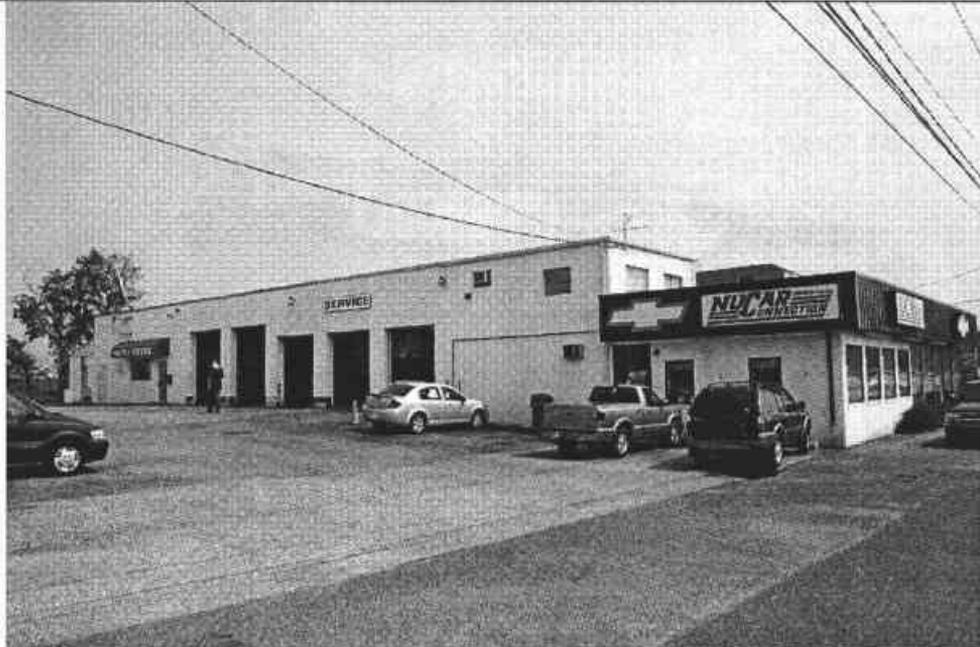
N14321. Photograph 2: Shallcross Chevrolet, showing showroom and automotive service bays (north and west elevations), looking southwest.

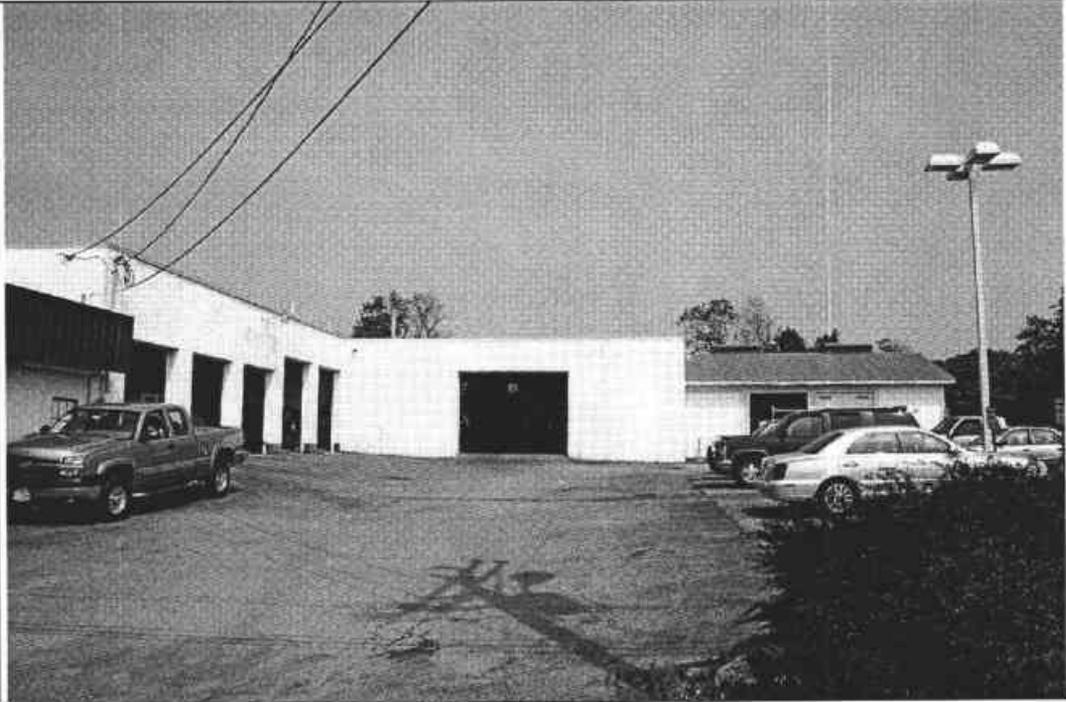
N14321. Photograph 3: Shallcross Chevrolet, showing service bays and garage area, (south and north elevations), looking north.

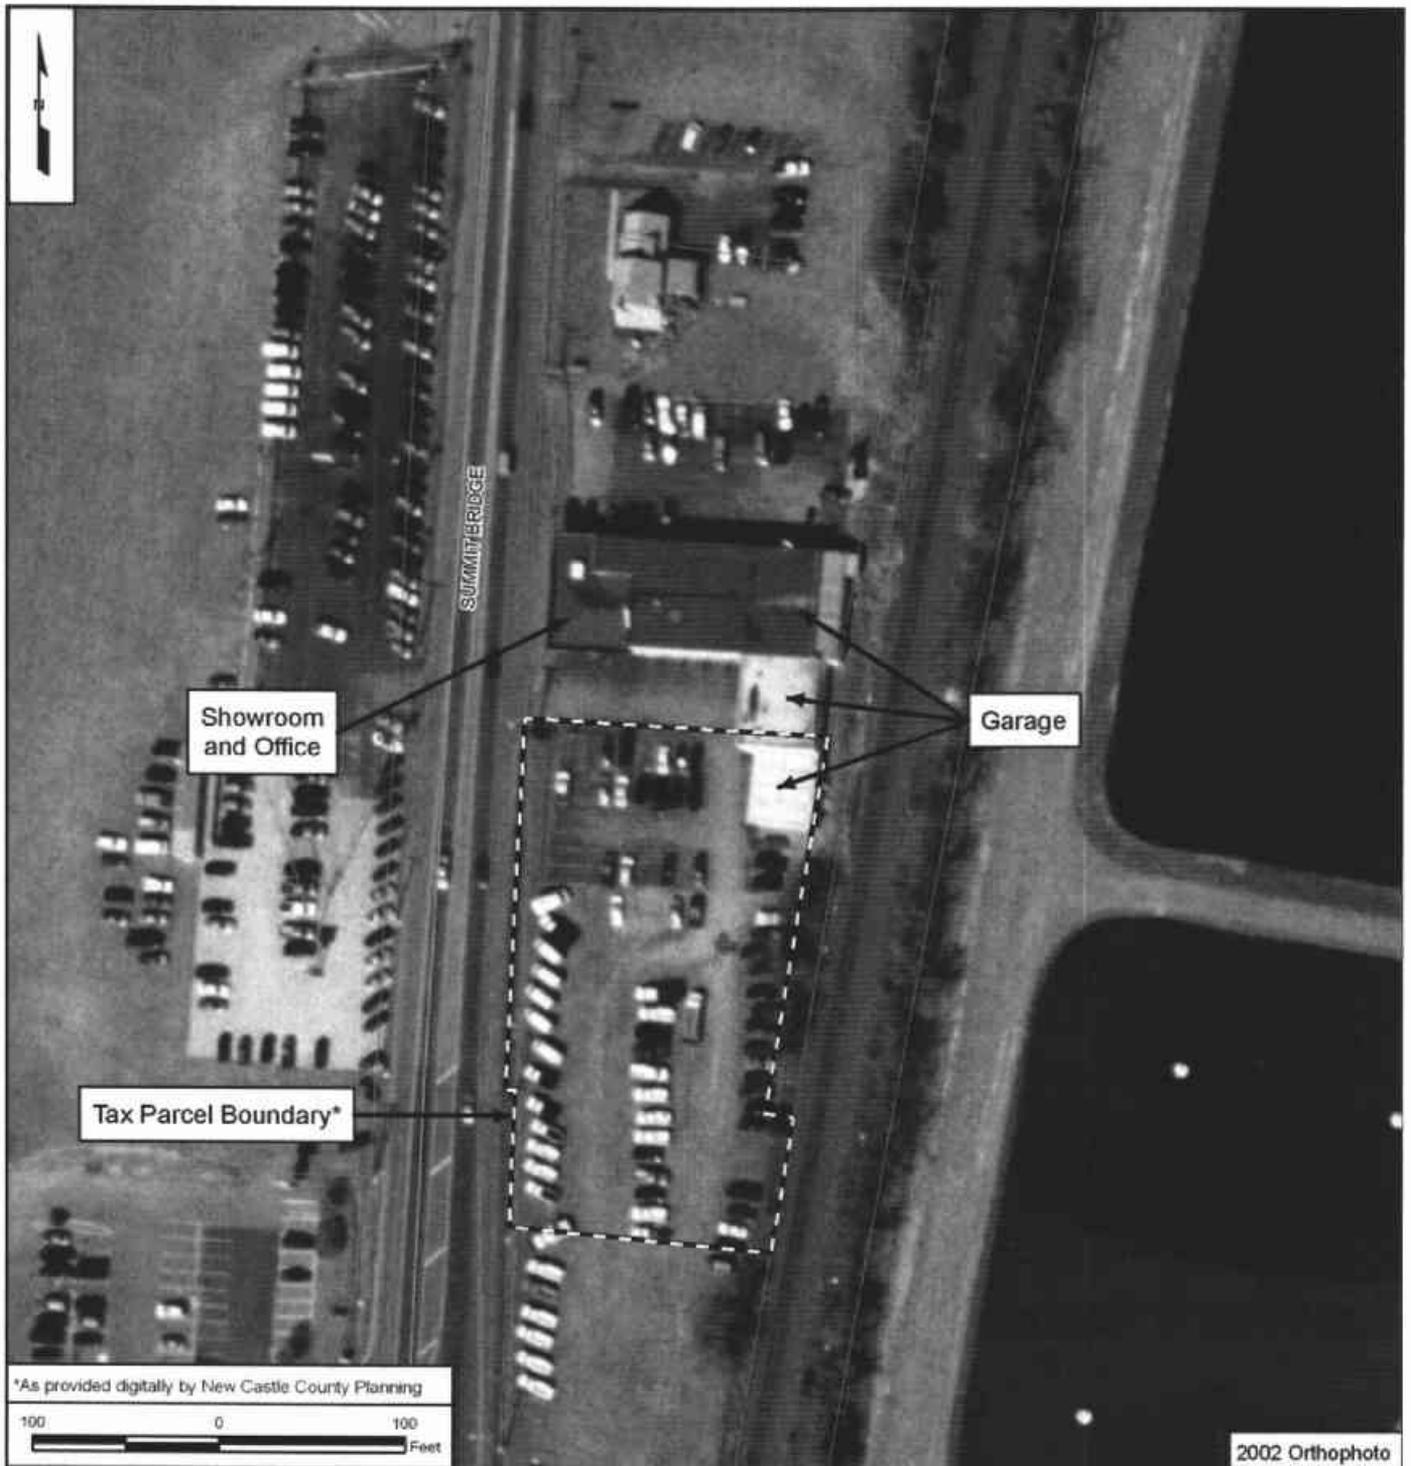
4. SITE PLAN:

11. **OTHER COMMENTS:** Asphalt lot both sides. Showroom section has brick construction on North half; plate glass & concrete block on South half. Replaced, modern pent roof added on front of showroom area. One filled-in "ghost" window & door on North elevation.

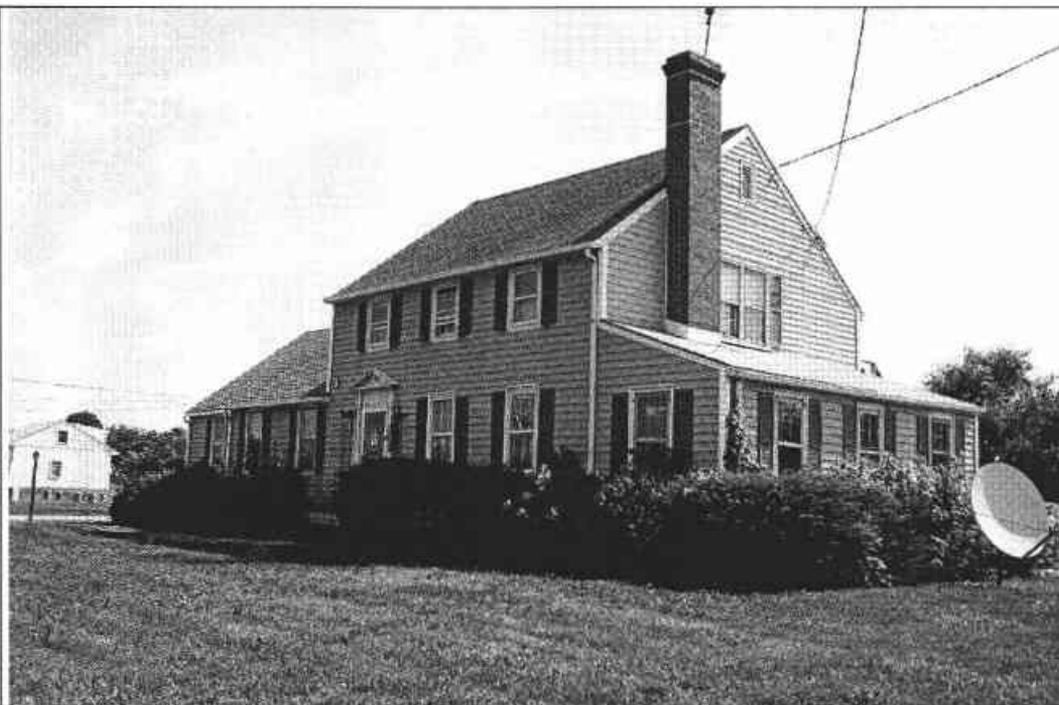
N14322. Photograph 1: Fred and Olive Jane Shallcross House, west and south elevations, view to northeast. Note vinyl siding and modern glass storm door.

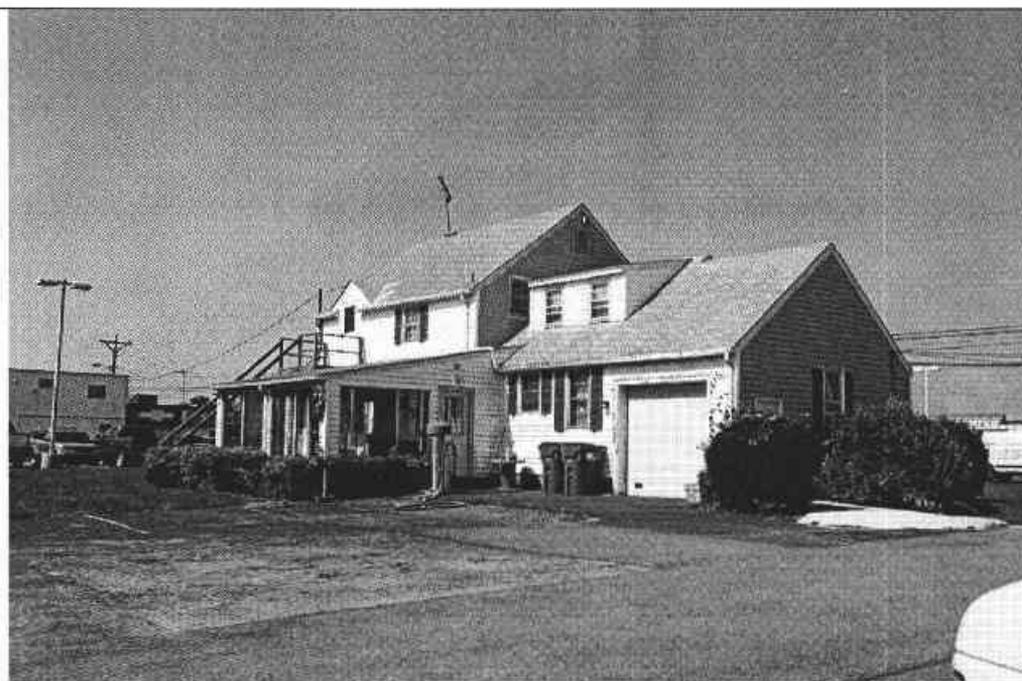
N14322. Photograph 2: Fred and Olive Jane Shallcross House, east and north elevations, view to southwest. Note sunroom and second floor entry.

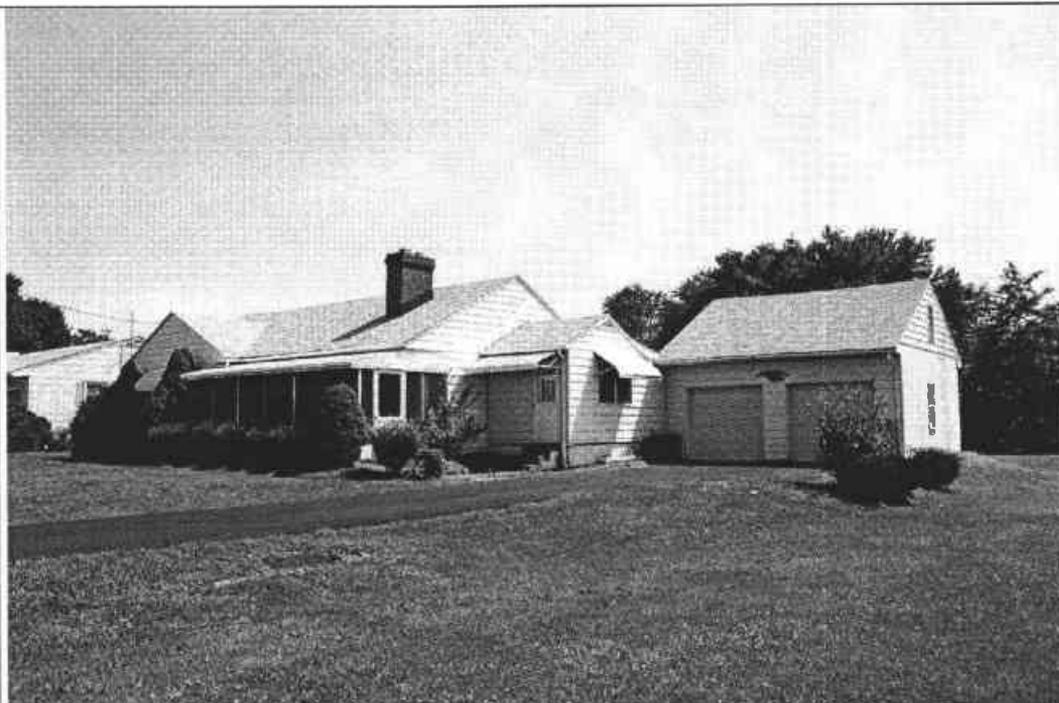
N14323. Photograph 1: Atwell and Edna Johnson House, west and south elevations, view to northeast. Note later screened-in porch.

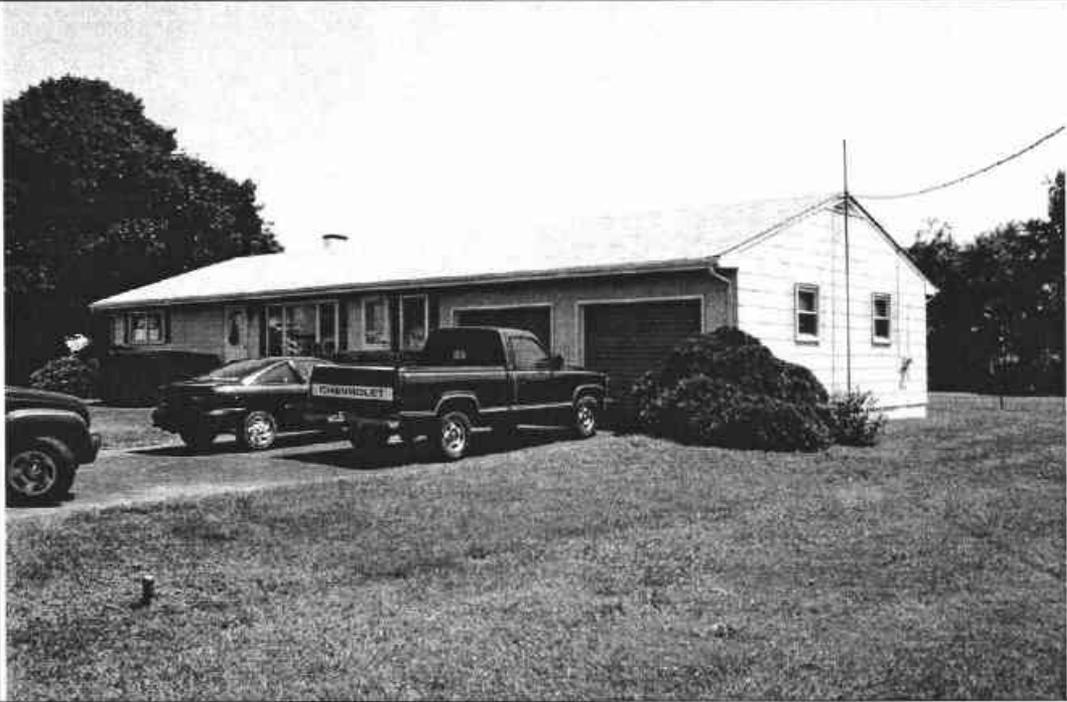
N14324. Photograph 1: Charles and Hilda Bailey House, west and south elevations, view to northwest. The Ranch house is a common property type in Delaware.

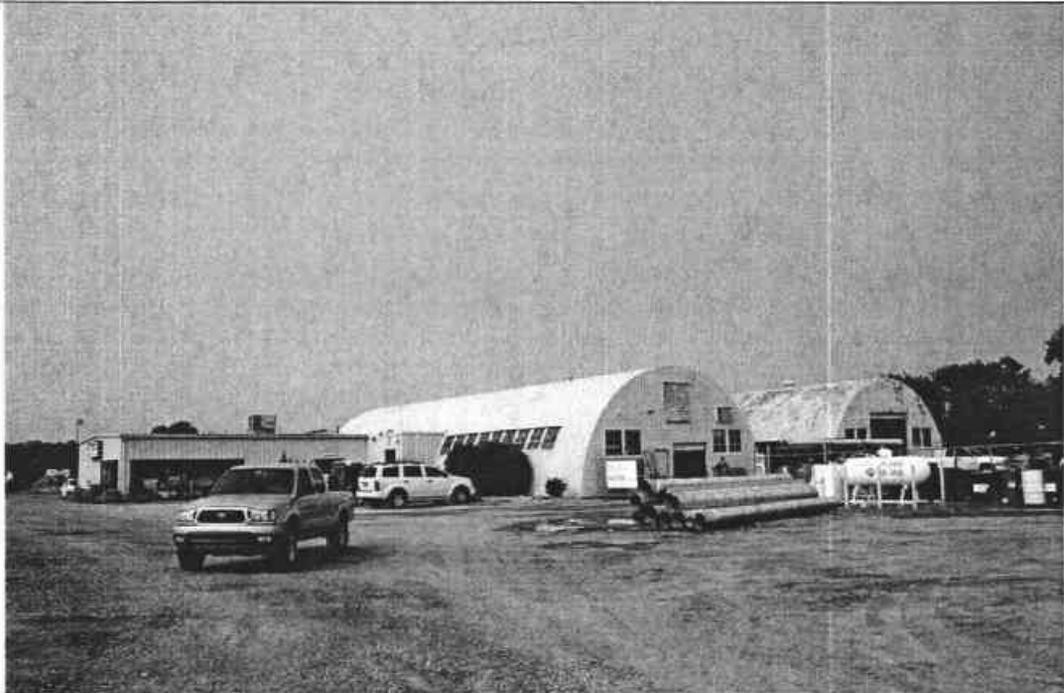
N14325. Photograph 1: White Bros. Supply Company, overview of property looking northeast, showing southern and western elevations of property. Note adjoining Quonset hut buildings and modern showroom addition.

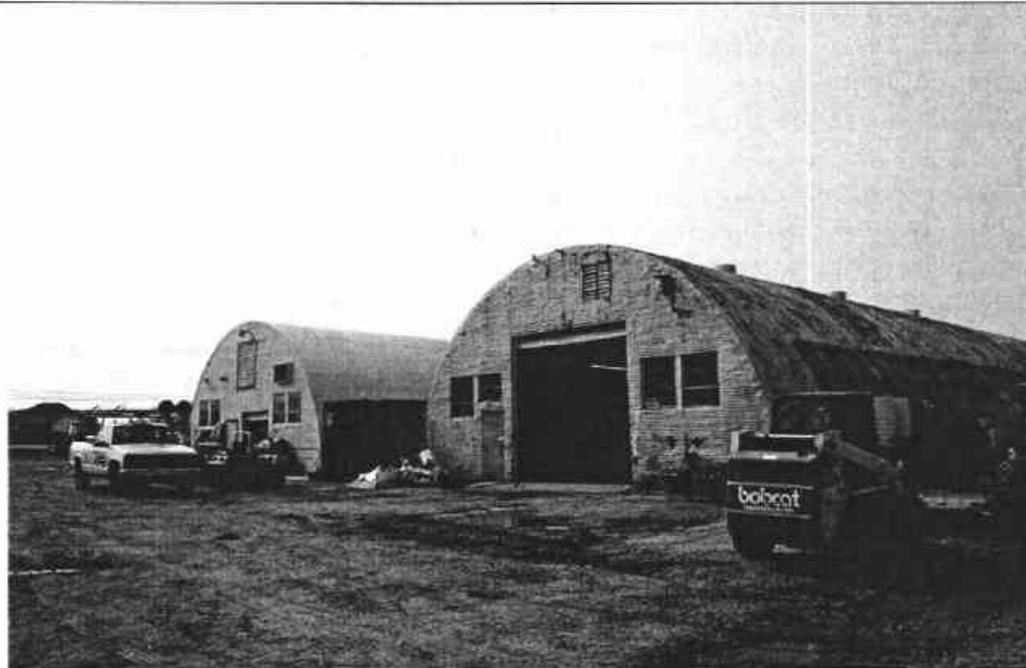
N14325. Photograph 2: South and east elevations, view to northwest. Note the multi-light windows. Also note that the large opening on the western hut has been altered.

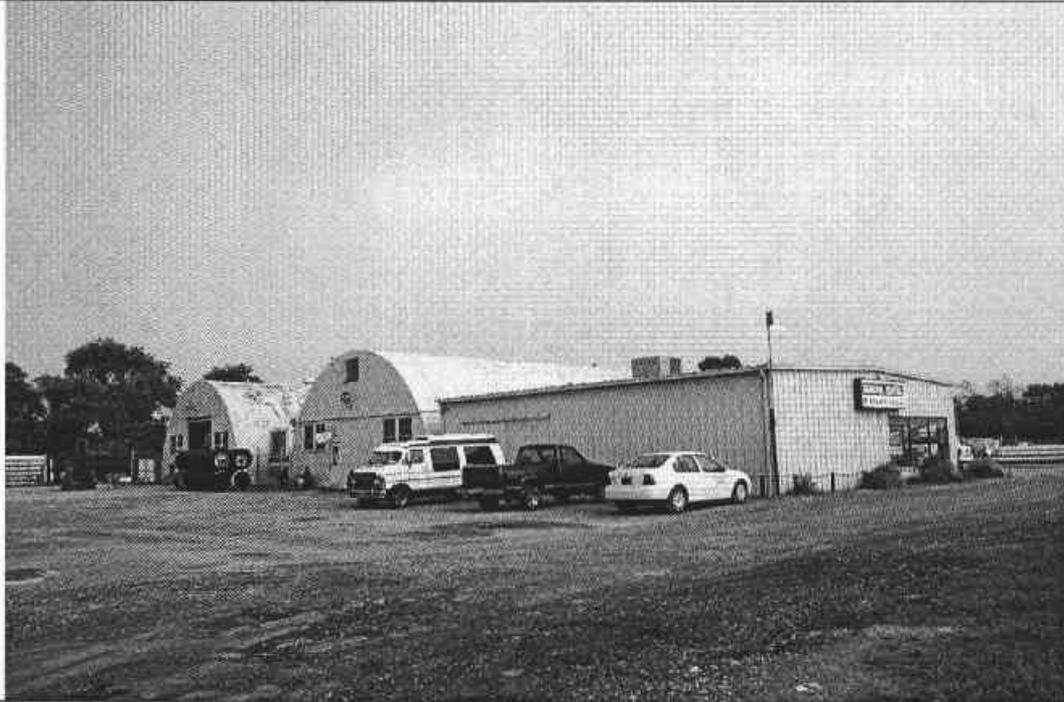
N14325. Photograph 3: North and west elevations, view to southeast. Note that the western hut's large opening has been filled in to accommodate a pedestrian door. The metal-clad showroom addition extending from the west elevation was built ca. 2000.

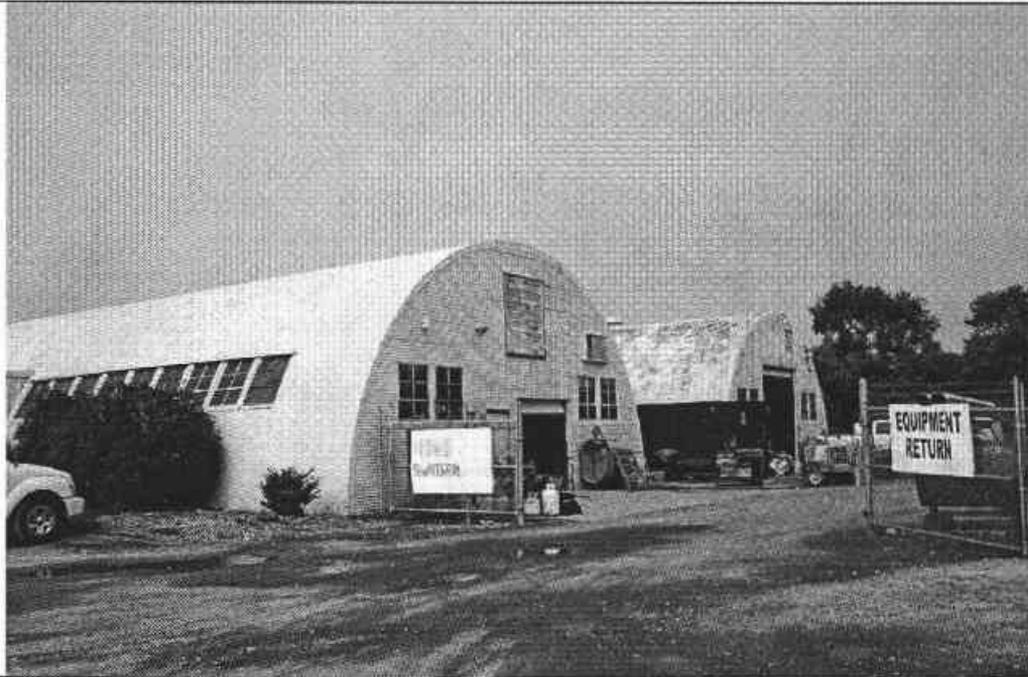
N14325. Photograph 4: Detail, south and west elevations, view to northeast.

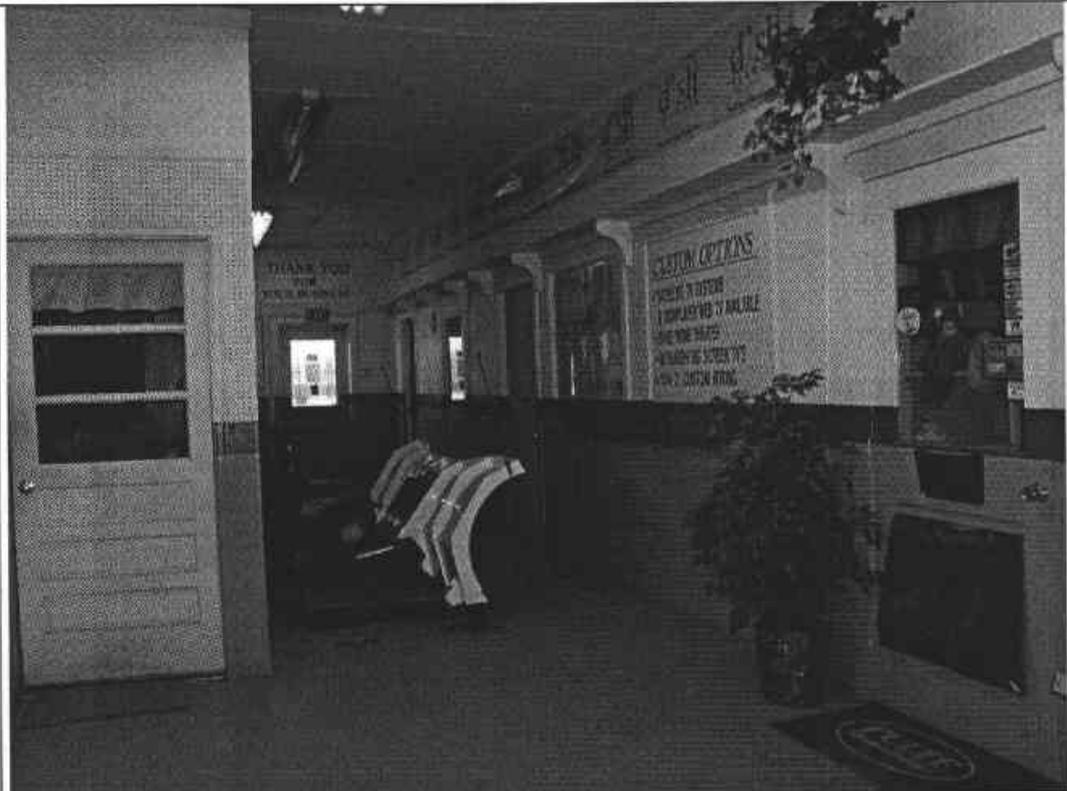
N14325. Photograph 5: Interior, western hut, view to north. Note the built-out concrete block offices that are individually rented.

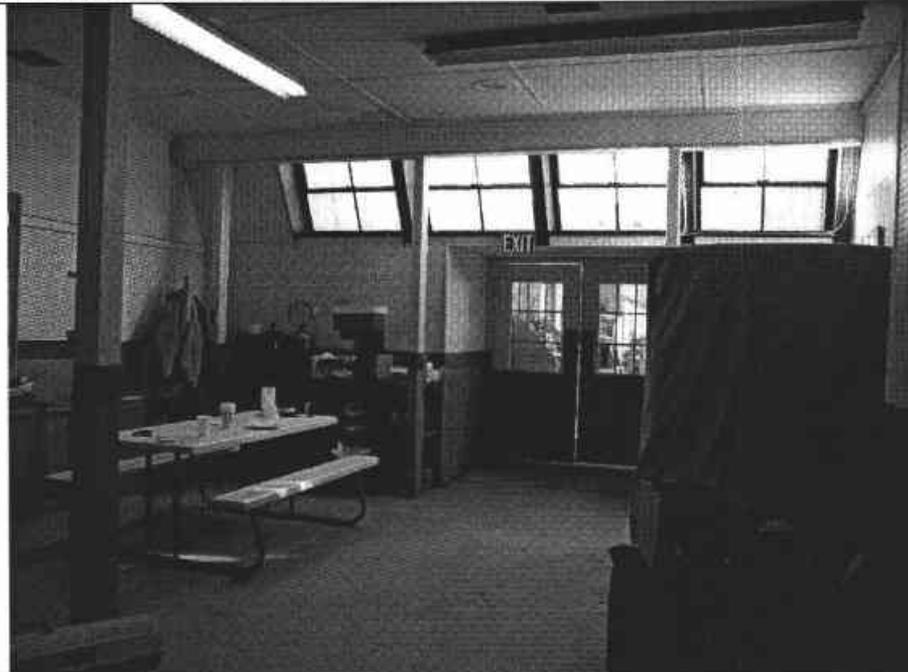
N14325. Photograph 6: Interior, western hut, view to west. Note the four, multi-pane windows. The swinging doors lead to the *circa*-1995 showroom.

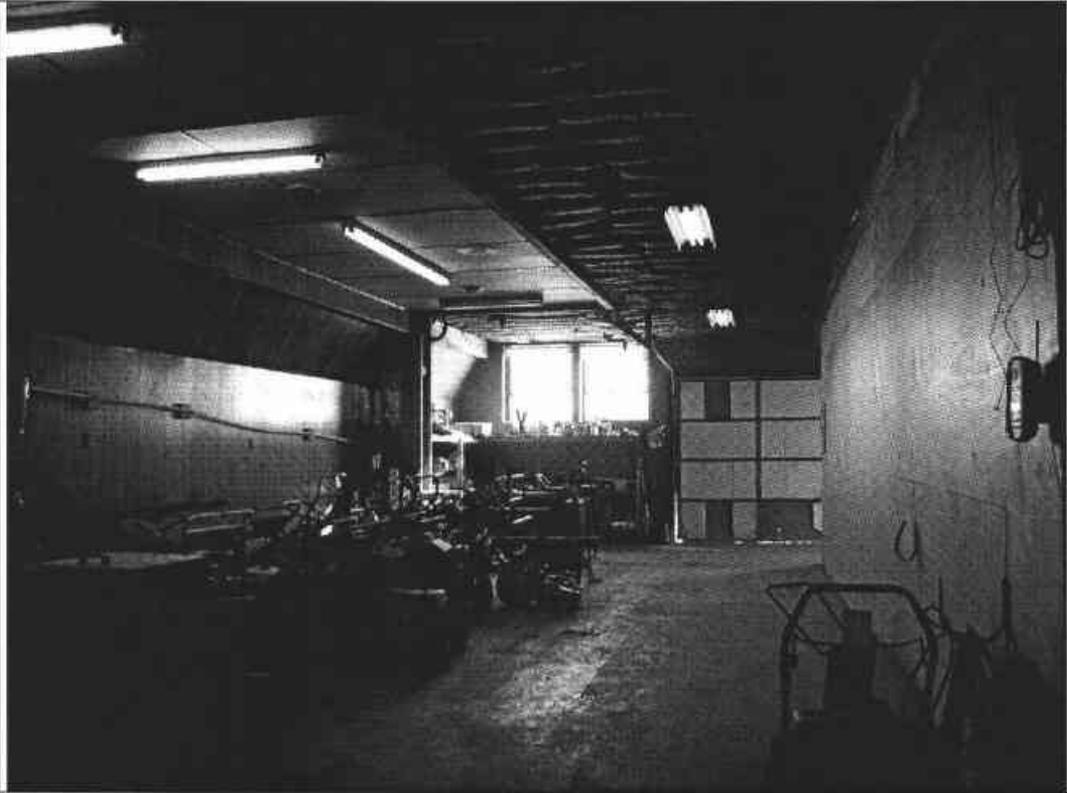
N14325. Photograph 7: Interior, western hut, view to southeast. Note the wood paneling and drop ceiling. The one-car overhead garage door is a replacement.

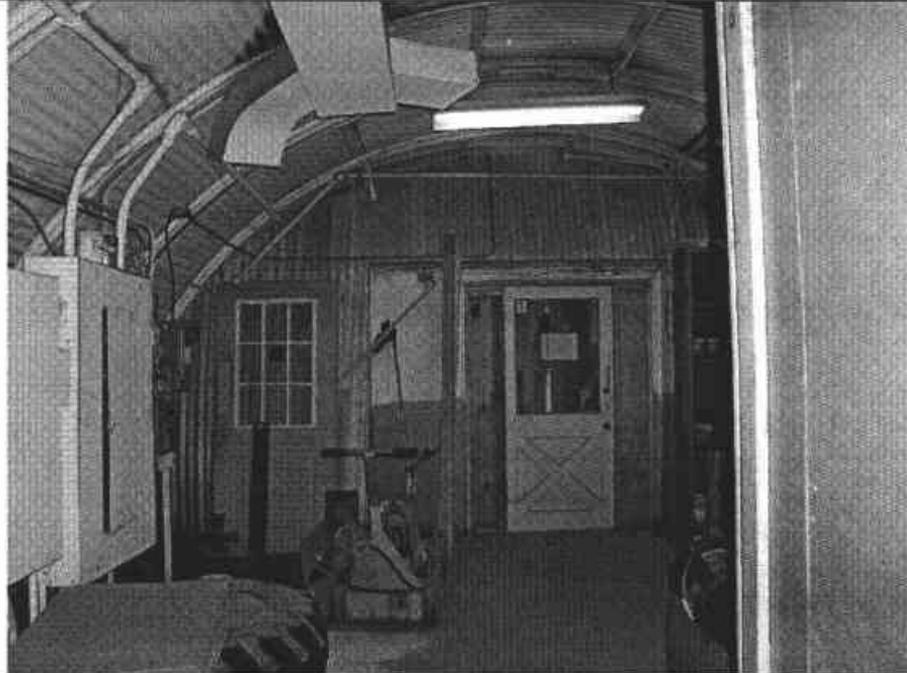
N14325. Photograph 8: Interior, hyphen, view to west. The pedestrian door leads to the western hut. Also note the corrugated metal cladding and arch rib design.

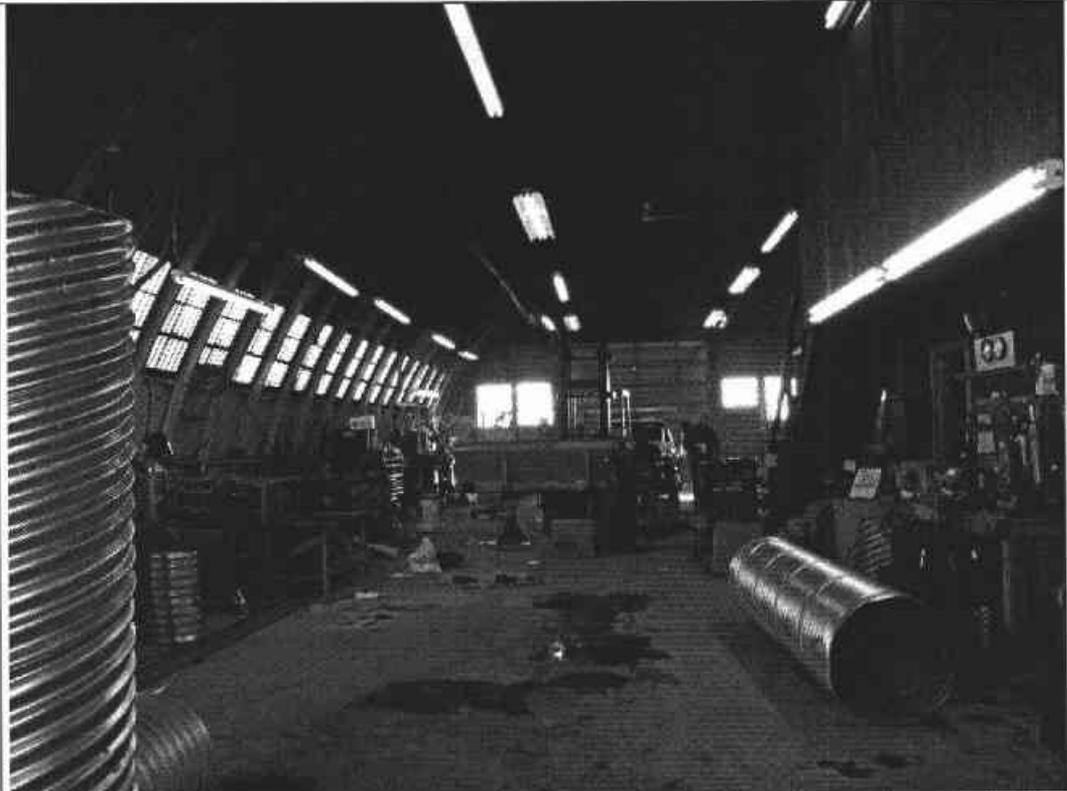
N14325. Photograph 9: Interior, eastern hut, view to south. Note the multi-pane windows to the east and the elevated, wood paneled office to the west.

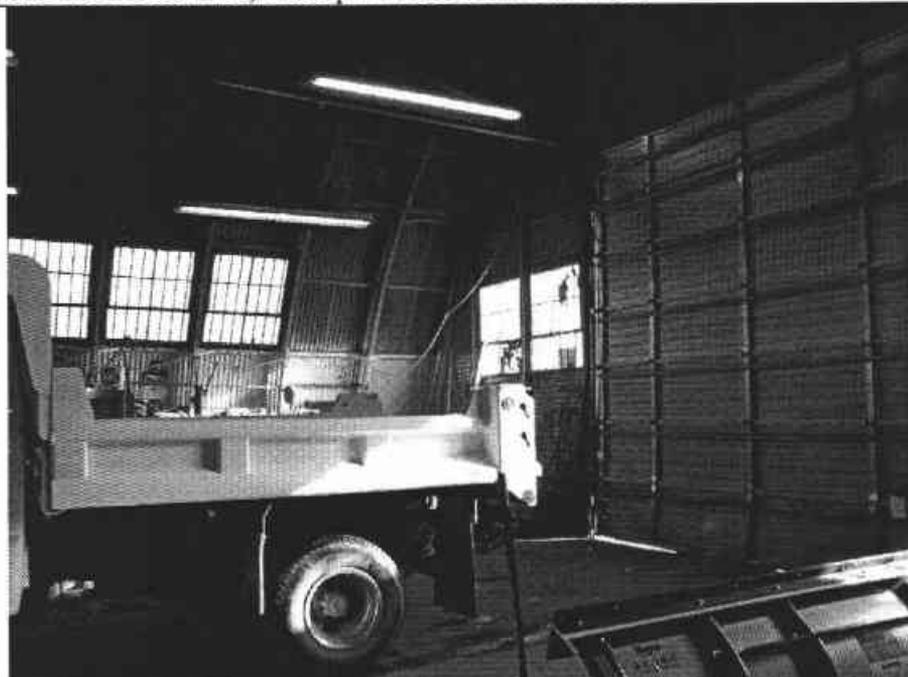
N14325. Photograph 10: Interior, eastern hut, view to southeast. Note the replacement overhead metal door.

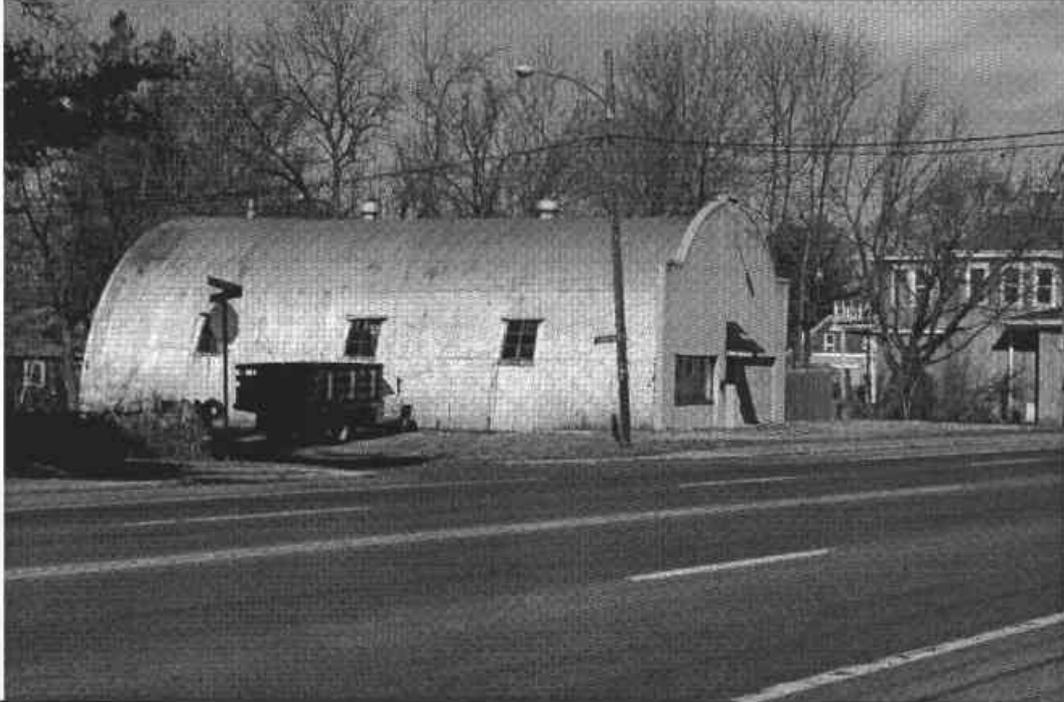
Photograph 11: Quonset hut located at 1501 Philadelphia Pike in Delaware. Note retention of corrugated metal walls and window at side wall and alteration of fenestration pattern at end wall. *Source: University of Delaware.*

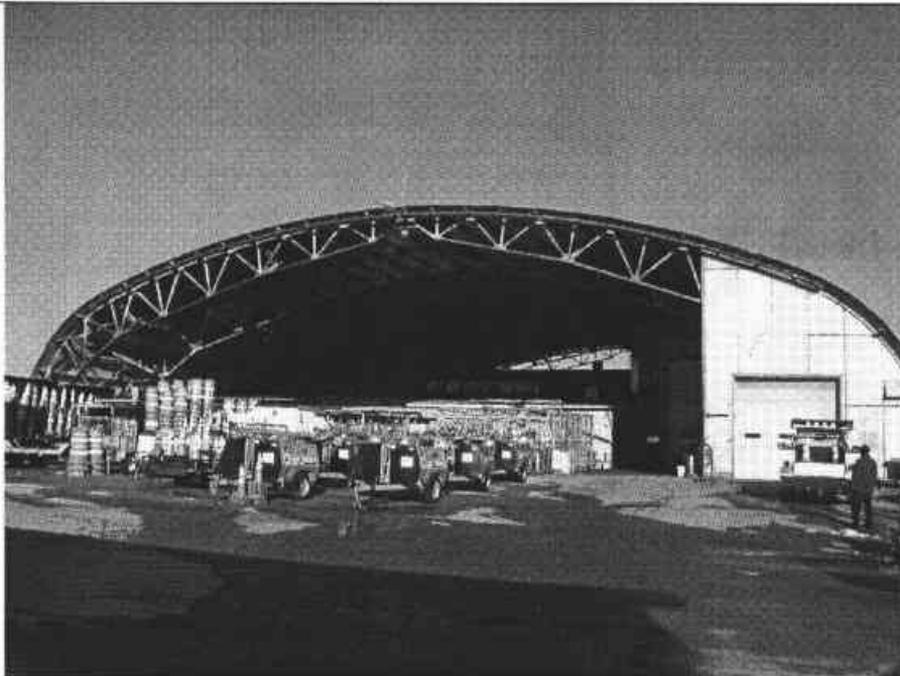
Photograph 12: Quonset hut located in DelDOT maintenance yard in Dover, Delaware. Note retention of interior floor plan except for office addition to right. *Source: DelDOT.*

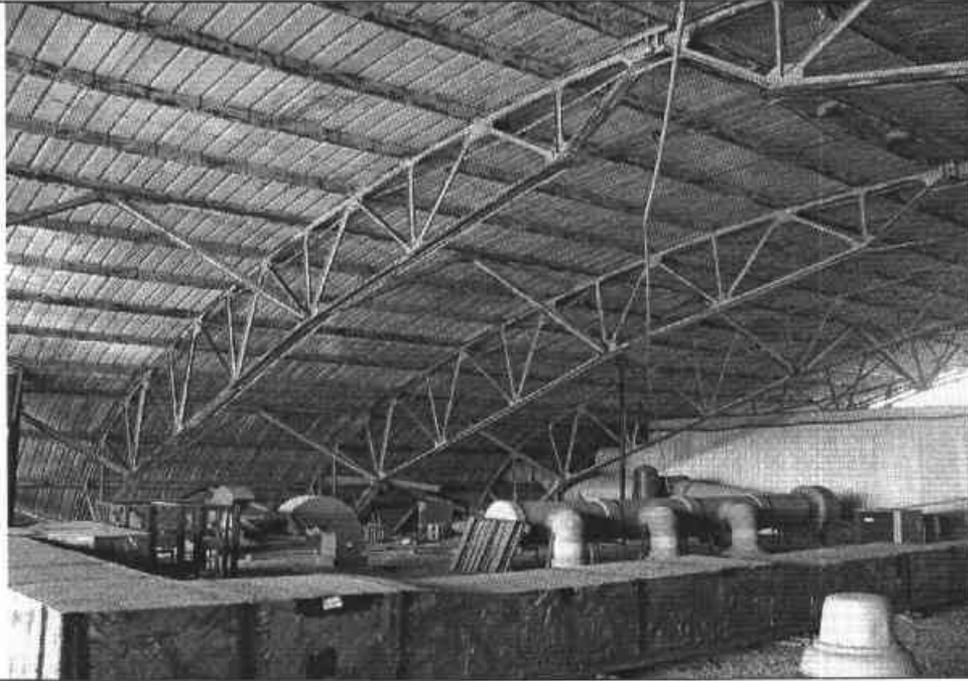
Photograph 13: Quonset hut located in DeIDOT maintenance yard, interior detail. Note exposed framing members and corrugated metal roofing. *Source: DeIDOT.*

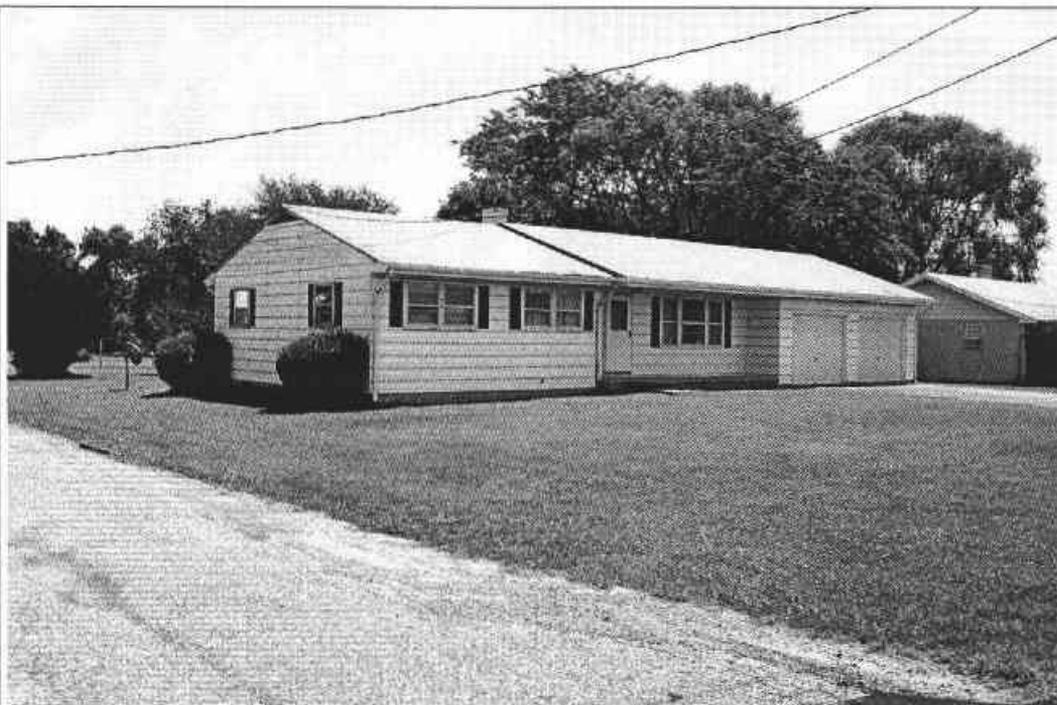
N14326. Photograph 1. Robert and Marcella Wallis House, west and north elevations, view to southeast. The Ranch house is a common property type in Delaware.

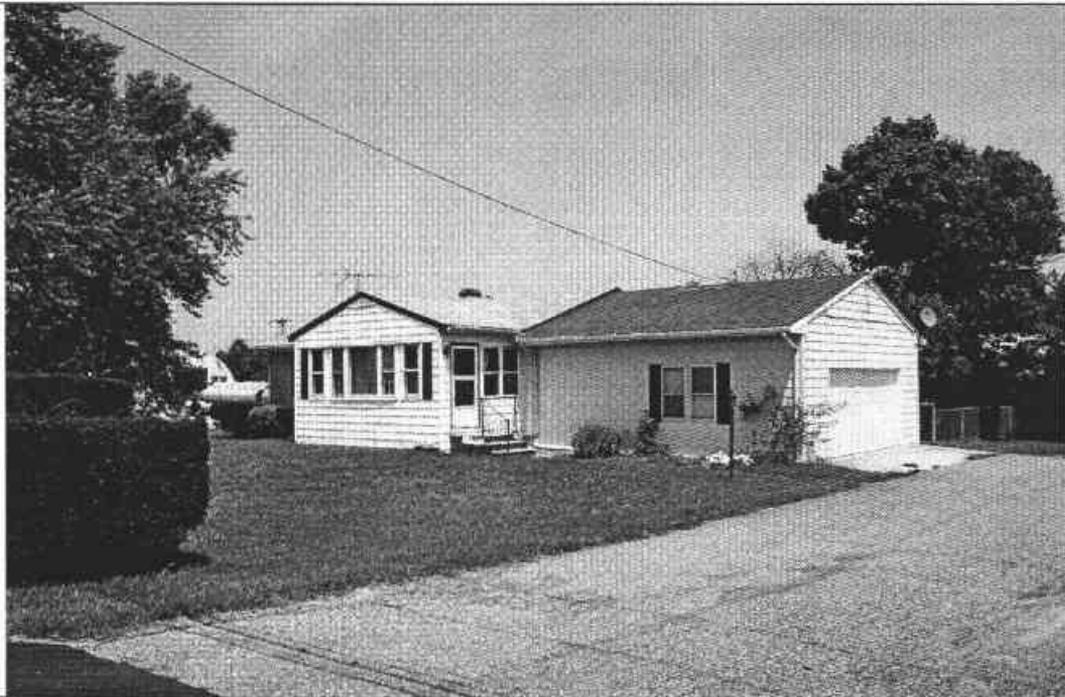
N14327. Photograph 1. Lester and Molly Biddle House, west and south elevations, view to northeast. Note post-1962 enclosed porch and garage.

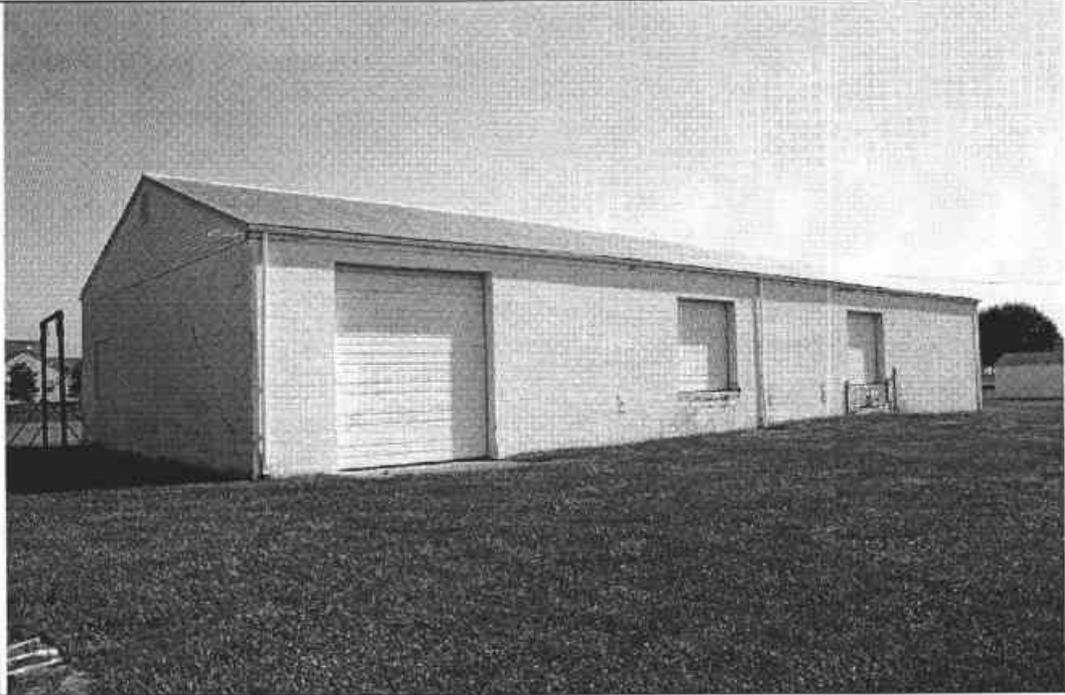
N14328. Photograph 1: Garage, 5156 Summit Bridge Road, western and southern elevations, looking southwest.

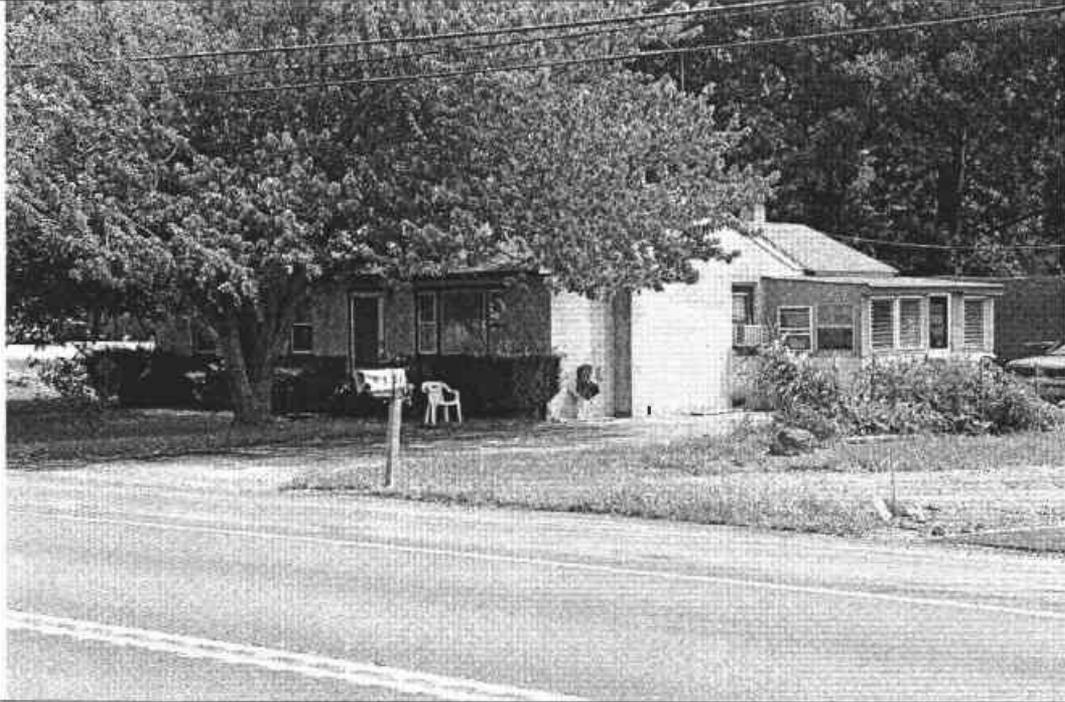
Photograph 1: Dwelling, view to the northeast showing the façade and side elevations. The dwelling is a common example of the mid-twentieth-century Minimal Traditional style. Note the multiple additions.

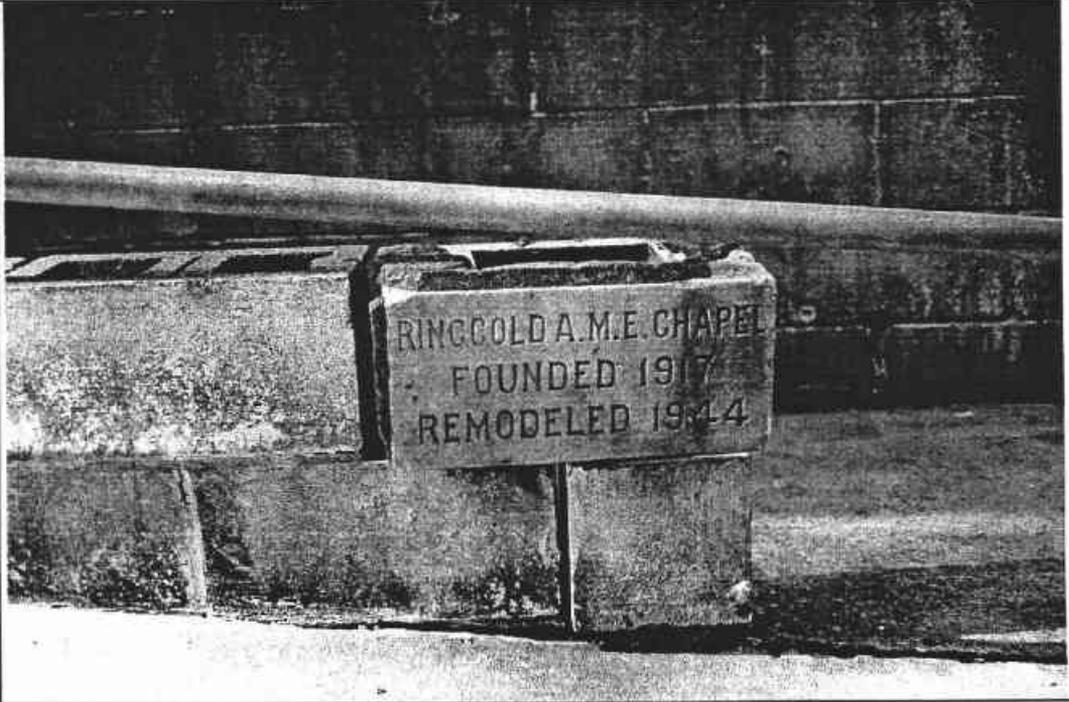
CRS No. N14330

<p>N14330. Photograph 1. Ringgold Chapel A.M.E. Church, showing stone plaque outside of building. The chapel once fronted Marl Pit Road and was moved to this location ca. 1944. The structure which now serves as the Ringgold Chapel A.M.E. Church was erected approximately 20 years ago (ca. 1985).</p>

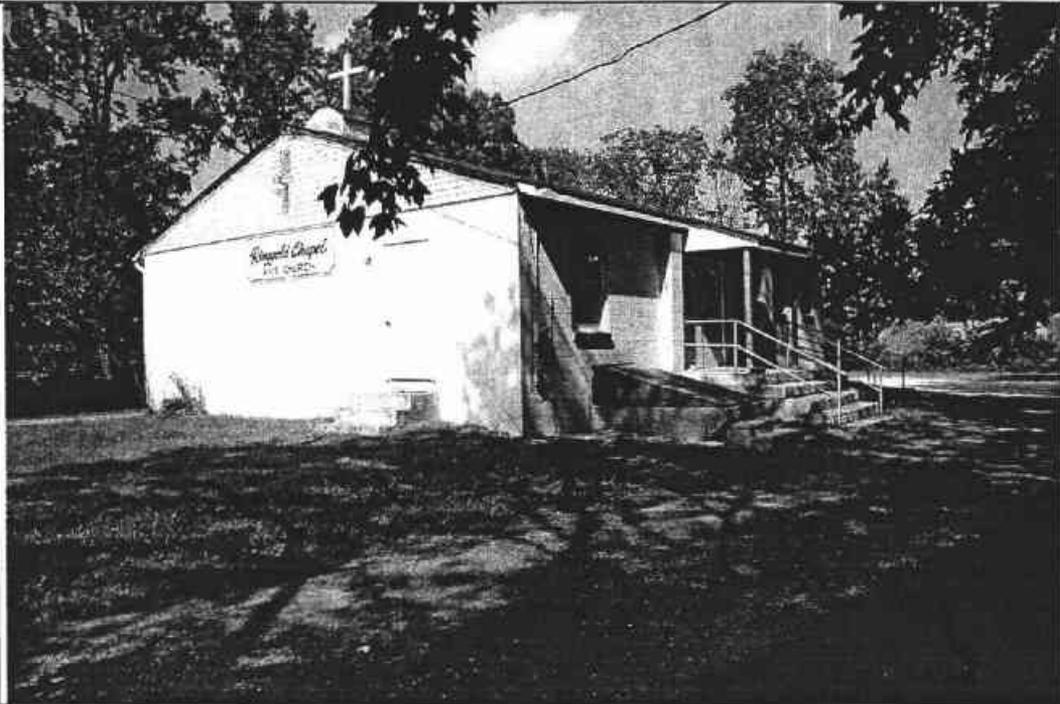
N14330. Photograph 2. Ringgold Chapel A.M.E. Church, looking northeast showing west and south elevations. Note replacement double doors.

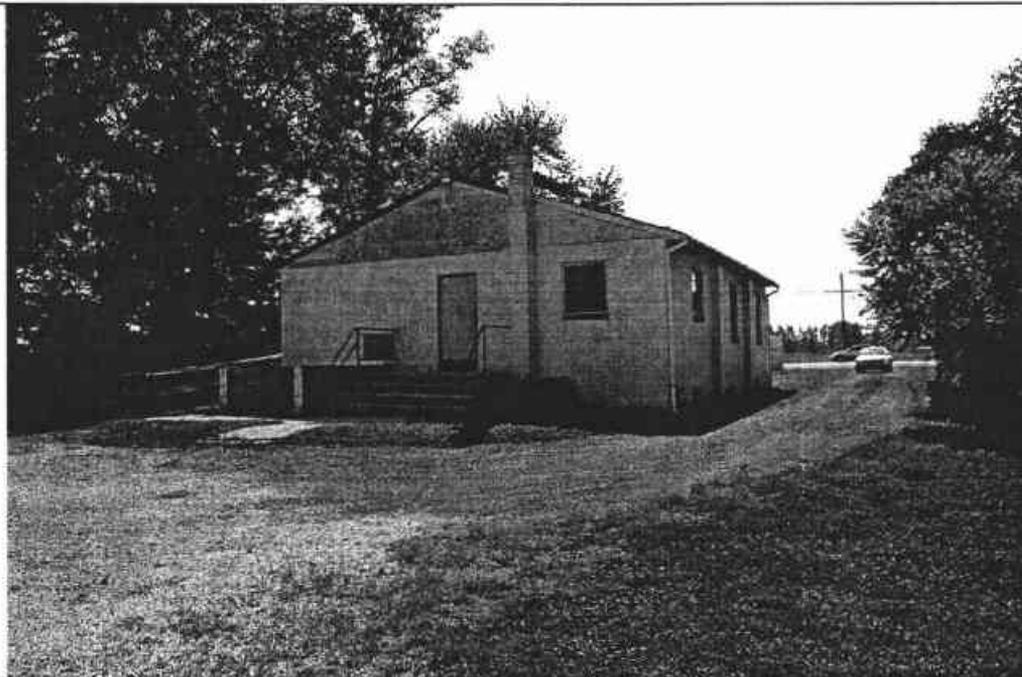
N14330. Photograph 3. Ringgold Chapel A.M.E. Church, view looking west, showing east and north elevations. Note modern door.
