CRS No. N14321

Name: Shallcross Chevrolet

Address: 5221 Summit Bridge Road

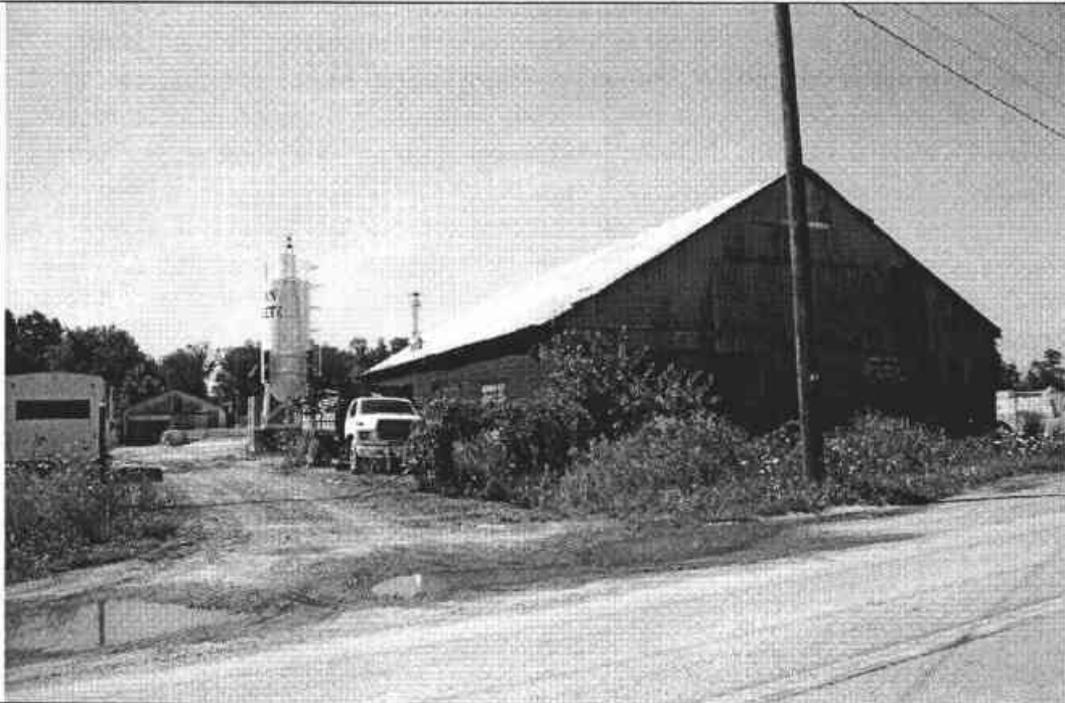
N14331. Photograph 1: H. G. Cole Canning Company, overview looking south, showing warehouse, with abandoned trailer to left of photograph, and storage building and modern equipment in background.

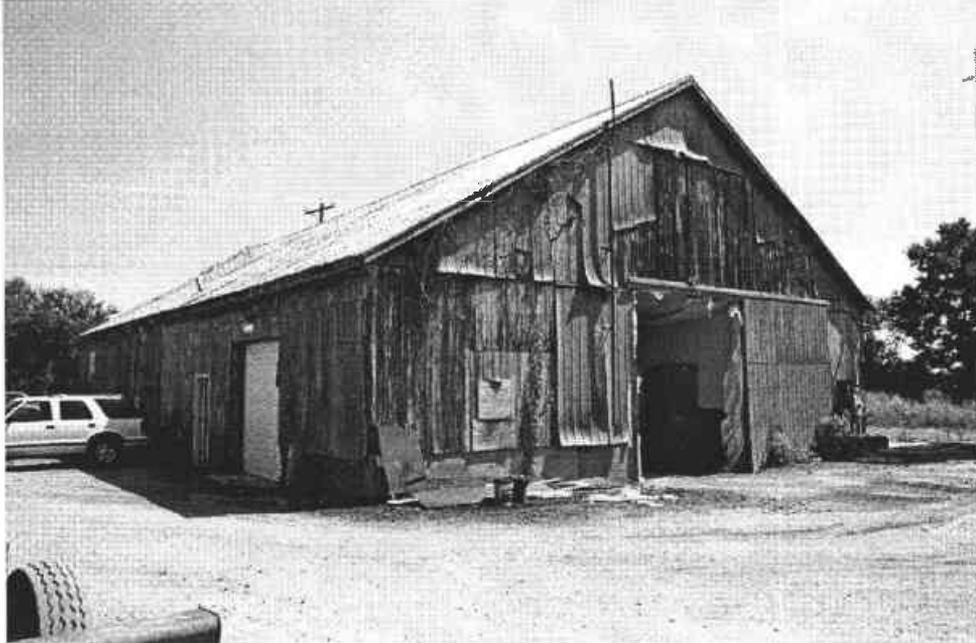
N14331. Photograph 2: H. G. Cole Canning Company, warehouse, southern and western elevations, view looking northeast. Part of the interior of this building has been partitioned and converted to offices.

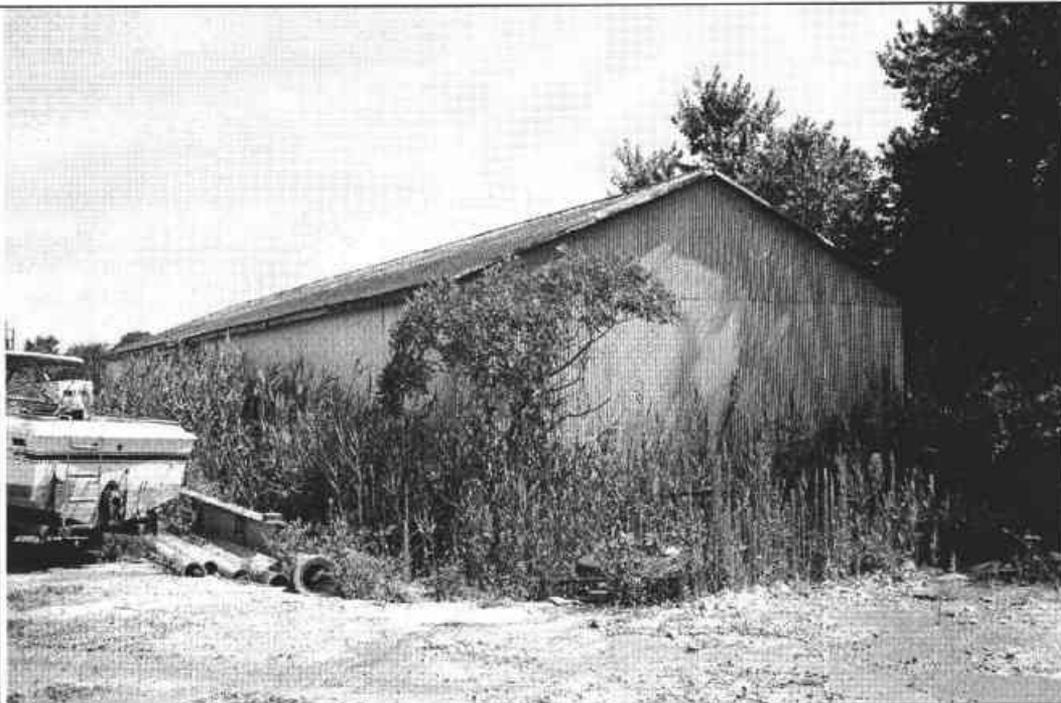
N14331. Photograph 3: H.G. Cole Canning Company, storage building, southern and western elevations, view looking northeast.
