Cultural Resource Survey
Survey Update Form

1. Name of Property: E. James Evans House (Tax Parcel 1-34-12-334.00)
2. Address of Property: South side of Rt. 26, west of Bethany Crest Trailer Park, Millville, DE (RR 2, Box 24)
3. Current Condition: fair excellent: good
poor demolished
4. Architectural Integrity: Architectural integrity is compromised by one-over-one vinyl replacement windows and aluminum exterior.
5. Setting Integrity: Setting is compromised by the Bethany Crest Trailer Park, located east of the dwelling. Infill is seen northeast of the property as well.
6. Historic Context Information: construction date circa 1940
chronological period(s) 1630-1730+/- 1730-1770+/-
1770-1830+/- 1830-1880+/- 1880-1940+/-
historic theme(s) Architecture, Engineering, and Decorative Arts

1. Name of Property: "Reflections" Antique Shop ('98 CRS Form)/ Millville MP Church (Historic) (T. P. 1-34-12-157)
2. Address of Property: N side of Rt. 26, NW of the intersection of Rt. 26 & Dukes Road, Millville, DE (P.O. Box 108)

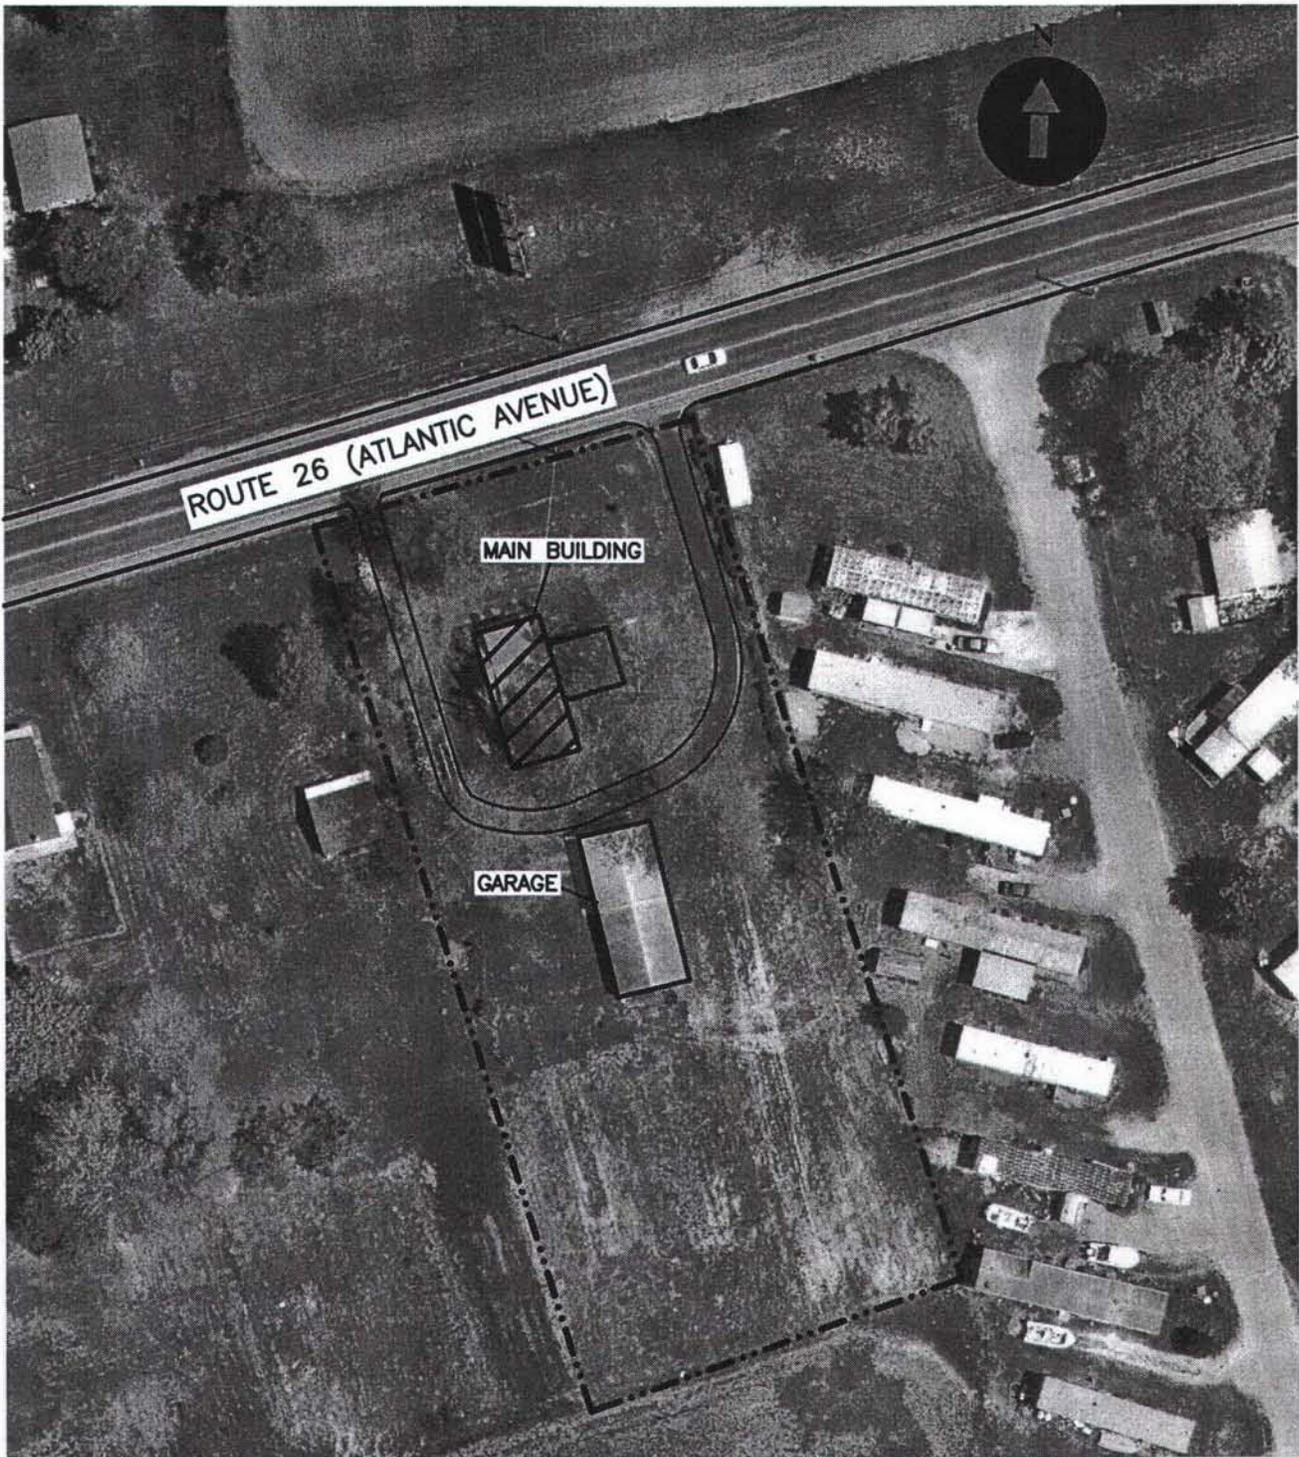
Section 8

To the south of the dwelling there is a one-story, two-bay, concrete block garage with an asphalt-shingle, side-gable roof. The main façade has two vehicular entrances with metal roll-down doors; this building has a gable roof addition with a double-wide open space for storage of tools and vehicles. The north façade has a single-leaf pedestrian entrance with a paneled and glazed aluminum door and a two-light awning window; the gable peak is clad in aluminum. This garage is mentioned and described in the June 1981 Cultural Resource Survey Structural Data Form; it was likely constructed c. 1940 together with the dwelling.

A horseshoe driveway encircles the residence, and small shrubs are seen in front of the dwelling. The Bethany Crest Trailer Park is seen directly to the east of the dwelling; infill is seen to the west.

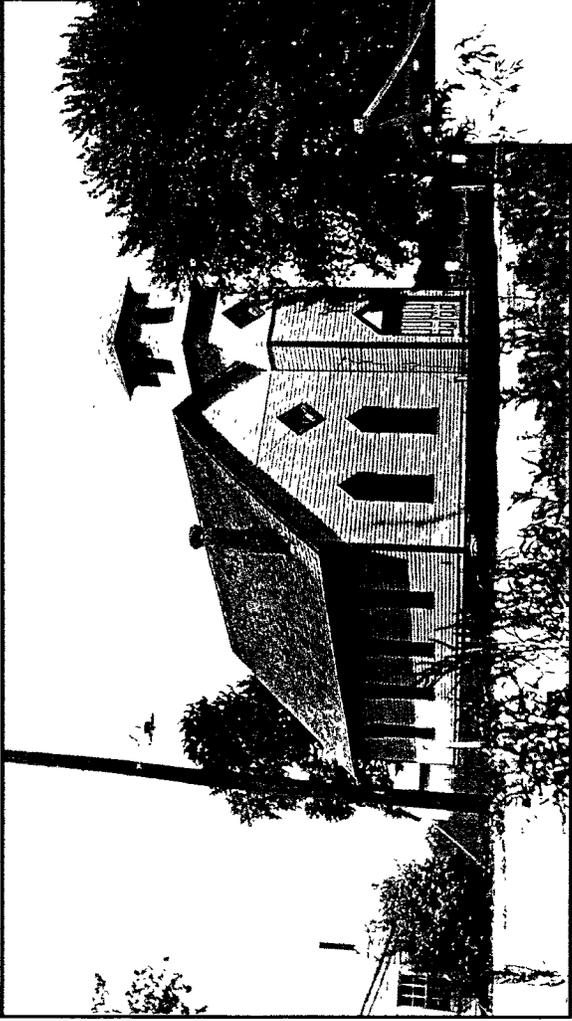
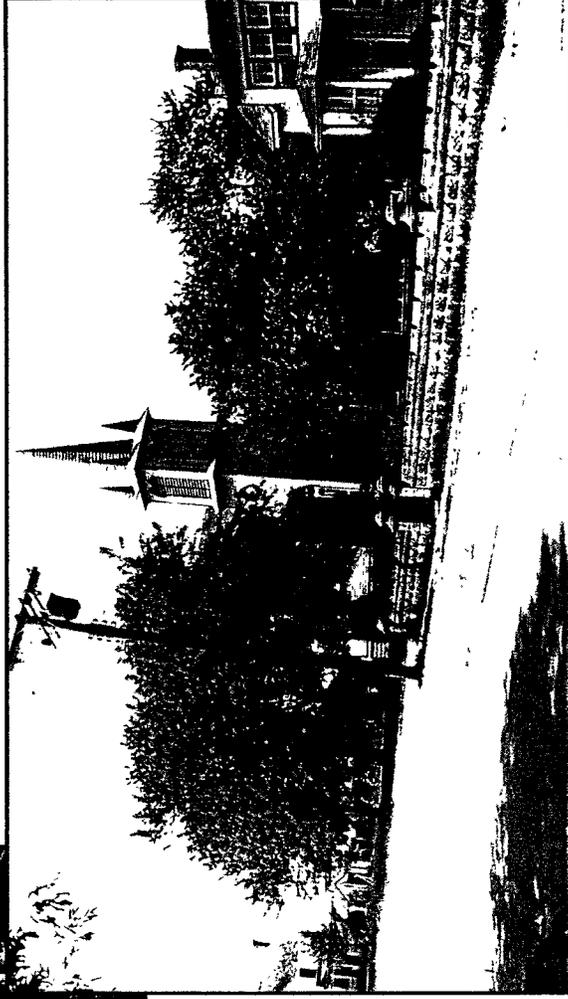
A gravel parking lot, with an entrance off Route 26, is seen to the west of “Reflections” Antique Shop. Based on historic photos of the church (See **Figures 1 & 2**), this gravel driveway is a recent addition.

Millville M.P.
The Frank Zebley Collection
Churches of Eastern Sussex County
Delaware State Archives
Date Unknown

This c. 1897 former Millville M.P. Church does retain some of its original exterior clapboard and fishscale siding; however, it has lost its belfry (See **Figures 1 and 2**), and its original lines, feeling, and association as a religious building has been compromised due to modern repairs, and an addition for living quarters seen to the rear (north) facade. The roof has also been replaced since March 1998, for the Cultural Resource Survey Main Building Form (CRS-2) prepared by Gary Sachan noted that the roof featured asphalt shingles. Since a religious property must be determined eligible for the National Register if it derives its primary significance from architectural or artistic distinction or historical importance (See the National Register Bulletin: *How to Apply the National Register Criteria for Evaluation*, Criteria Consideration A: Religious Properties, pp. 26-27), and "Reflections" Antique Shop has suffered a loss of design, materials, and workmanship, it is not a good representative example of a vernacular Gothic Revival Church, as per the property type criteria established in the *Route 26 Eligibility Study*. Due to a loss of historic fabric, modern additions, and probable changes to the interior to accommodate a retail establishment, "Reflections" Antique Shop is not a significant example of vernacular Gothic Revival church architecture.

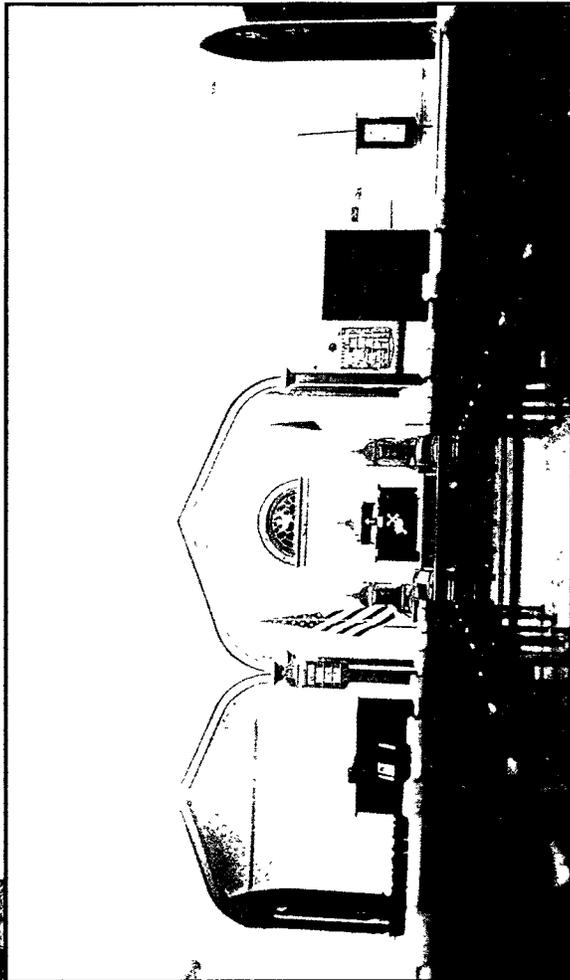
Figure 2

Millville, M.P.
The Frank Zebley Collection
Churches of Eastern Sussex County
Delaware State Archives
Date Unknown

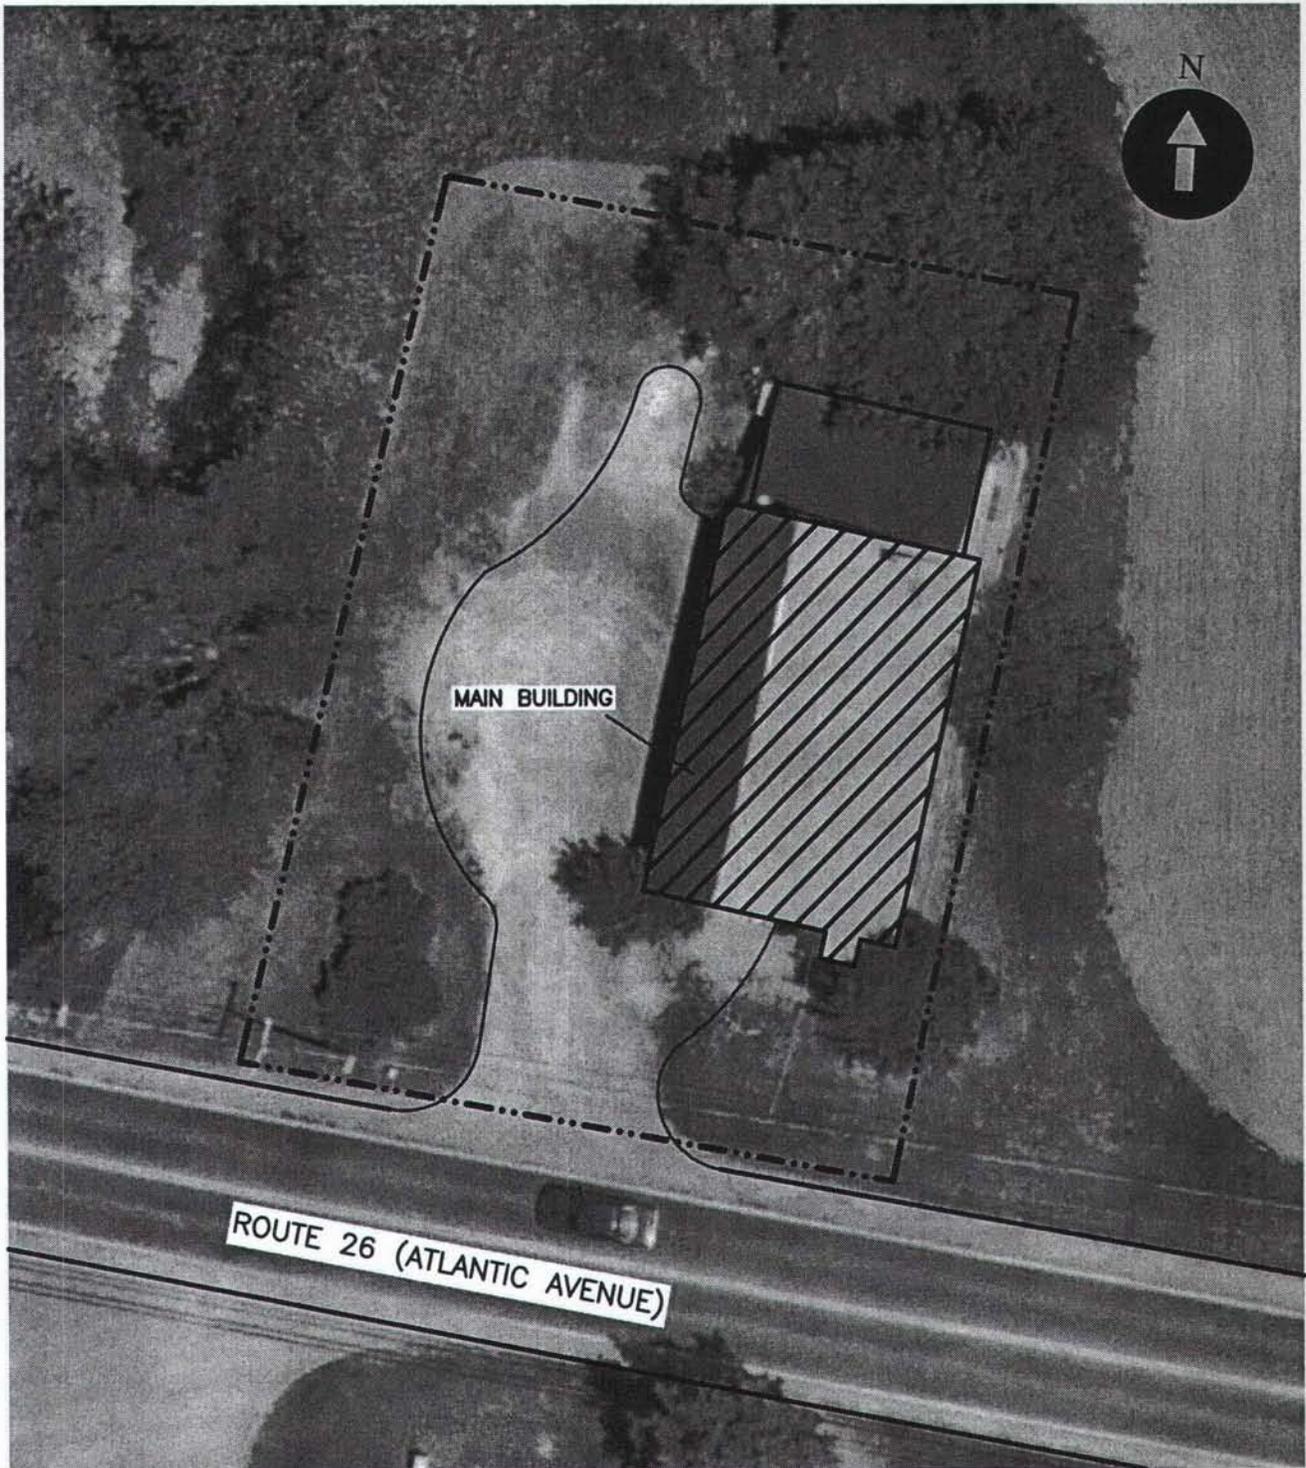
Section 8

5. Setting Integrity: A gravel parking lot is seen west of the building for "Reflections" Antique Shop; open field is seen to the north of the property.
