Pauline B. Porter House c. 1920s
626 Rehoboth Avenue (tax map #3-34-13.20-95)
Figure 42; Plate 127
CRS #S-8047

Charles E. Marsh Property c. 1880-1930
606 Rehoboth Avenue (tax map 3-34-13.20-103)
Figure 42; Plates 128-134
CRS #S-1104, S-1105, S-1107

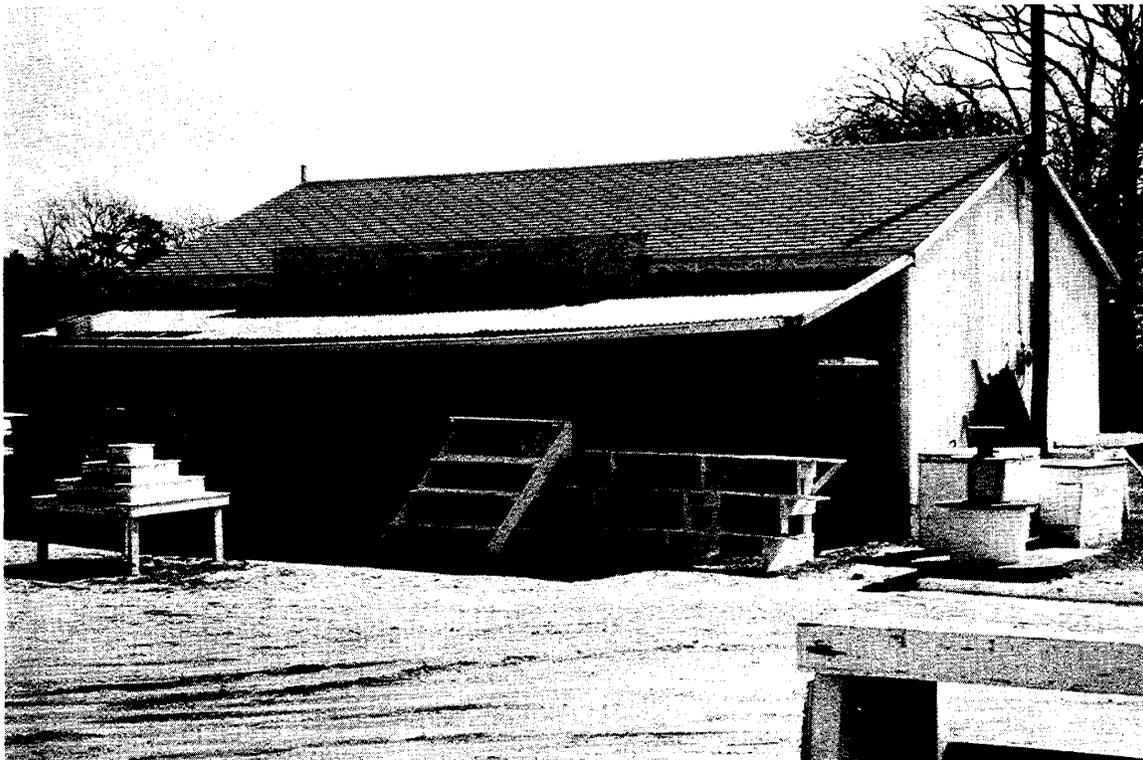
Plate 128. Charles E. Marsh Property (3-34-13.20-103),
Fruitstand, From the Northwest.

The fruitstand, labeled "Charley's Place," is a one story rectangular wood framed block, with a shed roof supported on wooden posts extending the full width of the northern or facade elevation. Above a concrete block foundation the exterior walls are covered with corrugated metal and gabled roof is covered with composite shingles. The facade elevation is open. One 1/1 sash window is located in each gable end.

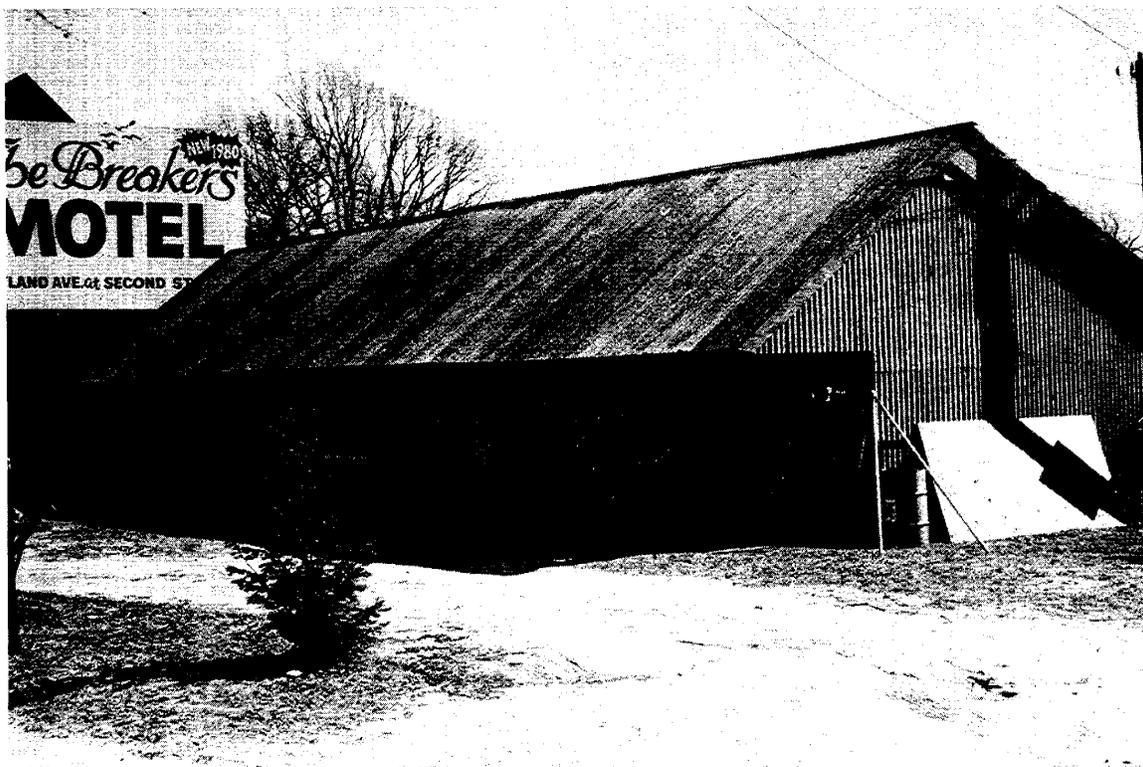
Plate 129. Charles E. Marsh Property (3-34-13.20-103), Garage,
From the Northwest.

The garage is a one story rectangular wood framed block, the walls and gabled roof covered with corrugated fiberglass paneling. Set back under the northern slope of the roof are four overhead garage doors centered in the northern or facade elevation, with an open bay at each end. This building is a non-contributing resource.

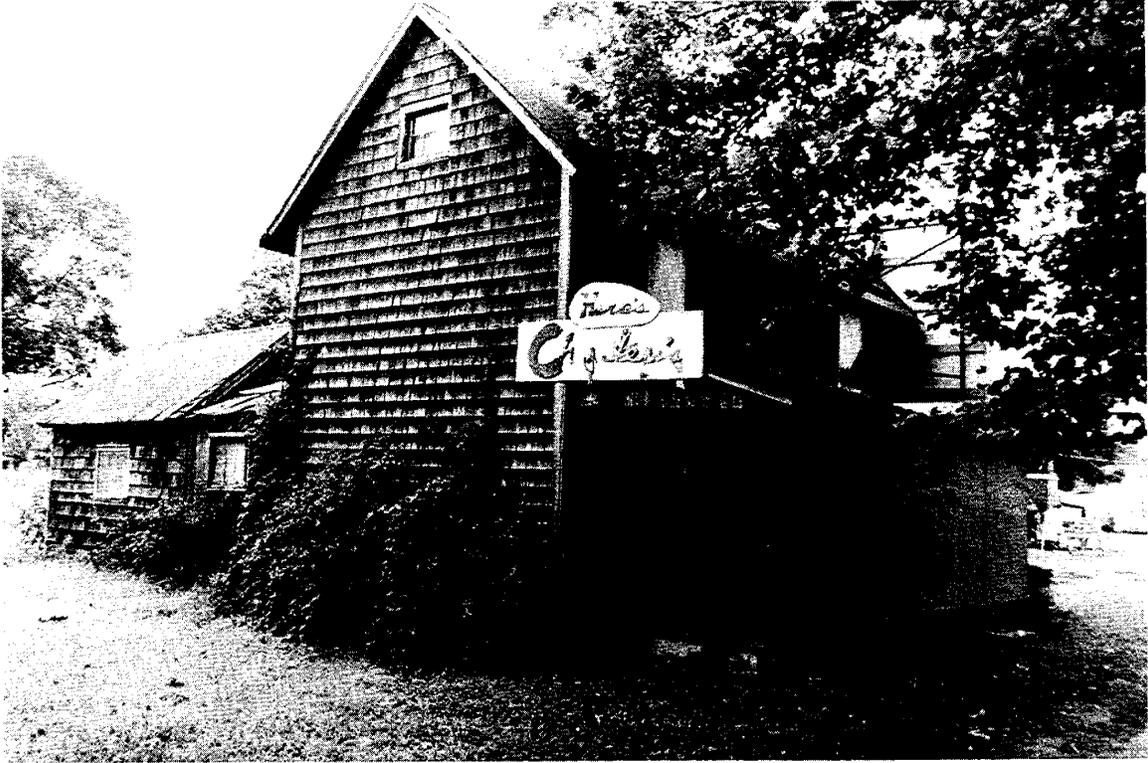
Plate 130. Charles E. Marsh Property (3-34-13.20-103), House 1,
From the Northeast.

House 1 is a two and a half story wood framed block, two bays wide and one bay deep, with a steeply pitched gabled roof. A single story porch adjoins the main facade, while a single story wing adjoins the rear. The exterior is covered in wood shingles.

A second tenant house is located on parcel 3-34-13.20-103 (Figure 42 and Plate 130). It also dates from the 1880s. This house was moved to this property by the Marsh family in the twentieth century according to the current owner (Marsh 1988). According to Marsh, the house had been moved "at least nine times" that he remembered.

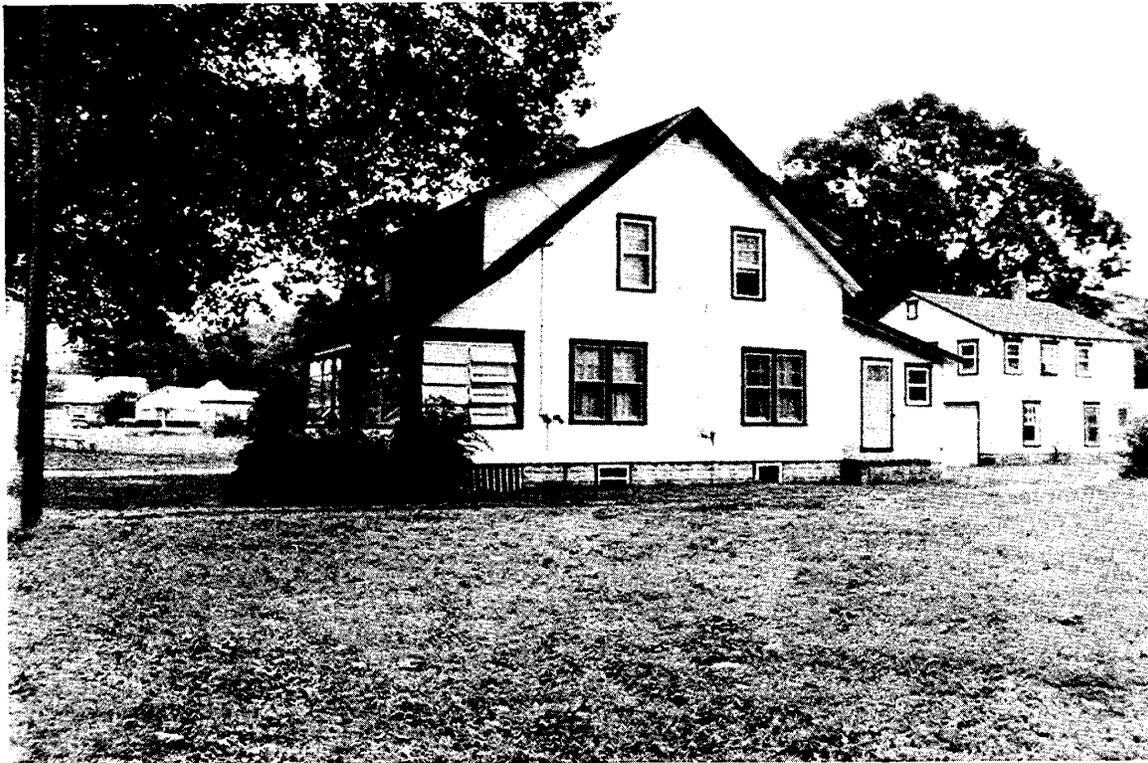
Plate 131. Charles E. Marsh Property (3-34-13.20-103), House 2,
From the Northwest.

House 2 is a two story wood framed bungalow with broad shed dormers projecting from a gabled roof. Windows are 6/1 sash. A front porch is fully enclosed by jalousied windows and is sheltered by the main roof. An enclosed shed roofed porch adjoins the rear of the house.

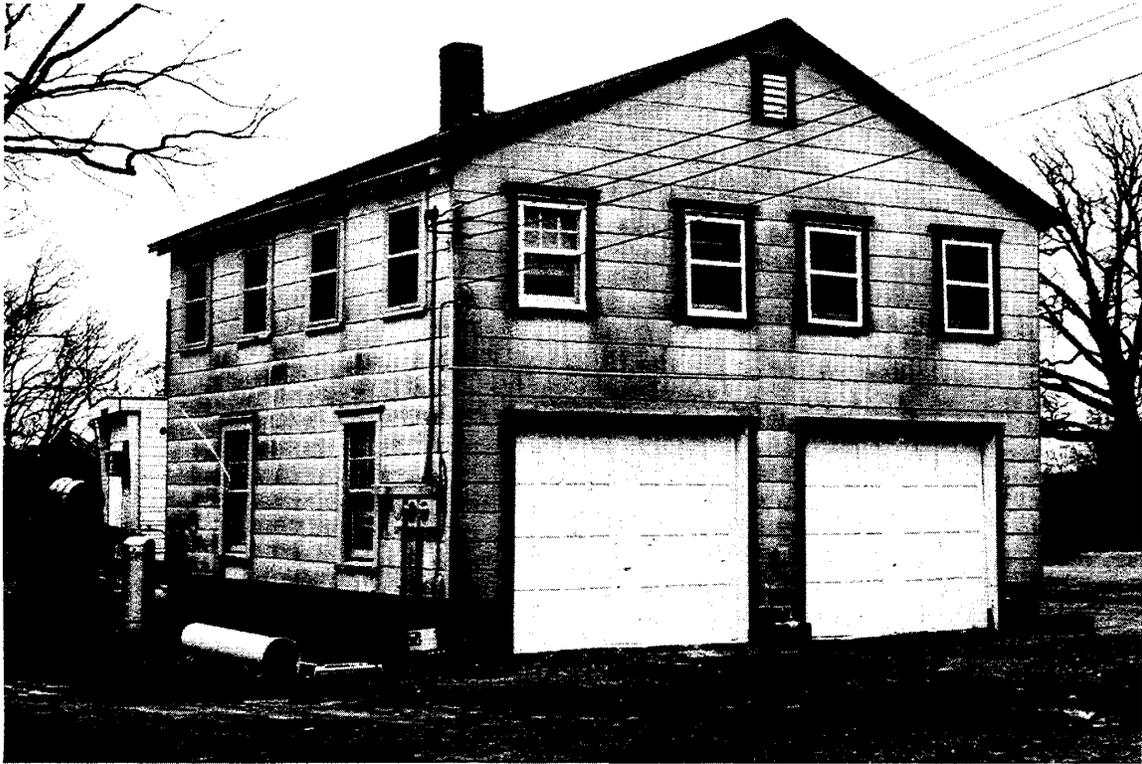
Plate 132. Charles E. Marsh Property (3-34-13.20-103), Garage, From the Northeast.

The garage/apartment building is a two story rectangular wood framed building, set on a CMU foundation. Composite shingles cover the exterior walls and the gabled roof, through which a brick chimney rises near the southern end of the eastern slope. Rafter ends are exposed under the roof overhang. The northern elevation or facade is symmetrically arranged, with two overhead garage doors on the first story and four 6/1 sash windows on the second story. On the eastern elevation, two 6/1 sash windows are located on the first story and four 6/1 sash windows on the second story. On the western elevation, two 6/1 sash windows and a sash entrance door occupy the first story and three 6/1 sash windows the second story.

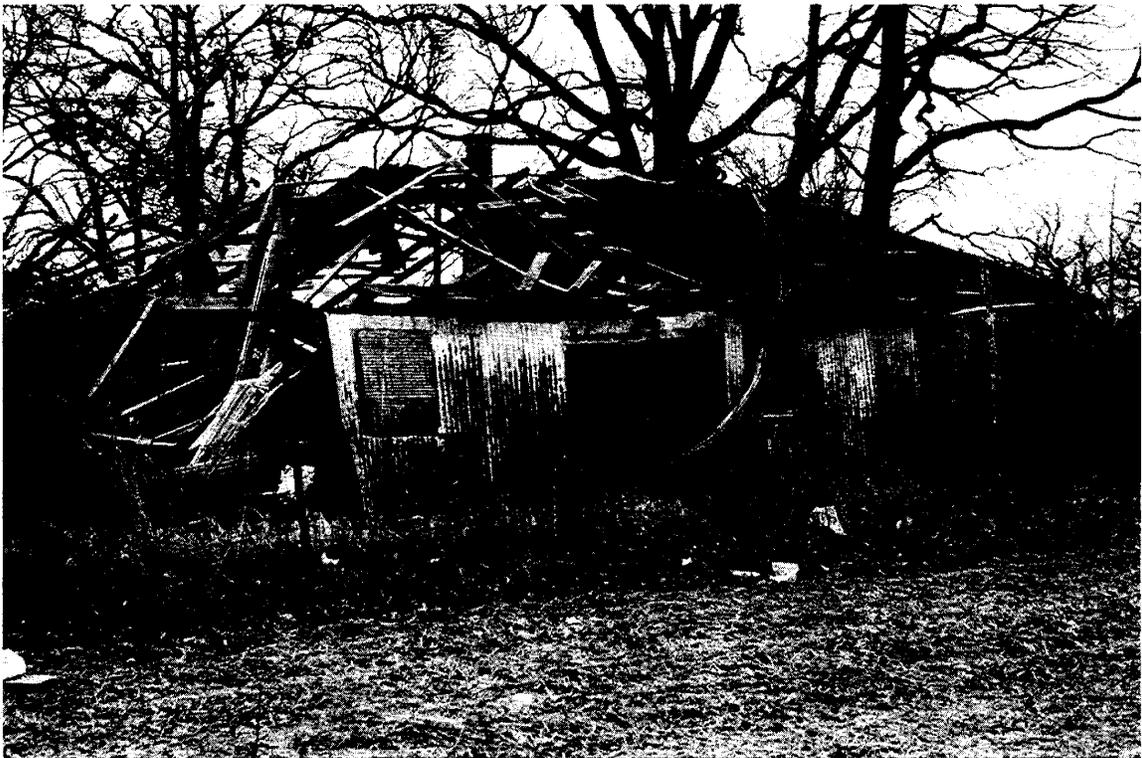
Plate 133. Charles E. Marsh Property (3-34-13.20-103), Warehouse, From the North.

The five outbuildings that stand on the southern section of the parcel include a warehouse and four sheds. The warehouse, now in ruinous condition, is a rectangular wood framed block, the walls and roof covered with corrugated metal. It stands near the western boundary of the parcel. Openings for three windows are located on the northwestern elevation or facade. A door opening is located near the westernmost end of this elevation. The four remaining outbuildings that stand to the southeast of the warehouse are wood framed sheds, with gable roofs covered

One other building is clearly associated with the early development of West Rehoboth. This is the large dilapidated building, originally a warehouse, which is located at the rear of parcel 3-34-13.20-103 (Figure 42 and Plate 133). The Atlantic Canning Company, established by John G. Townsend in 1911, purchased 14 acres of land south of the West Rehoboth Historic District in 1913 (Deed Book 188:300). This building was shown on a 1922 map as part of the Rehoboth Canning Company complex (Figure 43).

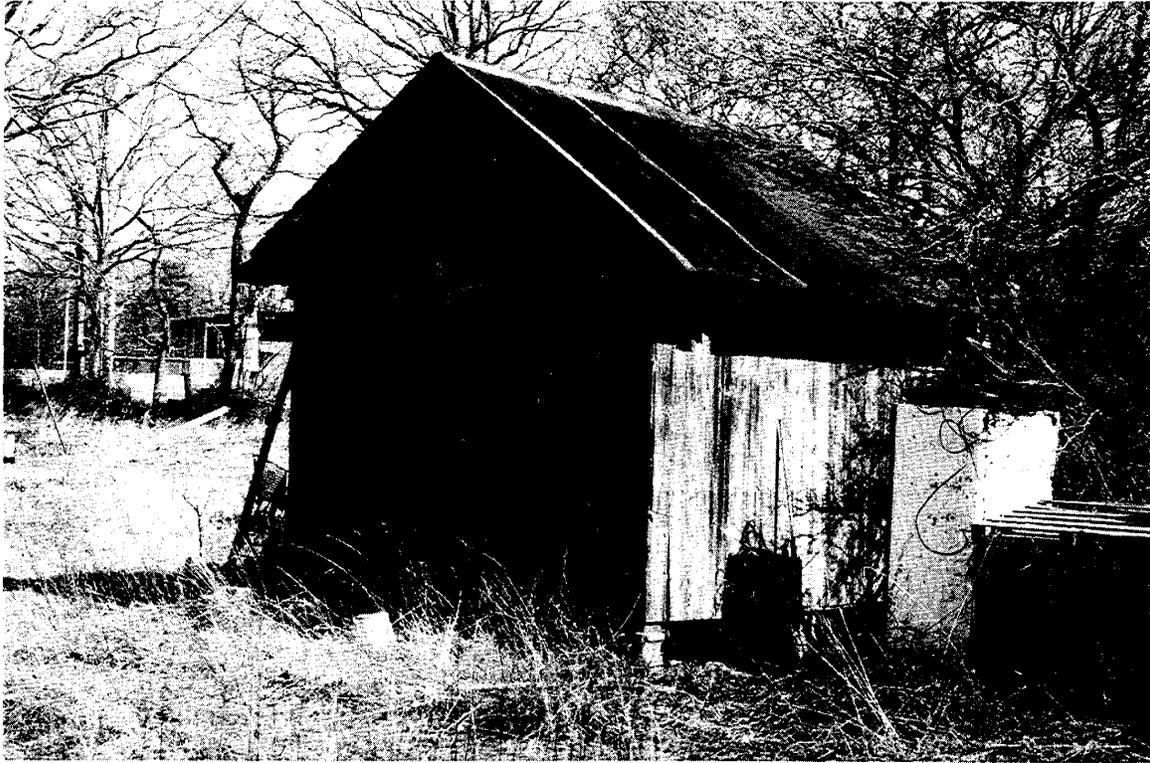
Plate 134. Charles E. Marsh Property (3-34-13.20-103), Shed,
From the Southwest.

with corrugated metal and vertical boards covering the walls. In at least one shed, a vertical board door, is centered in a gable end, and concrete block piers are used as a foundation.

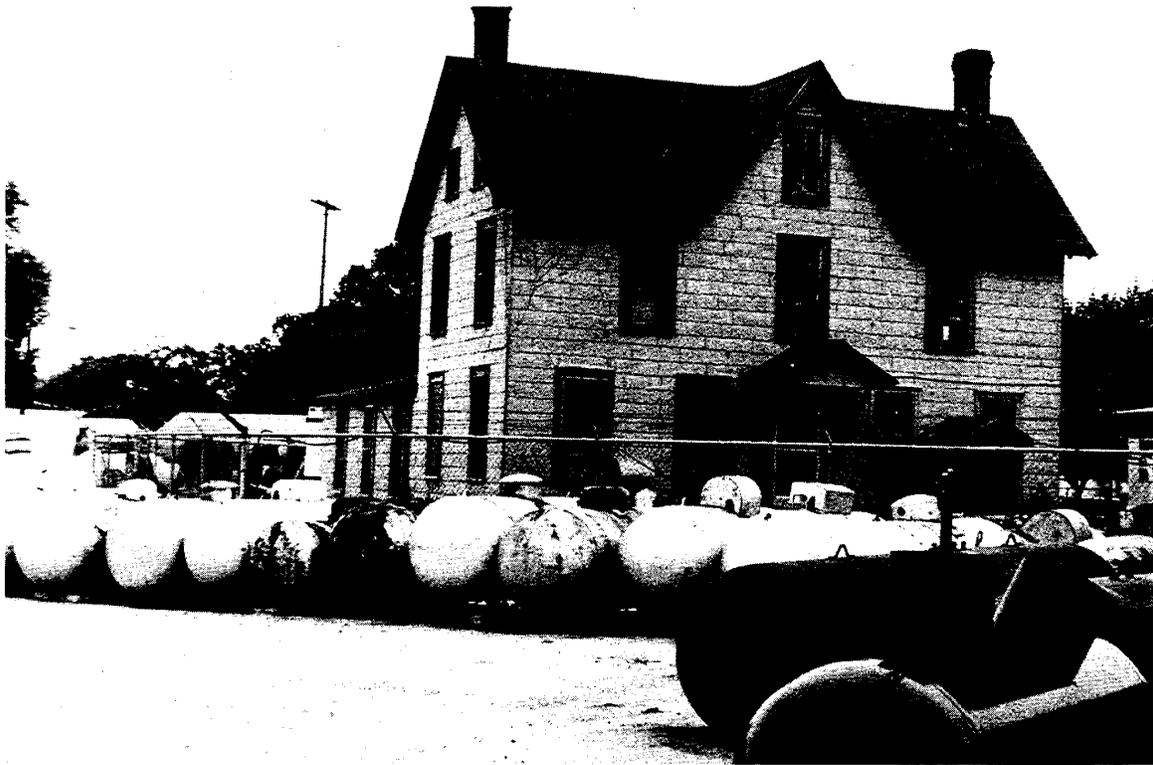
Plate 135. Charles E. Marsh House (3-34-13.20-109), From the
Northwest.

Description: The Charles E. Marsh House is a two and a half story wood framed building with a steeply pitched, cross gabled roof. Constructed as a T-plan dwelling, the house was given a rectangular groundplan when two shed roofed one story additions were built flanking the axial ell that extends to the rear. The foundation is not visible below exterior walls clad in composite shingles. Three brick chimneys rise above the composite shingled roof: two corbeled interior stack chimneys at either end of the roof ridge of the main block, and an exterior chimney centered on the southeastern elevation of the rear ell. A porch extends across the southernmost bays of the southeastern or rear elevation, the roof supported on wooden posts. The northwestern elevation faces Church Street/Route 1A and forms a symmetrical facade. Vertical emphasis on the facade is provided by the axial entrance sheltered under a gable roofed door hood, the 2/2 sash window directly above on the second story, and the axial cross gable enclosing a 2/2 sash window. Facade fenestration consists of four 2/2 sash windows on the first story, three on the second story, and one in the gable above. All window openings are framed in plain surrounds. On the northeastern elevation, two small casement windows occupy the peak of the gable; on the second story two 2/2 sash windows are arranged symmetrically above two 2/2 sash windows on the first story.

The earliest farmhouse located within the West Rehoboth Multiple Property Area is located on parcel 3-34-13.20-109 (Figure 42 and Plate 135). It dates from c. 1870 and was associated with Rhodes Thompson's farm (Deed Book 121:550). Thompson was listed as a farmer in Rehoboth Beach in the 1879 State Directory (Boyd 1879:269). Whether Thompson actually resided in the house or used it as a tenant house is unknown.

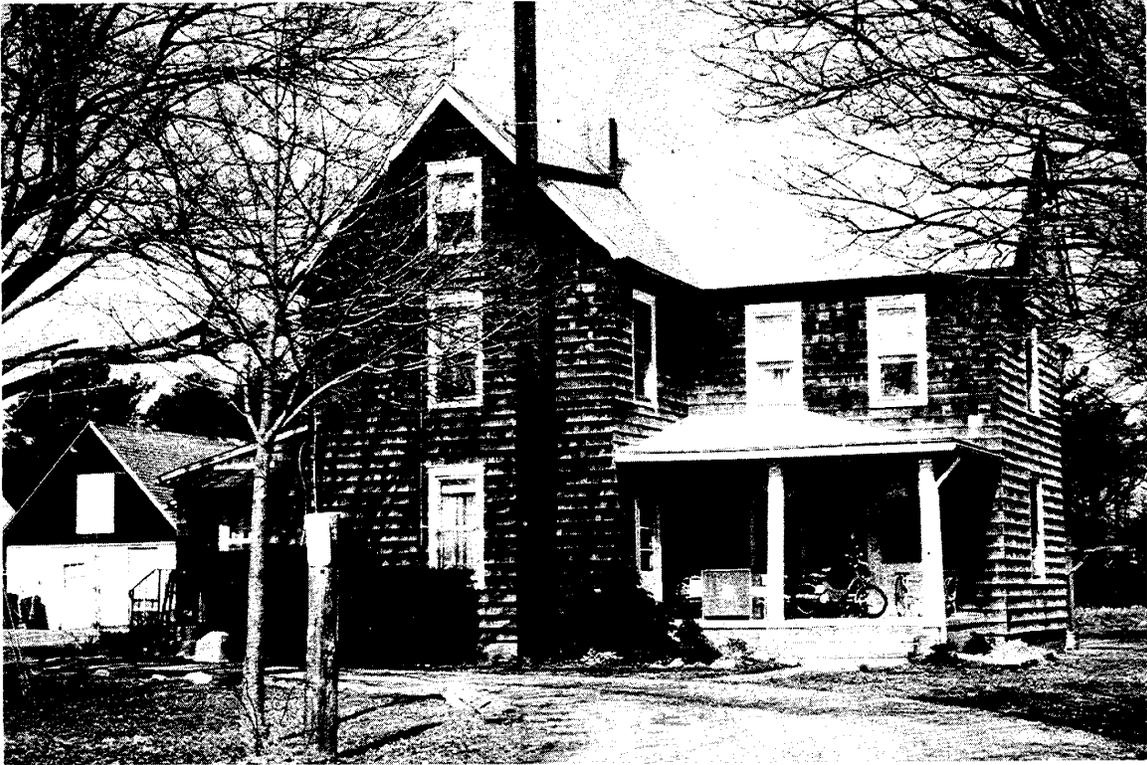
Plate 136. Marsh Family Farmstead (3-34-19-3), House, From the Southeast.

The main dwelling (House) is composed of a two and a half story gable roofed main block, arranged in a T-plan, to which have been added a two story one bay gable roofed section on the southwestern elevation and a one story shed roofed enclosed porch, also on the southwestern elevation. A one story front porch occupies the eastern corner, with two battered wooden posts supporting a hipped roof that shelters two sash entrance doors and a 1/1 sash window. Above a concrete foundation the exterior walls are covered in wood shingles, and composite shingles cover the slopes of the roof. A stuccoed chimney rises from the crossing of the roof ridges. Each gable end elevation is occupied by one 1/1 sash window on first, second and attic story levels. All window and door openings are trimmed with plain surrounds and a molded strip atop the lintel which forms a small hood-mold. The enclosed porch on the southwestern elevation contains a pair of six light casement windows.

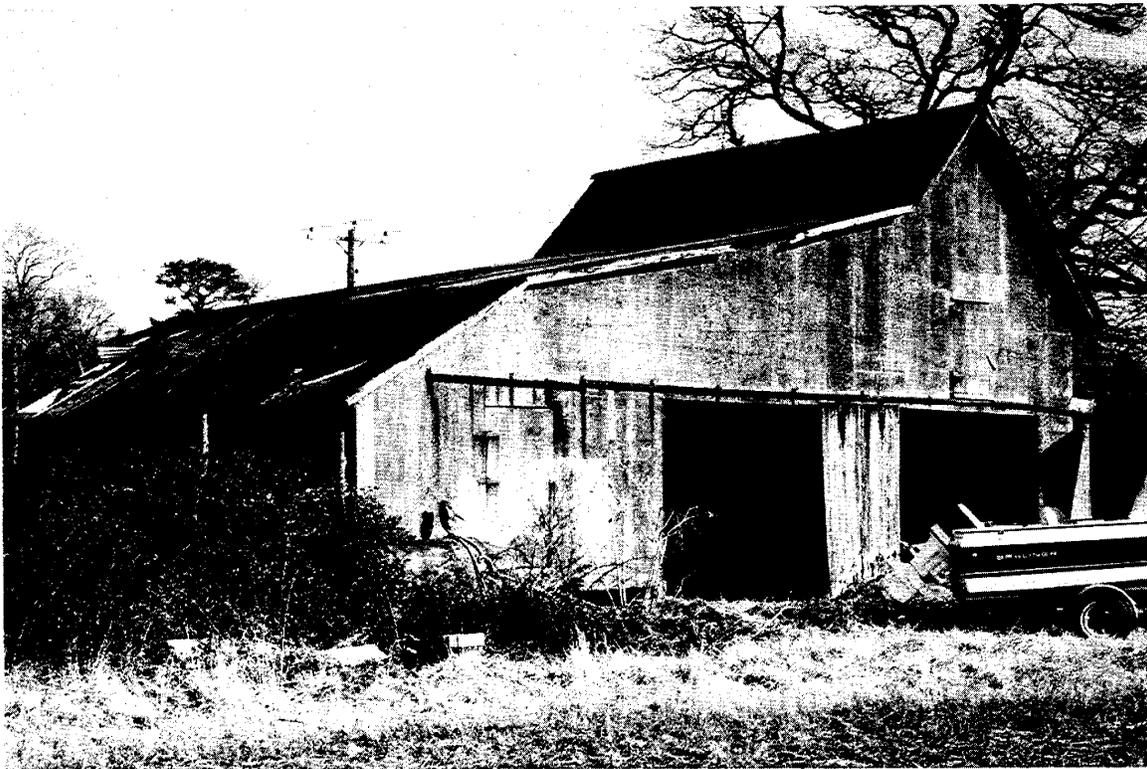
Plate 137. Marsh Family Farmstead (3-34-19-3), Barn 1, From the Southwest.

The barn next to the farm lane (Barn 1) is a wood framed rectangular block composed of a two story gable roofed section and a one story section joined by a shed roof. A shed roofed one story addition extends across the northwestern elevation. The exterior walls are supported on concrete block piers and covered with vertical boards and plywood; the roof slopes are covered with composite and metal sheathing. On the southeast elevation or facade are located two openings for sliding barn doors and a vertical board entrance door, with an access door to the left space centered above in the two story section. On the northeast side elevation are two 6/6 sash windows; on the southwestern elevation of the rear addition are one 1/1 sash window and a window opening covered by a hinged plywood door.

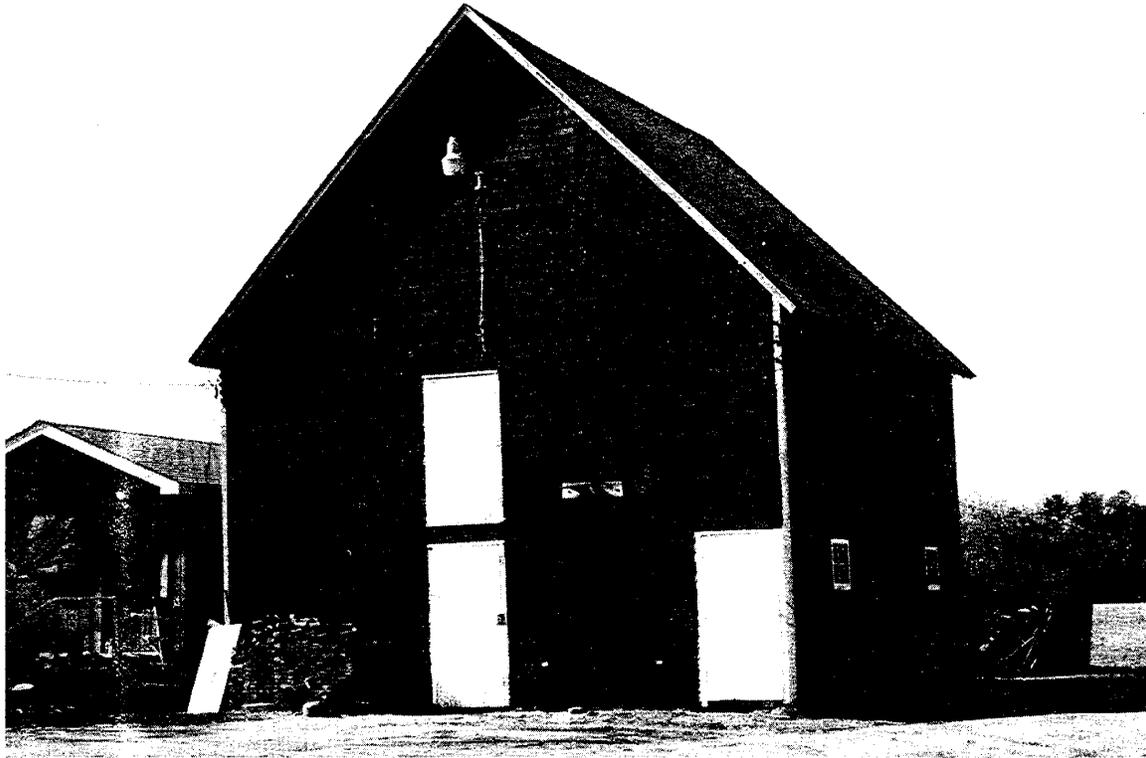
Plate 138. Marsh Family Farmstead (3-34-19-3), Barn 2, From the Northeast.

The barn to the west of the main dwelling (Barn 2) is a two story wood framed square block, set on a brick foundation. The exterior walls are covered with brick paper sheathing, and the overhanging gabled roof with composite shingles. On the eastern

gable ended elevation or facade, a vertical board door is centered on each of the first and second story levels, and a vertical board door occupies the northern bay of the first story. On the western gable ended elevation, a vertical board door is centered on the first story. Window openings are located on the side elevations, with two small six light sash windows on the northern elevation and two boarded-over openings centered on the southern elevation.
