S-12178. Ellendale State Forest
(PIN: multiple)
(Detail Maps #3, #4 & #5)

**S-12179. ECW (Emergency Conservation Work) Camp S-53 Mess Hall,
Redden Road
(PIN: 135-5.00-37.00)
(Detail Map #5)**

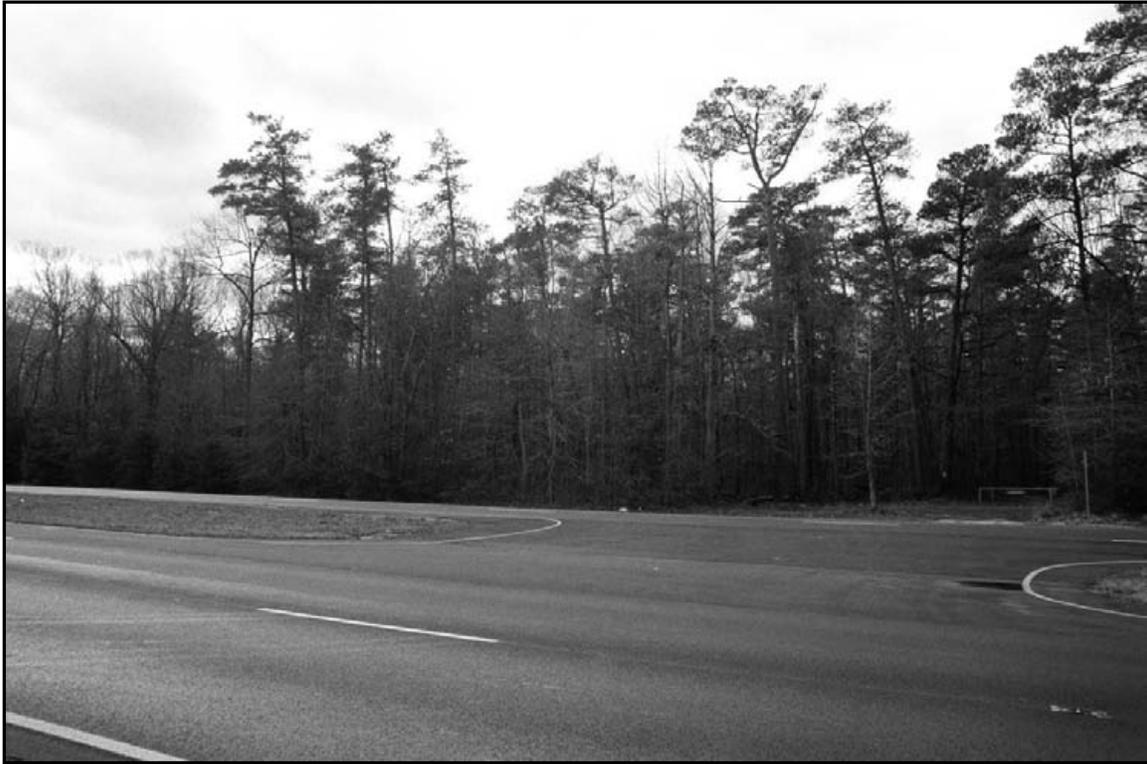
Ellendale Tract, Stands 8 and 9 of mixed pine and hardwoods on the west side of U.S. 113, view to SW

Stand #8 (40.5 acres) is located on the west side of U.S. 113 on the south side of an access road maintained by the Delaware Forest Service. The stand, established in about 1915, consists of a mixture of large loblolly pines, Virginia pine, red oak, and white oaks, as well as a substantial volume of low quality mixed hardwoods.

Stand #9 (37.2 acres) is located along a prong of Maple Branch on the west side of U.S. 113. A natural stand, established in about 1915, it consists of relatively poor quality mixed hardwoods including sweetgum, blackgum, and red maple. All of Stand 9 was added to the forest prior to 1939.

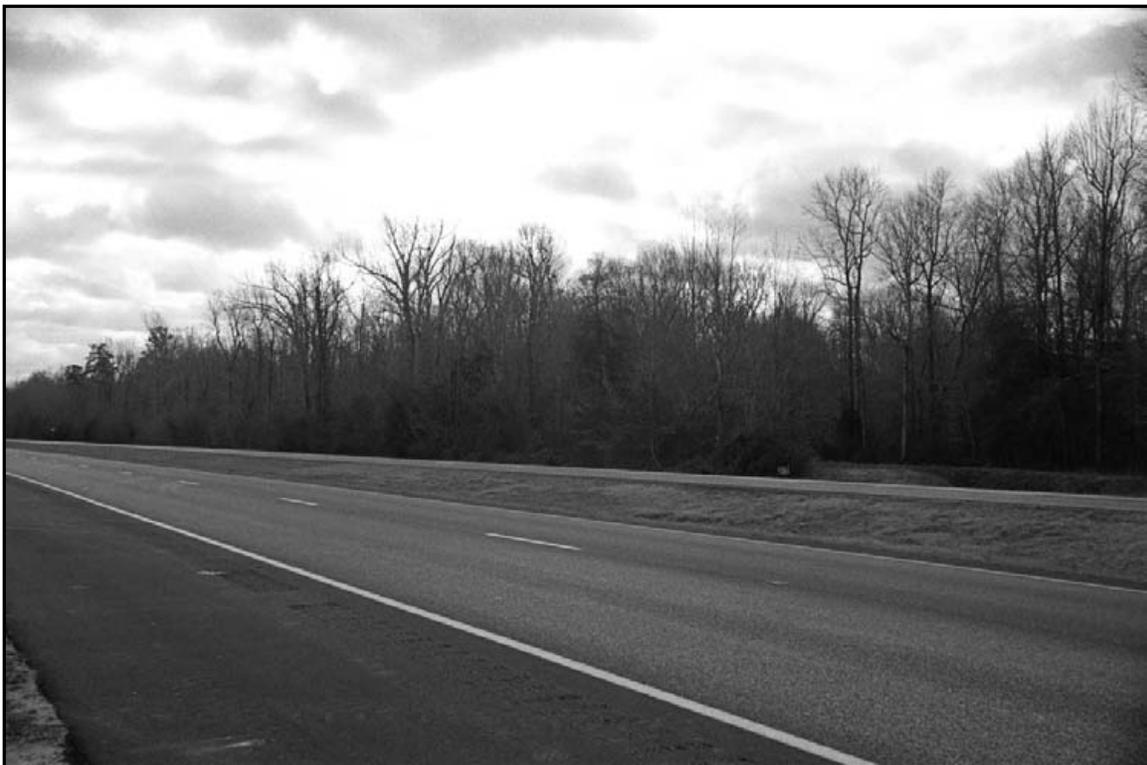
Ellendale Tract, Stand 6, a natural stand of mixed pines and hardwoods on the west side of U.S. 113, view to SW

Stand #6 (100.2 acres) is located on the northern boundary of the Ellendale Tract on the west side of U.S. 113. A natural stand, established in about 1915, it consists of relatively poor quality mixed hardwoods including sweetgum, white oak and willow oak, along with scattered loblolly and pond pines. All of Stand 6 was acquired by the state prior to 1939.

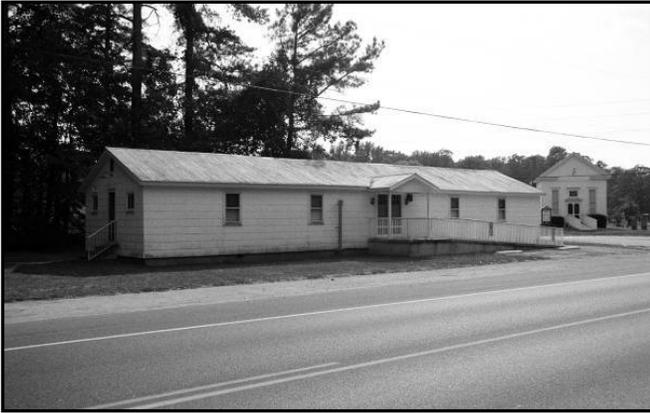
former CCC mess hall (.001) façade and east side, view to SSW

The fellowship hall—originally a Civilian Conservation Corps (CCC) mess hall—is a one-story, wood-framed c. 1934-1935 side-gabled building that faces north. A one-room shed-roof extension is located on the rear wall, slightly off center towards the east end. The building measures five bays wide by three bays deep with regular fenestration on all sides. A gabled entry porch extends from the center of the façade sheltering the main, double-door entrance, fronted by a modern handicap ramp trimmed in iron railing. Secondary, single-door entrances are located within both gable ends. The interior of the building is naturally lit by a combination of double-hung, one-over-one and casement wood-sash openings. The building is covered in asbestos shingles and rests on a concrete-block foundation. The roof is sheathed in metal. A concrete-block chimney rises from the exterior of the rear, southwest corner of the building.

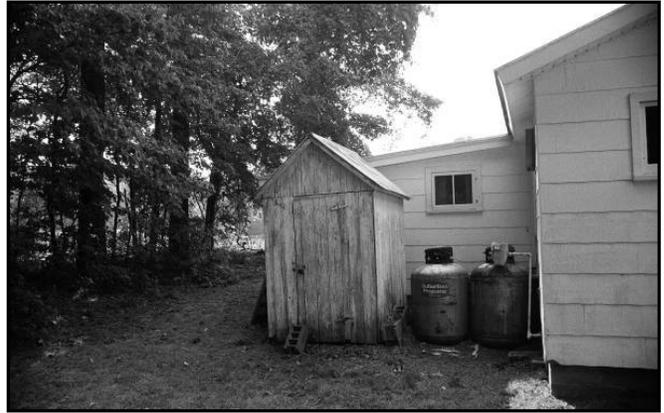
shed (.002), view to SW

Nestled behind the fellowship hall, to the rear of its eastern end, is a small, wood-framed storage shed (.002). This one-story c. 1920s gabled-front building faces east. A single wood door opening pierces the center of its façade. Overall, the building is clad in vertical wood siding, and rests on concrete-block piers. Its roof is sheathed in metal.

The proposed National Register boundary for the property consists of the present-day Sussex County tax parcel 135-5.00-37.00, encompassing the fellowship hall. The small shed (.002) behind the mess hall appears to have been built at least a decade before the mess hall, and there is no clear historical association between the two. The shed does not contribute to the architectural significance of the mess hall and is therefore a non-contributing element of the property.

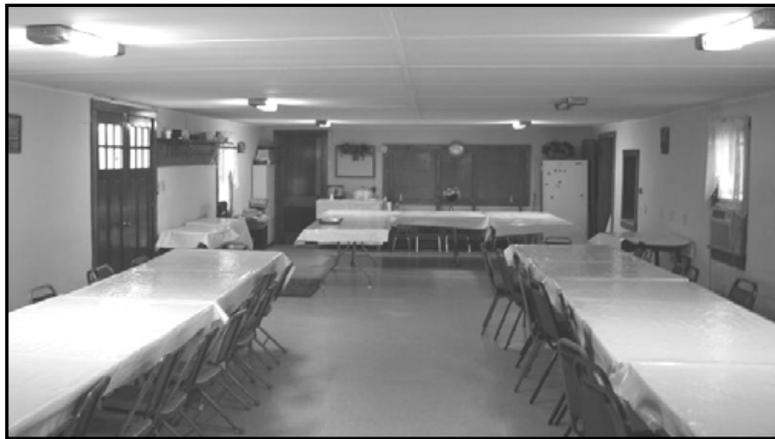
interior of former CCC mess hall (.001), main room, view to E; the wooden panel in the center of the rear wall is a pass-through to a kitchen

The interior of this building consists of three rooms, a large dining area and kitchen (main block), and a storage closet (rear extension). All of the openings appear to be original, and are cased in stained, plain wood molding. The wall between the kitchen and dining area is multi-functional; folded down it can serve as a counter top for serving between the two rooms, or kept up it can function as a wall. The dining area is open, and currently contains portable chairs and tables, and a piano. All of the original built-in features (cabinets, sink, heating elements, and countertops) remain in the kitchen, with the exception of a newer refrigerator. A small bathroom has been built in a corner of the storage room, but otherwise the interior remains intact.

Although Ms. Wells—the McColley's Chapel congregant interviewed by JMA during the field survey—identified the building as a barracks, it is more likely to have been a mess hall. The revised identification is based on the presence of a large kitchen at the east end of the building, connected to the main room by a wood panel pass-through. An interior photograph of a CCC mess hall in Connecticut (reproduced below) reveals remarkable similarities to the fellowship hall at McColley's Chapel.

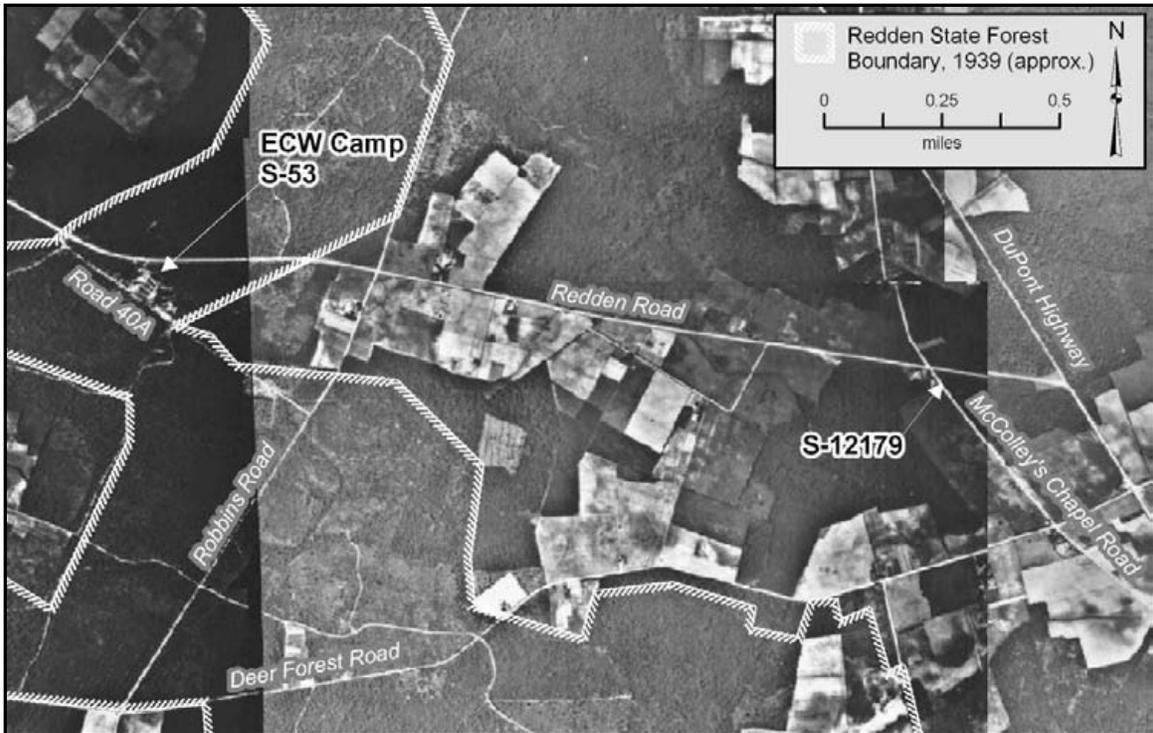
locations of ECW Camp S-53 and the former mess hall (S-12179) on the 1937 aerial photograph

Historic Overview: According to Reba Wells (2008), a neighbor and McColley’s Chapel congregant, the church’s fellowship hall, known as Redden Community Hall, originally served as a CCC barracks at a work camp to the south of Redden Road, approximately 1.5 miles further west of its current location. Historic-period aerial photographs indicate that the building was moved to McColley’s Chapel Road between 1954 and 1961.

Constructed in c. 1934-1935, the former mess hall at McColley's Chapel Road was a pre-fabricated, utilitarian building designed to support government-sponsored laborers. Its unelaborated rectangular form and wide-open floor plan reflect this use. A 1937 aerial photograph indicates that all of the buildings at ECW Camp S-53 had essentially the same footprint. Photographs (shown below) from the late 1930s of three of the camp's other buildings confirm this observation and suggest that the exterior design was highly standardized. Like most CCC camp buildings, the former mess hall was designed in the military style to be both utilitarian and

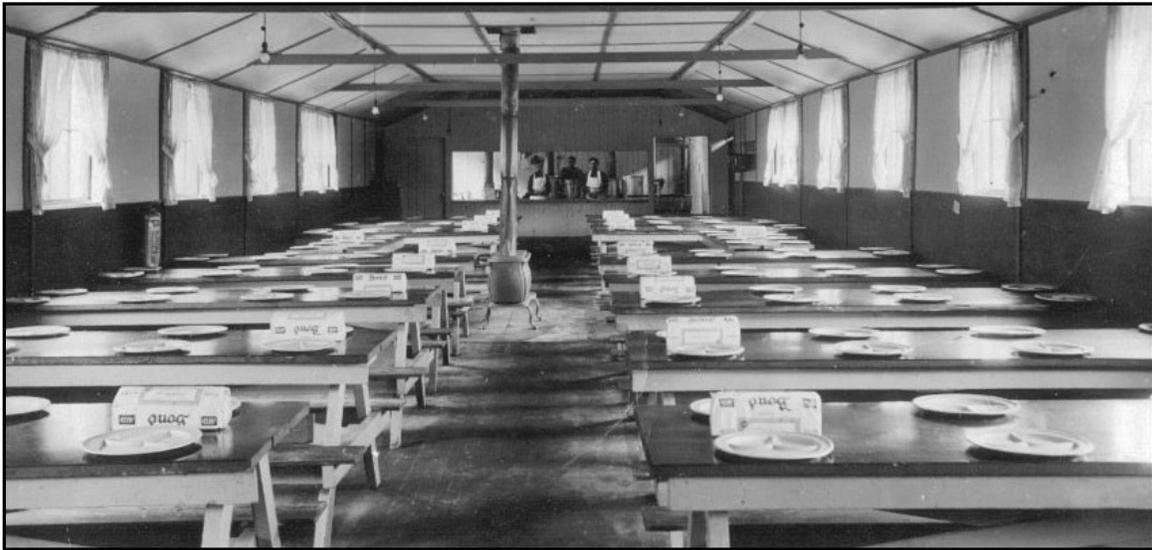
interior of mess hall at Cross CCC Camp S-51, Housatonic Meadows State Forest, West Cornwall, Connecticut; note pass-through to kitchen at end of main room (source: Civilian Conservation Corps Stories n.d.)
