**PHASE I ARCHAEOLOGICAL SURVEY OF  
THE NORTH MILLSBORO BYPASS  
PROJECT, SUSSEX COUNTY, DELAWARE**

**PARENT AGREEMENT 1924F, TASK 6**

**November 2021**

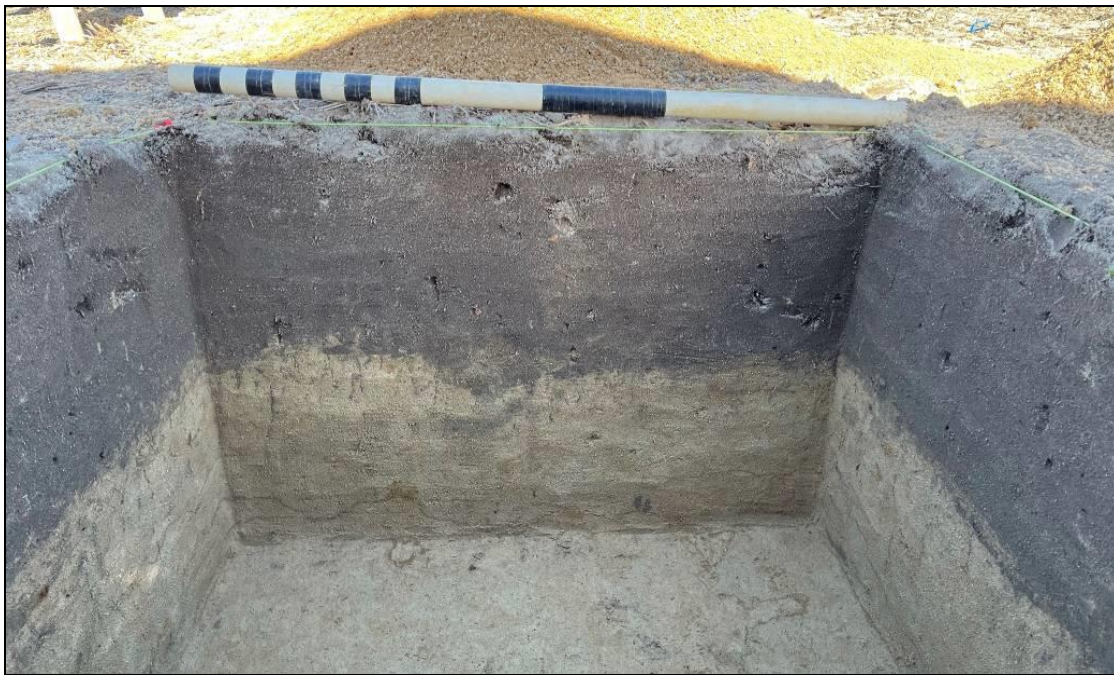
Photo 13: TU 12, North Wall Profile, Showing Typical Soils in Area 2A, Site 7S-F-175A .

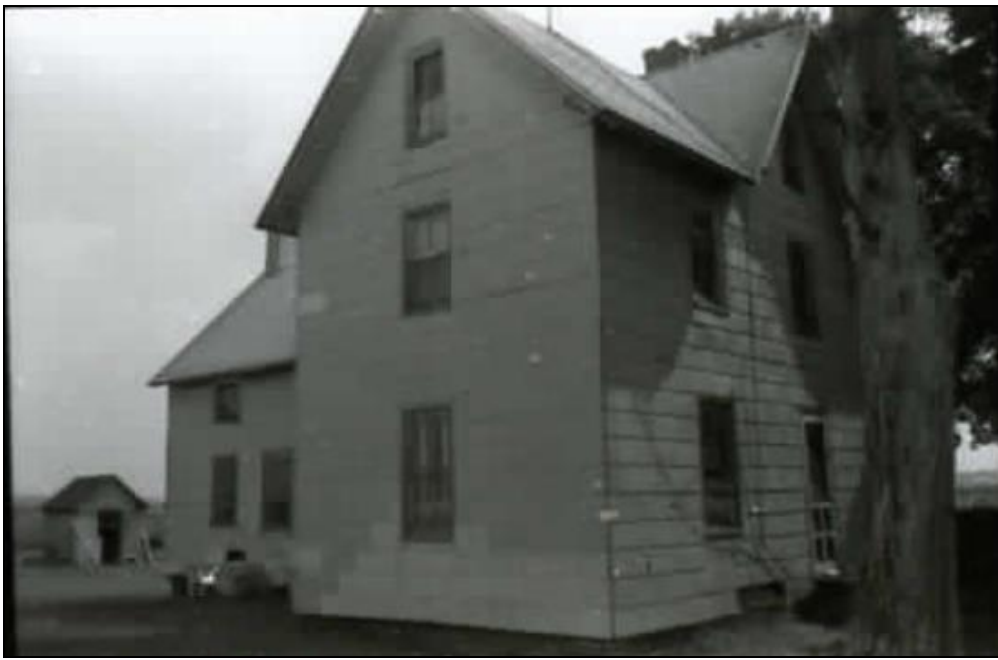
Figure 44: Survey Photo of the House (CRS# S03147) within Area 6.

The house had a one-and-a-half story addition or possibly an earlier core. Records indicate that the house's structural system, likely frame, was supported by a brick foundation (Figure 44). The physical components of the Betts' house are different from those mentioned in earlier deeds; the house owned by Jacob Cramfield was called a "stone two-story" dwelling; it is possible that the earlier house noted on the 1868 map and in deed records was demolished at one point during a change in ownership or encapsulated within siding masking its appearance. Regardless, the property, and Area 6 in particular, had a house located within its boundaries between the mid-nineteenth century and into the late-twentieth century. The site was surveyed in 1983 and listed as a Priority 2 building in a survey of National Register eligibility evaluation of Indian River Hundred (Herman et al. 1988:126). By 1992, the farmhouse was no longer extant. In 2004, a survey of the area recorded the farmhouse as demolished and the area had reverted to an active agricultural field.

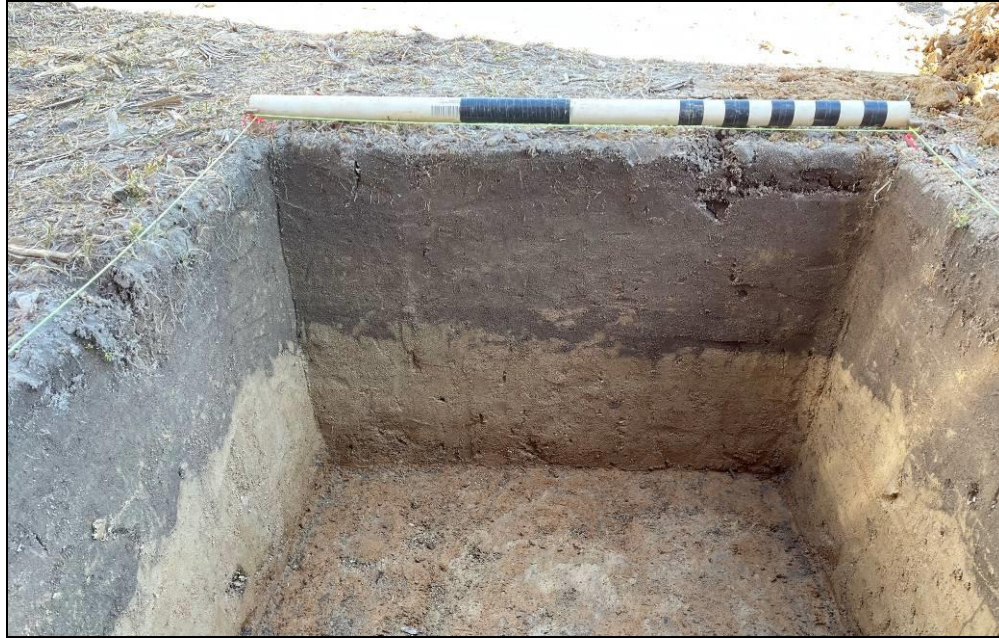
Photo 19: TU 4, North Wall Profile, Showing Typical Soils Within Site 7S-F-173.

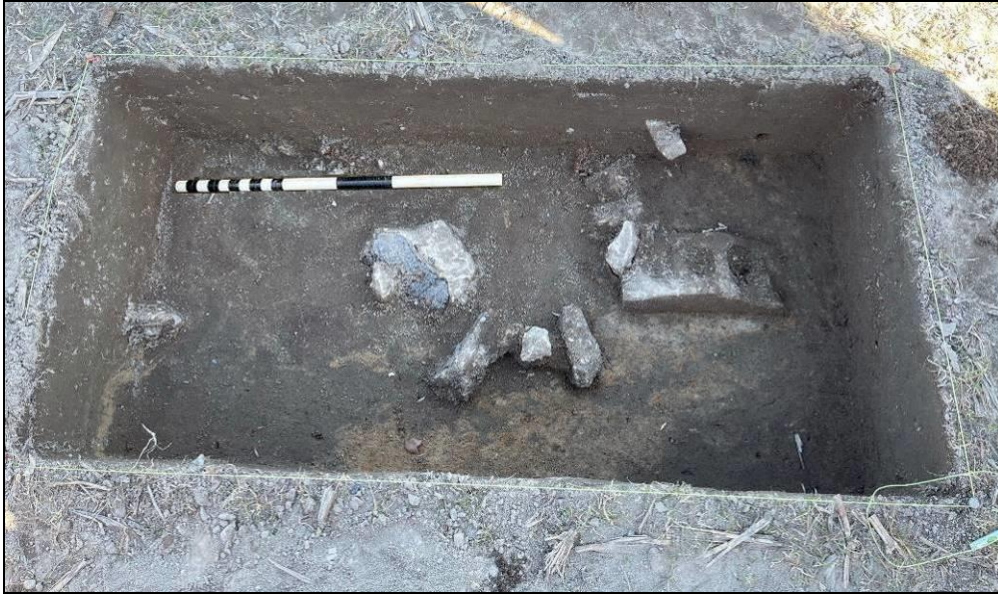
Photo 20: Site 7S-F-173, Plan View of TU 1, Looking East.

Although TU soil profiles were generally similar to STPs, and few features associated with a probable small outbuilding were encountered in the subsoil, TU 1 was placed around STP H-4 in order to examine the possible feature represented by a cinder-block believed to be in situ. A line of broken cinder blocks dating to the first half of the twentieth century was identified at the base of Stratum I, likely representing the former foundation of a small outbuilding associated with the farmstead.

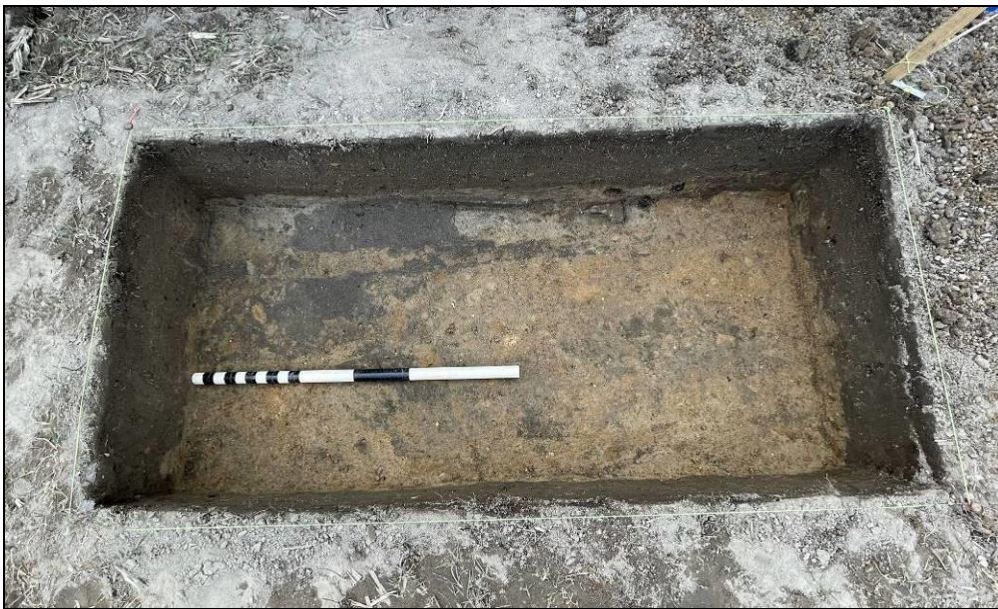
Photo 21: Site 7S-F-173, Plan View of TU 7, Looking North.

TU 7 was placed perpendicular to the end of TU 1 in order to determine the orientation of the outbuilding and its possible function. No intact courses of cinderblocks were observed, suggesting the foundation was shallow, but a builder's trench indicates that the orientation likely paralleled DE-24. No other features were found in the remaining excavated TUs.
