HABS/HAER INVENTORY

State Bridge Number 137A

Dickerson Street over Duck Creek
Clayton, Kent County, Delaware

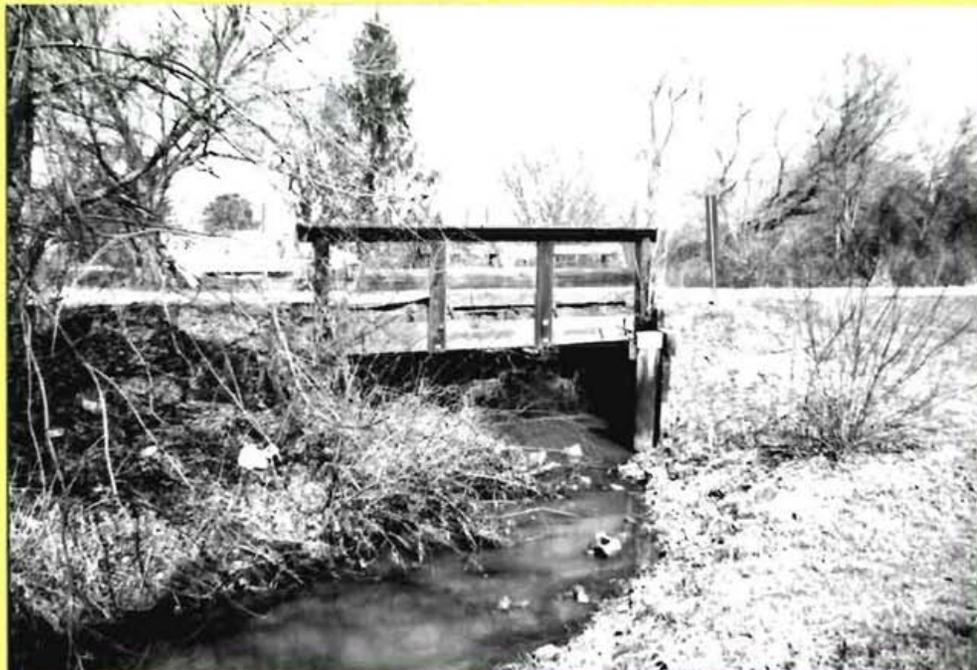
22:B13-18

State Highway Bridge 137A is a 15'-2" single span timber girder bridge with a timber substructure and superstructure. The bridge has been built at a 30 degree skew. The superstructure rests on timber bents, each comprising six piles 12" in diameter supporting a 10" x 12" header, or cap. Twenty-three 4" x 14" girders support the deck which is constructed of 4" x 10" planks. The deck has been paved over. The bridge is 36'-3" wide and carries two lanes of traffic on a 21'-8" roadway. The wing walls are straight and composed of 4" x 10" planks. The simple wood railing, 3'-0" in height, is constructed out of 6" x 8" posts and 3" x 8" rails.
