HABS/HAER INVENTORY

State Bridge 161

Road 28A, Poplar Street over Broad Creek
Laurel, Sussex County, Delaware

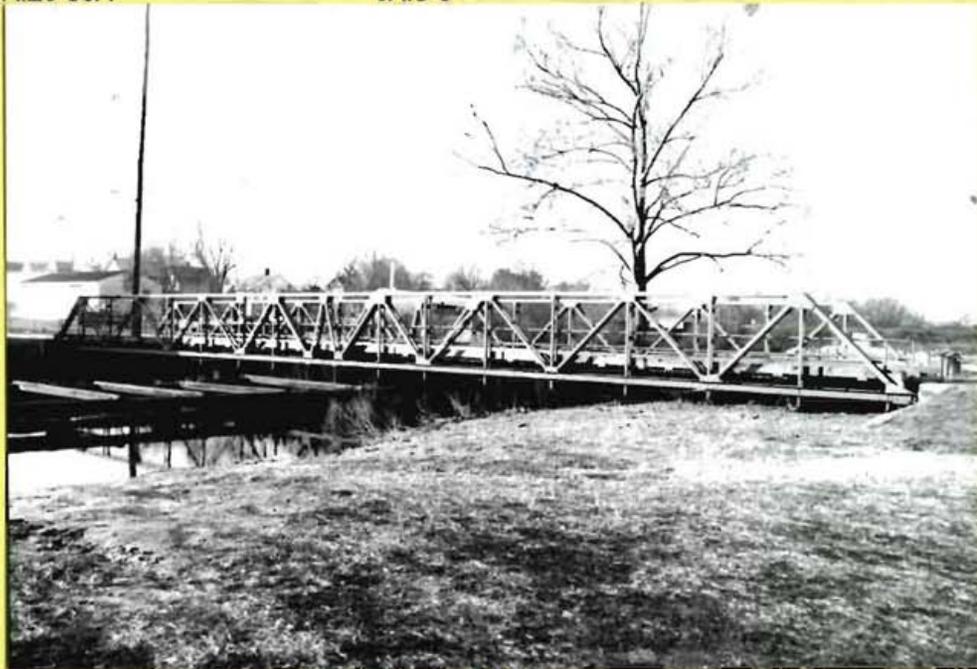
5A:27

State Bridge 161 (Poplar Street Bridge in Laurel) is a hand-operated, center bearing, swing bridge consisting of Warren pony trusses. The swing bridge is 112 feet long, and consists of two 56 feet long spans. The substructure consists of a center pier of timber and concrete abutments. Measuring 14 feet wide from curb to curb, the bridge is considered a one lane bridge. The trusses have seventeen panel points. The top chord consists of 2 - 4" x 3" x 3/16" angles with a 10" x 3/16" top plate. The bottom chord is a 7" channel. The struts are two 3" x 2-1/2" x 3/16" angles and the verticals are two 2-1/2" x 2-1/2" x 3/16" angles. The floor system is formed by 12" I-beams at 6'-11" on center (corresponding to panel points) that run under the truss; 4"x12" creosoted floor joists run longitudinally and are topped by 4"x10" planking. Curbs are built up of 2"x8" and 6"x8" lumber. A 2" pipe forms two rows of railing. Although no longer operable, this swing bridge originally pivoted on a center bearing with eight balance wheels at the rim. The mechanism for hand-operation is visible on the deck.
