# HABS/HAER INVENTORY

## 1. NAME(S) OF STRUCTURE

State Bridge Number 177

Brackenville Road over Mill Creek  
Gateway Farms, New Castle County, Delaware

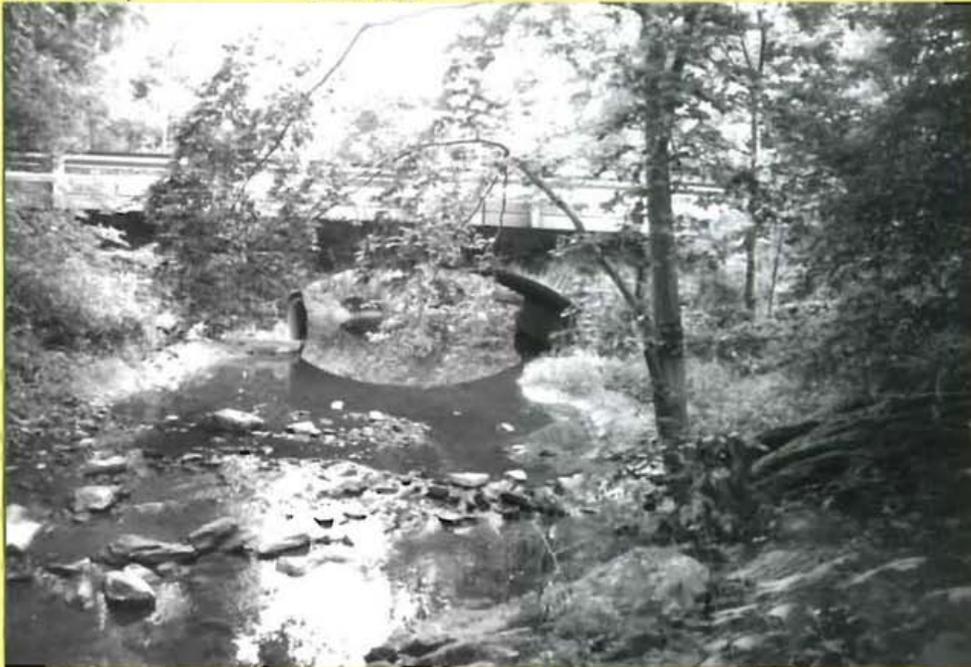
1E:10A

Good: Much of the substructure has been parged.

State Highway Bridge 177 is a 20'-0" single-span stone arch bridge. The voussoirs consist of radiating bricks; the barrel was constructed of rubble, as were the spandrel walls. A galvanized guard rail serves as a parapet. The deck is 24'-0" wide and carries two lanes of vehicular traffic. The abutments and wing walls are partially parged semi-coursed rubble, with U-shaped wing wall configuration. A concrete overhang is the most visible evidence of a 1965 alteration.
