# HABS/HAER INVENTORY

State Bridge Number 456

Road 45 over Saw Mill Bridge  
Chambersville, New Castle County, Delaware

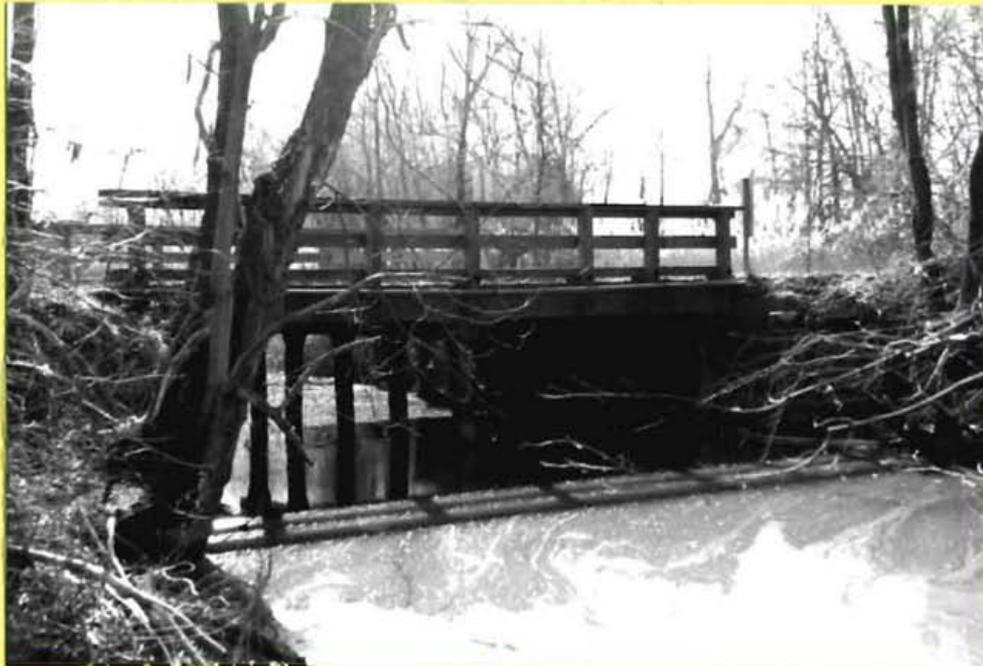
26B:12

State Highway Bridge 456 comprises two 15'-6" timber girder spans, for an overall length of 31'-0". It carries two lanes of traffic on a 22'-0" wide deck. The substructure rests on timber bents, comprising a 10" x 12" timber pile cap on seven 12" diameter pilings. The abutments are constructed of 4" x 10" planks; the flared wing walls are stone, laid in semi-coursed rubble masonry. Eleven girders, 6" x 14" in section, support the deck, which is constructed of 4" x 10" planks. The parapet consists of two 2"x4" wooden rails on 4"x6" posts.
