HABS/HAER INVENTORY

State Bridge Number 680

Road 317 over Walls Ditch
Springfield Crossroads, Sussex County, Delaware

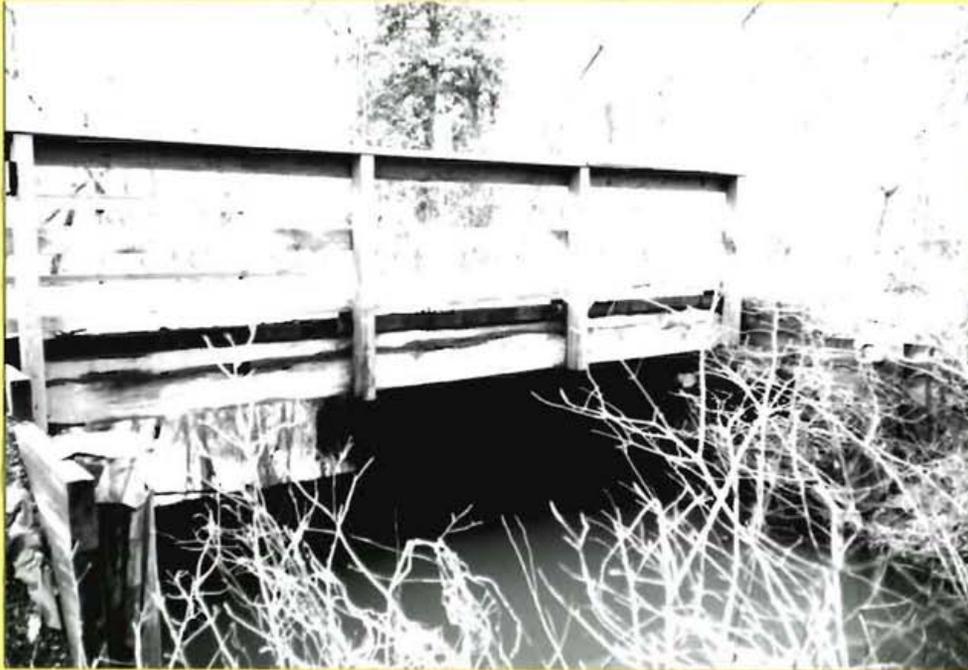
9B:33

Good

Delaware State Highway Bridge 680 is a 20'-0" single span timber bridge with timber bents and straight timber wing walls. The bridge carries two lanes of traffic on an 18'-8" roadway. The superstructure consists of 6" x 14" timber beams, with a simple plank deck nailed directly into them. There is a 3'-6" high wood railing made of four 4" x 6" posts and two 3" x 8" rails, capped by a horizontal 3" x 8". The substructure consists of pile timber bents made of 10" x 12" caps on 12" diameter piling and straight wing walls made of 4" x 10" planking.
