I-95/DELAWARE TURNPIKE PROJECT NEW CASTLE COUNTY, DELAWARE

HISTORIC ARCHITECTURAL INVESTIGATION

prepared for
Delaware Department of Transportation
Dover, DE

July 2004

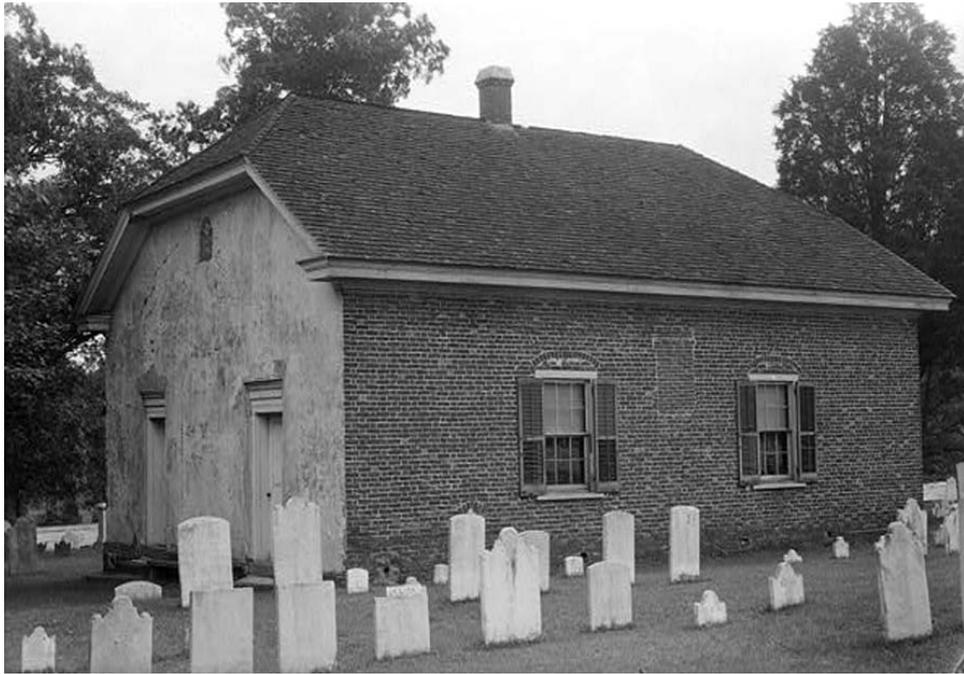
Welsh Tract Baptist Church is a simple rectangular brick building on a brick foundation (Plate 1; Figure 3). A clipped gable-front roof, sheathed in wood shingles, shelters the single-room building. The north (front) wall measures two bays wide and has been covered in smooth stucco. An iron date plaque in the center of the gable-end of the north façade is inscribed with the date 1746. It is believed that the date stone was cast at Abingdon Furnace or one of the other ironworks operated by the early Welsh Settlers. The side walls measure two bays deep and are exposed

Plate 1. Welsh Tract Baptist Church and Parsonage, Welsh Tract Road. North and west elevations toward south (Stewart 1936).

brick. The brickwork is laid in Flemish bond, with segmental arches featured over each of the rectangular windows. A beveled brick water table is seen on all facades of the building.

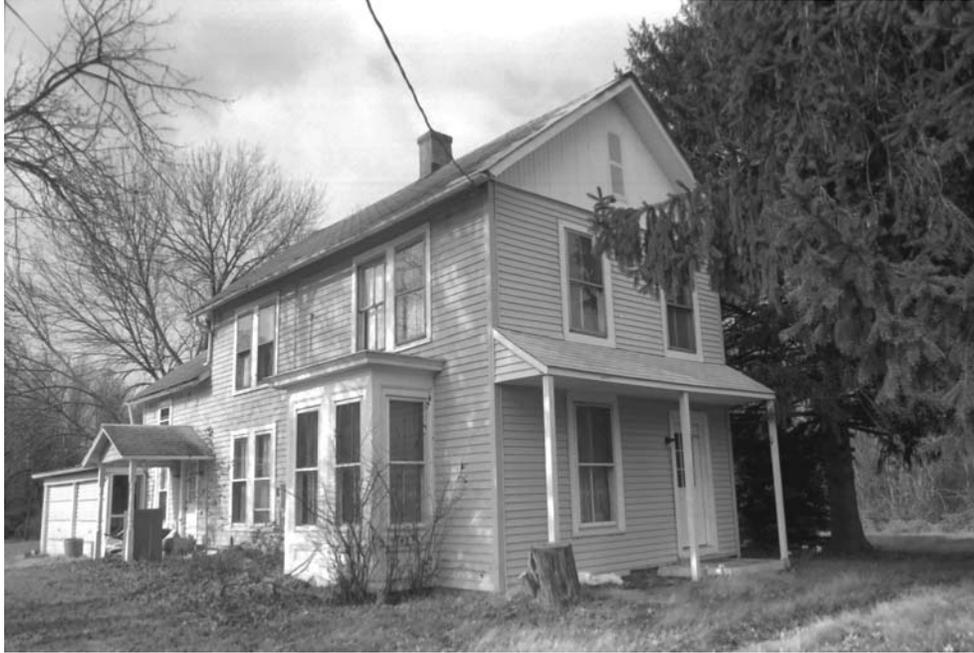
Plate 2. Stephen Ott House, 922 Otts Chapel Road. East and south elevations toward northwest.

The property consists of a vernacular, nineteenth century, side hall dwelling, rectangular in footprint with a side-projecting bay, and several rear additions. The two-story, wood-framed house is completely covered in horizontal vinyl siding and is sheltered by a gable-front roof sheathed in asbestos shingles. A brick chimney, covered in stucco, rises from the center interior of the dwelling.

The east façade (front) has two first-story bays and two second-story bays. All of the windows featured in the main block are double-hung, two-over-two sash windows, protected by modern storm windows. A modern shed-roofed, single story porch stands across the front facade. The porch is supported by wood post partially buried into the ground. The house is entered through a modern vinyl-and-glass door. The south façade (side) of the main block measures two bays deep (two rooms). A single-story, flat-roof bay projects from the southeast corner.

The rear elevation has been substantially altered by additions. The first of these is a modern, two-story, gabled addition that runs the width of the house. A single-story, shed-roof addition extends from its north side. Modern windows light the interior. A modern vinyl door gains access into the addition at its northeast corner. The entrance is sheltered by a single-story, gabled porch. A modern, single-story gabled garage is attached to the rear façade of the addition. The two-bay garage features vinyl roll-down garage doors on the south façade.

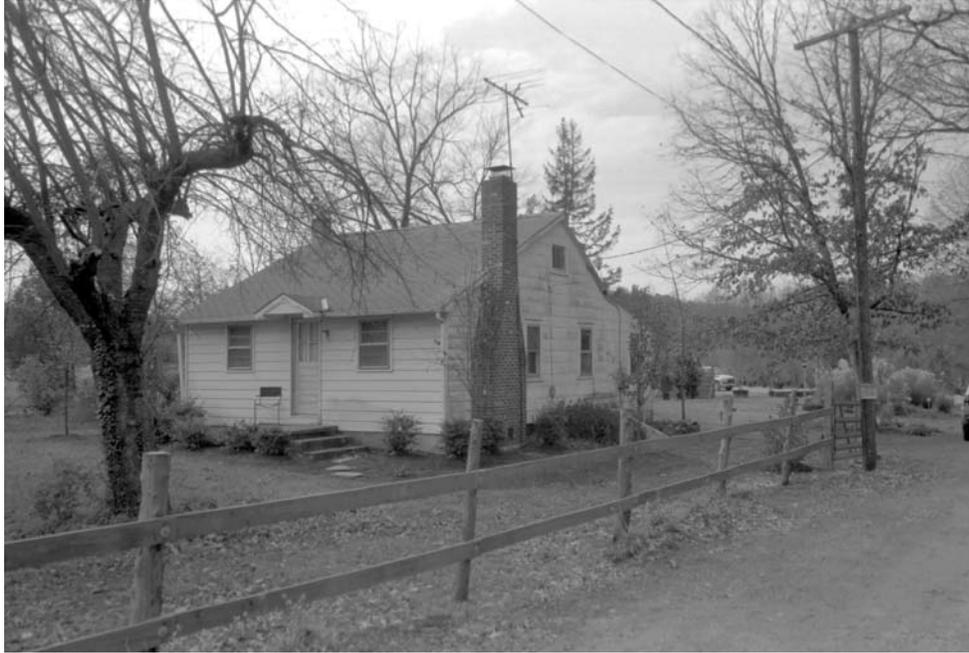
Plate 3. Dwelling, 1463 Otts Chapel Road. Northeast and northwest elevations toward southwest.

The entire front (east) facade of the dwelling consists of a full-width addition. The addition is covered in aluminum siding and measures three bays wide. Double-hung, two-over-two horizontal-pane sash windows flank the centered entrance. The door is wood-and-glass and is sheltered by a gable-front hood. A partial concrete deck, with concrete steps sits adjacent to the entrance.

The north elevation of the main block measures two bays deep. A third window is located on the north end of the rear addition. All three openings are double-hung, one-over-one sash windows.

A six-pane casement window is centered in the gable peak. A wood, double-door bulkhead is located at the northwest corner of the main block.

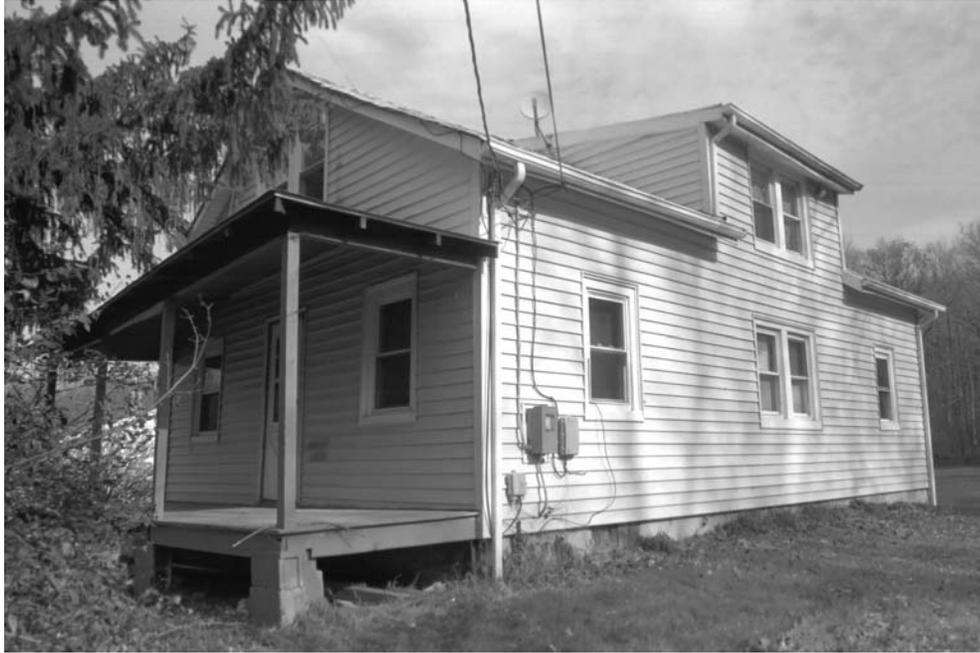
Plate 4. Dwelling, 1636 Otts Chapel Road. West and south elevations toward northeast.

Situated on the east side of Otts Chapel Road, heavily obscured by tall trees planted across the front lawn, stands this early twentieth-century, vernacular bungalow-style, front gable, double-pile cottage dwelling (Plate 4). The one-and-one-half-story, wood-framed, center-passage dwelling is rectangular in shape, and faces west toward the roadway. The house is covered in vinyl siding and is sheltered by a gable-front roof sheathed in rolled asphalt.

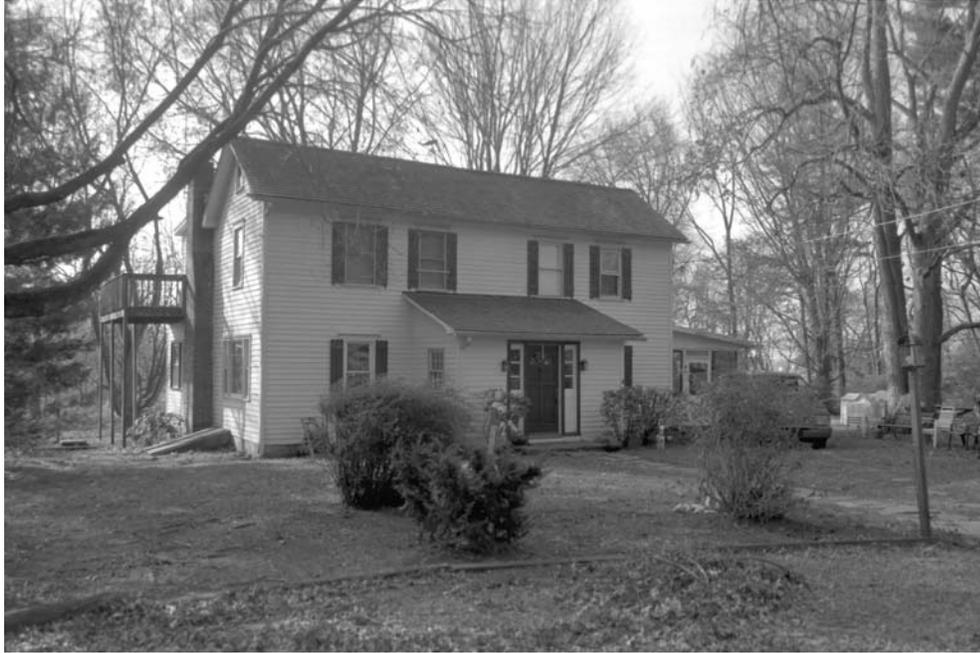
Plate 5. Barber House, 123 Tall Pines Road. East and south elevations toward west.

The Barber House (Plate 5) is located on the west side of Tall Pines Road facing east toward the roadway. Tall trees shade the dwelling from all sides. A gravel circular driveway lies across the front portion of the property, with tall trees planted along the sides and in the center of the drive. A dirt walkway flanked by tall shrubs lead to the main entrance of the dwelling.

This center hall dwelling is representative of a mid-nineteenth-century vernacular I-house. The two-story, wood-framed house consist of a main block, rectangular in footprint, with a side shed porch, several rear additions, and a raised, side, wood-framed deck.

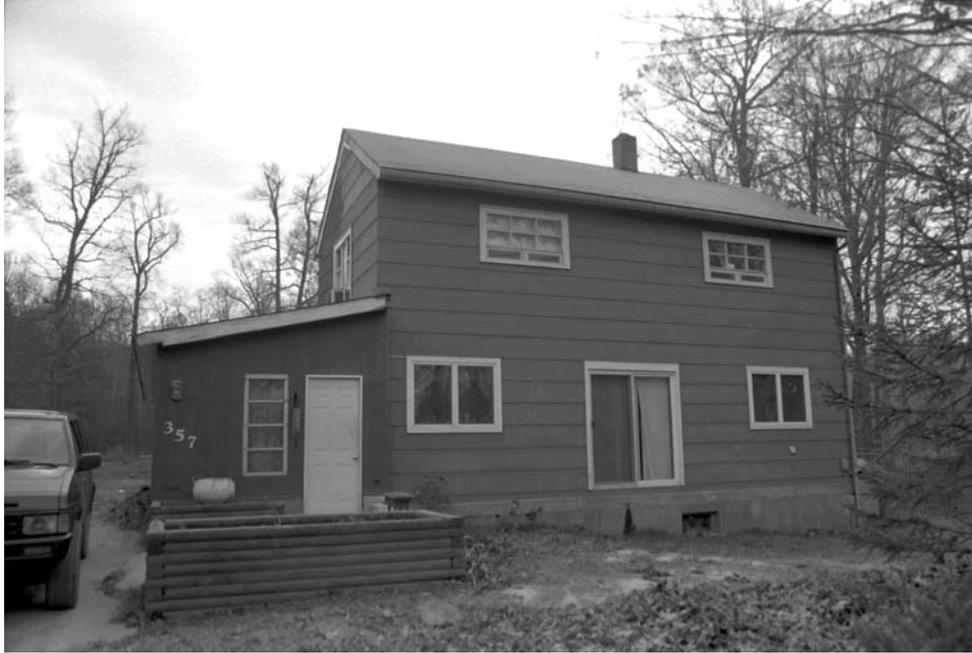
Plate 6. Dwelling, 357 Welsh Tract Road. North façade toward south.

Slightly setback from the roadway on the south side of Welsh Tract Road stands this early twentieth-century, vernacular I-house (Plate 6). Tall trees grow toward the two front corners of the property, and large clusters of mixed vegetation grow the rear of the property. A partially concrete and dirt driveway lies to the east side of the dwelling. The two-story, wood-framed dwelling is rectangular in shape, with an addition to the side and rear, and faces north toward the roadway. The house is covered in asbestos shingles and is sheltered by a side-gable roof, sheathed in rolled asphalt. A concrete-covered chimney rises from the center interior of the main block.

The north façade of the main block is three bays wide. Pairs of modern casement windows flank the entrance along the first-story, and two multi-pane windows pierce the second-story. These wood-framed, multi-pane windows are divided into two sections: the top portion having six, fixed panes and the lower portion having two, awning panes. Double sliding glass doors are centered on the front façade. These doors do not appear to be functional. A shed-roofed side

addition, along the east elevation shelters the modern main entrance, a vinyl door. A ground-level concrete pad, with wood knee-wall surround is located adjacent to this modern entrance.

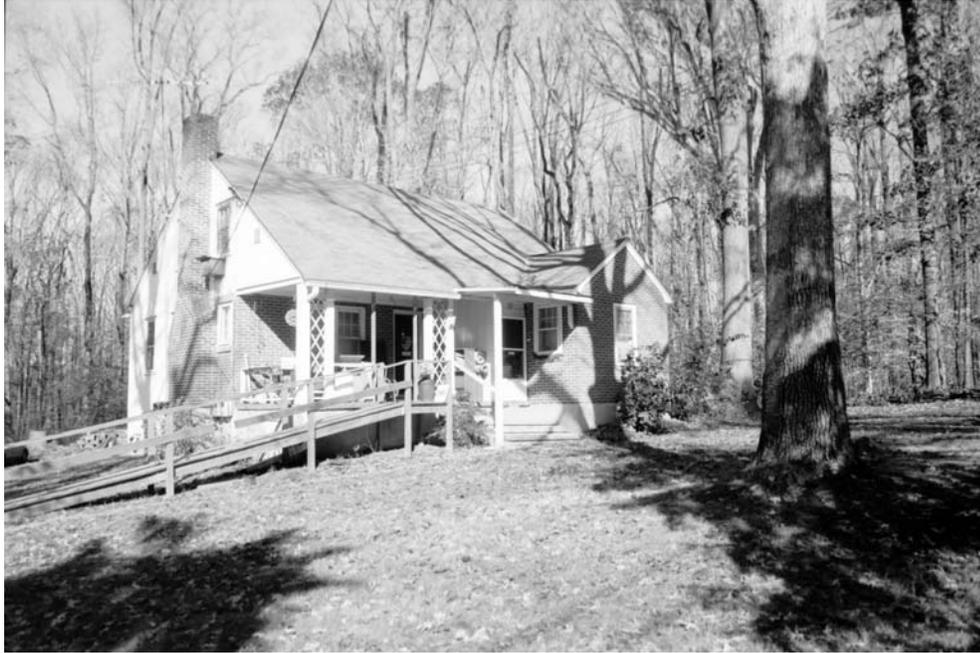
Plate 8. Dwelling, 248 Welsh Tract Road. Southeast and southwest elevations toward north.

rural. The integrity of material and design have been compromised by the construction and insertion of an additional front entrance, and its enclosed vestibule entrance. Additionally, the construction of the modern handicap ramp across the front has changed the design of the front entrance. Outstanding workmanship appears on no part of the exterior. Overall, the integrity and significance of this property is lacking, and it is recommended not eligible under National Register Criterion C. Information potential under National Register Criterion D does not exist. Potential historic archeology is not evident in the background research and field assessment. Building construction methods employed in the standing structures are not significant.

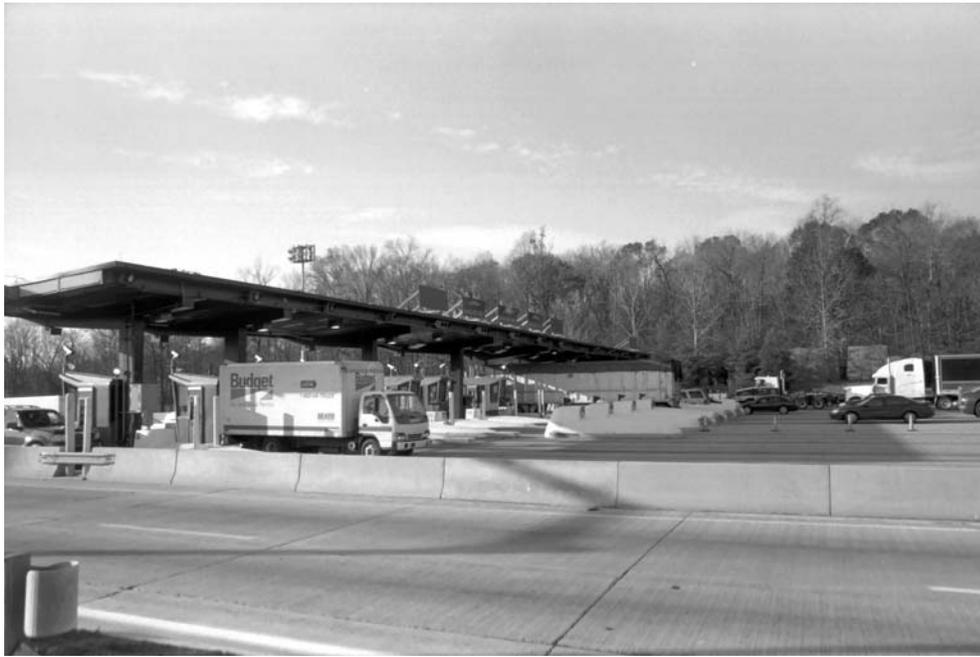
Plate 9. Toll Barrier, Delaware Turnpike. General view toward northwest.

The most recent alterations to the toll plaza were designed in 1999 and constructed in 1999-2000. With these alterations, which included implementation of the EZ Pass system, the number of toll lanes had increased to 15 in the main toll plaza and five additional lanes in a satellite toll plaza to the north. These additional lanes are separated from the main travel lanes by Jersey barriers.

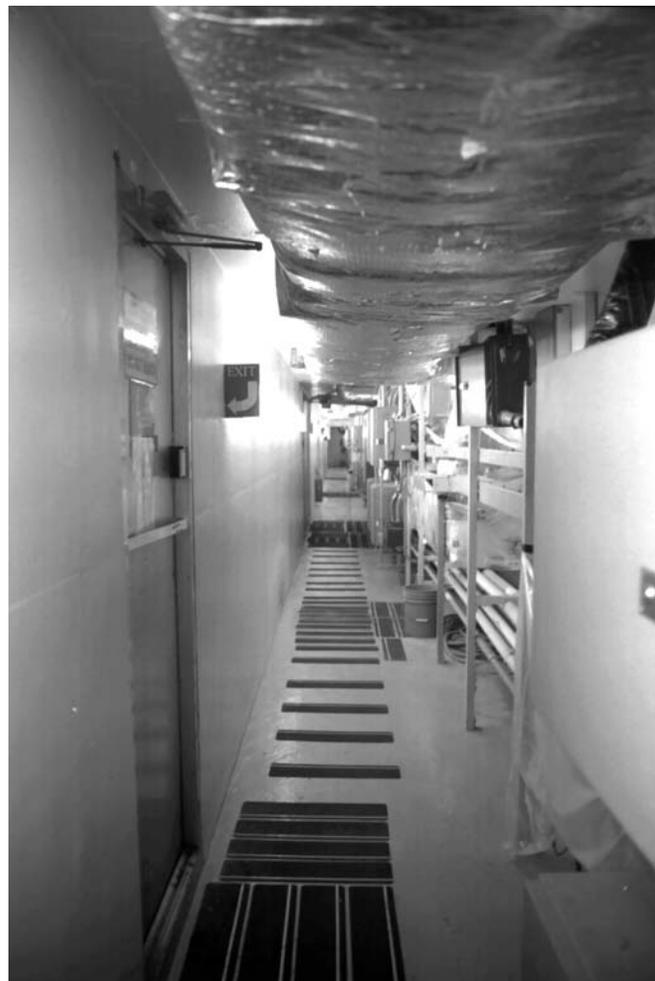
Plate 10. Toll Plaza Tunnel, Delaware Turnpike. General view toward northwest.

The toll plaza tunnel (Plate 10) extends the width of the roadway and connects to the administration building. This narrow tunnel has concrete walls and floor. No-skid strips are mounted to the floor. Utility conduits are mounted in racks along one side wall, and fluorescent

light fixtures are mounted on the opposite wall. Steel doors lead to the plaza stairways. The ceiling of the tunnel is partially obscured by plastic sheeting.

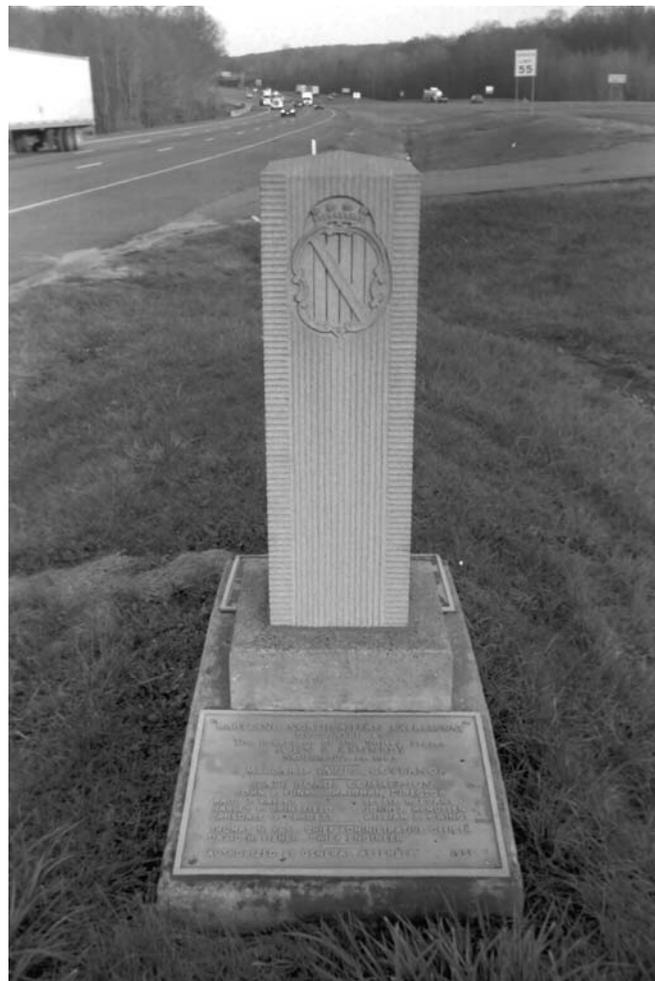
Plate 12. Interstate 95 Dedication Monument. Maryland side toward northeast.

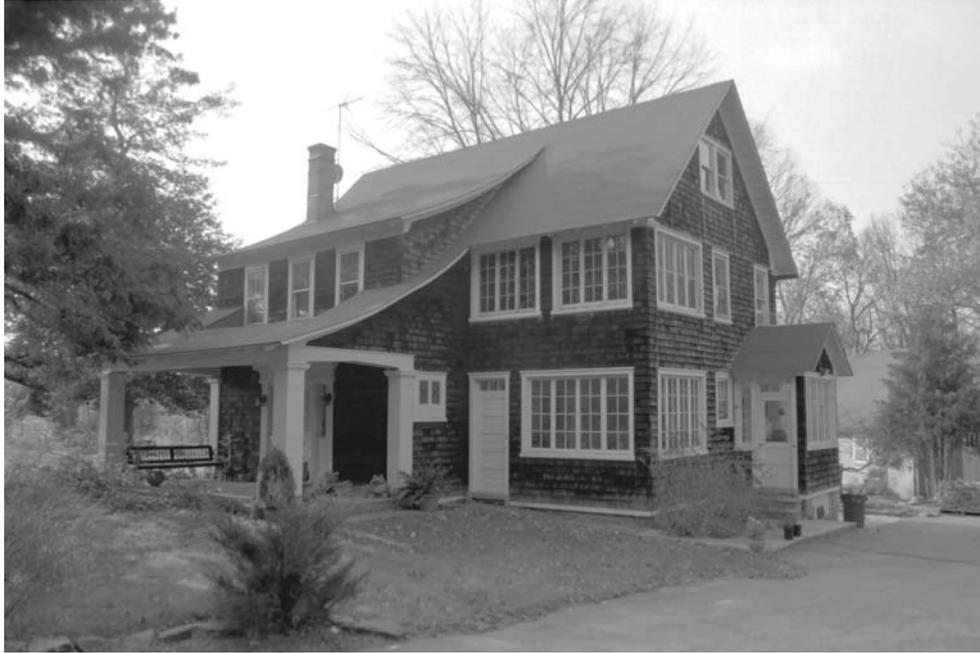
Plate 13. Dwelling, 180 Welsh Tract Road. Southeast and northeast elevations toward west.

The remainder of the northeast façade wall has a four-paneled wood door, surmounted by a three-light transom and two pairs of eight-light casement windows in the first story and two groups of three, eight-light casement windows in the second story.

The northwest gable end is marked by a projecting, single-story, gabled roof vestibule. This vestibule has a single-light, two-panel door in its southeast elevation. This door is surmounted by

a transom and is reached by concrete steps. Reflecting the downward slope of the site, the basement level of the rear of the vestibule is exposed. Two-leaf, five-panel, wood doors are placed in the basement wall. The outer wall of the vestibule is fenestrated with two pairs of eight-light, casement windows, while the rear elevation is fenestrated with a pair of eight-light casement windows. The northeast gable end is fenestrated with a mixture of paired, eight-light, casement windows and three-over-one, double-hung, sash windows in the first and second stories. Paired, double-hung, sash windows are placed in the gable peak.

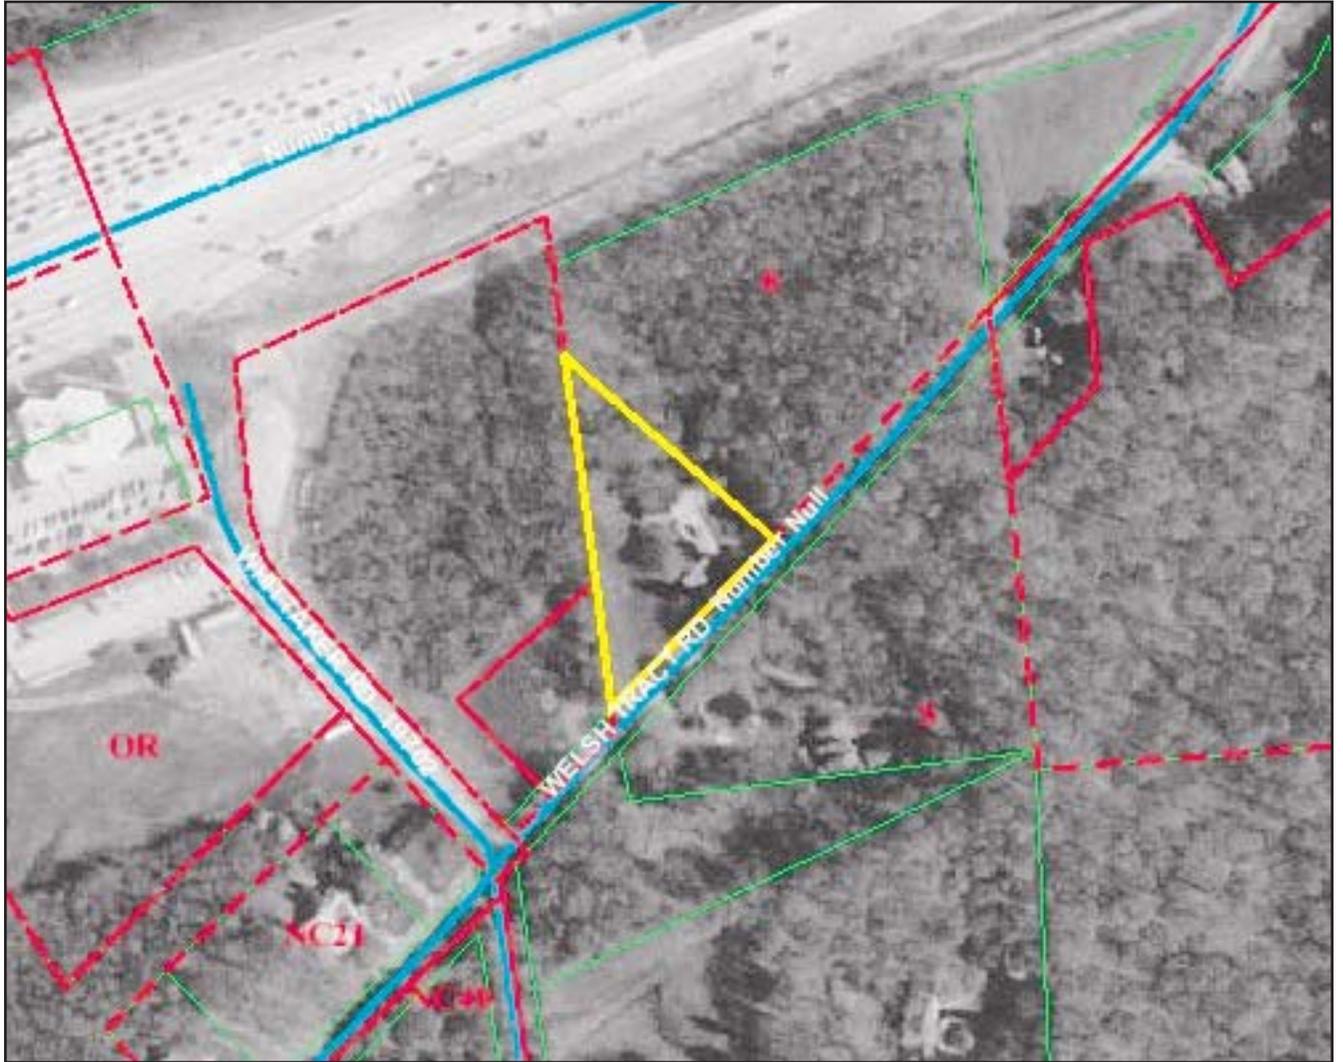
Figure 12. Recommended National Register boundary of 180 Welch Tract Road.

The recommended National Register boundary, the entirety of the parcel presently associated with the house, is shown in Figure 12.

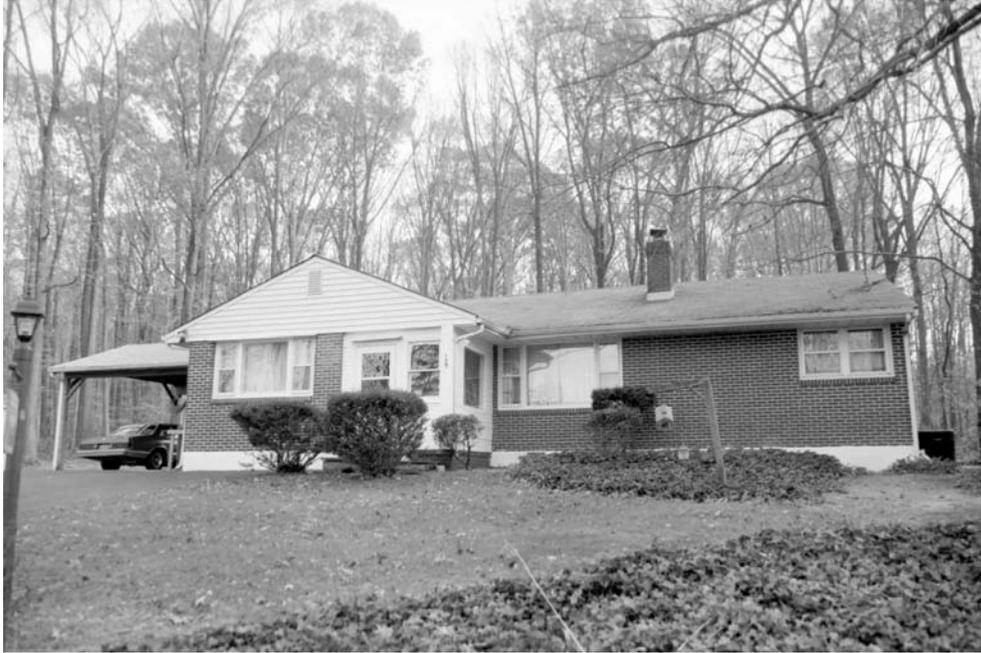
Plate 14. Dwelling, 159 Welsh Tract Road. Northwest façade toward southeast.

the interior from the east elevation. A single-car, gabled carport, supported by wood posts, is attached to the northeast gable-end of the dwelling.

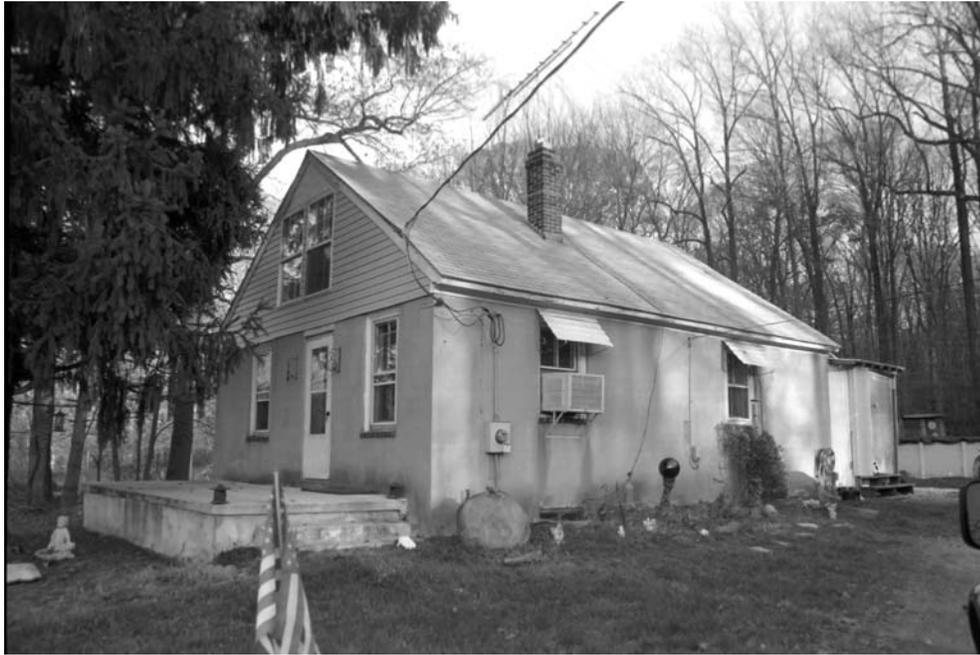
Plate 15. Dwelling, 147 Welsh Tract Road. Northwest and southwest elevations toward east.

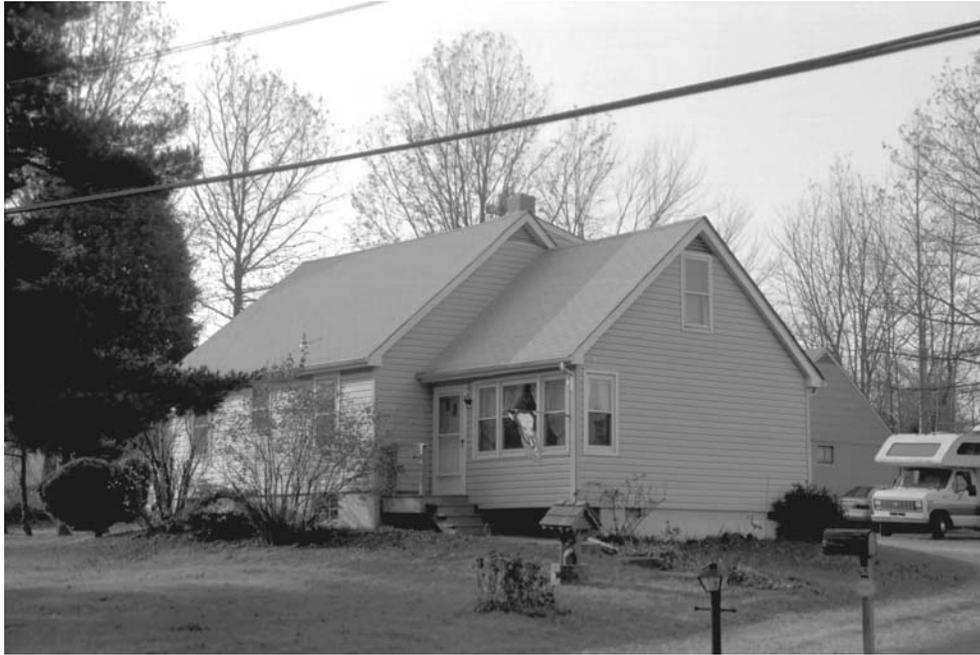
Plate 16. Dwelling, 92 Welsh Tract Road. Southeast and northeast elevations toward west.

This mid-twentieth-century, one-and-one-half-story, wood-framed dwelling faces southwest toward Welsh Tract Road (Plate 16). Vinyl siding covers the exterior, and the side-gabled roof is sheathed in rolled asphalt. A shed-roofed rises from the northeast roof slope. A stucco-covered chimney rises from the center interior of the dwelling. The rectangular-shaped dwelling measures three bays wide by two bays deep (two rooms). The house is lit by modern double-hung, one-over-one windows. A one-and-one-half-story gabled enclosure, located on the northeast end of the dwelling, shelters the main entrance. The door is a late twentieth-century slab wood door with stepping lights. A modern wood stoop sits adjacent to the entrance. The vinyl-covered enclosure is primarily lit by modern, double-hung, one-over-one windows. A modern Chicago bay with flanking double-hung one-over-one windows is located on the southeast elevation, adjacent to the entrance. A large shed-roofed screen porch is attached to the rear elevation. This one-story porch is supported by wood posts on a concrete deck. The porch shelters a rear entrance, a single light and-panel door, and two modern windows.

A mid-twentieth-century, one-story garage stands immediately northeast of the house. The building is primarily covered in stucco with aluminum siding covering the upper portions of the gable ends. The gable-front roof is sheathed in rolled asphalt. The building measures three bays wide by one room deep. Two modern garage doors and a centered single-light, wood panel door access the building from the southwest façade. Fixed aluminum-framed windows pierce the side walls of the building, lighting the interior.

The property's legal tax boundaries are square in shape. A fence stands along three sides: the southeast, northeast and northwest. The dwelling is situated in the center of the property. A gravel driveway creates a U-shape configuration around the rear of the house, lying between the dwelling and garage. The Delaware Turnpike lies to the immediate west side of the property. Tall mature trees planted along the western boundary of the described property obscure views toward the turnpike facility. Modern apartments are located to the immediate north and east side of the property.

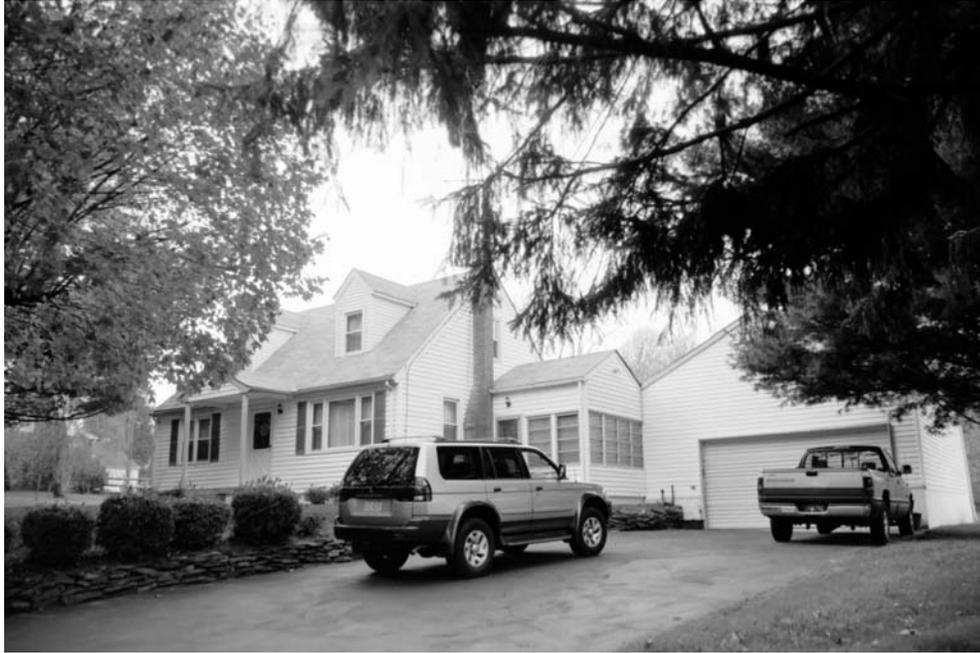
Plate 17. Dwelling, 46 Welsh Tract Road. Southeast and northeast elevations toward northwest.

According to New Castle County tax assessment records, the house was constructed in about 1956. The house sits on one of two adjacent parcels under common ownership. The first parcel was conveyed from William M. English to Frederick D. and Sarah J. Downs in June 1920 (New Castle County Deed Book U28:432, June 9, 1920). The Downs owned the property until 1939 when they conveyed it to Robert R. and Annie M. Springer for \$2,500 (New Castle County Deed Book K41:1, April 18, 1939). The second parcel, originally consisting of 9.24 acres, was sold by James H. and Florence I. Swann of Nova Scotia to the Townley Land Company for the token sum of five dollars (New Castle County Deed Book N51:431, October 3, 1951). In 1953, the Townley Land Company transferred the parcel to Robert R. and Annie M. Springer for the sum of \$50 (New Castle County Deed Book N53:465, July 10, 1953).

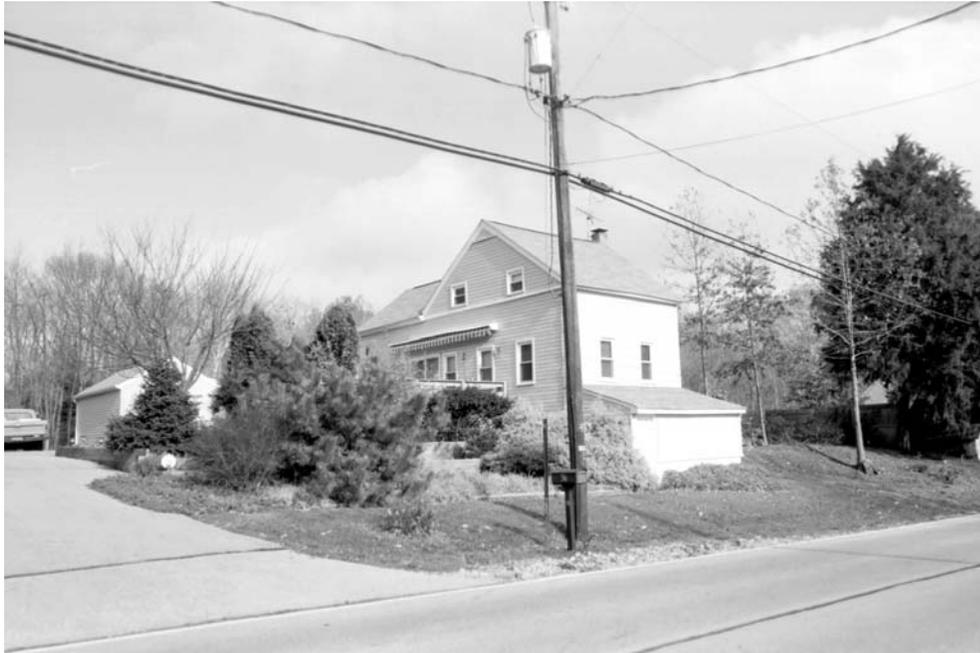
Plate 18. Dwelling, 36 Welsh Tract Road. South and west elevations toward northeast.

This early twentieth-century, two-and-one-half-story, vernacular dwelling faces south toward Welsh Tract Road (Plate 18). Vinyl siding serves as the exterior cladding of the rectangular-shaped house. The side-gabled roof is sheathed in rolled asphalt. A concrete-block chimney rises from the exterior of the east gable-end. The dwelling measures approximately two rooms wide by two rooms deep. The house is lit by modern double-hung, one-over-one windows. A full-width shed-roof enclosed porch shelters the main entrance, located on the southwest corner of the south façade. The door is wood with inset panels. Vinyl siding encloses the porch. A modern pressure-treated wood deck has been built along a portion of the west elevation. Modern sliding glass doors access the interior from this side. A full-width, gabled-roof addition extends from the north (rear) elevation. This one-and-one-half-story addition is clad in vinyl siding and rests on a concrete-block foundation. A modern, enclosed, shed-roofed entrance is attached to the north wall of the gabled addition. This one-story block rests on concrete-block piers. A modern door enters the enclosure from the west elevation. The addition is lit by two modern windows which pierce the east elevation.

Overall, the legal tax parcel is rectangular in shape. The dwelling is situated toward the front of the property, near the roadway. A paved L-shaped driveway lies to the west side of the house. Low-lying vegetation is planted across the front lawn. The rear lawn is open with tall trees lining the rear property boundary. Two modern garages are located to the rear of the dwelling.

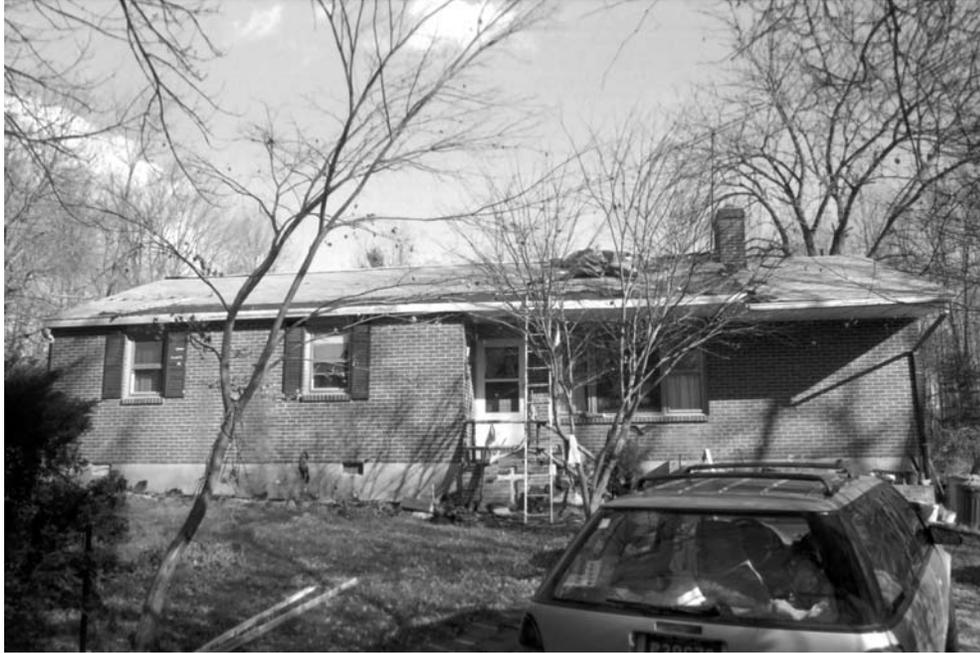
Plate 19. Dwelling, 104 Stanton Christiana Road. West façade toward east.

Set back from the roadway on a heavily wooded lot on the east side of Stanton Christiana Road stands this mid-twentieth-century, ranch-style dwelling (Plate 19). Tall trees grow closely on all sides of the house, obscuring the view of the dwelling from the road. A winding dirt driveway leads to the dwelling from the front of the property.

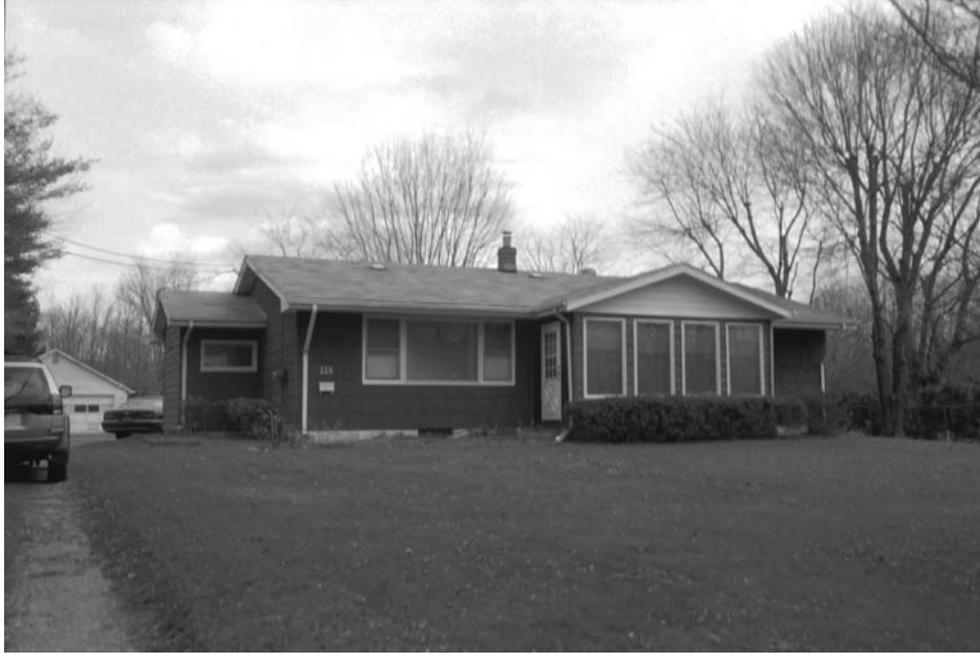
Plate 20. Dwelling, 120 Stanton Christiana Road. West façade toward southeast.

The mid-twentieth-century, ranch-style dwelling is primarily rectangular in shape with a gable-front enclosure projecting from the front, a small gable extension to the north end, and a large gabled addition attached to the southeast corner (Plate 20). This one-story, wood-framed house is completely covered in aluminum siding and is sheltered by a gabled roof, sheathed in asphalt. A brick chimney rises from the center interior of the dwelling.

A large, one-story gabled addition is appended to the southeast corner of the house. The homeowner referred to this addition as the "in-laws" suite. The addition measures approximately

three rooms in size. Aluminum siding serves as the exterior cladding. Double-hung, two-over-two horizontal pane sashes light the interior. A vinyl door provides entry to the addition from the north side.

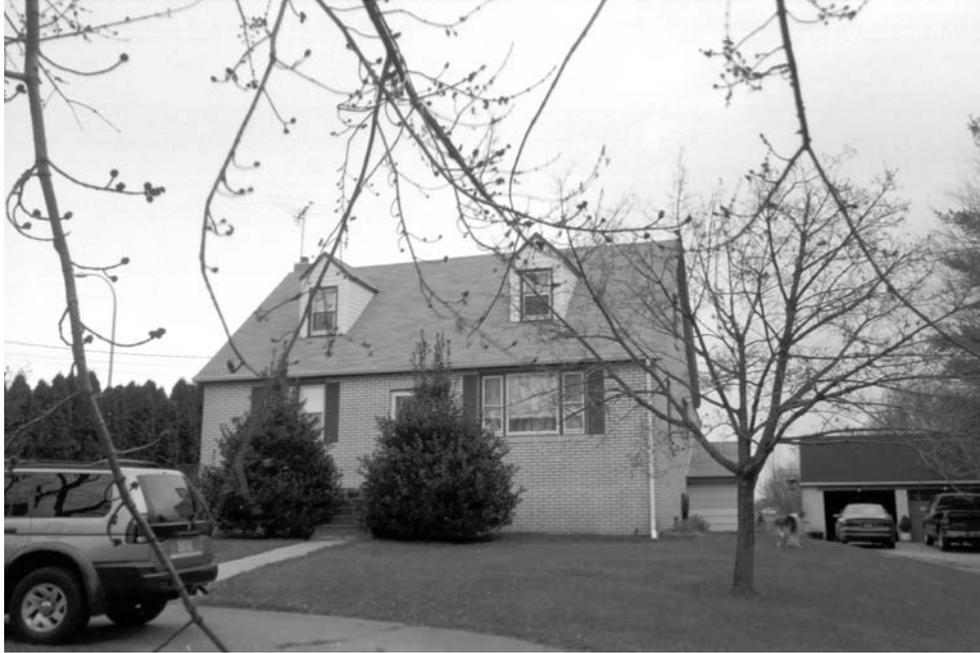
Plate 21. Dwelling, 128 Stanton Christiana Road. West façade toward east.

This one-and-one-half story, brick-clad Cape Cod dwelling is set back from the east side of Stanton-Christiana Road (Plate 21). A concrete walk flanked by two evergreens extends up to the front door, centered on the west façade wall. The door adjoins a concrete stoop and is surmounted by a vertical brick stretcher lintel. The central doorway is flanked by groups of windows. Paired one-over-one, double-hung, sash windows flanked by louvered wood shutters are placed at the north side of the façade wall. A tripartite window consisting of a central picture window flanked by narrow, one-over-one, double-hung, sash windows is placed in the south portion of the façade wall. These windows are also flanked by ornamental louvered wood shutters. The windows have concrete slab sills. Typical of Cape Cod dwellings, the front slope of the steeply pitched roof is pierced by two gabled dormers, each fenestrated with a single, one-over-one, double-hung, sash window.

The house has a concrete foundation and is sheathed in buff-colored bricks. Its roof is sheathed in composition shingles. A brick heater chimney adjoins the north gable end.

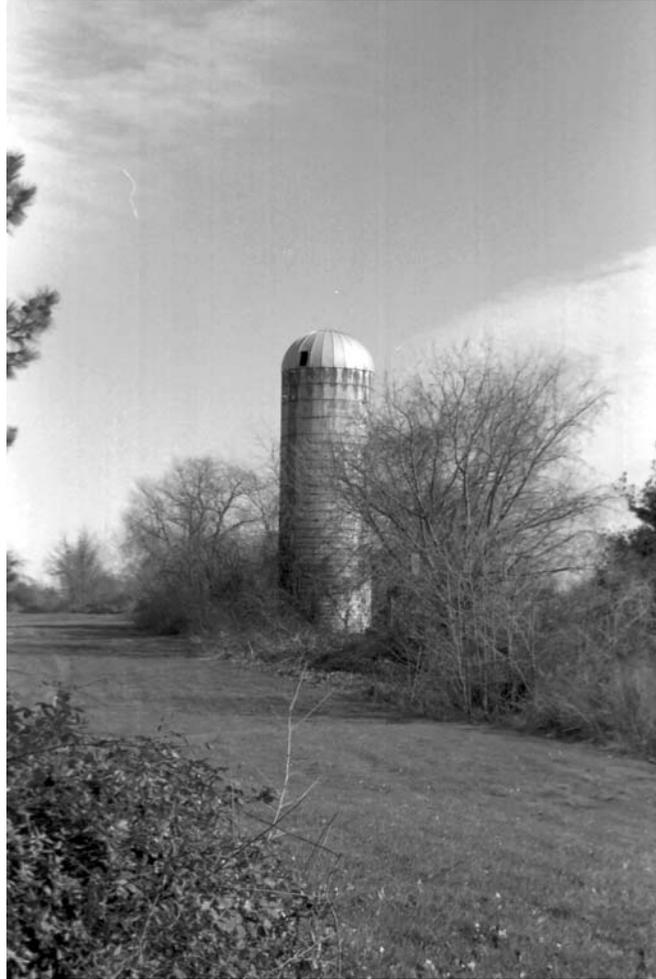
The silo to the former farm continues to stand along the north side of I-95 and to the rear of several modern motel and hotels (Plate 22). The structure stands approximately four-stories in height. Cylindrical in form, it is constructed of concrete block and topped by a dome-shaped cap. The silo is in fair condition with a small amount of brush growing out the top.

Plate 22. Silo, former Stafford Farm, 857 Churchmans Road. General view toward east.

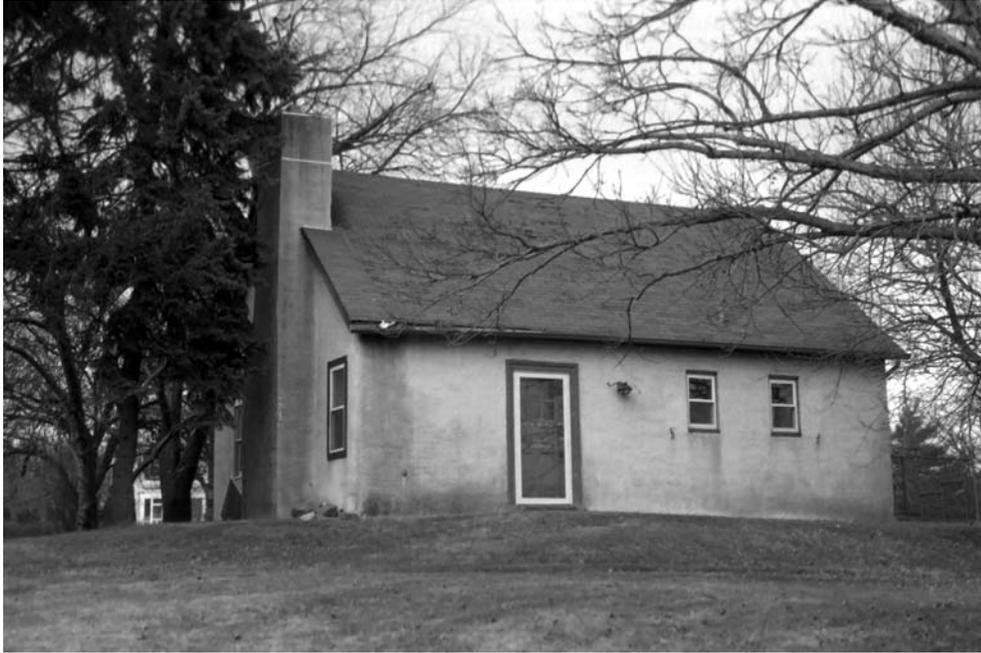
The building is sheathed in stucco, while its roof is sheathed in rolled asphalt.

Plate 23. Dwelling, Churchmans Road. Southeast and southwest elevations toward northwest.

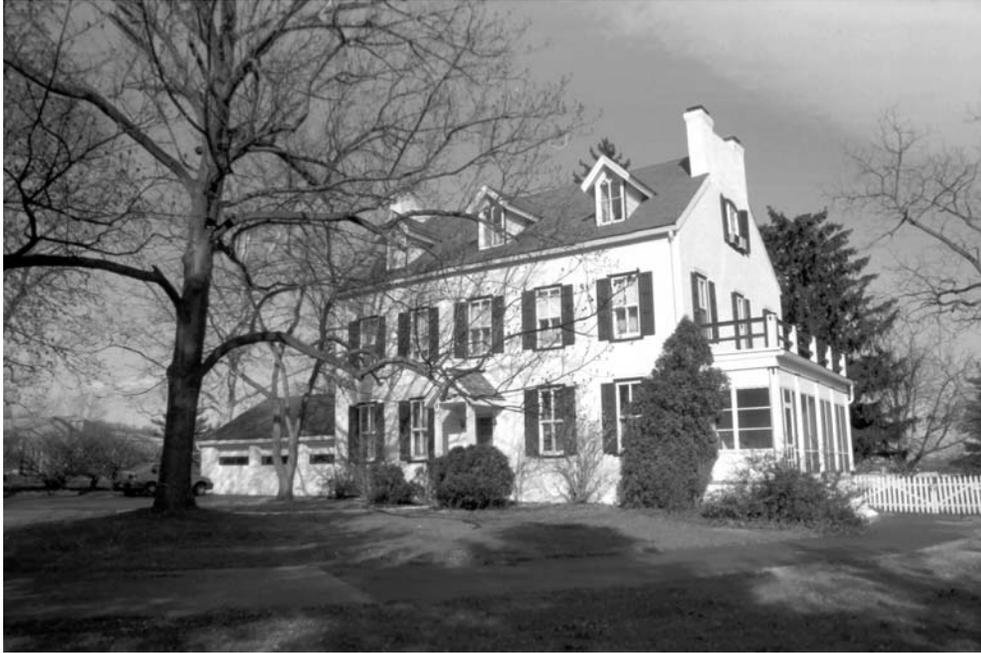
Plate 24. Henry L. Churchman House, 648 Churchmans Road. Southwest and southeast elevations toward north.

The house itself consists of a two-and-one-half story, stuccoed, side-gabled main block with a sun porch addition to its east gable end (Plate 24). Its façade, five bays wide, is symmetrically arranged. The front door, placed in the center of the façade, has four lights in its upper section with panels beneath. It is sheltered by a gabled front stoop, supported by plain wood posts, square in cross section. The central entry is flanked by paired two-over-two, double-hung, sash windows, each with ornamental louvered wood shutters. Five second story window openings are vertically aligned with the first story openings. These windows are also flanked by louvered wood shutters. Three gabled dormers, each with two-over-two, double-hung, sash windows, rise from the front roof slope.

As noted, a mid-twentieth-century garage is attached to the west end of the house. This single-story, side-gabled garage has three overhead doors in its south façade wall.

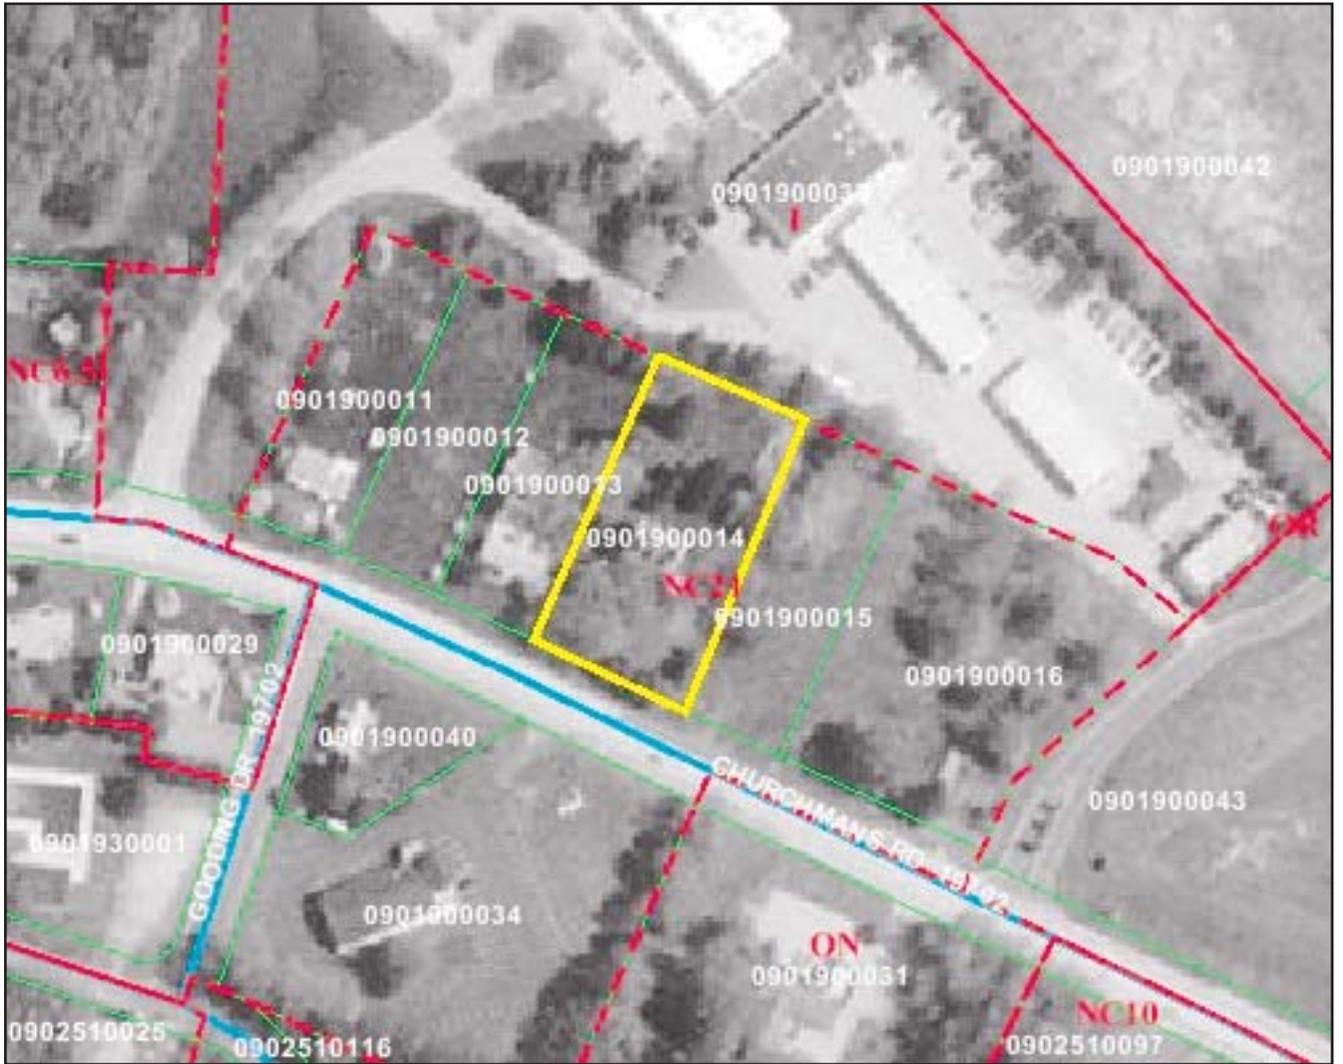
Figure 13. Recommended National Register boundary of the Henry L. Churchman House.

The recommended National Register boundary, the entirety of the parcel presently associated with the house, is shown in Figure 13.
