I-95/DELAWARE TURNPIKE PROJECT NEW CASTLE COUNTY, DELAWARE

HISTORIC ARCHITECTURAL INVESTIGATION

prepared for
Delaware Department of Transportation
Dover, DE

July 2004

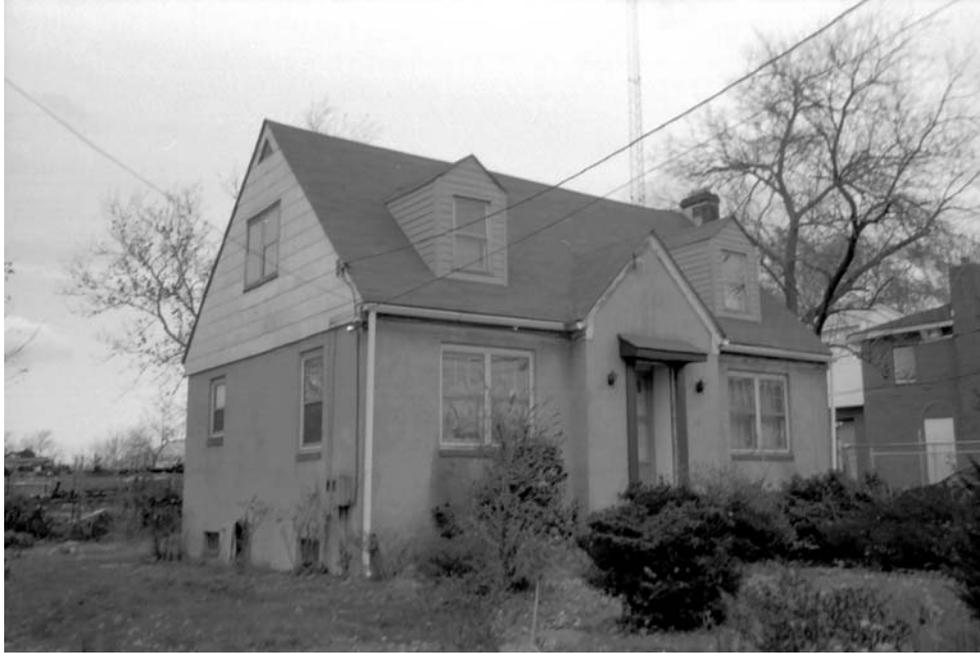
Plate 25. Dwelling, 423 Airport Road. Southeast and southwest elevations toward north.

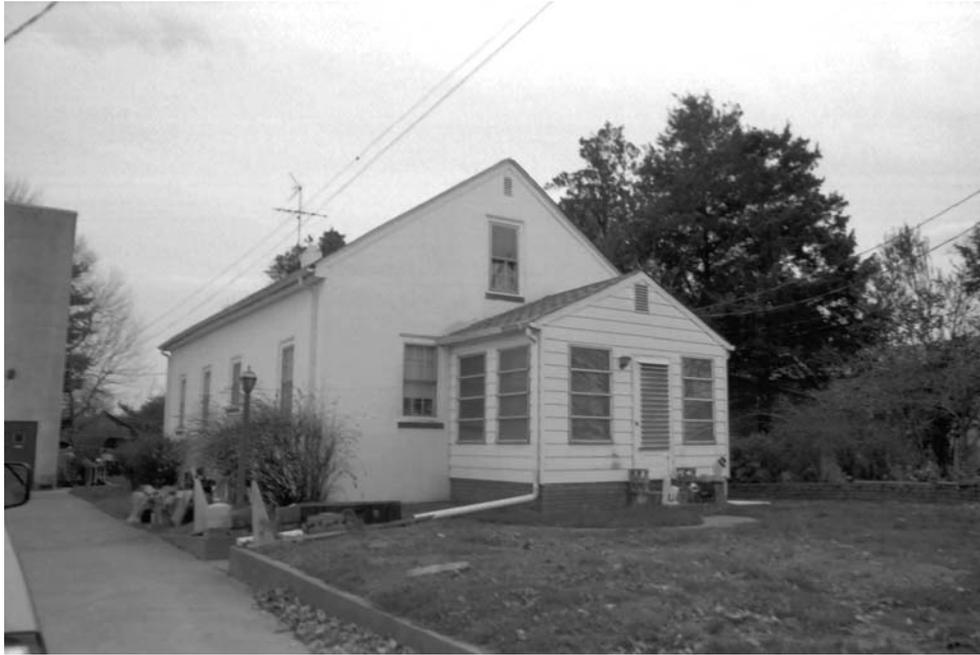
Plate 26. Dwelling, 424 Airport Road. Northwest and northeast sides toward south.

The vernacular center-hall house is a one-and-one-half stucco, gabled front dwelling, rectangular in footprint (Plate 26). A single-story, wood-framed, gabled vestibule projects from the northwest gable end. This vestibule has a central louvered wood door flanked by four-part, tilt windows. The sidewalls of the vestibule feature similar tilt windows. The vestibule has a brick foundation, walls sheathed in aluminum siding, and a roof sheathed in rolled asphalt.

A first story window is placed in the façade wall east of the vestibule. This window has a brick sill and six-over-six, double-hung sashes. A similar window is centered in the gable peak. A small, louvered wood vent is placed near the apex of the gable.

The northeast sidewall is four bays deep. Each bay contains and single, double-hung, six-over-six sash window similar to those on the front façade wall. Each bay features a brick sill. The house is largely sheathed in stucco, and its roof is sheathed in rolled asphalt. A chimney rises from the rear gable end.

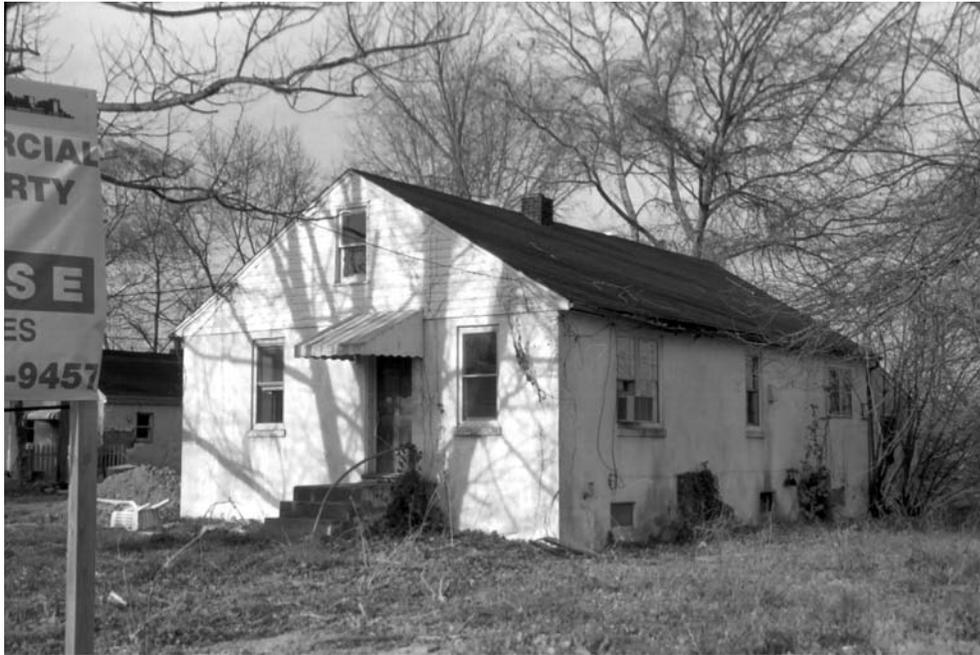
Plate 27. Dwelling #1, 431 Airport Road. Southeast and northeast elevations toward northwest.

This property, located on the northwest side of Airport Road consists of three similar stucco-covered dwellings. Tall trees growing throughout shade the property. Overgrown shrubs and vines grow along the exterior facades and sides of the buildings. The first, located in the northeast portion of the lot, is a gabled front, one-and-one-half story vernacular center-passage dwelling, rectangular in footprint (Plate 27).

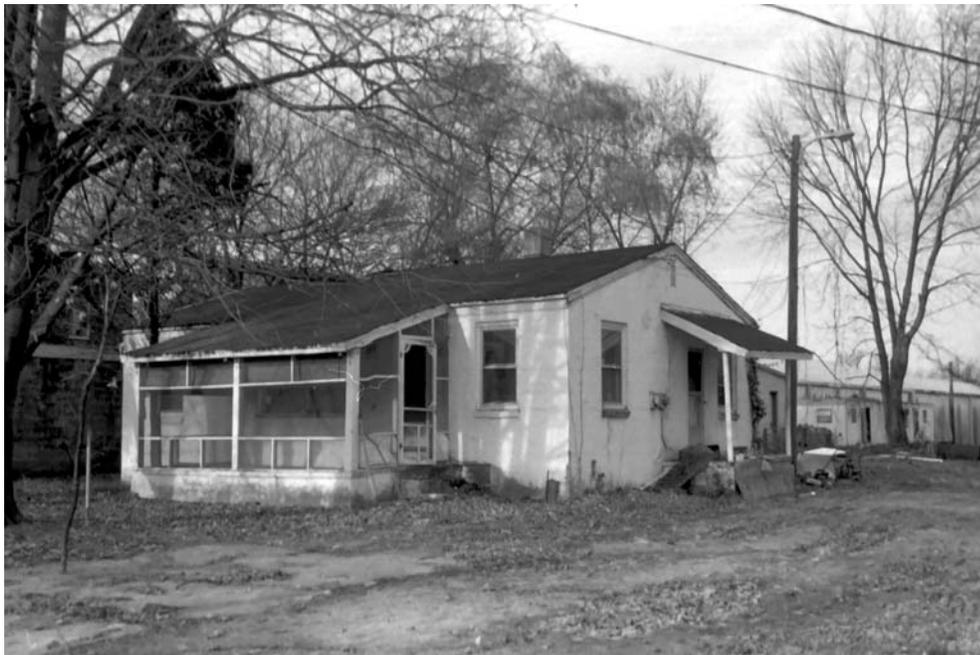
Plate 28. Dwelling #2, 431 Airport Road. Southeast and northeast elevations toward northwest.

The second dwelling is larger than the first (Plate 28), an early ranch style dwelling. It has a side-gable orientation. The southeast façade measures four bays wide with a central doorway flanked by single, one-over-one, double-hung, sash windows. The door is sheltered by a central, projecting, shed-roofed screened porch.

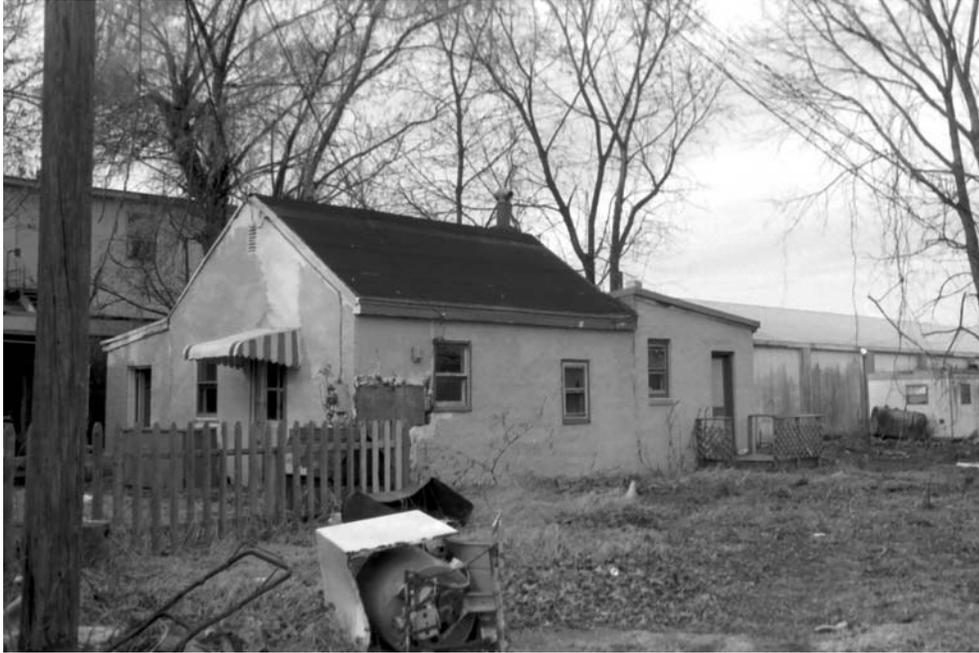
Plate 29. Dwelling #3, 431 Airport Road. Southeast and northeast elevations toward northwest.

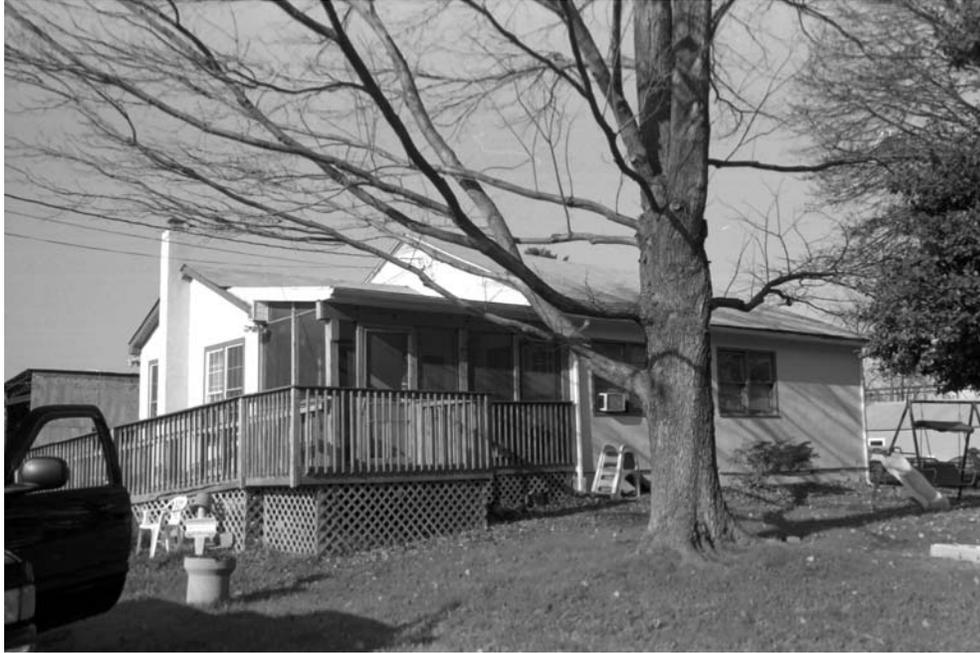
Plate 31. Dwelling, 467 Airport Road. Southeast and southwest elevations toward north.

The vernacular one story, side-gabled, stuccoed cottage is the original dwelling. The larger and taller east block is a mid-to-late twentieth-century addition. The wood-framed addition is clad in vertical wood paneling. Paired, double-hung, sash windows are placed in its southeast façade wall. The lower west block contains the main entry to the house, accessed from a full-width, shed-roofed, screen front porch. A wood-framed wheelchair ramp extends along the side wall of this block and terminates at the porch door. The southwest gable end of this block is stuccoed and is fenestrated with paired and single windows. The paired windows are six-over-six, double-

hung sashes. A concrete heater chimney adjoins the southwest gable end. The house has open eaves and roofs sheathed in composition shingles.

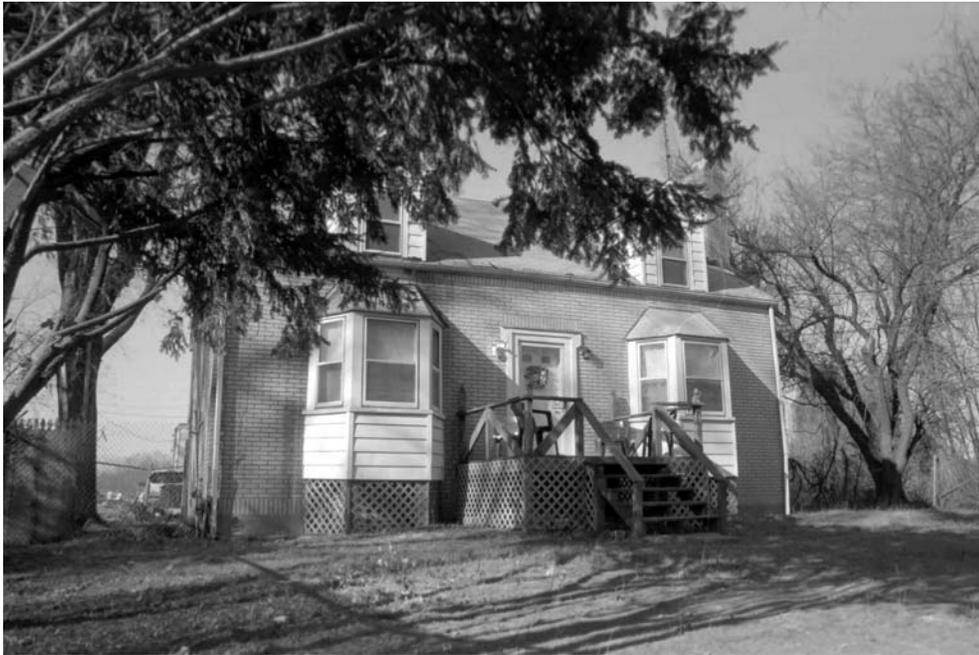
Plate 32. Dwelling, 495 Airport Road. Southeast façade toward northwest.

The house at 495 Airport Road (Plate 32) faces southeast toward Airport Road. A late Cape Cod design, the brick dwelling features a raised front door and flanking angled bay windows. The front door adjoins a wood-framed deck reached by wood-framed stairs. The door itself is placed in an eared wood surround beneath a vertical brick stretcher lintel. The flanking bay windows have piers hidden by wood lattice, walls sheathed in aluminum siding, and hipped roofs sheathed in composition shingles. Fenestration consists of modern one-over-one, double-hung, sash windows. Two gabled dormers project from the front roof slope. Each is sheathed in aluminum siding and contains a single, one-over-one, double-hung, sash window. The walls of the house are sheathed in buff brick and the roof in asphalt roofing paper. A brick chimney adjoins the northeast gable end of the house.

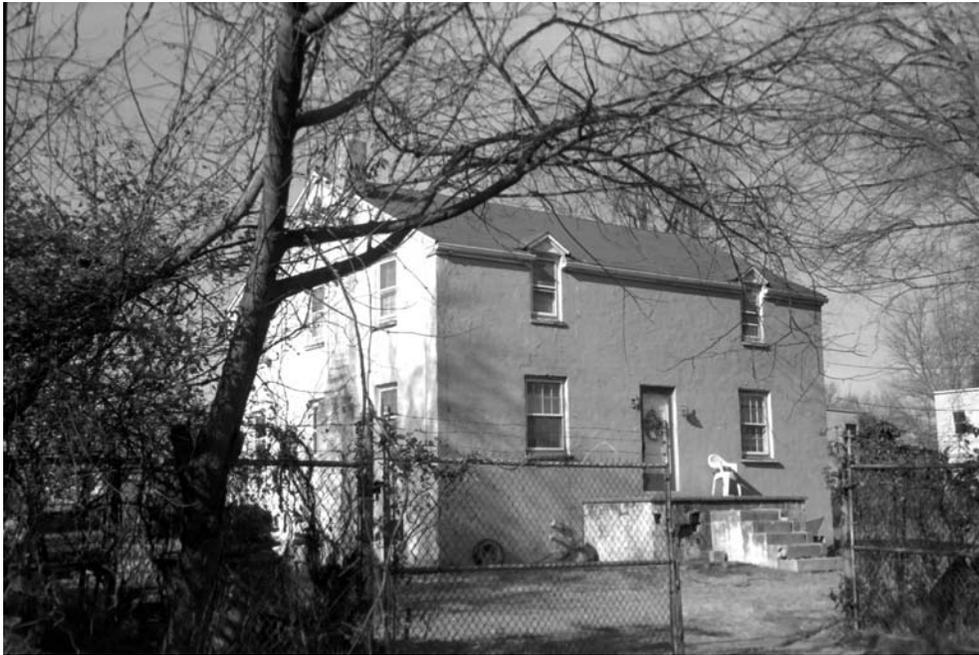
Plate 33. Dwelling, 491 Airport Road. Southeast and southwest elevations toward north.

The house at 491 Airport Road (Plate 33), is a one-and-one-half story, stucco-covered dwelling, rectangular in footprint. Its southeast façade wall faces toward Airport Road. This façade features a central raised door that adjoins a concrete patio. Access to this raised patio is by means of concrete steps. The paneled wood-and-glass door is protected by a storm door and is flanked by metal and glass lamps. Eight-over-eight, double-hung, sash windows are placed to either side of the front door. Two gabled wall dormers are aligned vertically with the first story windows. Each of these windows is of the six-over-six, double-hung sash type. The side elevations are three bays wide with three window openings in the first and second stories. A concrete half-engaged chimney adjoins the southwest gable end. The roof of the house is sheathed in asphalt shingles.
