**APPENDIX A**  
**CULTURAL RESOURCE SURVEY FORMS**

CULTURAL RESOURCE SURVEY  
LOCUS IDENTIFICATION FORM

1. NAME OF LOCUS: Jonathan Davis Farmstead (AGCX)
2. STREET LOCATION: DE Route 7, south of Faith City Medical Center
3. OWNER'S NAME: Thomas Clough TEL. # \_\_\_\_\_  
ADDRESS: \_\_\_\_\_

CULTURAL RESOURCE SURVEY  
STRUCTURAL DATA FORM

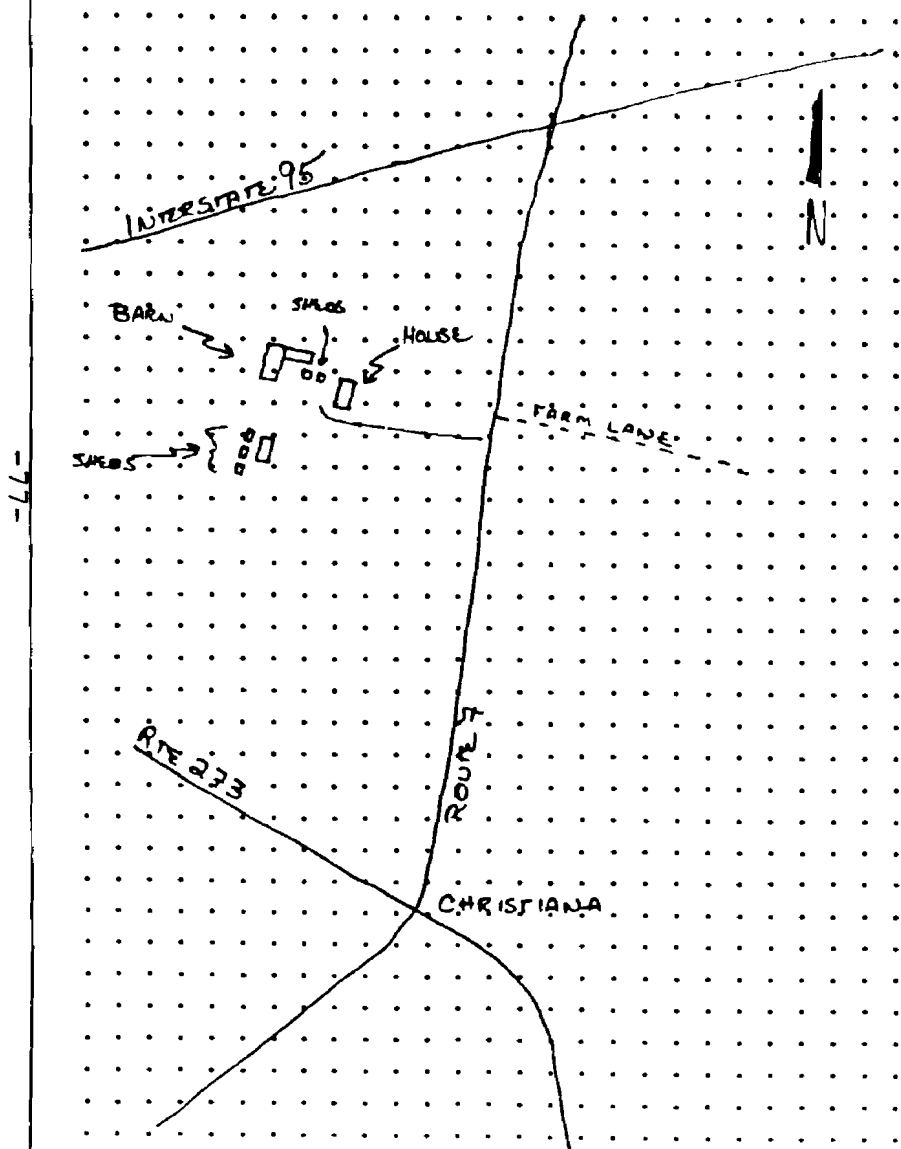
## 8. SKETCH MAP

This former farmstead includes a dwelling, barn with attached machine shed, and several small sheds, most of which (including the barn) are in ruinous condition. The frame house is of the I-type, three bays wide with a centered gabled wall dormer--a treatment common to other dwellings of its kind and age in this area of Delaware. Based on historic maps of the area, construction of the house and barn is attributed to Jonathan Davis, who is shown as owner of the farm on Hopkins (1881) and Baist (1893)

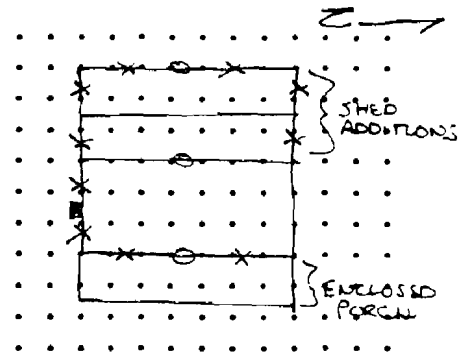
SKETCH PLAN

3. CONDITION: good \_\_\_\_\_ deteriorated XX

remarks: barn has collapsed, most other outbuildings in ruinous condition

d) list major alterations and dates (if known) shed-roofed fully-  
enclosed porch and kitchen additions across front and rear; vinyl  
siding applied

describe: collapsed two-level "English" type barn with large machine shed  
at right angles to east
