APPENDIX B
DETERMINATION OF ELIGIBILITY FORMS

historic name Silver Hill Farmhouse

historic name John T. Simmons Farmstead
other names/site number N-4039

historic name Harlan-Chandler Mill Complex
other names/site number N-250, N-251

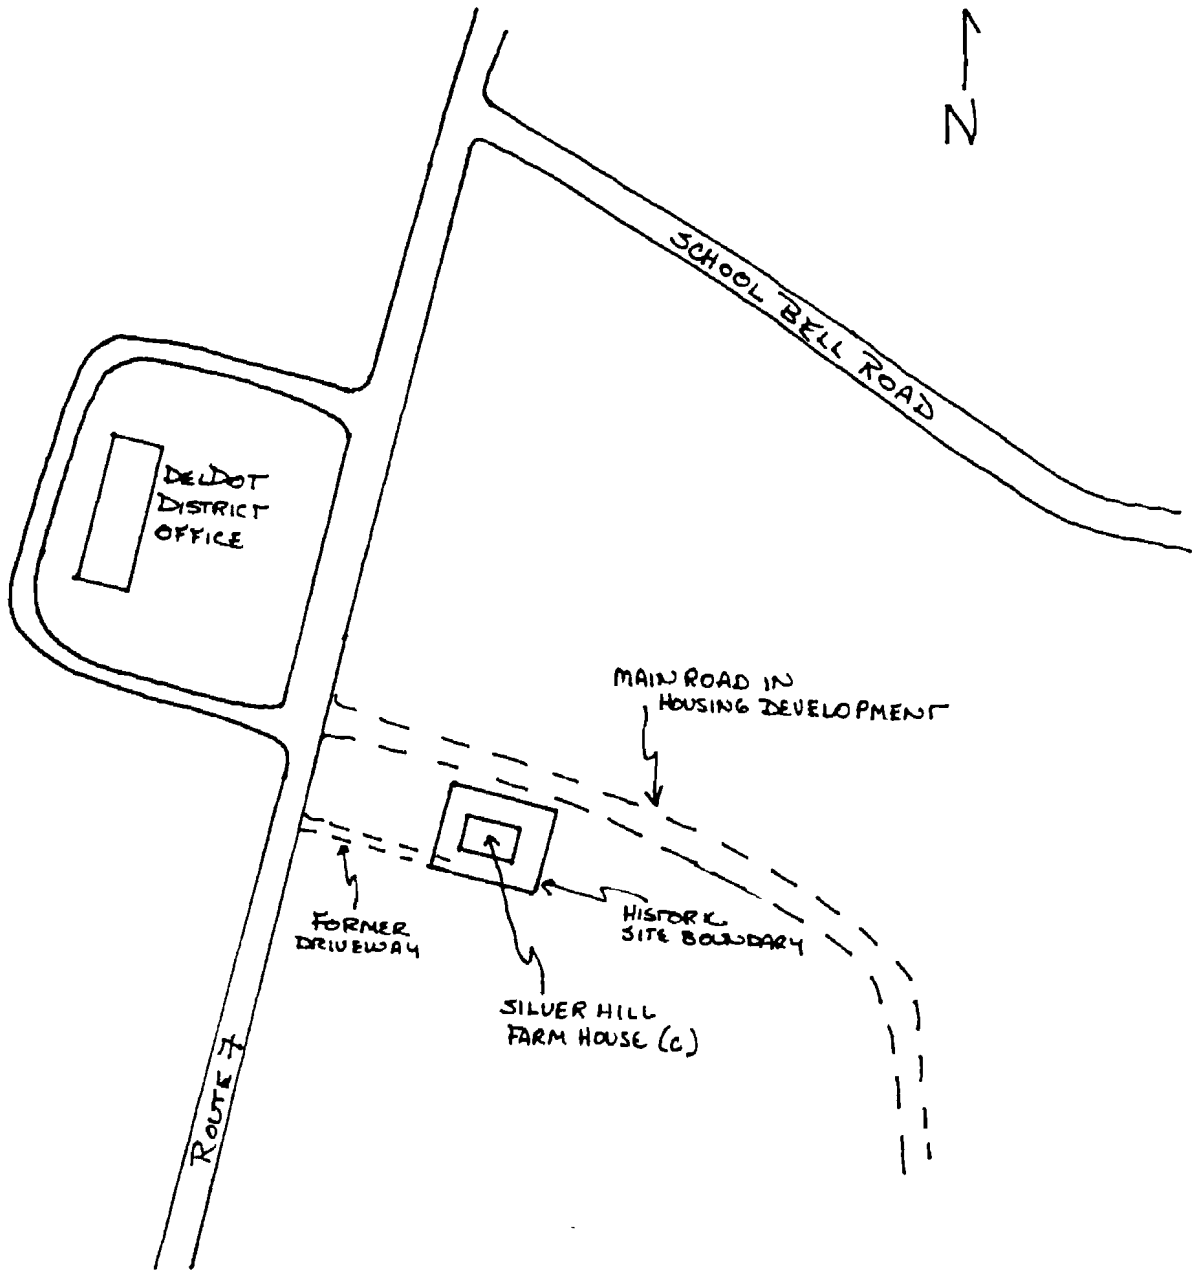
SILVER HILL FARM HOUSE
N-1592
SCALE APPROX. 1" = 200'
C = CONTRIBUTING

The boundary of Silver Hill Farmhouse is as shown on the accompanying sketch map entitled "Silver Hill Farmhouse, N-1592".

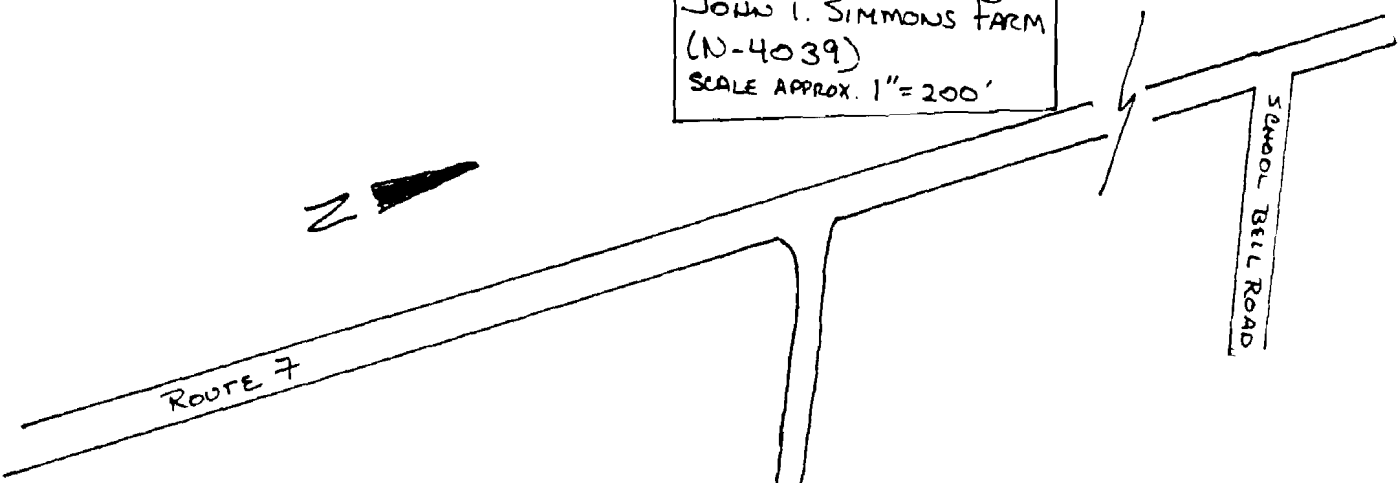
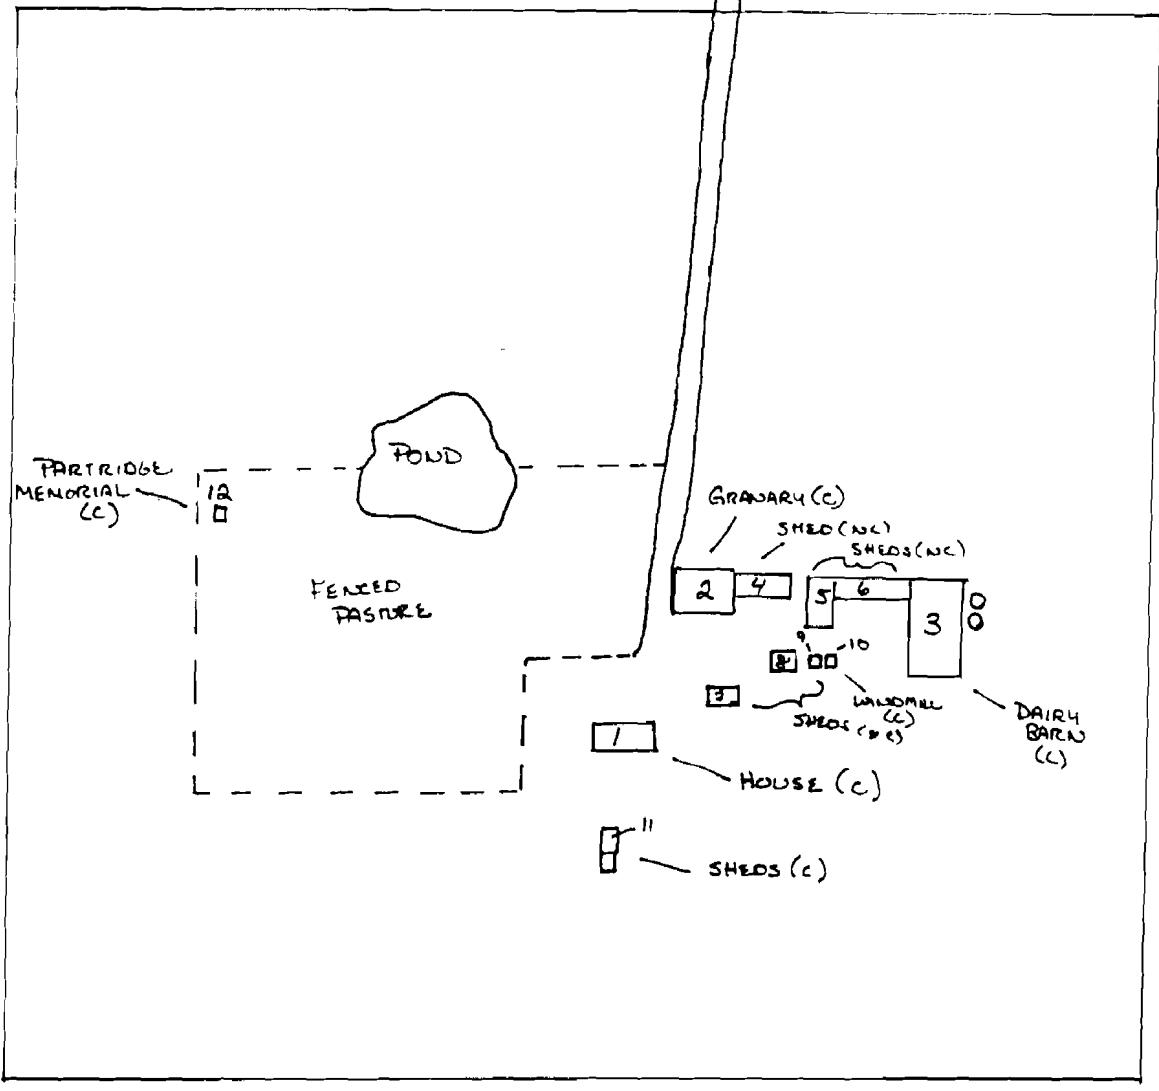
JOHN T. SIMMONS FARM
(N-4039)
SCALE APPROX. 1" = 200'

The boundary of the Simmons farmstead is as shown on the accompanying sketch map entitled "John T. Simmons Farmstead, N-4039".

NOTE: C = CONTRIBUTING
NC = NON-CONTRIBUTING
