RESULTS OF THE ARCHAEOLOGICAL SURVEY

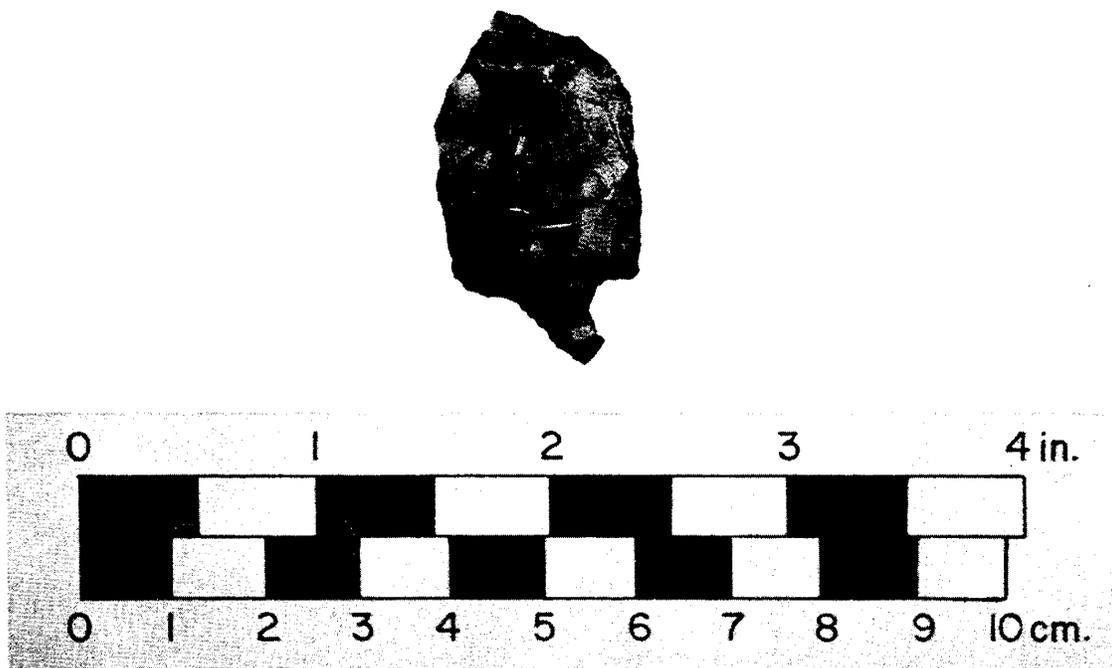
Plate 1. Reworked Biface, Black Chert, Area A, Surface.

Area A, located in the vicinity of the proposed Route 273 intersection, is comprised of a fallow agricultural field and a wooded segment containing an ephemeral stream (Figures 8-9). Surface visibility in Area A ranged from 40 to 60 percent. One prehistoric artifact, a black chert reworked biface, was recovered from the western portion of the proposed right-of-way (Plate 1). The remainder of the artifacts recovered from the surface were historic in origin and consist of glass, brick, and shell fragments (Appendix II).

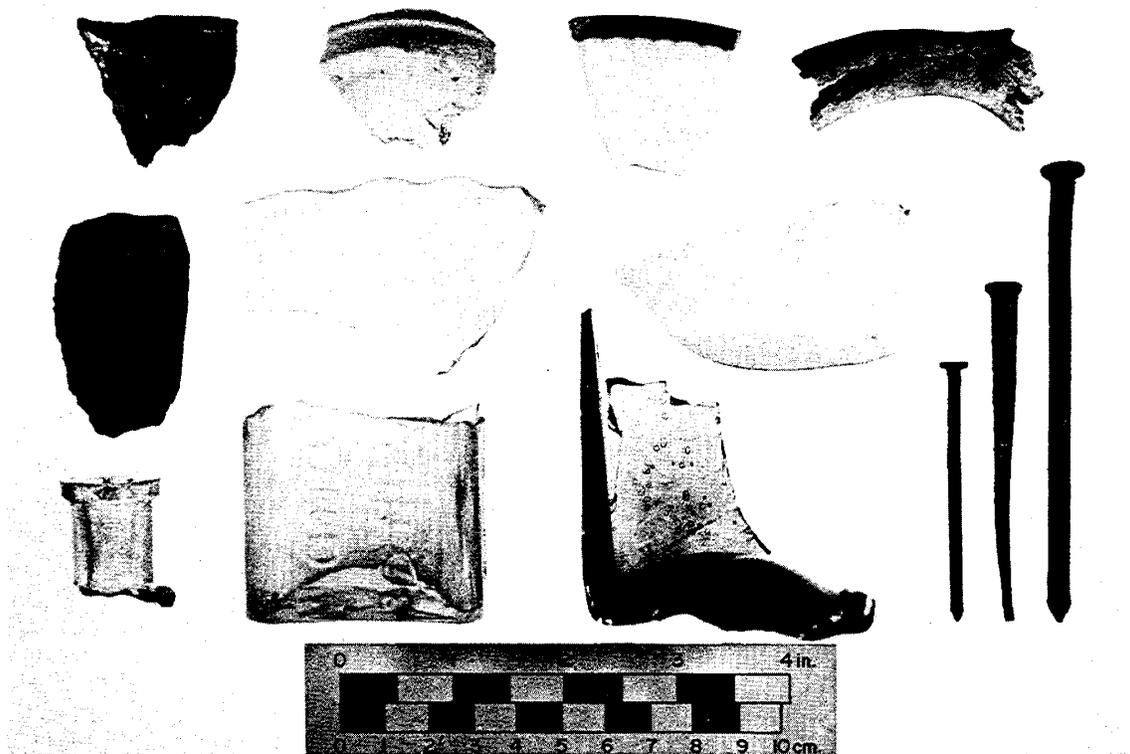
Plate 2. Artifacts, Area B, Dodd Property, Surface.

which has been relocated to another site, was built on a brick foundation in the southeastern corner of the tract (Figure 11). Outbuildings formerly associated with the farmstead had been razed prior to the archaeological survey. The agricultural fields adjacent to the project area boundary were subjected to surface reconnaissance. A total of 160 artifacts was recovered. These consisted of 59 white earthenware sherds, 33 fragments of bottle glass, 20 shell fragments, and 8 metal fragments, including nails and farm machinery parts. Other artifacts include 15 fragments of window glass and lesser amounts of red earthenware, porcelain, stoneware, ironstone, bone, and brick (Plate 2; Appendix II). In addition, one prehistoric artifact, an argillite biface, was recovered (Plate 2).

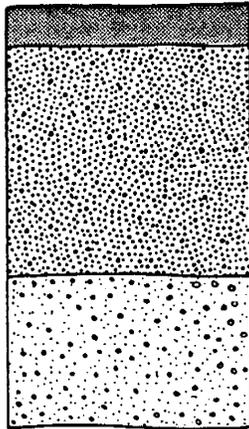
Figure 10

REPRESENTATIVE SHOVEL TEST UNIT PROFILES
AREAS A and B

AREA A - WOODS
SHOVEL TEST UNIT 35

10 YR 3/2 very dark grayish brown humus

10 YR 4/3 brown/dark brown loamy sand

10 YR 5/6 yellowish brown wet coarse sand

Relatively poor surface visibility, combined with the presence of the small stream and the recovery of a prehistoric tool, prompted subsurface testing to determine whether in situ deposits existed below the plowzone. A total of 46 shovel test units was excavated at 20 meter transect intervals. These units were limited to the area of the proposed alignment. Soil stratigraphy typical of the formerly plowed fields is represented by Shovel Test Unit 41 (Figure 10). This unit consisted of 26 centimeters of yellowish brown (10 YR 5/4) silt loam underlain by 24 centimeters of brown (7.5 YR 5/4) sandy silt loam. The shovel test units excavated in the wooded portion of the alignment (Figure 10) displayed three levels of soil deposition. These soils are exemplified by Shovel Test Unit 35, which displayed five centimeters of very dark grayish brown (10 YR 3/2) humus, 39 centimeters of brown/dark brown (10 YR 4/3) loamy sand, and 25 centimeters of yellowish brown (10 YR 5/6) wet coarse sand.

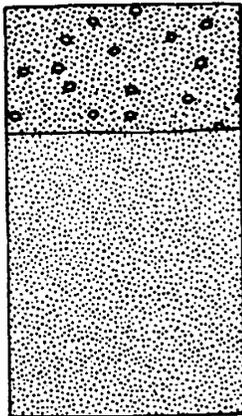
Figure 16

REPRESENTATIVE SHOVEL TEST UNIT PROFILES
AREAS C, D and E

AREA C
SHOVEL TEST UNIT 6

10 YR 5/4 yellowish brown sandy loam

sand fill

recovery of seven artifacts. These consisted of one iron stove plate, two fragments of white earthenware, and one fragment each of porcelain, red earthenware, glass, and brick. Thirteen shovel test units were excavated in Area C. None produced artifacts, and the area was found to be disturbed by the excavation for underground utilities and the grading of the creek banks. The soil stratigraphy typical of Area C is represented by Shovel Test Unit 6 (Figure 16). The profile displayed 21 centimeters of yellowish brown (10 YR 5/4) sandy loam overlying 49 centimeters of sand fill.

Shovel Test Unit 4 represents the soil profile most commonly occurring within Area D (Figure 16). This profile displayed 30 centimeters of brown/dark brown (10 YR 4/3) sandy loam overlying 10 centimeters of strong brown (7.5 YR 5/6) silty clay with sand. Shovel Test Units 1, 3, and 5 produced a total of three artifacts from the active plowzone level. These artifacts consist of two cut nails and one piece of a modern iron plow. No in situ deposits were encountered.

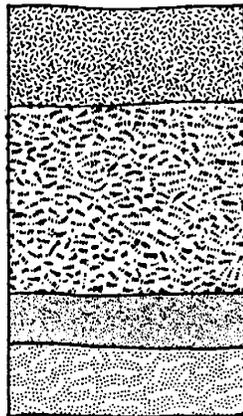
Figure 24

REPRESENTATIVE SHOVEL TEST UNIT PROFILES
AREAS I and J

SHOVEL TEST UNIT 3

10 YR 4/3 brown/dark brown sandy loam

10 YR 5/6 yellowish brown clayey sand

10 YR 5/2 grayish brown sandy clay

10 YR 5/4 yellowish brown sand mottled with
10 YR 5/2 grayish brown sand

During the present survey, five shovel test units were excavated at 20 meter intervals along the proposed construction right-of-way (Figure 25). Stratigraphic profiles recorded are illustrated by Shovel Test Unit 3 (Figure 24). This shovel test

unit was comprised of four soil strata. Stratum 1, 17 centimeters of brown/dark brown (10 YR 4/3) sand loam was underlain by 32 centimeters of yellowish brown (10 YR 5/6) clayey sand. Strata 3 contained eight centimeters of grayish brown (10 YR 5/2) sandy clay, and Stratum 4 showed 13 centimeters of yellowish brown (10 YR 5/4) sand mottled with grayish brown (10 YR 5/2) sand.

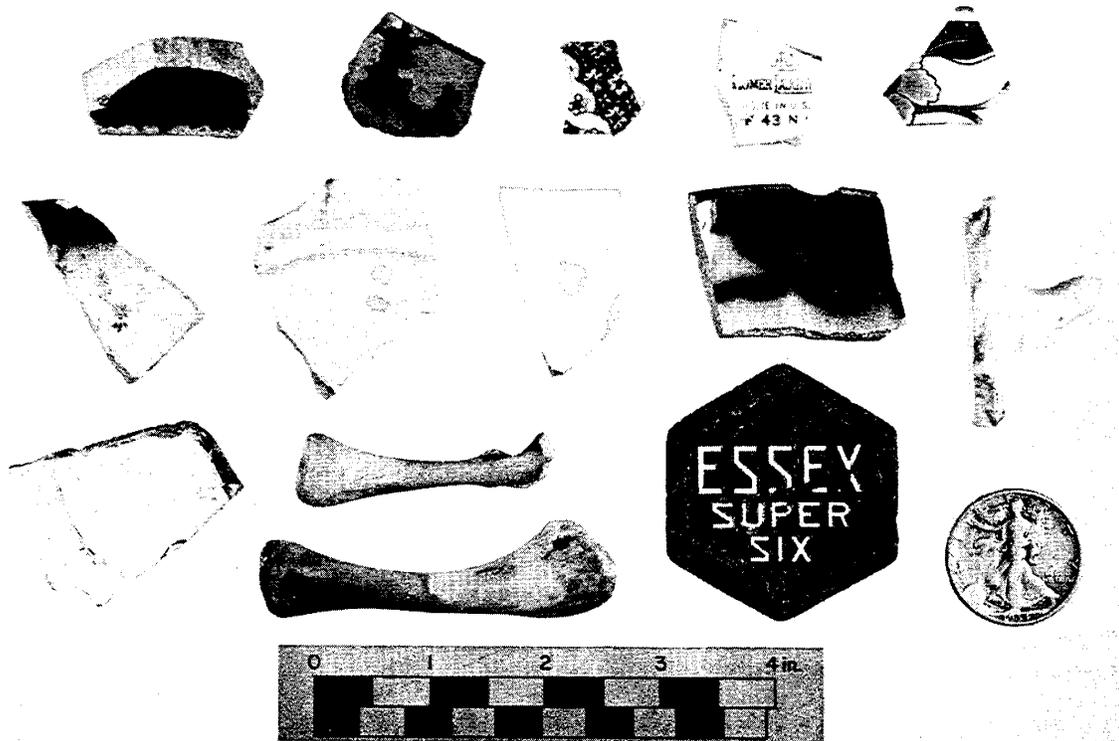
Plate 3. Artifacts, Area N, Surface and Plowzone.

excavated. The shovel test units that were excavated in the proposed interchange were given number designations, while those excavated adjacent to Route 1 were given letter designations (Figure 26). The plowzone is illustrated as the first level in Shovel Test Unit 6 in Figure 20. This unit profile showed 30 centimeters of brown/dark brown (10 YR 4/3) sandy loam overlying 13 centimeters of yellowish brown (10 YR 5/6) silty clay subsoil. Eleven units produced artifacts from the plowzone; bottle glass is the most common artifact, with eight fragments being recovered. Also found were five fragments of window glass, three brick fragments, two white earthenware sherds as well as two buff stoneware sherds and two nails. Rounding out the collection were a fragment of coal, a chunk of mortar, a 1934 half dollar, one red earthenware sherd, a shell, and a fragment of plastic (Plate 3; Appendix II). No artifacts were recovered from the subsoil level.

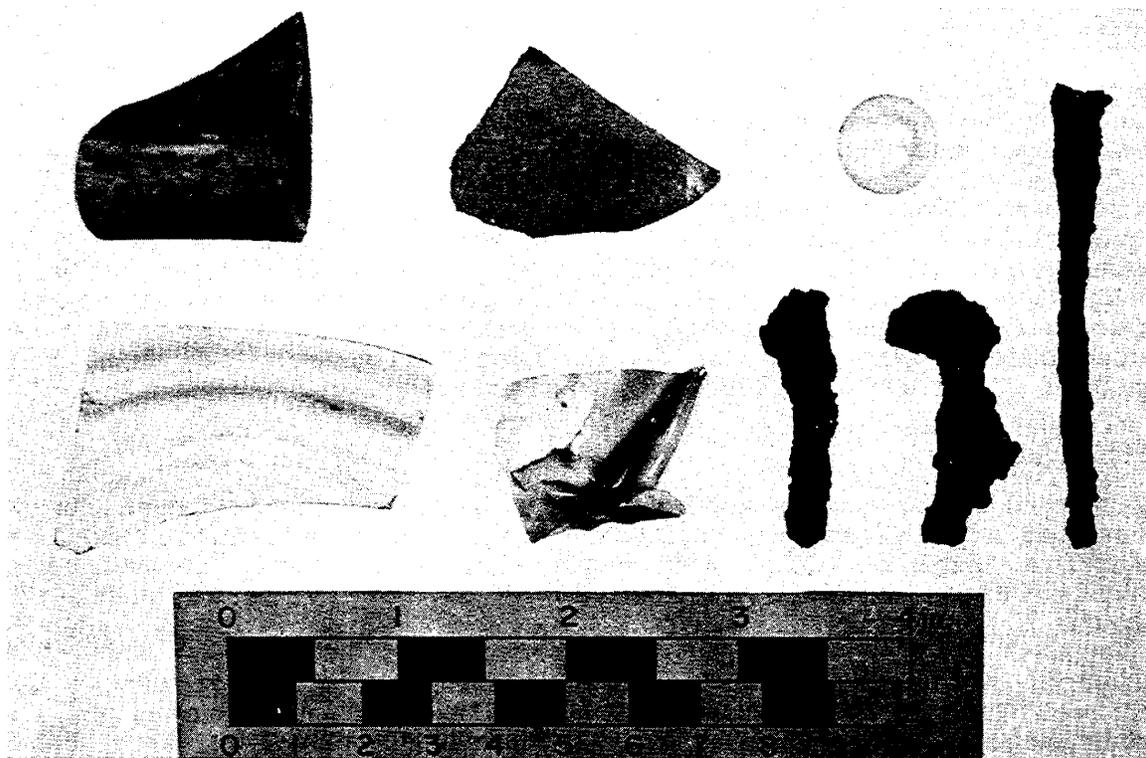
Plate 4. Artifacts, Area N, John H. Maker House (3-34-5-210).

Soil stratigraphy encountered at the John H. Maker House is exemplified by the profile of Shovel Test Unit 5 (Figure 31). This unit contained 25 centimeters of very dark grayish brown (10 YR 3/2) silt loam that was underlain by 15 centimeters of yellowish brown (10 YR 5/6) sandy clay. A total of 83 artifacts was recovered during testing, consisting primarily of 25 fragments of bottle glass and 24 nails. The remaining artifacts include five white earthenware sherds, a porcelain sherd, and a stoneware sherd. One crown closure bottle cap, a hinge, a bolt, a brick fragment, plastic, and a lamp part were also recovered (Plate 4). The majority of the artifacts are modern in origin, and do not provide significant information regarding former inhabitants or house construction methodologies.

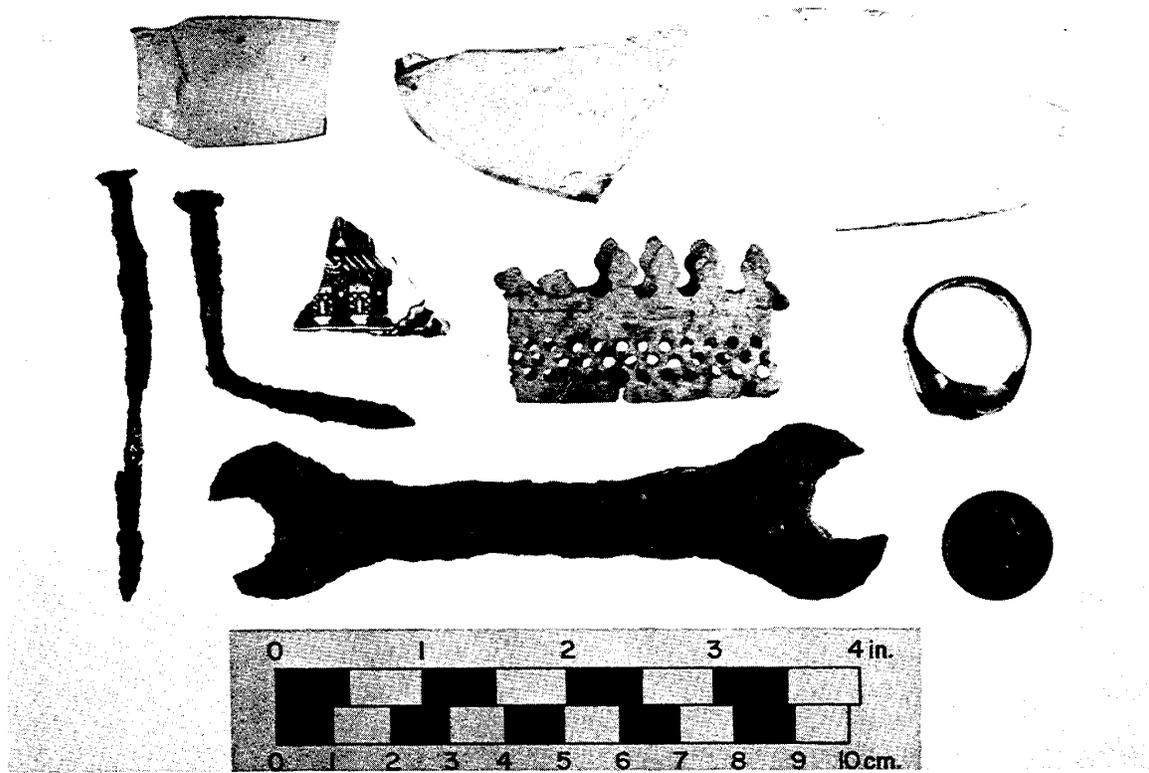
Plate 5. Artifacts, Area N, Virginia Williams House (3-34-5-197).

A total of 142 artifacts (Plate 5; Appendix II) was retained for analysis and included 65 fragments of bottle glass, 31 fragments of window glass, and eight wire nails. The remaining artifacts include two white earthenware sherds, a brick fragment, a 1935

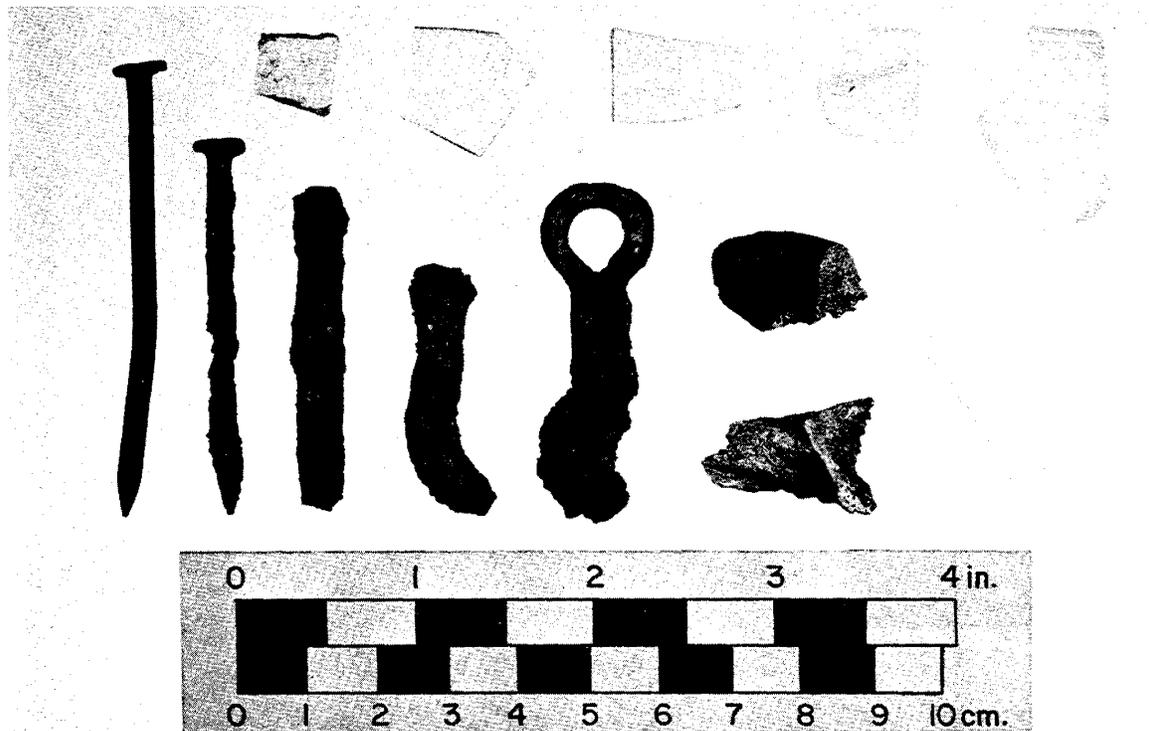
Plate 6. Artifacts, Area N, Hattie Burton House (3-34-5-211).

The stratigraphic profiles at the Hattie Burton House varied across the site and are illustrated by Shovel Test Units 2 and 4 (Figure 32). Shovel Test Unit 2 contained 25 centimeters of dark grayish brown (10 YR 4/2) silty clay underlain by 15 centimeters of brown/dark brown (7.5 YR 4/2) silty clay. Shovel Test Unit 4 contained four distinctive soil strata. Stratum 1 showed five centimeters of very dark grayish brown (10 YR 3/2) silt loam. This stratum was underlain by 17 centimeters of brown/dark brown (10 YR 4/3) sandy loam mottled with yellowish brown (10 YR 5/6) sandy loam. Stratum 3 contained 13 centimeters of brown (10 YR 5/3) silty clay, while Stratum 4 contained five centimeters of yellowish brown (10 YR 5/6) clayey sand. A total of 64 artifacts was recovered and include seven wire nails, 14 fragments of bottle glass, and fragments of coal. Other artifacts include three white earthenware sherds, fragments of bone, wire, and mortar; and two porcelain sherds, as well as a cotter pin, brick and shell fragments, a red earthenware sherd, and a drawer handle fragment (Plate 6; Appendix II).
