CULTURAL RESOURCE SURVEY
SURVEY UPDATE FORM

CRS # N05042

1. HISTORIC NAME/FUNCTION: Bloomfield

2. ADDRESS/LOCATION: 4663 Kirkwood St. Georges Road, Saint Georges, 19733

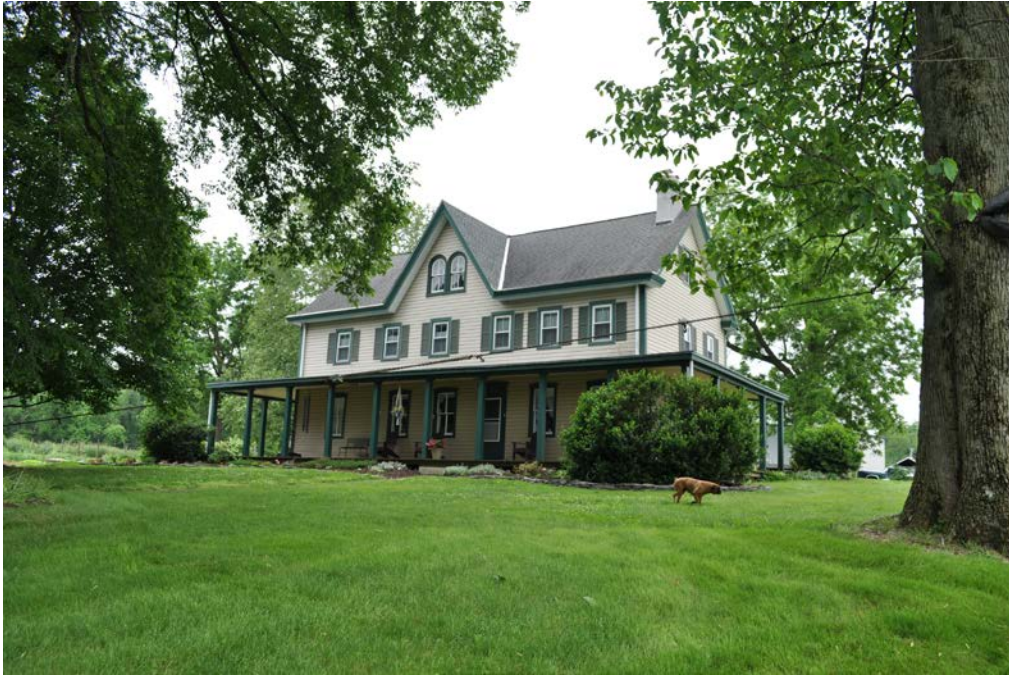
Description Façade (north elevation) and west elevation of main building looking southeast; West elevation of main building looking east

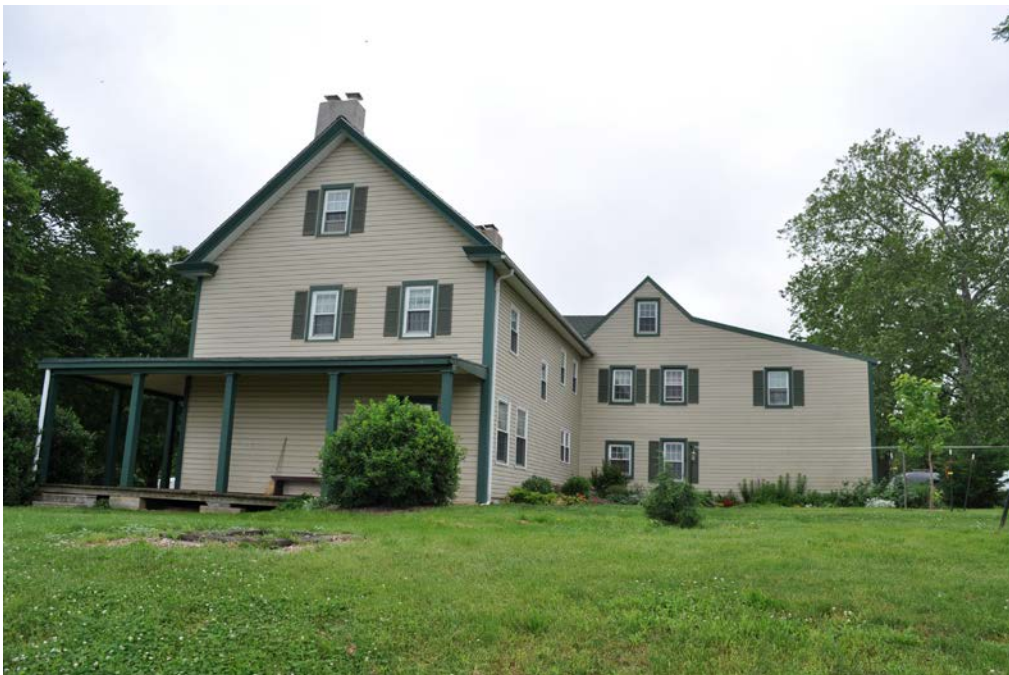
- 1) **Bays** 2 on main block, 3 on rear ell
- 2) **Windows** 3 on main block, 6 on rear ell
 fenestration irregular, Main block - 2 bays on 2nd story, 1 on 2.5 story; Rear ell – 2 on 1st story, 3 on 2nd story, 1 on 2.5 story
 type 6/6 double-hung vinyl sash
 trim N/A
 shutters replacement fixed louvered vinyl
- 3) **Door(s)** 1
 location S end of main block
 type single leaf
 trim N/A
- 4) **Porch(es)** 4 bays, wrapping around from north elevation on main block
