Chapter 5

FIELD INVESTIGATIONS

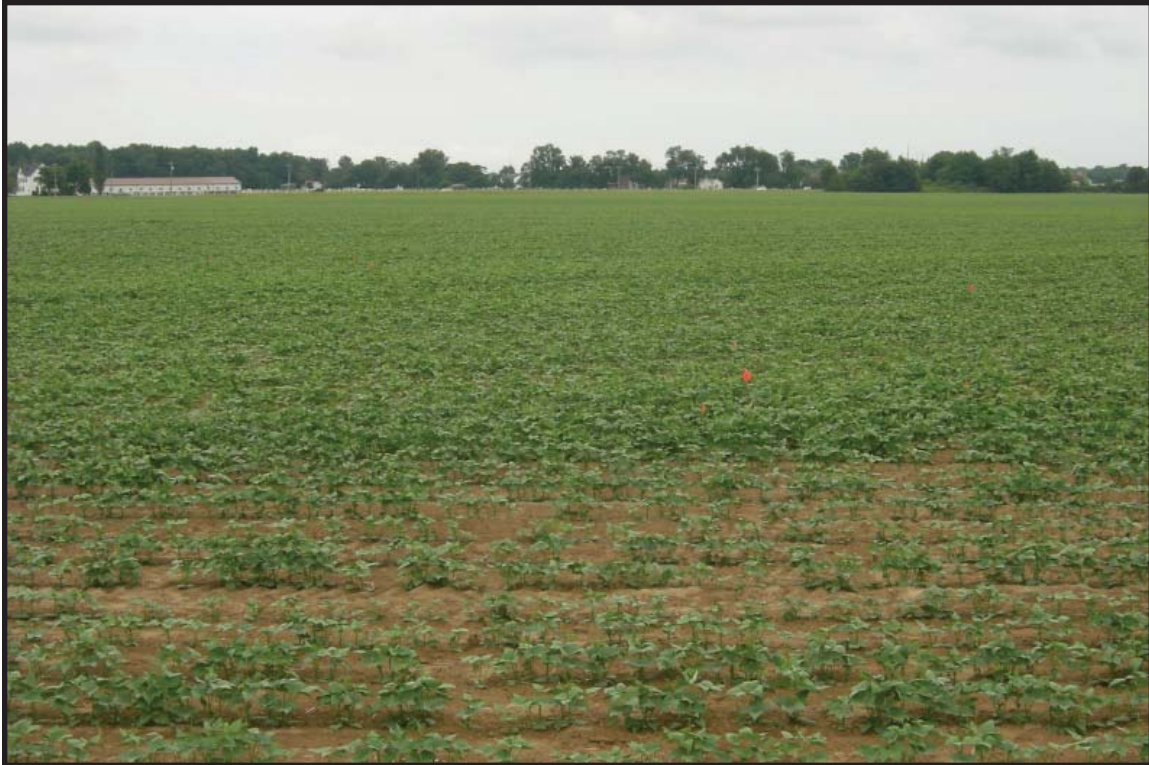
Plate 5.6. General view of bush lima bean field, the Proposed Locations of Ramps A and B facing northeast towards State Route 1. (Photographer: Sue Ferenbach, July 2009) [HRI Neg. # 09014/D1:001].

A controlled surface collection was undertaken within the freshly plowed agricultural field in the area of the proposed ramps connecting SR 1 and SR 30/Cedar Creek Road. Surface collection was initiated from the southbound side of SR1 heading southwest towards SR 30/Cedar Creek Road (Plates 5.6 and 5.7). Very few artifacts were observed on the surface in the eastern part of the alignment. The heaviest concentrations were immediately east of SR 30/Cedar Creek Road. During the initial walkover the ground was dry and powdery with less than optimal visibility. As the upcoming forecast was for rain additional passes were put on hold in lieu of shovel testing in other areas. Following a steady overnight rain two additional passes were conducted in opposite directions. All artifacts were flagged and labeled with individual point provenance numbers (PP) and an initial inventory was recorded in the site notebook. The position of each flag was then recorded using a handheld sub-meter GPS unit (TOPCON GMS-2). Artifact locations were coded for quick identification as prehistoric or historic artifacts with subdivisions into artifact classes. A map of the first two days' survey was generated for use in the field and in consultation with archaeologists from DelDOT.

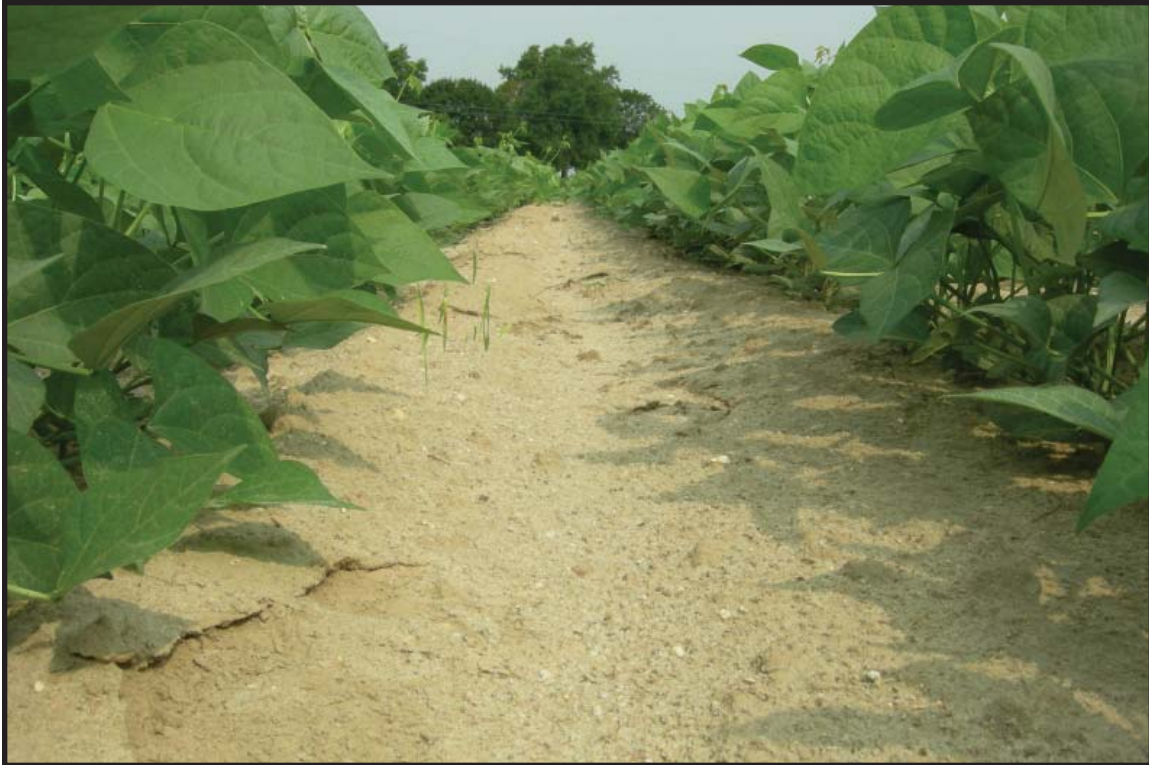
Plate 5.7. Surface visibility within the bush lima bean field between State Route 1 and State Route 30/ Cedar Creek Road at the end of fieldwork facing north. (Photographer: Joelle Browning, July 2009) [HRI Neg. # 09014/D1:013].

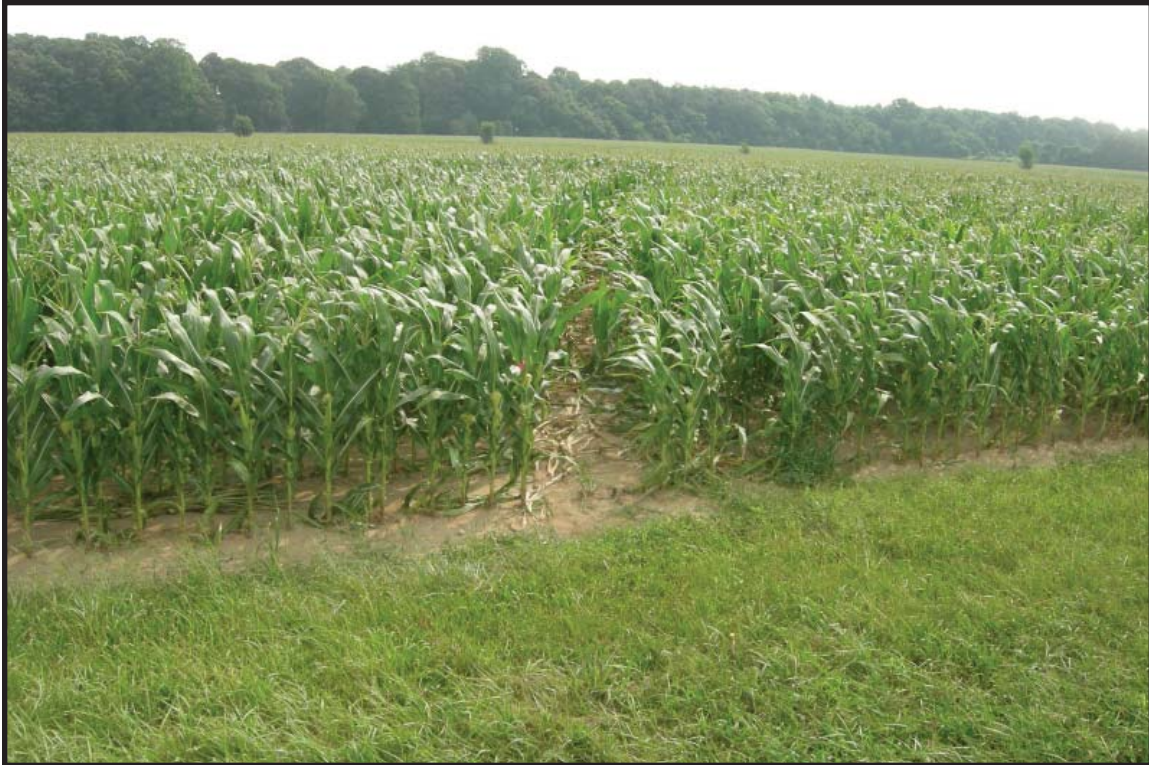
Plate 5.8. General view of corn field along north side of State Route 1 in the area of the proposed Ramps C and D facing northeast. (Photographer: Sue Ferenbach, July 2009) [HRI Neg. # 09014/D1:007].

Sixty-seven shovel tests assigned to the 200 series (STs 200 through 266) were excavated east of the SR 1 and Cedar Neck Road/State Route 206 intersection entirely within a mature feed-corn field (Plate 5.8). Shovel Tests 200 to 223 and 238 to 266 were spaced 50 feet apart following the proposed routes of the on and off ramps and along the proposed shift of Cedar Neck Road/State Route 206. A single transect was also tested (STs 224 through 237) across a proposed detention basin located in the same area. Soils in this area consist of silty sand and loamy sand subsoil overlain by an active silty sand plowzone. The only artifacts retained from this area were an isolated small brick fragment recovered from the plowzone in ST

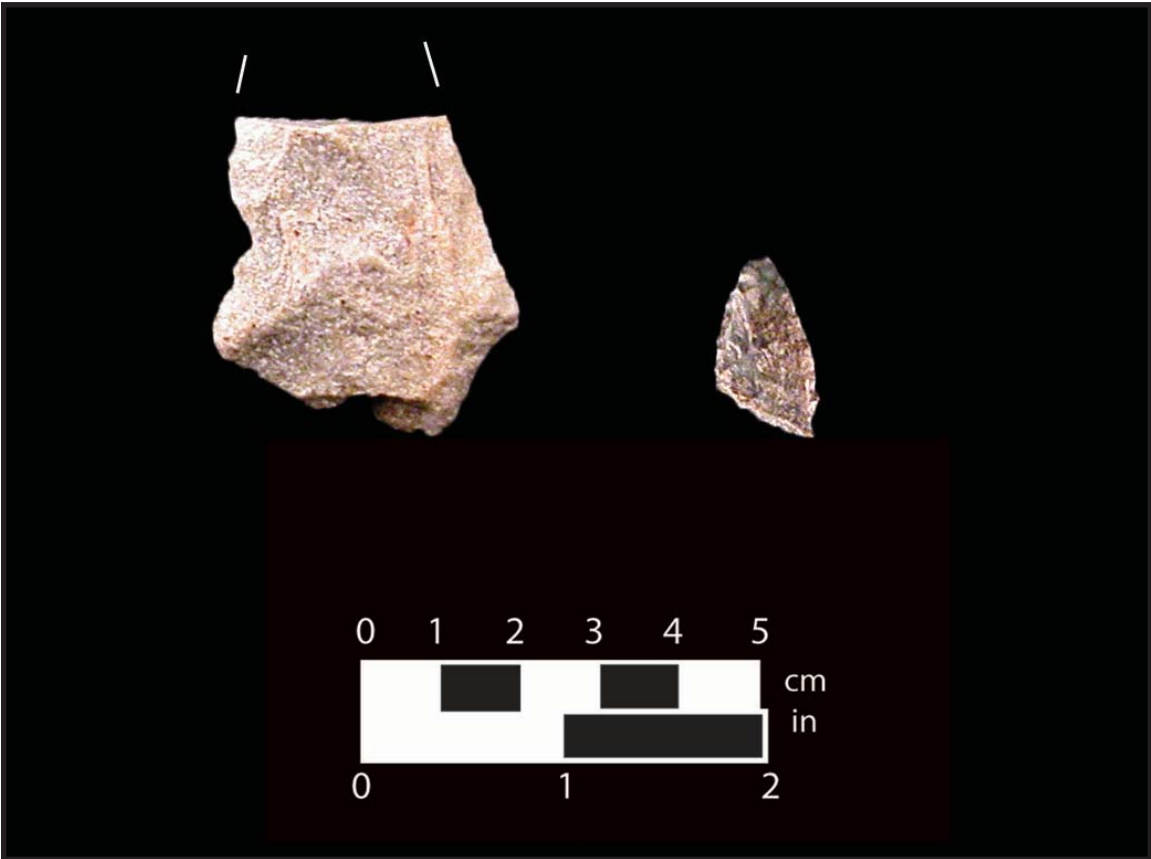
Plate 5.9. Selected prehistoric artifacts recovered from the proposed locations of Ramps A and B between State Route 1 and State Route 30/Cedar Creek Road. (Left to right); Quartzite biface/knife; Chert projectile point fragment (Photographer: Marjan Osman, September 2009) [HRI Neg. # 09014/D2:001].

The prehistoric assemblage consists of ten lithic (stone) artifacts: thermally fractured rock fragments (6) associated with hearths for heat and cooking; lithic debitage (2) also known as waste flakes, the byproducts of stone tool production or maintenance; a broad quartzite biface/knife used for a variety of cutting purposes; and a small narrow-bladed black chert projectile point (midsection/distal) fragment used for hunting. Neither the biface nor the projectile point are considered diagnostic, but the broad style of the knife is suggestive of the Clyde Farm and Barker's Landing Complex of the Woodland I period between *circa* 5,000 B.P. and 2,500 B.P. as defined by Jay Custer (Custer 1984: 75-144). The absence of prehistoric ceramics from this small assemblage also hints at an earlier date for the occupation. The location of the site, 940 feet away from an un-named third order branch of the Cedar Creek on what at first glance appears to be a featureless, level terrain does not fit into typical settlement models. Close examination of the one-foot contours (Figure 5.3) indicates the course of a former fourth-order stream running directly through the middle of the scatter of prehistoric materials. As the number of prehistoric artifacts is low and the range of artifacts is limited, the function of the site is unclear at this time. The site may represent a

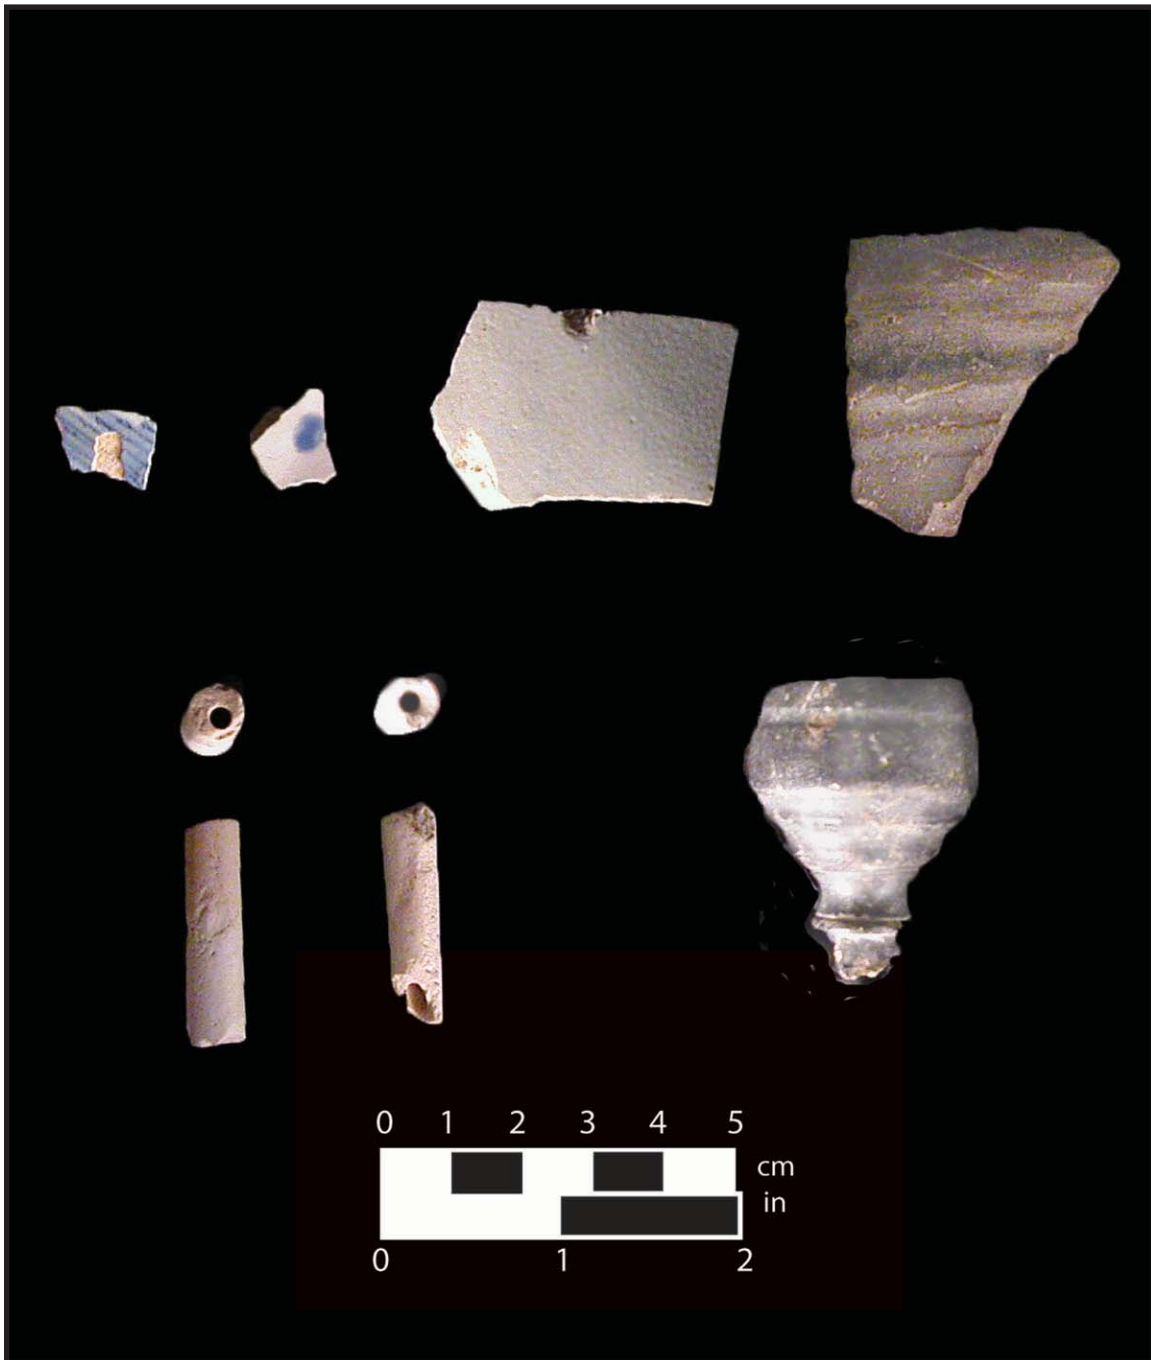
Plate 5.10. Selected historic artifacts recovered from the proposed locations of Ramps A and B between State Route 1 and State Route 30/Cedar Creek Road. *Top row (left to right):* Delftware with blue linear decoration; White salt-glazed stoneware (“scratch blue”); White salt-glazed stoneware; Gray-bodied stoneware (“Albany slip interior”). *Bottom row (left to right):* Pipe stems (7/64-inch bore); Cast bronze knob or finial (Photographer: Marjan Osman, September 2009) [HRI Neg. # 09014/D2:002].

A small tin-enameled, buff-bodied, earthenware rim sherd (PP 42) was recovered from the surface in close proximity to a sherd of creamware and a white clay tobacco pipe stem (7/64 bore diameter, see below). The form of the original vessel represented by this small sherd is indeterminate, as is its country of origin, but this can be limited to Holland or England. The dating of tin-enameled ware also known as Delftware (after the Dutch city of Delft) is often difficult on small sherds as it was imported to the colonies from the late 17th through the 18th centuries (Hume 1977:1-11). This small sherd, as is the case with so many tin-enameled sherds, is missing the interior glaze. Tin glazes do not fuse well with the earthenware bodies and expand and contract at different rates when exposed to variations in temperatures. This causes the glaze to detach from the body. By the time sherds are collected from the surface of a plowed field, they have been separated from their glazes. A second tin-enameled, buff-bodied, earthenware sherd (PP 92) recovered from the surface exhibits a series of hand painted parallel blue lines, a design element

A base sherd from a molded, white, salt-glazed stoneware plate (PP 44) recovered from the surface unfortunately does not exhibit any molded decoration typical of this type of ware. These plates, manufactured in England, have a date range of *circa* 1740 to 1785 (Hume 1985:116) (Gusset 1980: 82-132). Another white, salt-glazed stoneware sherd (PP 38) from small hollowware form, likely a tea bowl, exhibits what is referred to as debased scratch-blue decoration and dates to *circa* 1765-1790 (Hume 1985:118) (Gusset 1980:37-67). This small sherd is decorated on the interior with a lightly scratched oval which has been in-filled with a cobalt wash.

Two white-ball-clay tobacco pipe stems (PP42 & PP91) both exhibit bore diameters of 7/64 of an inch, which, using “Harrington’s Theory” (Hume 1985) for dating pipes based on their diameter, suggests a date range of 1620-1710. The dating of sites based on pipe stem bore diameters should never be used alone, but it does provide supporting evidence when examining the assemblage as a whole. In this case there are other artifacts suggesting a possible early date for a portion of the site, delftware, redware, and a brass knob/finial (see below). Two other pipe stems with 5/64-inch bore diameters have a date range of 1710-1800.

A cast brass knob or finial (PP 18) is of a baroque style, suggestive of pre-Georgian (pre 1711) bulbous ornamentation. This knob or finial could be a pull from a piece of furniture or a finial from the handle of an ornate fireplace tool such as a poker.
