PHASE I SURVEY RESULTS

Route 7 North Corridor, Current Status of Cultural Resources

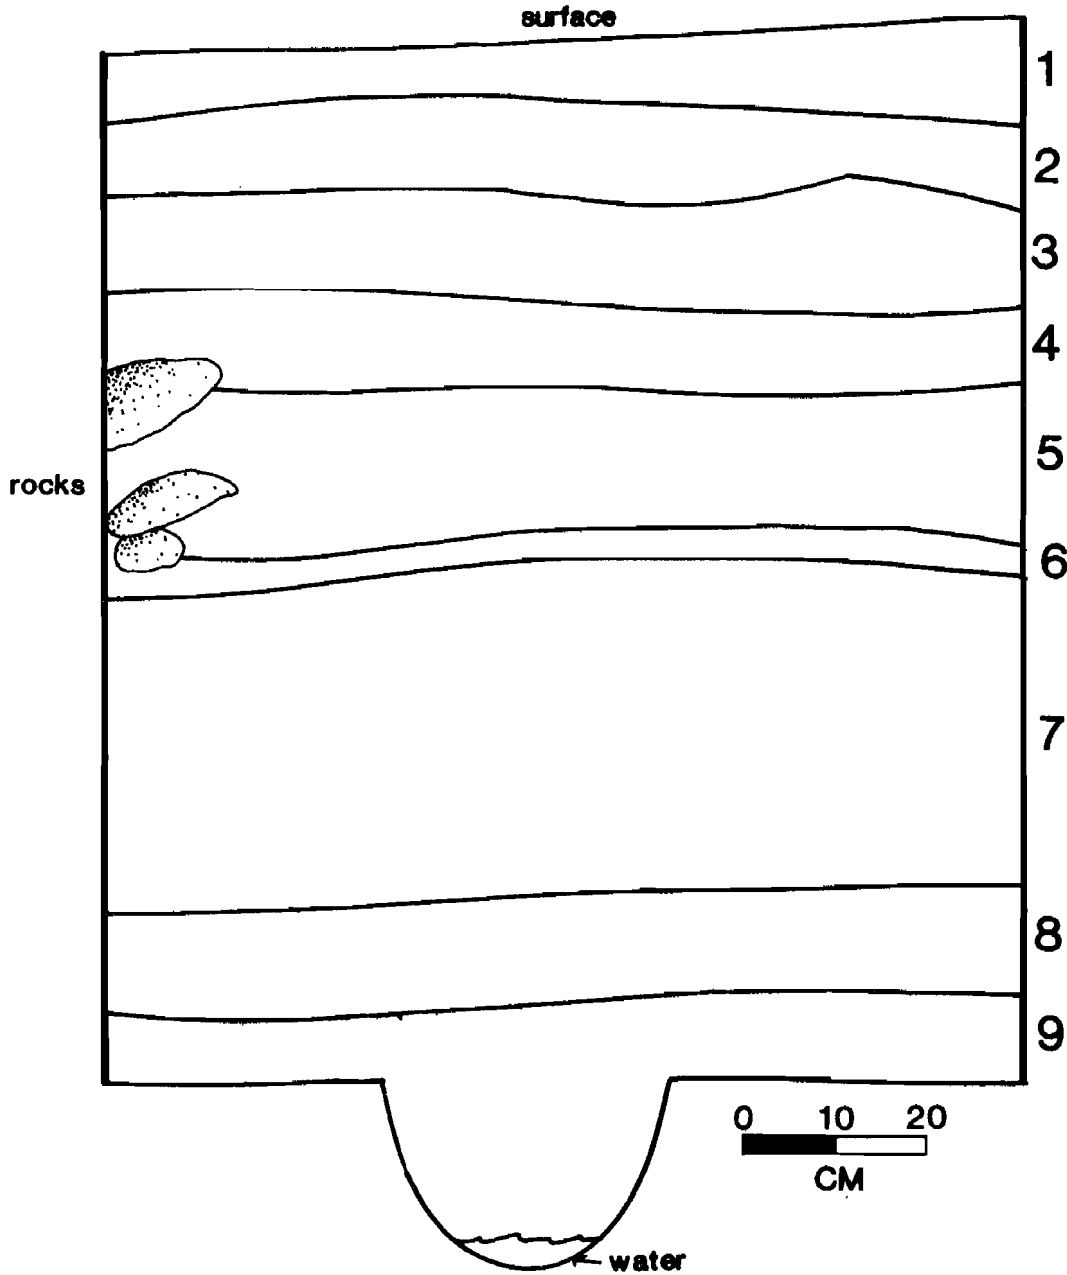
FIGURE 9

Locus 2, Profile of Test Unit 2, South Wall

1-brown silty loam with humus and roots

2-brown orange loamy silt with sand

3-gray brown silty sand with charcoal and small gravels

6-gray and orange brown sand with iron stains

7-brown sandy silt with lenses of gray and orange brown sand and iron stains

8-orange brown sandy silt with lenses of dark gray and light gray sand and iron stains

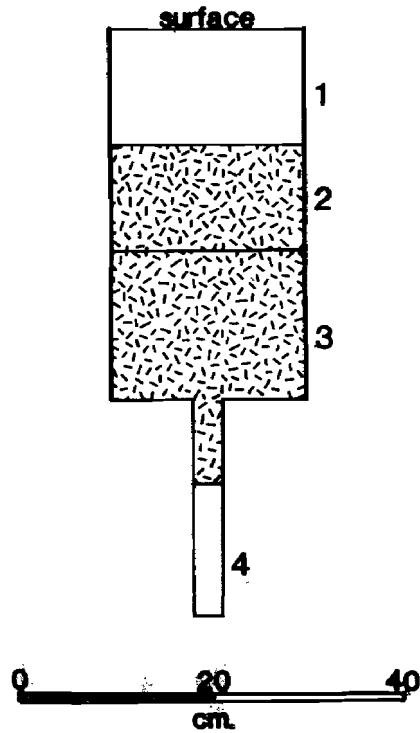
FIGURE 12

Locus 7, Profile of Shovel Test Pit 2

- 1-dark brown sandy humus
- 2-orange sandy clay loam
- 3-brown sandy clay loam with gravels
- 4-gray brown sandy clay with decomposing schist

Phase I Survey - A total of 63 1m test units and 21 shovel tests were excavated in this segment (Figure 11A-E). Testing was conducted on both sides of Route 7, except directly in front of the Derrickson-Ball House (N-211), where the proposed ROW is narrow and the slope is extremely steep. The majority of proposed ROW within this segment was found to be heavily disturbed by residential and commercial development, and by previous DelDOT construction activities on both sides of the road. In 1964, Limestone Road was shifted and straightened by DelDOT in the section between Carousel Farms and Goldey-Beacom College. This work has resulted in extensive subsurface disturbance within the ROW on both sides of the road, illustrated by the stratigraphic profiles found in Loci 7 and 8 (Figures 12 and 13).

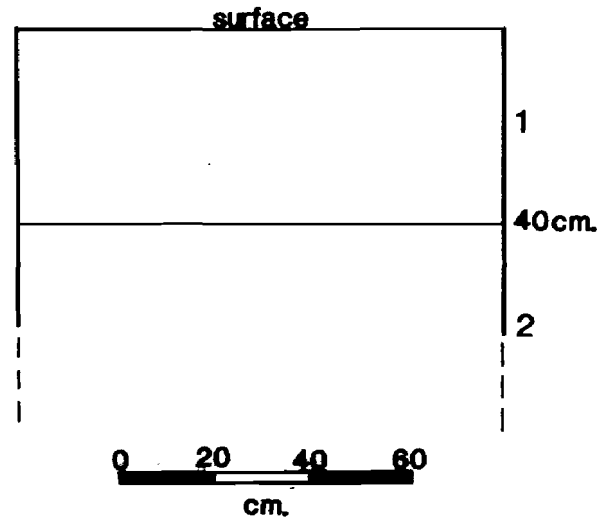
FIGURE 13

Locus 8, Profile of Test Unit 1, South Wall

1-homogenous brown gravelly and loamy soil with some modern debris

2-coarse yellow sand

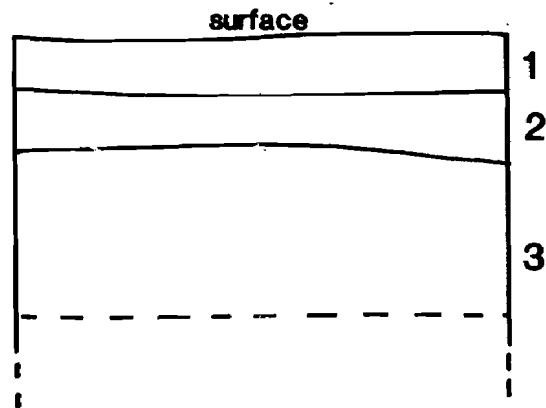
FIGURE 14
Locus 5, Profile of Test Unit 1,
North Wall

- 1-brown silty loam with gravels
- 2-brown silty clay
- 3-yellow brown sandy silty clay with gravels

Locus 5, on the east side of Limestone Road, was found to have been disturbed by grading and filling in the yard area. The soil stratigraphy at this locus consisted of a loamy fill with gravels above subsoil derived from weathered bedrock (Figure 14).

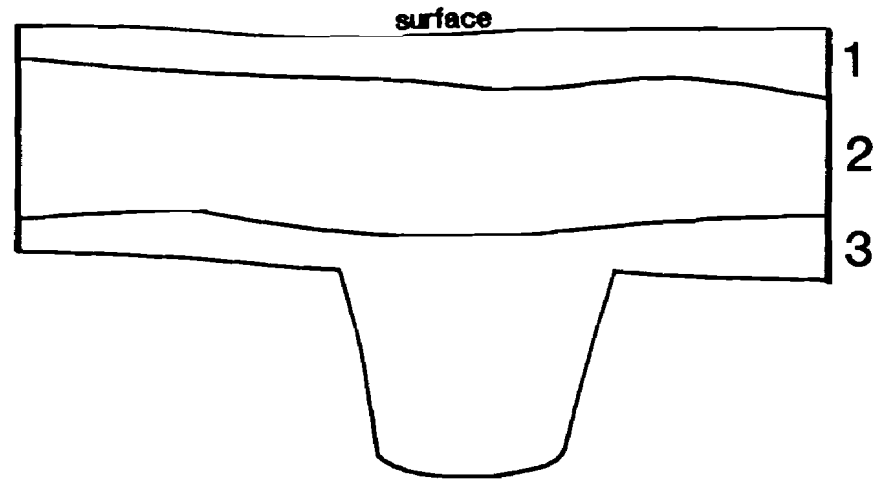
FIGURE 15
Locus 10, Profile of Test Unit 3,
North Wall, Showing
Agricultural Land Use

- 1-humus
- 2-brown clay loam
- 3-yellow brown clay loam
- no gravels in any levels

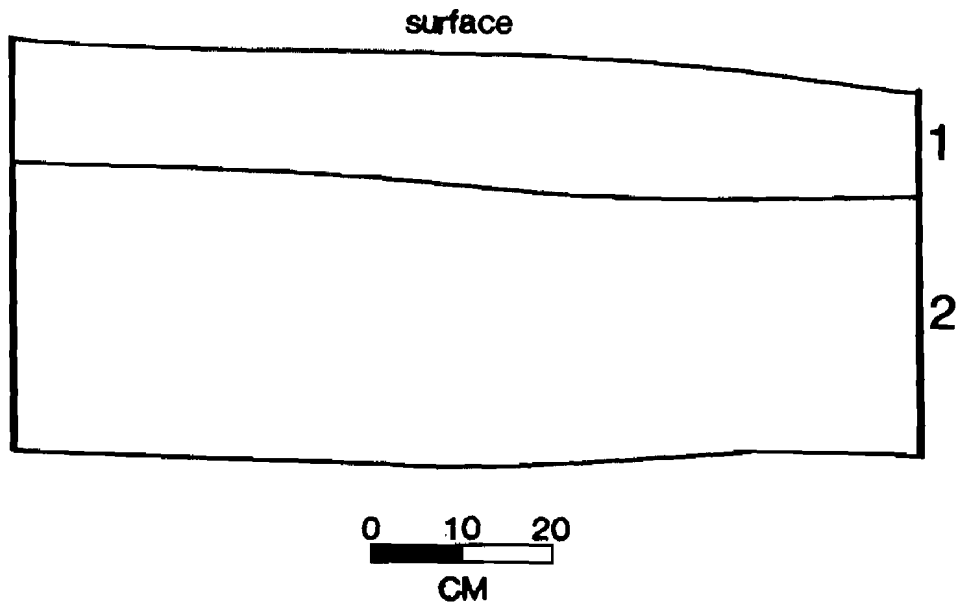
FIGURE 16
Locus 4, Armor Site,
Profile of Test Unit 1, South Wall

1 - brown silty loam humus

2 - red brown silty clay loam with gravels and cobbles

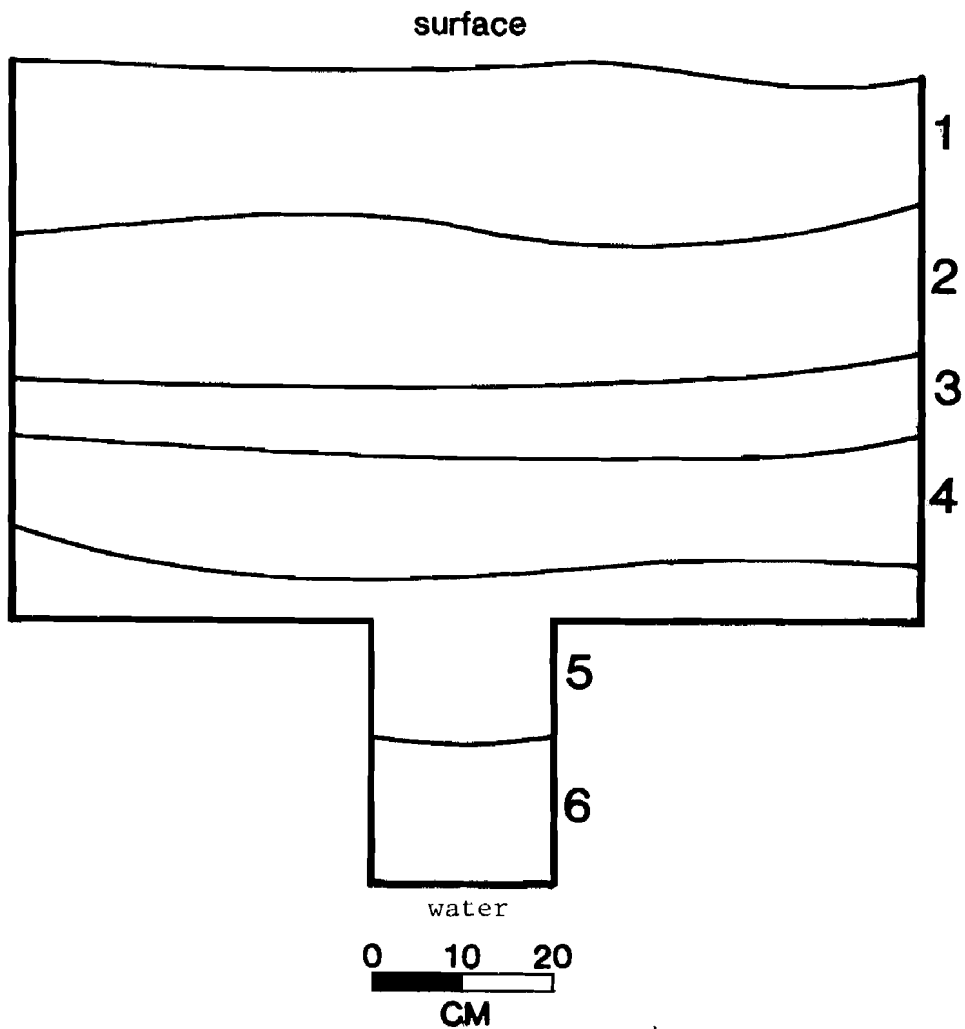
FIGURE 17
Locus 6, Klair Site,
Profile of Test Unit 2, North Wall

- 1-dark brown humus and probable plow zone
- 2-light brown silty loam with a little clay
- 3-mixed gray/brown clay loam with sand (coarse grained)
- 4-light brown clay loam (increasing clay content)
- 5-medium brown clay loam (more clay)
- 6-dense yellow clay

The Klair Site is located on a slope and knoll on the east side of the proposed ROW, approximately 400 feet south of Old Linden Hill Road. To the east of the site and downslope is a small ephemeral stream, the same tributary that flows through the Armor Site to the south. Nine 1m test units were placed and excavated at regular intervals near the base of the slope. Soil profiles of all of these units indicated several episodes of colluvial activity which has obliterated any older landscapes in the area (Figure 17).

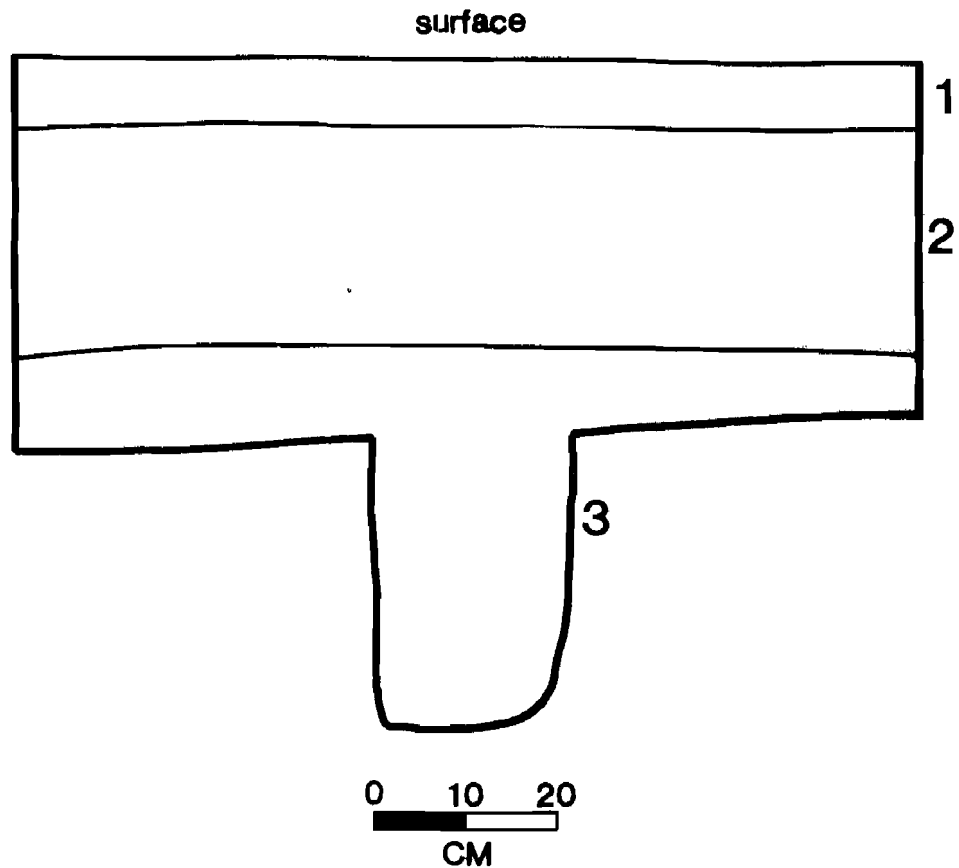
FIGURE 18
Locus 4, Armor House Site,
Profile of Test Unit 17, North Wall

1-humus, root

2-medium brown silt to clay loam

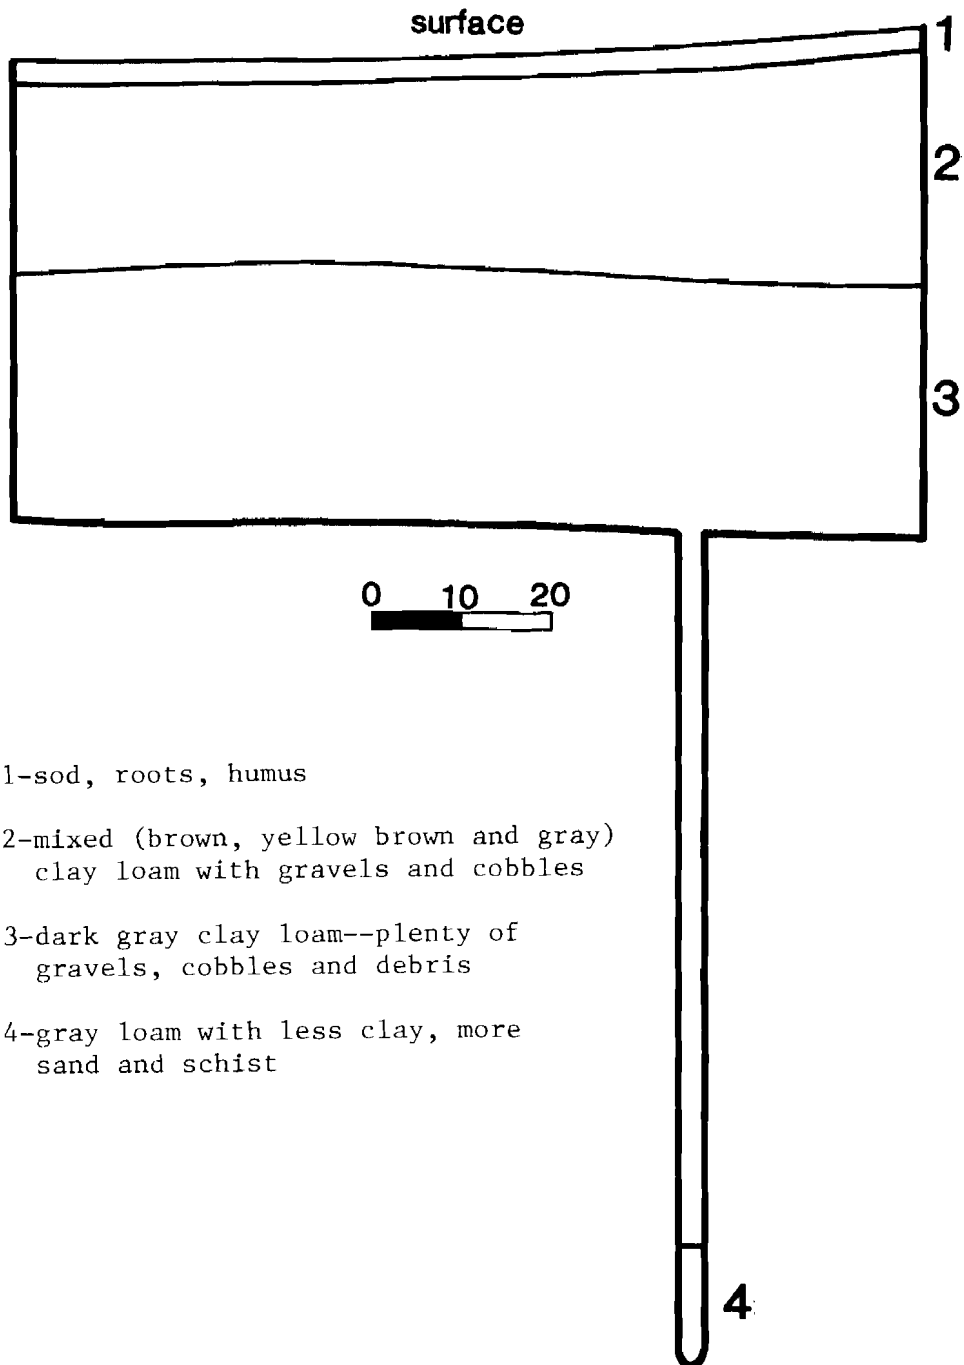
FIGURE 20
Locus 4A, Armor Barn Site,
Profile of Test Unit 3, South Wall

marked by the uneven nature of the backyard "landscaping", and by the protrusion of large foundation stones from the ground. Four 1m test units were placed in the vicinity of the barn within the ROW. All encountered heavily disturbed soils, rubble, and demolition fill (Figure 20). Artifacts dating from the 19th and 20th centuries, with no stratigraphic context, were recovered; however, no features were discovered. No further work was conducted at this site because the integrity of the site was completely destroyed.

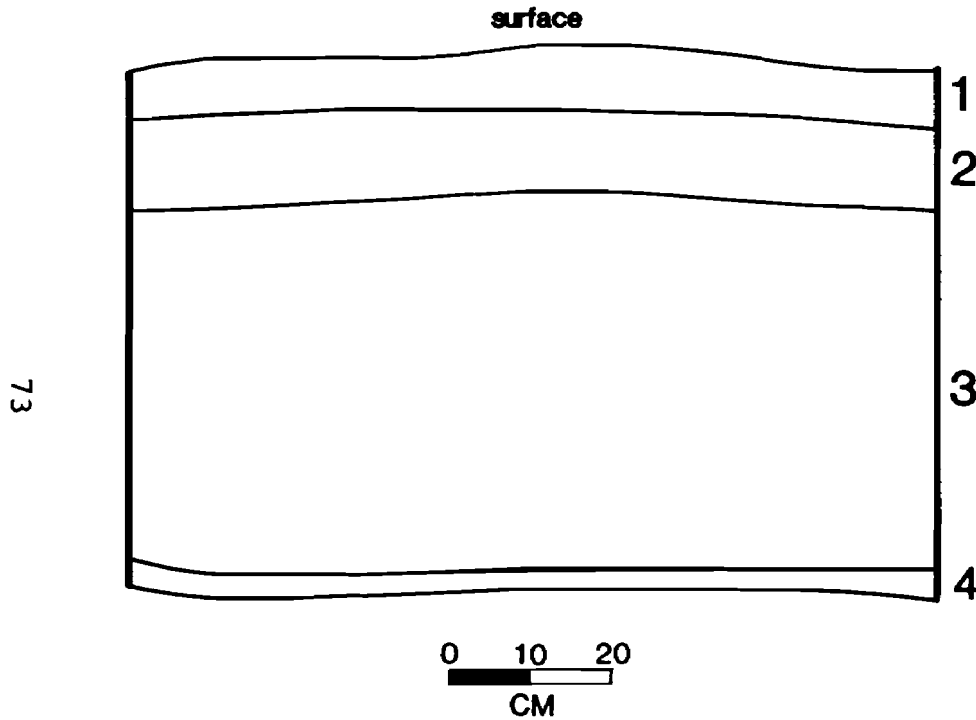
FIGURE 22

Locus 13A, Profile of Test Unit 3, North Wall

- 1-brown silty loam with gravels and roots
- 2-orange brown silty loam with gravels
- 3-orange brown clayey loam with gravels and decomposing schist
- 4-decomposing schist (very little soil)

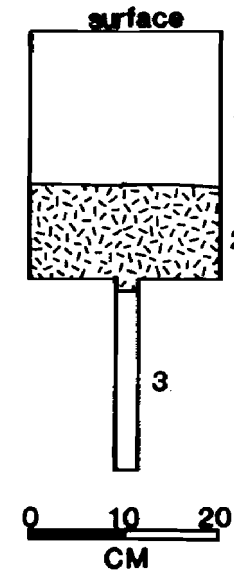
FIGURE 23

Locus 37, Profile of Shovel Test Pit 2, Showing Highway Construction Disturbance

- 1-brown silty loam with humus and sod roots
- 2-tan grey compact silty loam with sand and gravel
- 3-yellow orange sand with pebbles and gravels
-

- disturbed

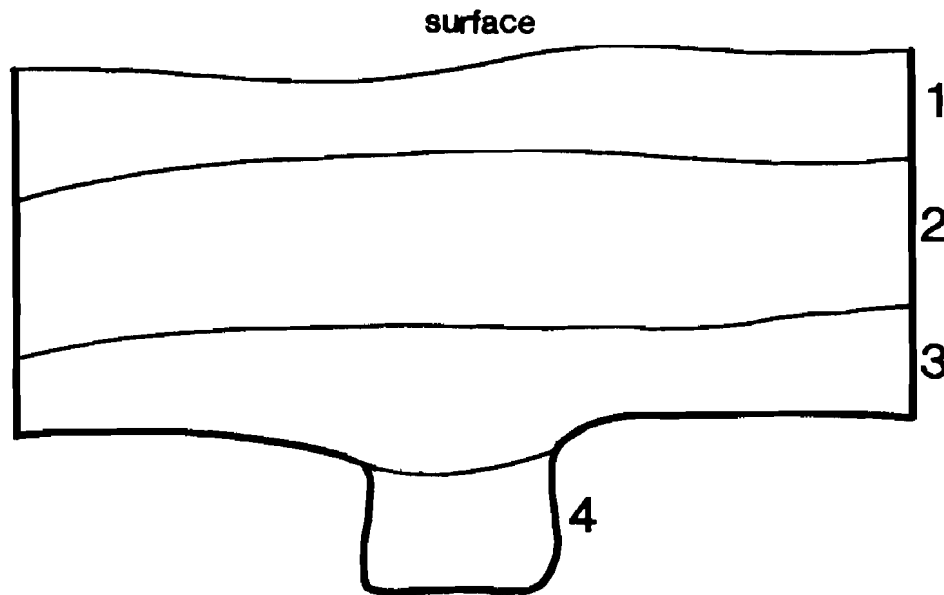
FIGURE 25
Locus 10, Mermaid Tavern Wheelwright Shop Site,
Profile of Test Unit 6, North Wall

1-humus

Prior to that time the site was the location of a wheelwright shop associated with the Tavern complex. Phase I testing consisted of six 1m test units placed around the house. These test units found a variety of 19th century artifacts -- whiteware fragments, gray salt-glazed stoneware fragments, nails, a partial horseshoe, bottle and window glass fragments, shells, and brick fragments-- between 0 and 30cm below ground surface. The stratigraphy of these test units consisted of a humus level, underlain by a silty loam, above a clay loam subsoil (Figure 25).

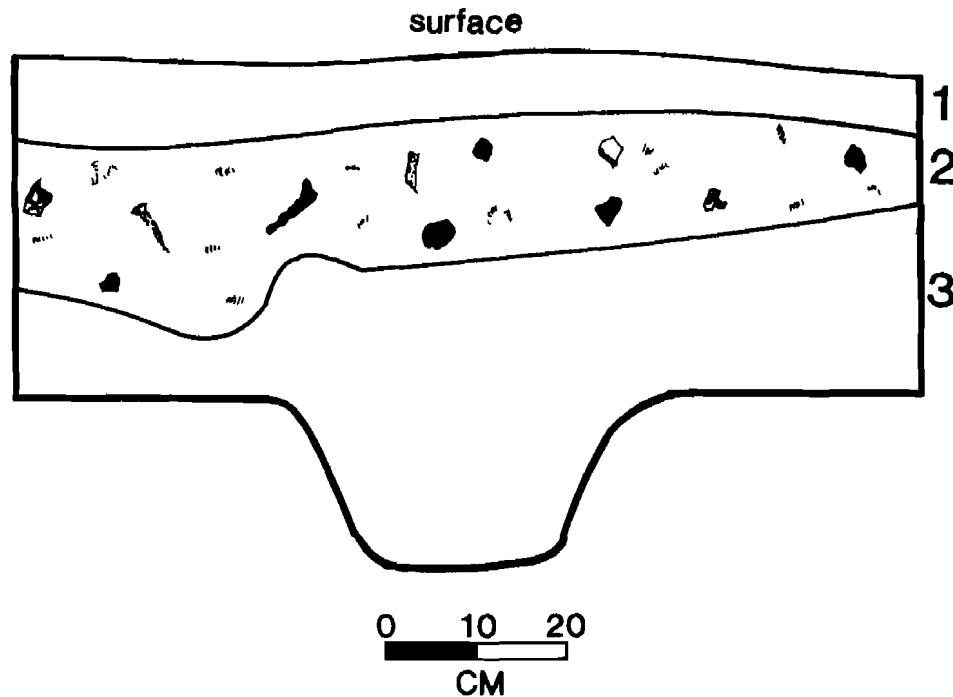
FIGURE 26

Locus 10, Mermaid Tavern Wheelwright Shop Site,
Profile of Test Unit 7, North Wall, Trash Feature

1-humus

2-brown silty loam full of burned ash, coal, artifacts

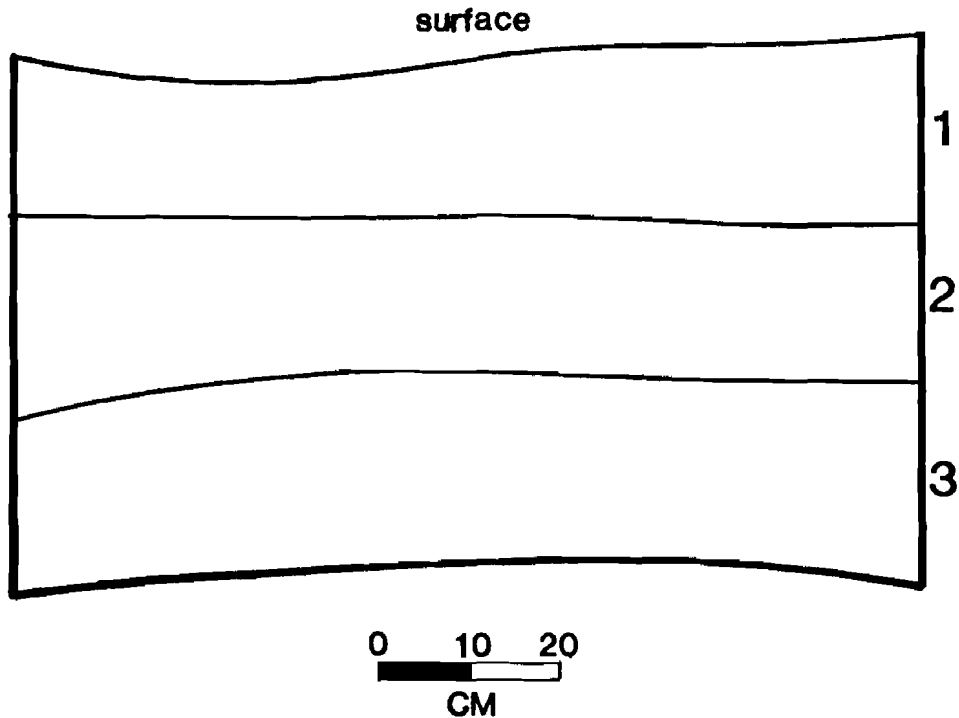
FIGURE 27

**Locus 11, Mermaid Tavern Blacksmith Shop/
Stable Site, Profile of Test Unit 2, North Wall**

1-humus/brown clay loam (may be associated with construction)

2-dark (almost black) silty loam--organic--at top of which was found rotting wood fragments

The Mermaid Tavern Blacksmith Shop/Stable Site is located on the eastern edge of the ROW at the northeast corner of Mermaid - Stoney-Batter Road and Route 7 intersection. It is directly opposite from the Mermaid Tavern, and north of the Mermaid Tavern Wheelwright Shop Site. Background research revealed that a blacksmith shop and stable associated with the Mermaid Tavern were located here by the second decade of the 19th century. To identify and locate this structure, four auger probes and two 1m test units were excavated at the site. A very dark brown organic A horizon was found buried about 18cm below ground surface, and extending to a depth of approximately 25cm (Figure 27). Within

this buried level were found decaying organic material (rotting vegetation and wood fragments) and artifacts, including redwares, whitewares, annular ware, nails, window and bottle glass fragments, and shell fragments. Phase II excavations were undertaken at this site, because artifacts seemed to be buried in good stratigraphic context. Further discussion of this site is included in the Phase II section of this report.

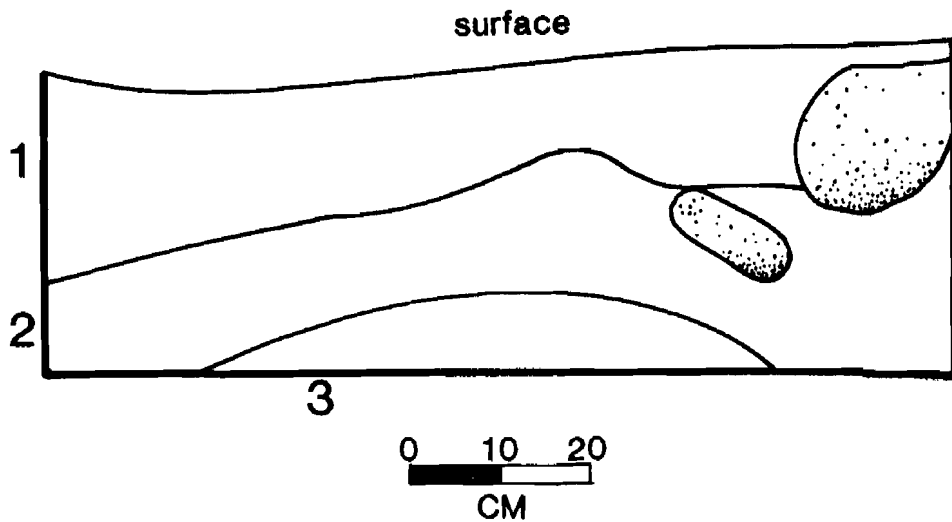
FIGURE 29
Locus 9, Mermaid Tavern Site,
Profile of Test Unit 3, North Wall

- 1-humus and root matter and brown sandy to clayey loam
- 2-mixed orange and gray clay loam
- 3-coarse brown gravelly soil

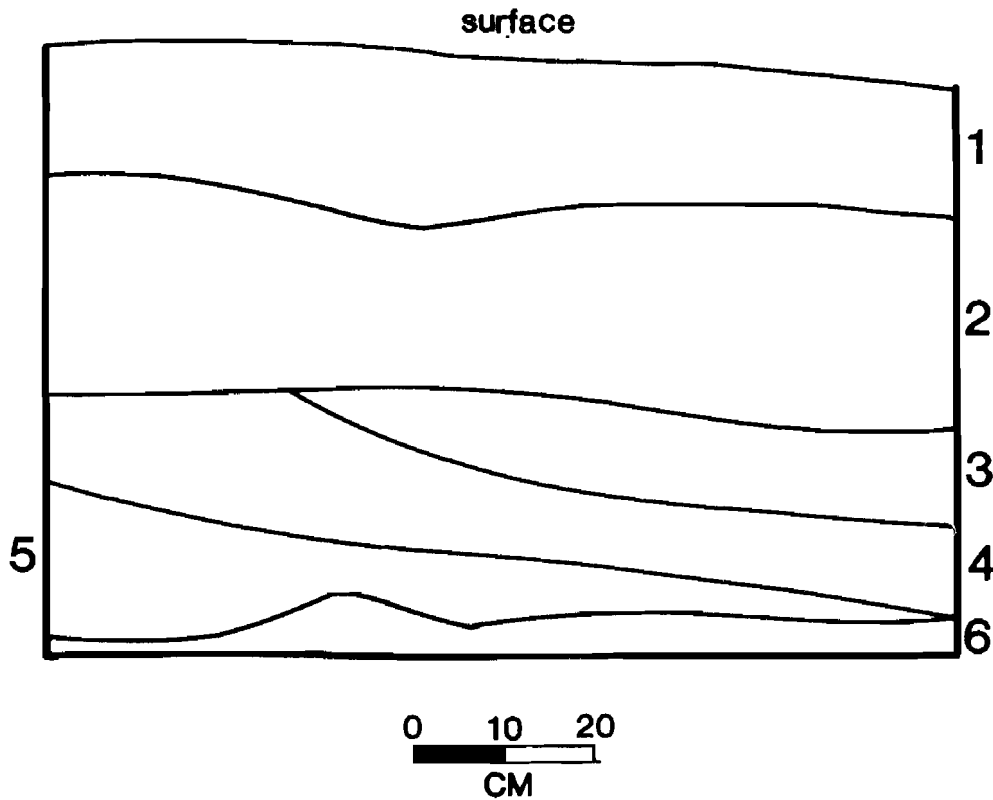
FIGURE 30
Locus 9, Mermaid Tavern Site,
Profile of Test Unit 5, North Wall

- 1-thin humus underlayed by brown clay loam
- 2-gray brown silty loam
- 3-thin orange sandy to clayey loam
- 4-gray sand with some decomposing schist
- 5-mixed yellow brown clay loam
- 6-dense yellow clay--sterile

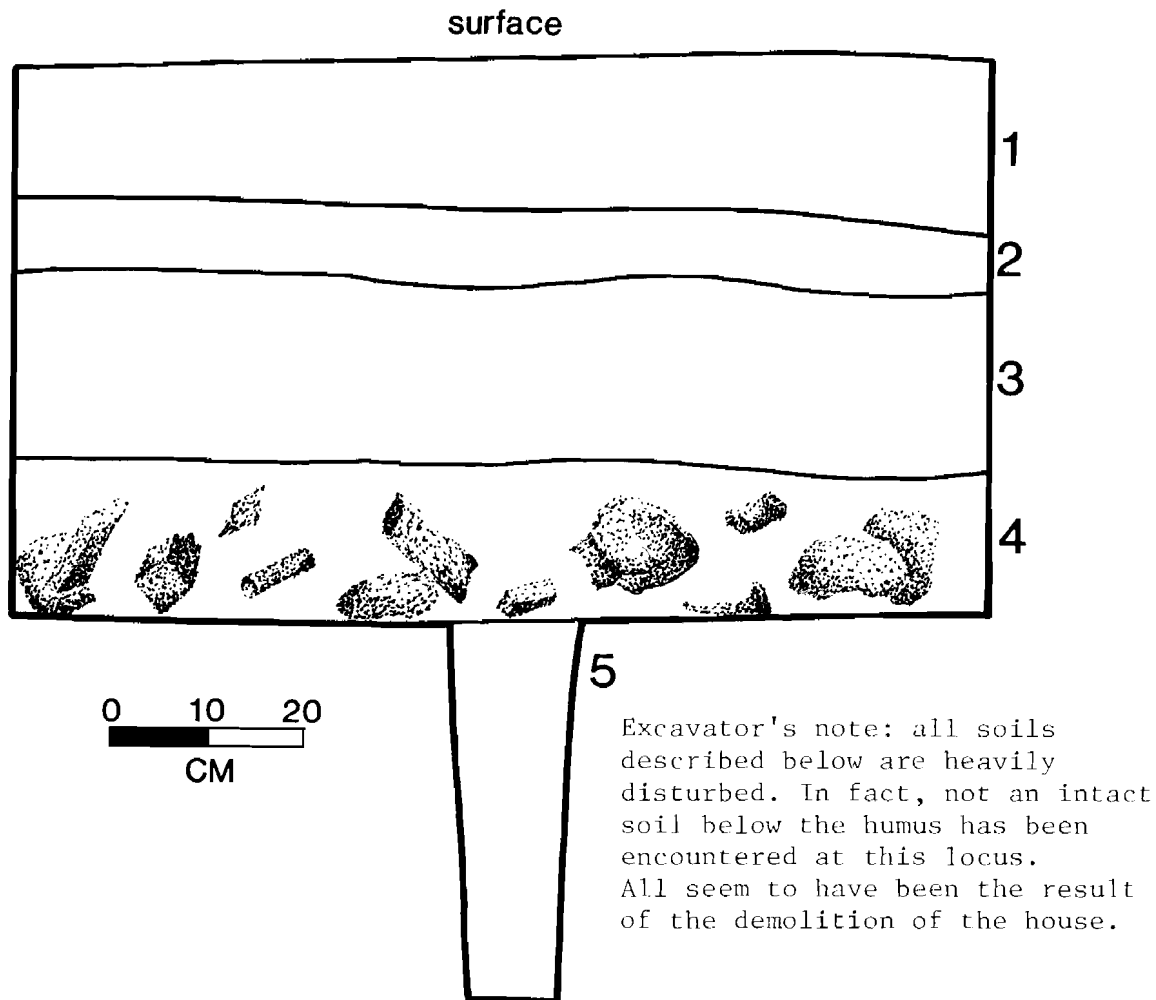
FIGURE 33
Locus 33, T. Cavender House Site,
Profile of Test Unit 8, South Wall

1-root material and humus (medium brown silt-like loam)

2-orange sand and gravel

4-gray/brown compacted clay loam with demolition debris, iron sewer pipe, terra cotta pipe (fragments of both) burned wood, aforementioned black "plastic" pipe, cobbles (plus some yellow clay pockets)

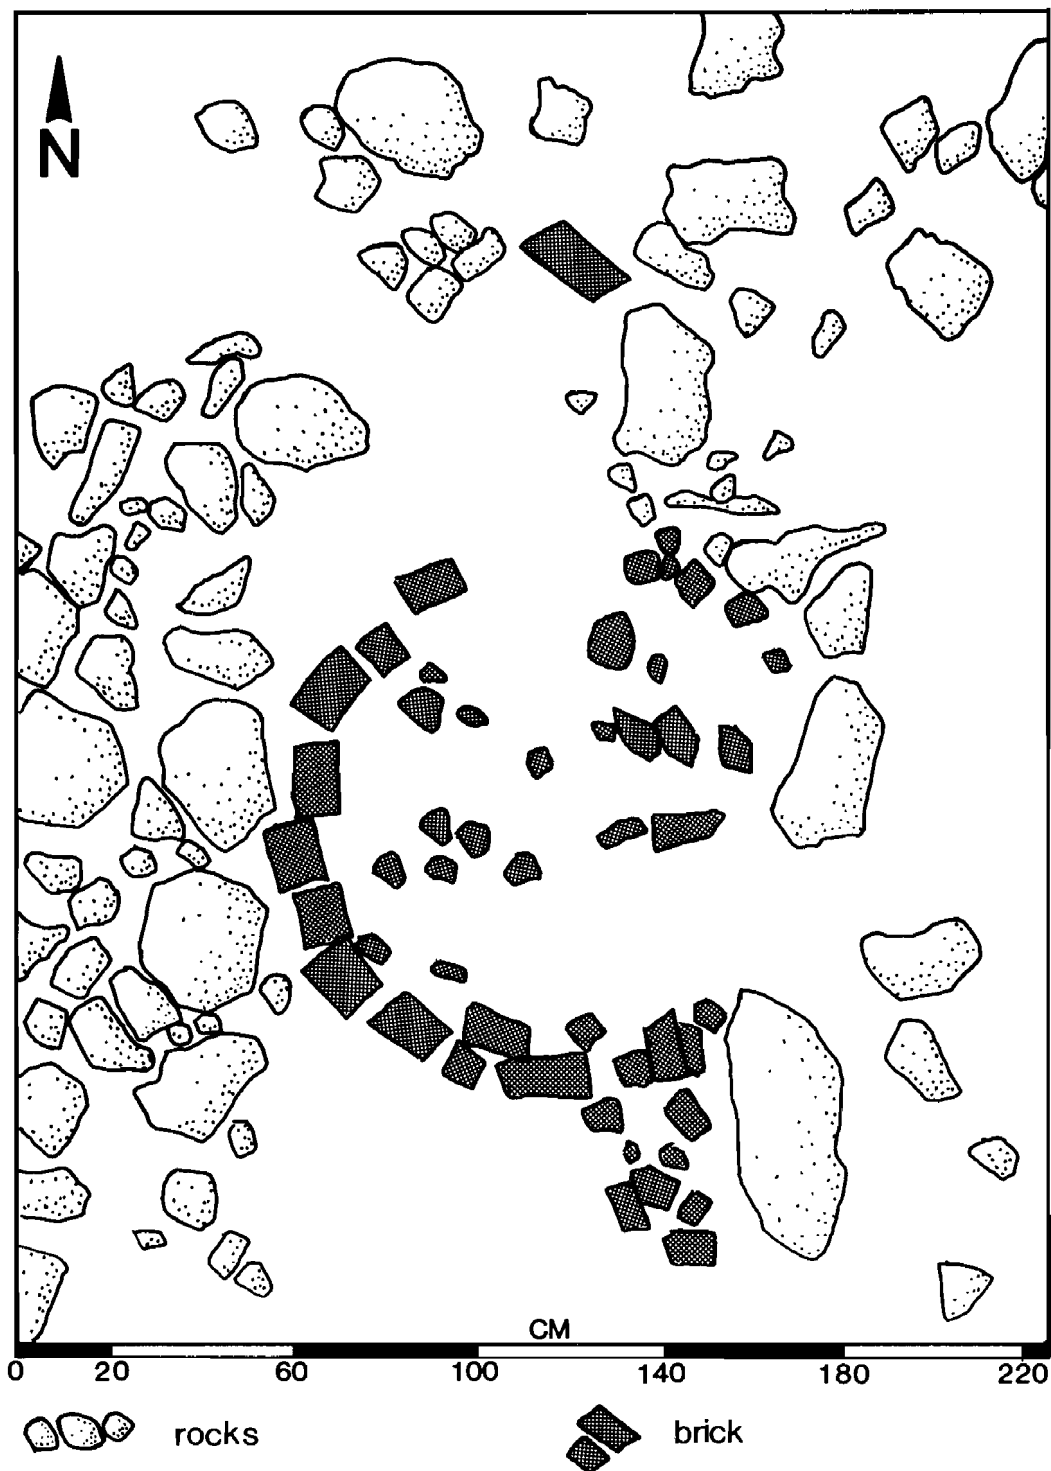
FIGURE 34
J. Chambers Site, Locus 16, N-10278,
7NC-A-15, Plan View of Brick Well Feature

century. Four 1m test units were excavated at the site, and a shallow, brick-lined well feature was uncovered (Figure 34). In addition, several stone wall foundation lines were uncovered below the sod level. These foundation lines were found to be shallow and unconnected. Artifacts found were from disturbed stratigraphic contexts, and included redwares, whitewares, and pearlwares intermixed with modern 20th century debris. This site was included in the Phase II testing program, because there were evidently some subsurface features present. Further discussion of the testing at this site is included in the Phase II section of this report.

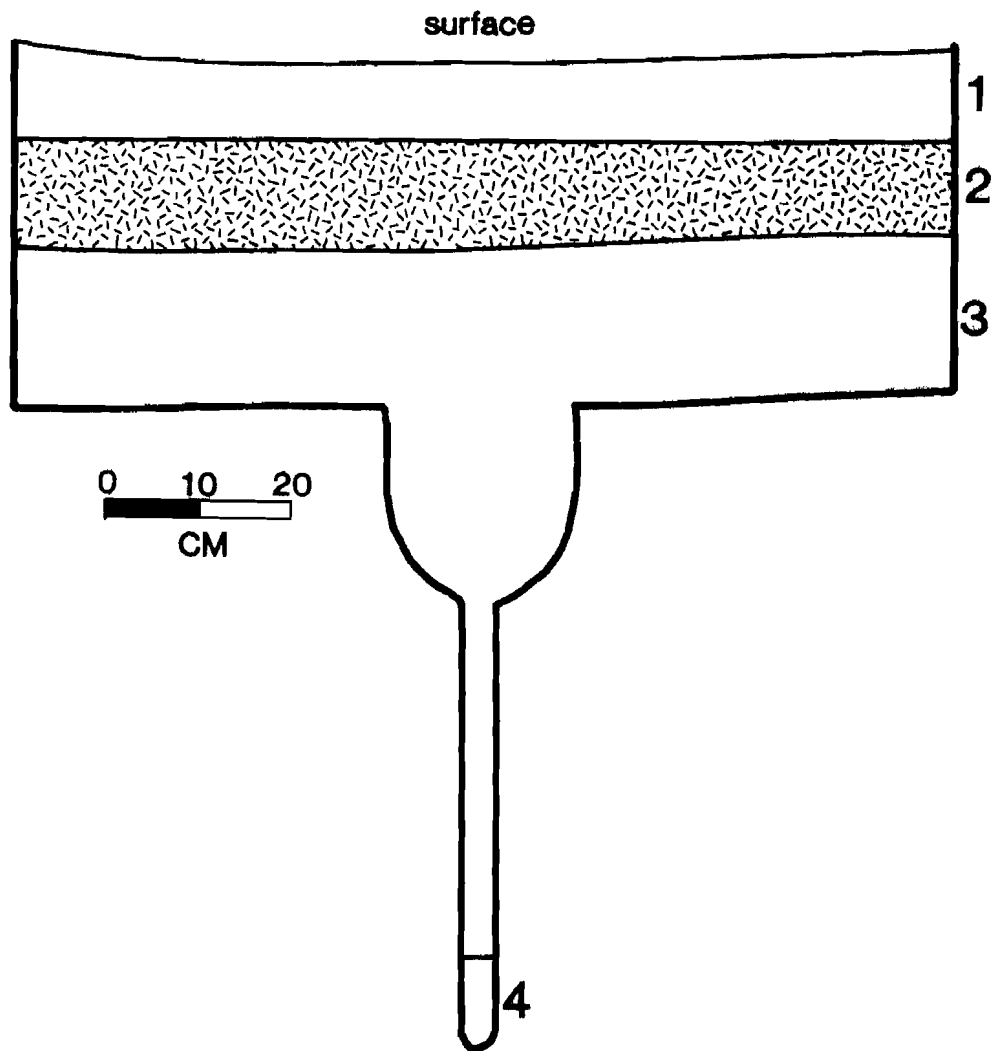
FIGURE 37
Locus 43, Profile of Test Unit 1, North Wall

1-brown silt loam (humus and root material)

2-brown silt loam with gravels

Phase I testing was conducted in Locus 43, the structure identified as "J. Chambers" in Figure 5. The excavation of 3 1m test units and 5 shovel tests revealed an area of subsurface disturbance ranging from 20cm to 70cm below ground surface in the vicinity of a house that was torn down in the 1930s (Figure 37). No further testing was conducted in this area because modern disturbance had altered the site's context.

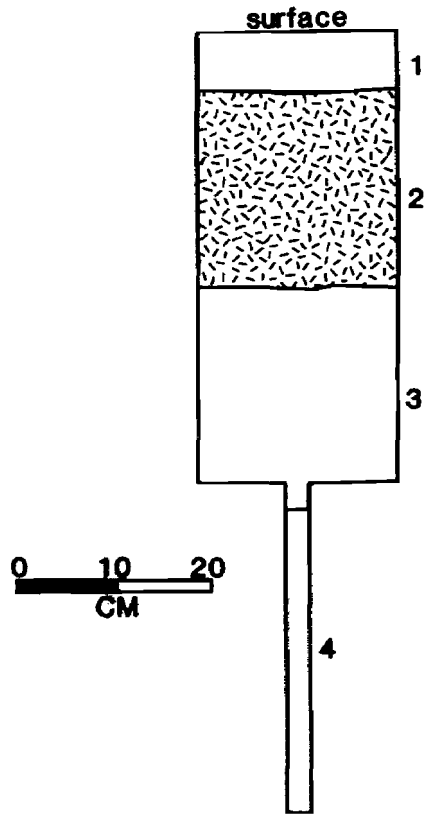
Locus 42, Profile of Test Pit 9,
Showing Previous Disturbance

1-humus

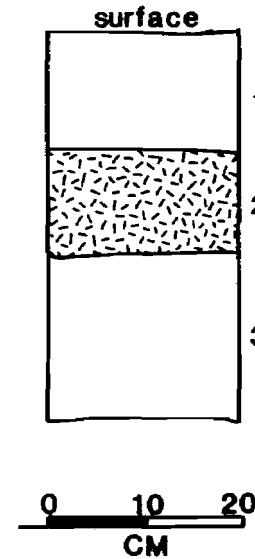
Locus 29, Profile of Shovel
Test Pit 1

1-root mat underlain by brown silt loam

2-yellow brown silt loam

segment. On the west side of the road, 1964 DelDOT activity had shifted the roadbed eastward, thus the present proposed ROW on the west side was found to be located in a disturbed context. This shifting had also occurred on the east side of the road, from the vicinity of Mendenhall Village to Valley Road. Loci 39, 40, and 42 are representative of this realignment, and a typical stratigraphic profile from this disturbed context is shown in Figure 40. In the vicinity of Cavender's Shops and the first Harmony Schoolhouse, extensive grading and subsurface disturbance and construction precluded any testing in the area. Landscaped yard areas with considerable subsurface disturbance were represented by the stratigraphic profile from Locus 29, illustrated in Figure 41.

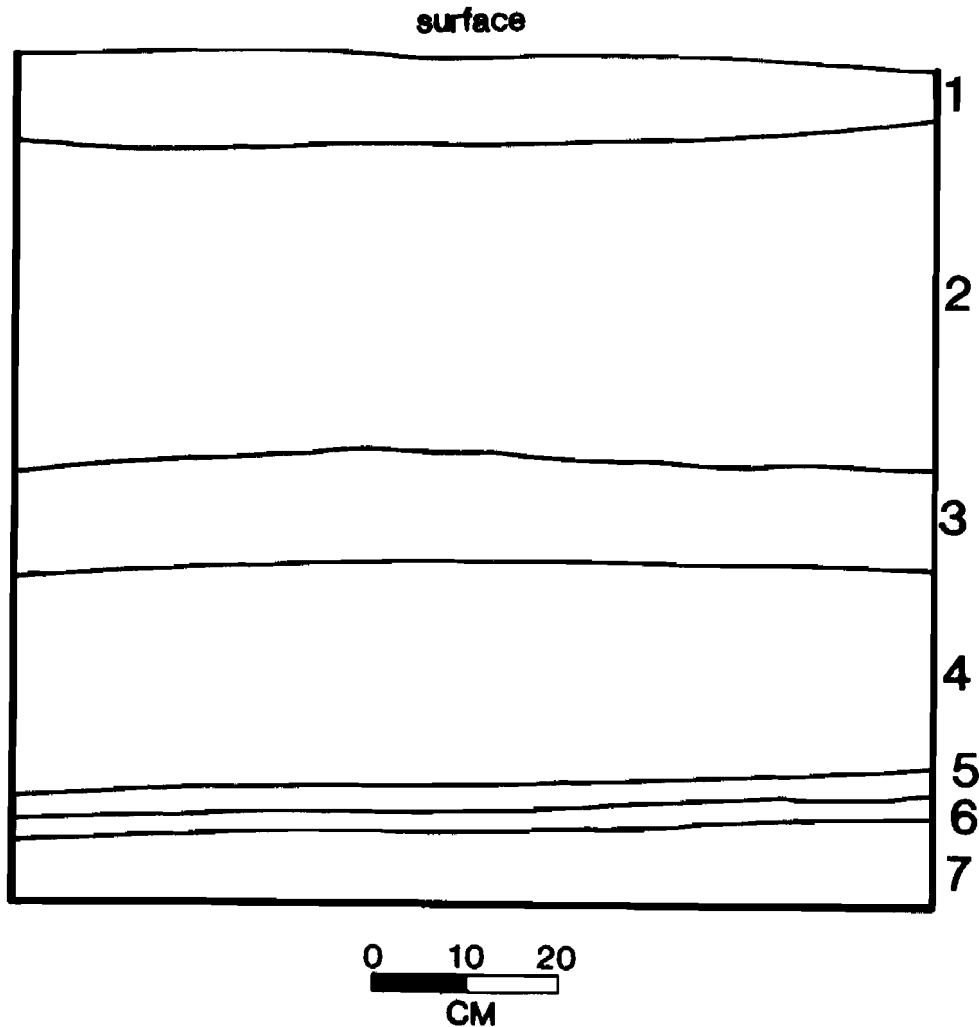
Locus 26, Hockessin Valley Site,
Profile of Test Unit 1, North Wall

1-sod layer--humus

2-brown silt loam--prehistoric artifacts recovered

7-gray clay with iron stains and decomposing schist--very moist

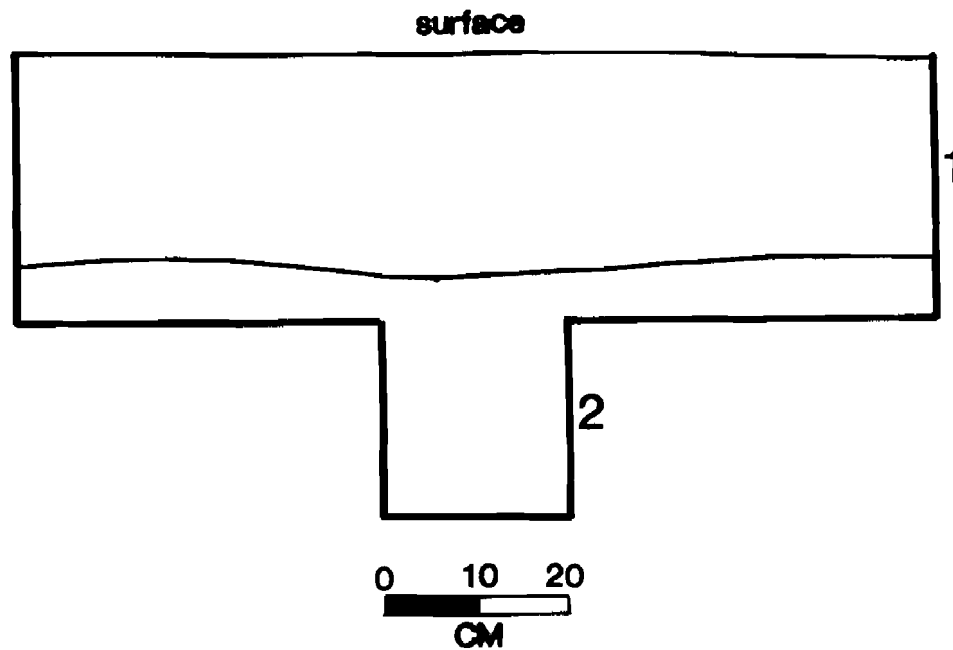
FIGURE 43
Locus 17, Profile of Test Unit 6, North Wall,
Showing Agricultural Land Use

- 1 - brown silty sandy loam full of gravels-- plow zone
2 - orange sandy loam full of decomposing schist/gneiss fragments

In this segment, the soils and profiles found in Loci 15, 16, 17, 28, and 29 were indicative of agricultural land use, i.e., plowed fields. An example of a typical stratigraphic profile for these areas is illustrated in Figure 43. In all cases plow-disturbed soils overlay in situ soils developed from weathered bedrock.

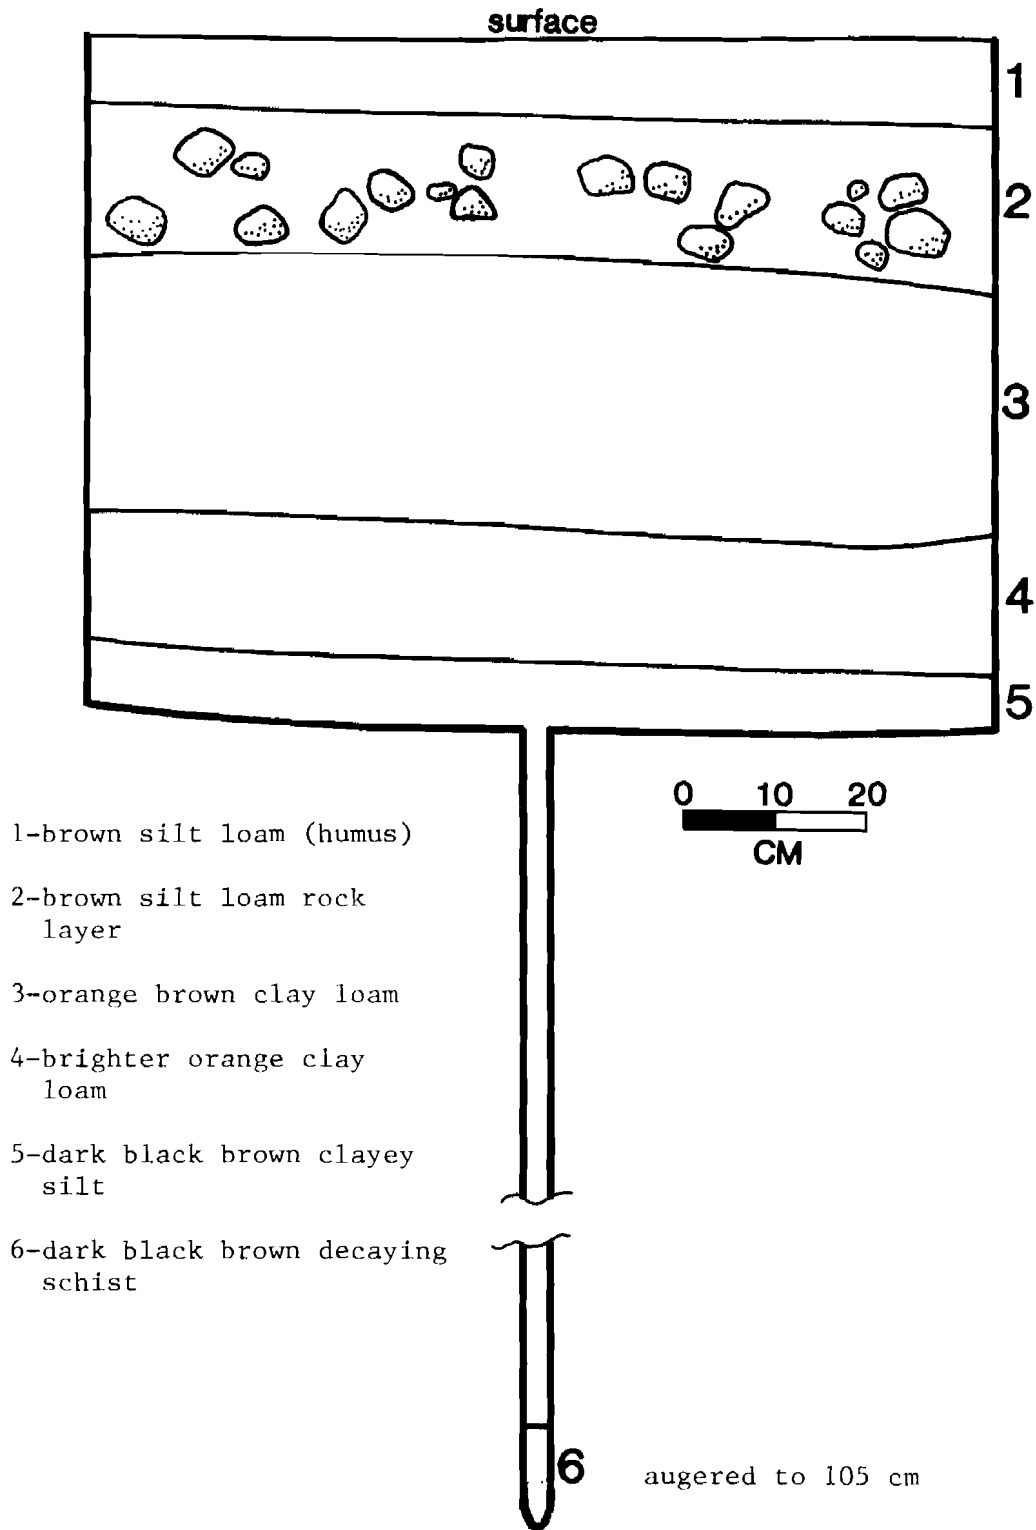
Locus 19, Tweed's Tavern Site, Profile of Test Unit 4, South Wall

The Tweed's Tavern Site is located on the northwest corner of the intersection of Limestone Road and Valley Road. Background research indicated that the present house at the site had once been Tweed's Tavern. Five 1m test units were excavated in the yard area around the house, and numerous late 19th and 20th century artifacts were recovered. These artifacts were found in a disturbed stratigraphic context (Figure 45). The results of this testing indicated that the yard area around the dwelling was extensively disturbed. The property owners suggested that excavations be conducted in the crawlspace under a recent addition to the house. Additional investigations consisted of two 2' square test units in the crawlspace (Figure 46). Due to the cramped conditions in the crawlspace, it was not possible to place the units along the wall of the original foundation to look for a builder's trench. Nonetheless, faunal remains, whiteware fragments, buttons, oyster shell fragments, redware fragments, and window and bottle glass were recovered from these excavations. These artifacts were found within the top 20cm of the ground surface. Figure 47 illustrates the profile of test unit 6 in the crawlspace. Further excavations

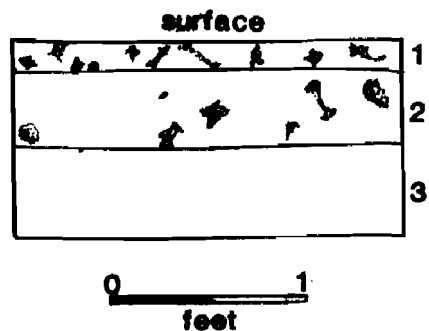
FIGURE 47
Locus 19, Tweed's Tavern Site,
Profile of Test Unit 6

- 1-building debris and rubble, mortar and concrete
- 2-dark brown silt loam intermixed with mortar and concrete,
rock and rubble
- 3-yellow silty clay
- rodent activity present throughout yellow clay
-

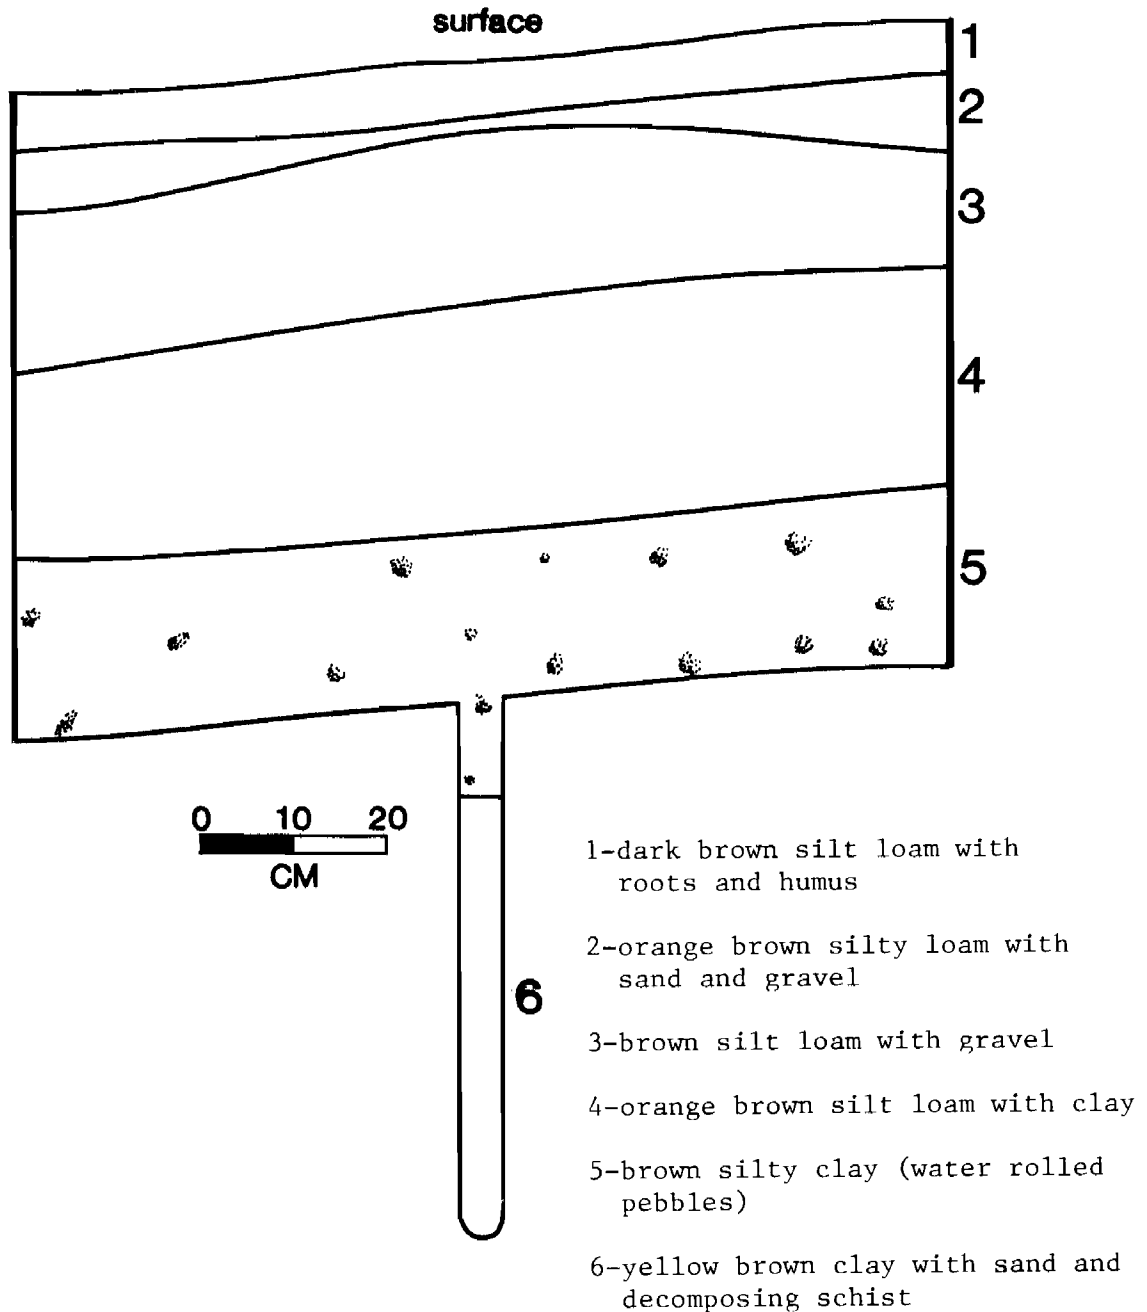
FIGURE 49
Locus 22, Springer Barn Site,
Profile of Test Unit 6, North Wall
