PHASE I SURVEY RESULTS

Route 7 North Corridor, Current Status of Cultural Resources

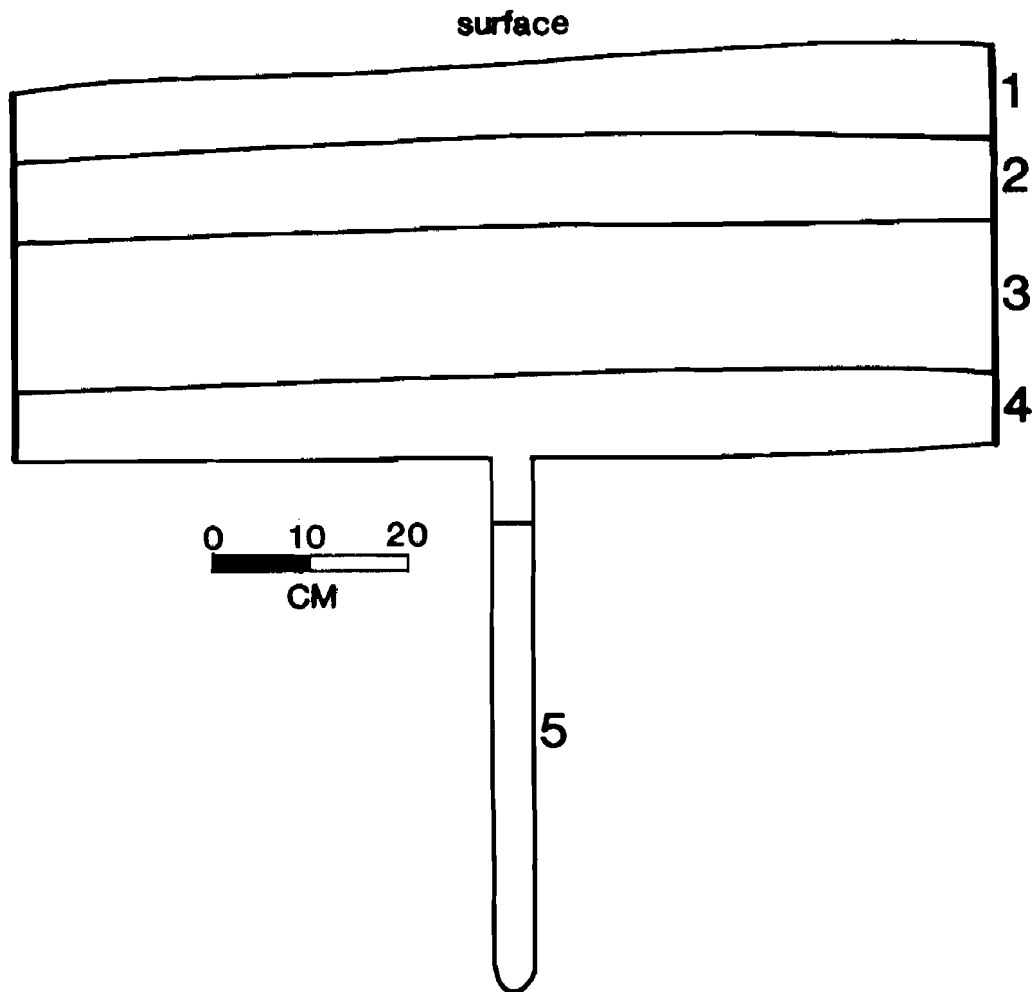
FIGURE 50
Locus 32, Beeson Yeatman House Site,
Profile of Test Unit 3, North Wall

1-humus

2-yellow brown gravelly silt loam--historic artifacts recovered
