CULTURAL RESOURCE SURVEY
SURVEY UPDATE FORM

CRS # S-08571

Resurveyed for US113 North/South Study, Delaware Department of Transportation, by John Milner Associates, Inc.

CRS # S-08572

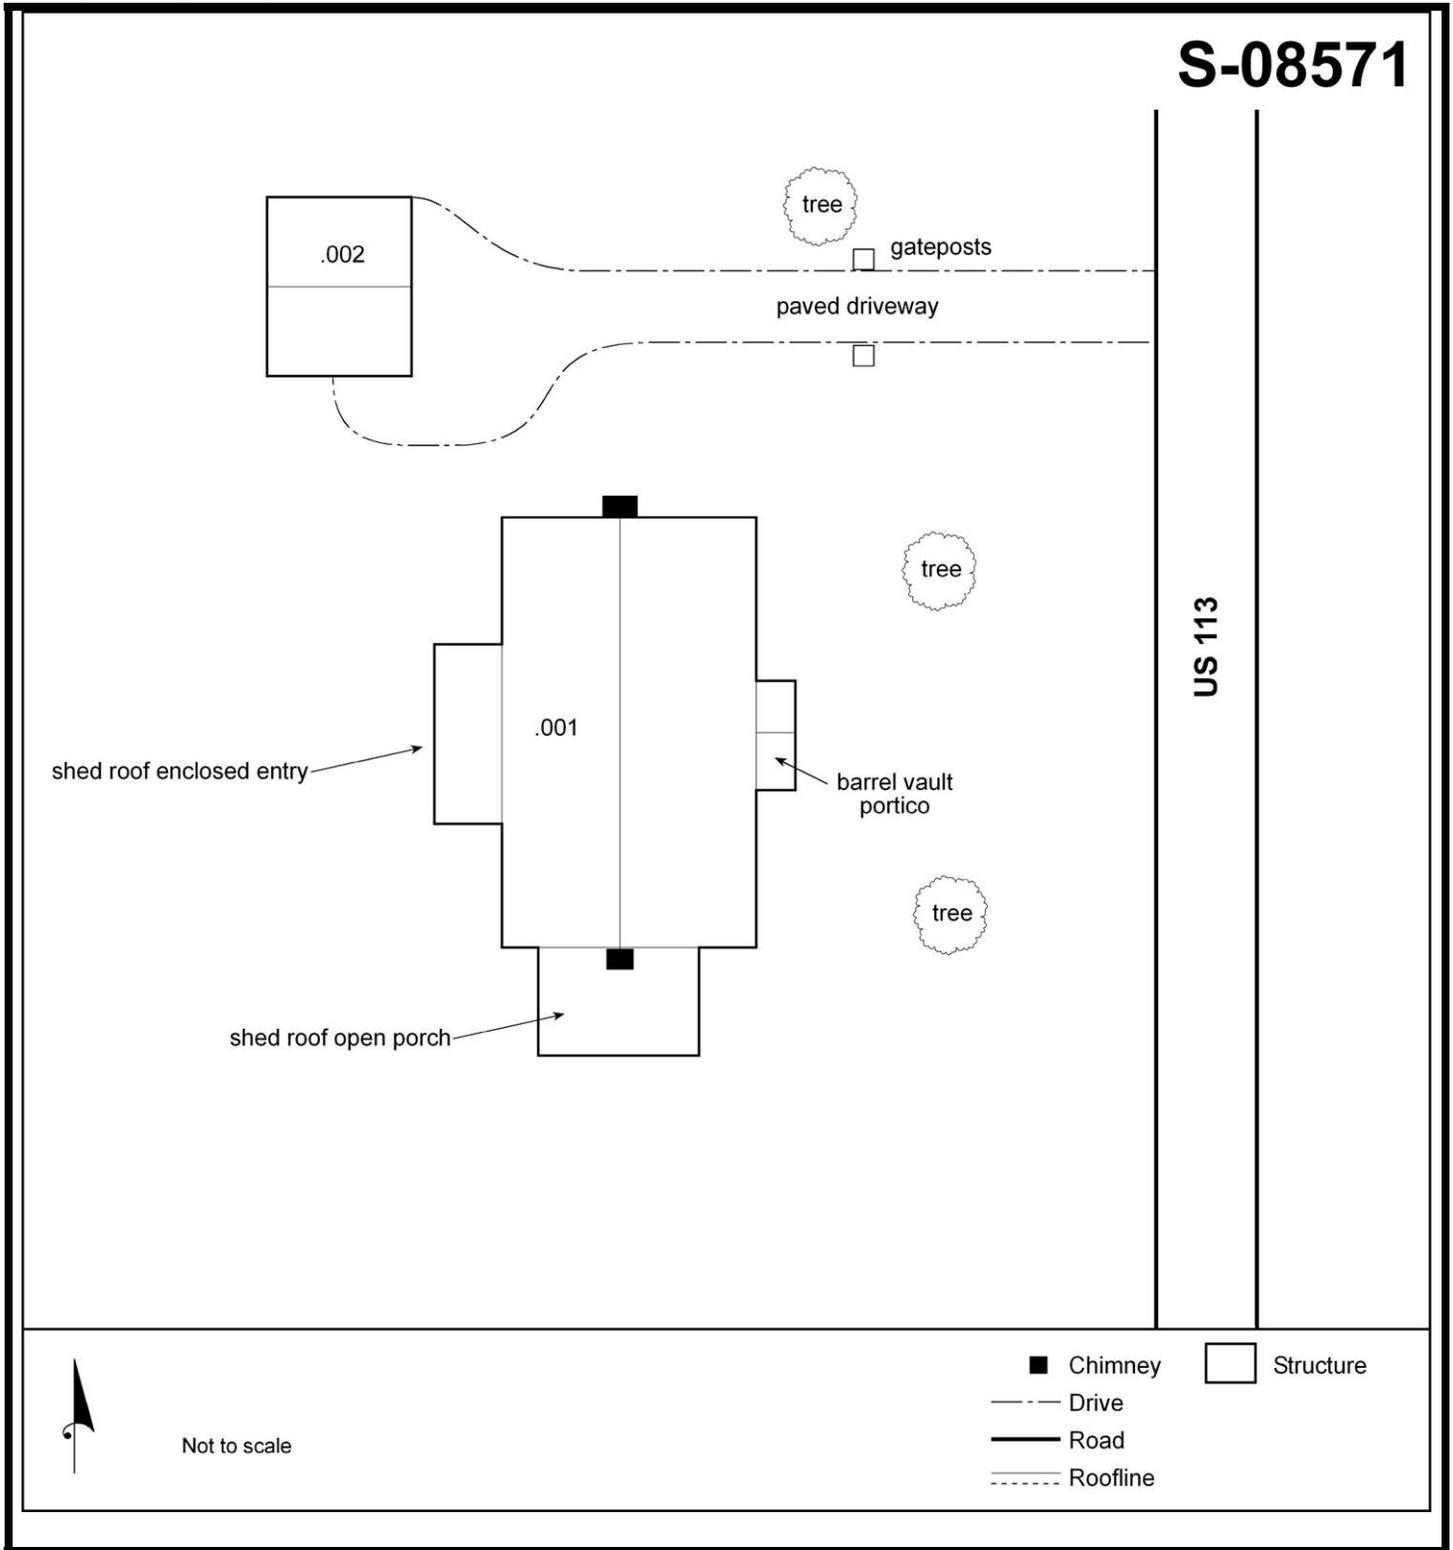
4. SITE PLAN:

9.	INTERIOR:
10.	LANDSCAPING: set back from road, large grassy level lawn, a few mature trees near house, paved driveway on N side of lawn leads back to garage
11.	OTHER COMMENTS:
