# Department of Transportation

## I-495 Bridge Update

June 18, 2014

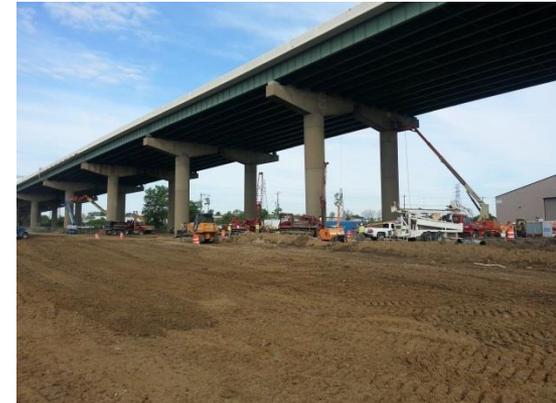
# June 2, 2014 Closure

- ▶ Bridge and Maintenance crews inspected the superstructure and the ground
- ▶ Notification to the Secretary at 2:00PM
- ▶ Notification to the Governor's Office
- ▶ Commenced closure procedure as quickly and safely as possible
  - Between Terminal Avenue and 12<sup>th</sup> Street

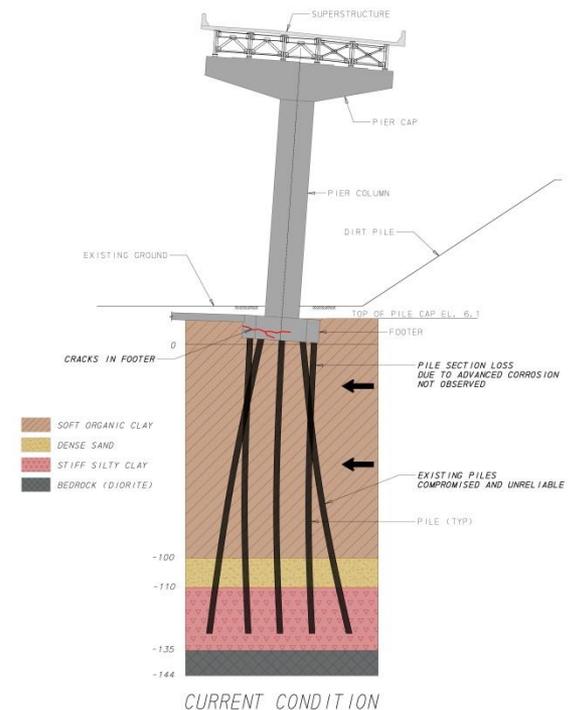
# Condition of the Bridge

- ▶ Tilt sensors installed
- ▶ 4 of the 37 support columns were tilted as much as four percent out of vertical alignment
- ▶ Inspection of affected piers and subsurface
  - No corrosion
  - Cracks found in footers
    - Lateral displacement of soil
- ▶ No damage to other piers
- ▶ Inclinometers installed
- ▶ Convened team of experts to assess options

- ▶ AECOM and JD Eckman (design and construction)
  - Stabilize and re-align a 400-foot section of the bridge
  - New concrete-filled shafts down to bedrock beneath the columns create a stable surface above the underlying unstable soil
  - Concrete shafts will be tied together with a reinforced concrete grade beam
  - Temporary jacking towers to be erected on the grade beam to restore the bridge's superstructure to its original position, and allow reopening
  - Permanent new concrete columns will be erected taking the place of the jacking towers

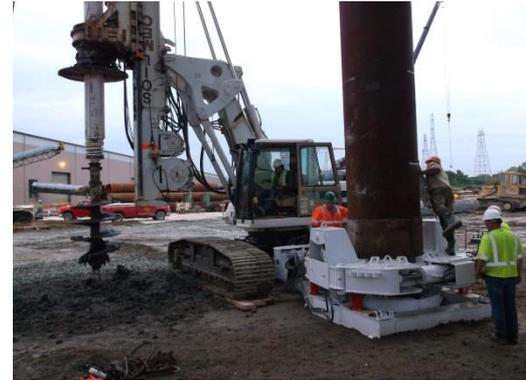
# Work to Date

- ▶ Work taking place 24/7
- ▶ 50,000 tons of dirt removed
- ▶ Existing concrete piers tied together
- ▶ Drilling has begun for the new foundation
- ▶ Equipment and materials have arrived from across the country
  - Steel cages from the Tappan Zee Bridge project
  - Casings from Oklahoma and Washington State
  - Drilling rigs from New Jersey and Texas
