SUSSEX COUNTY

East - West Routes

Update

Summary of Sussex County East-West Routes

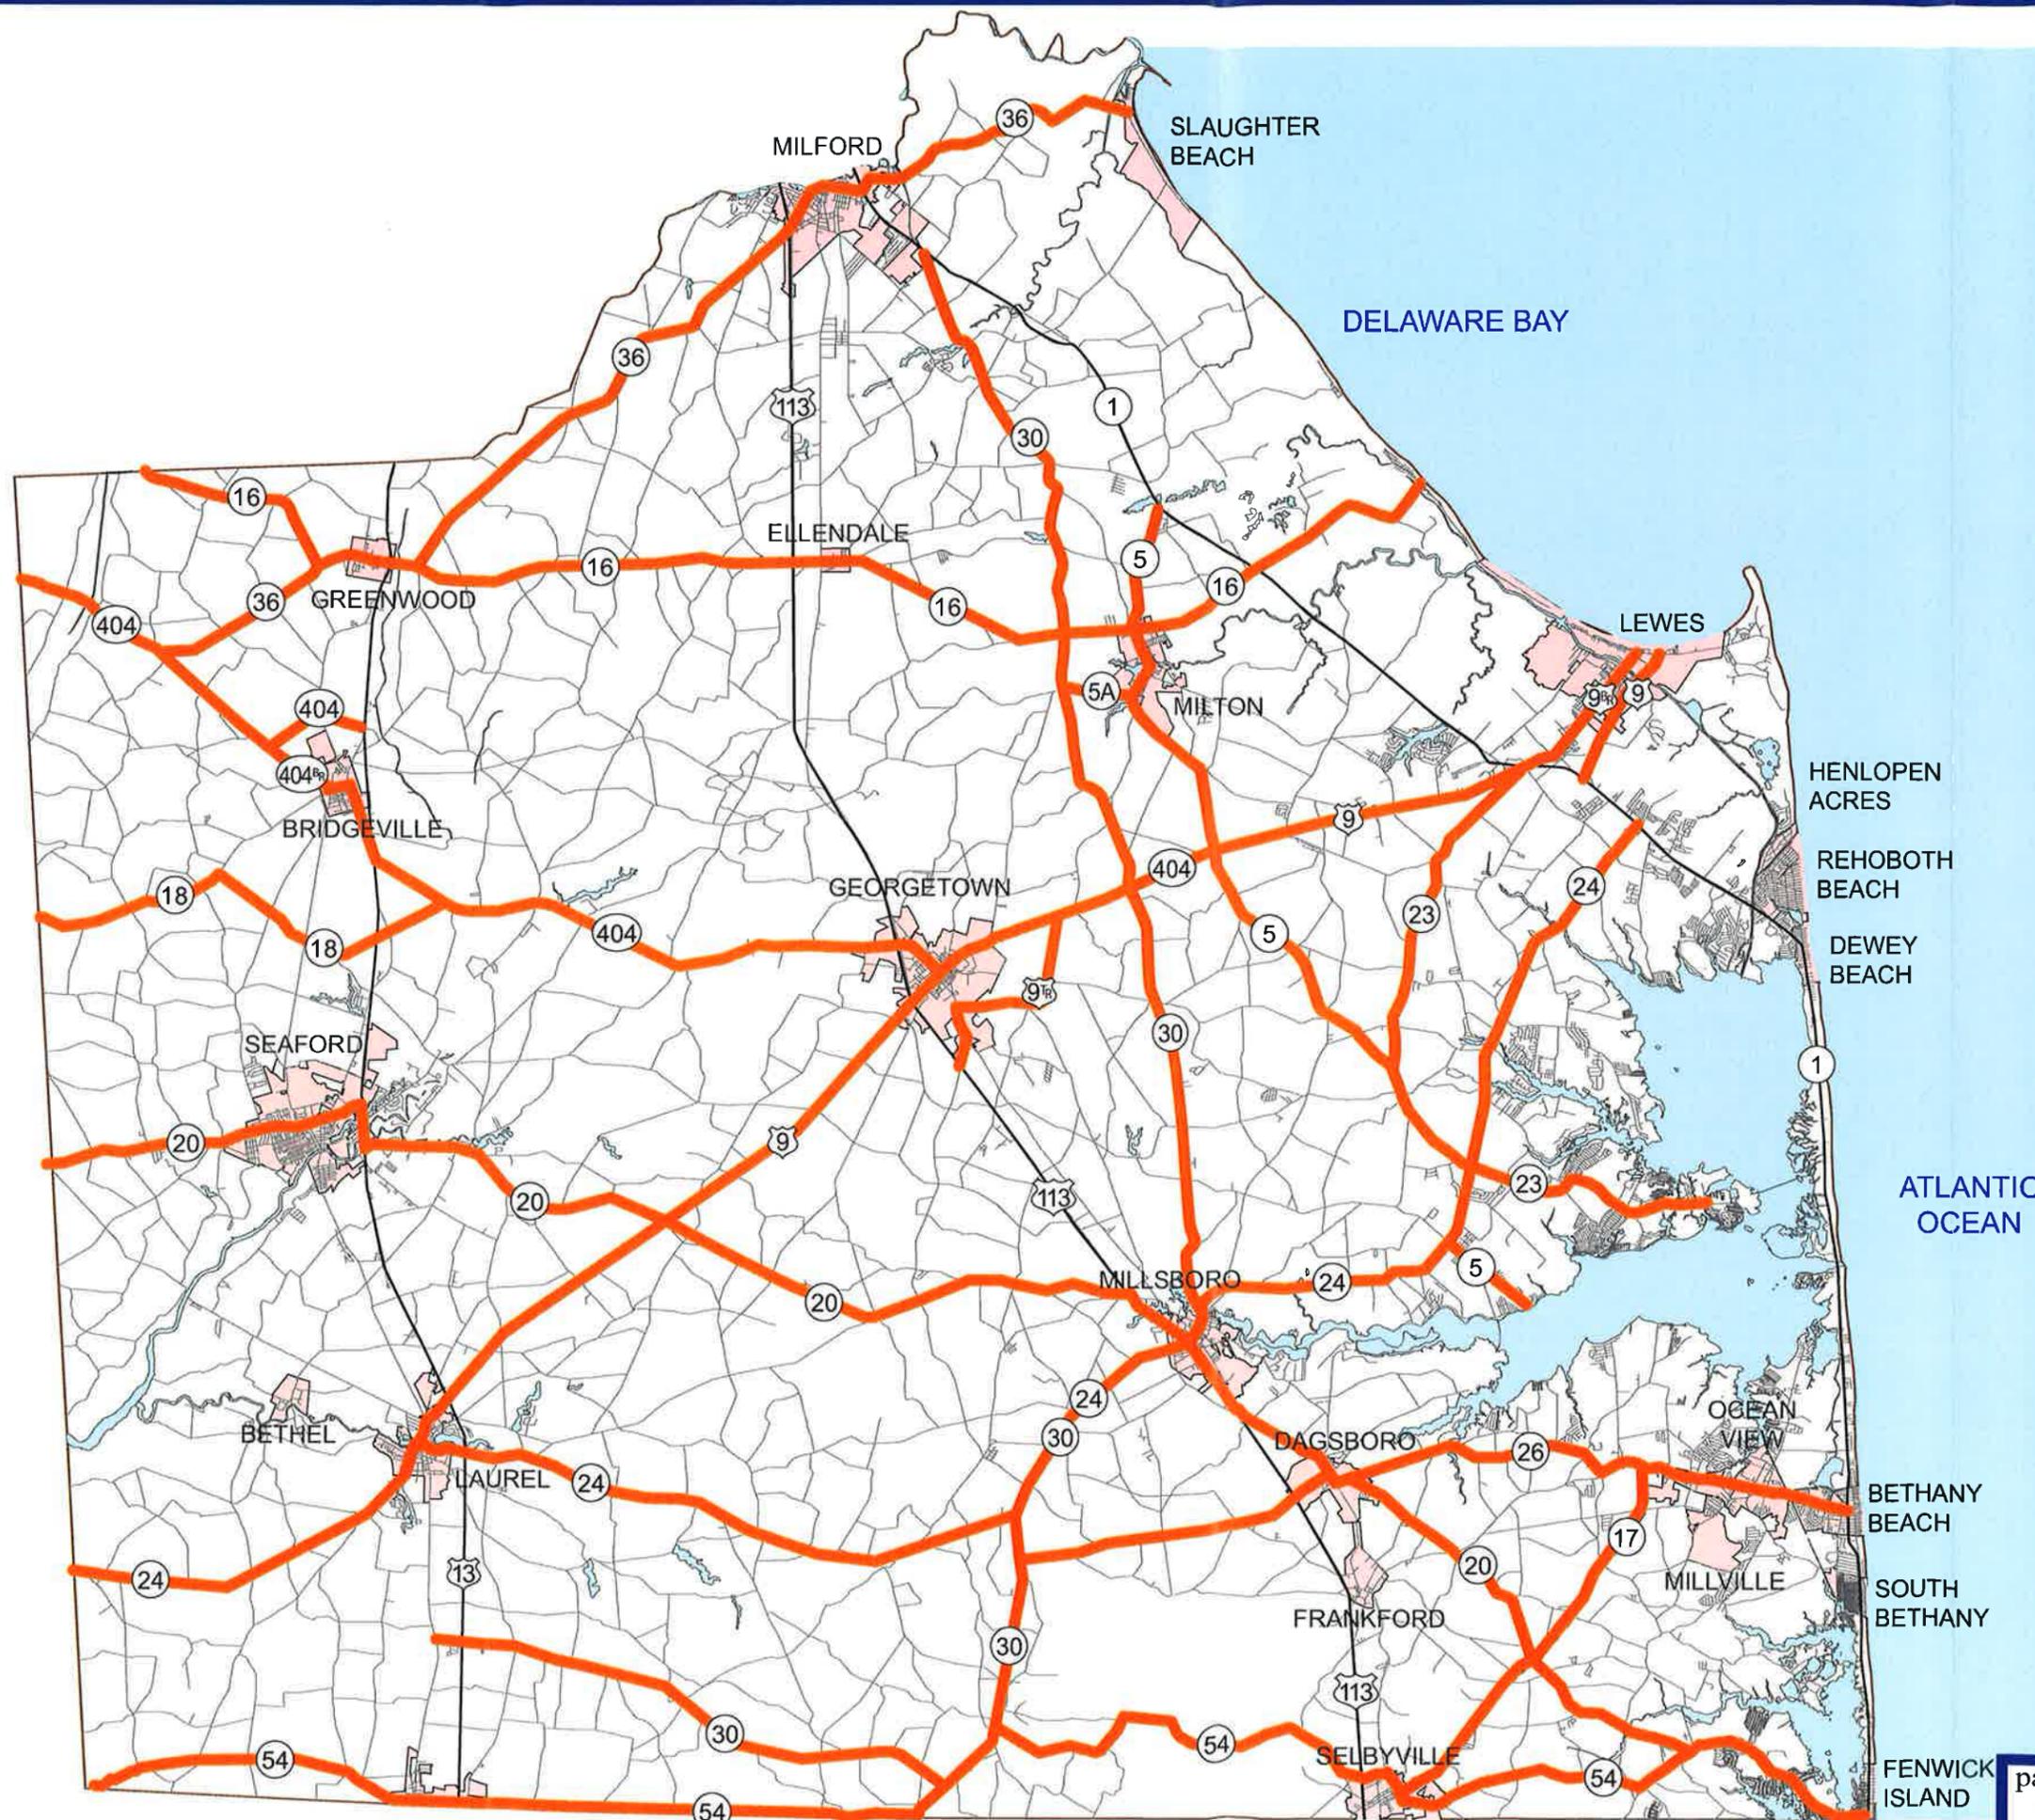
Routes Reviewed

Figure 1 shows the routes that were reviewed, a representative sample photograph of each route is shown on *Figure 2*, and *Figure 3* identifies the conditions of the shoulders and location of bike lanes, parking and sidewalks.

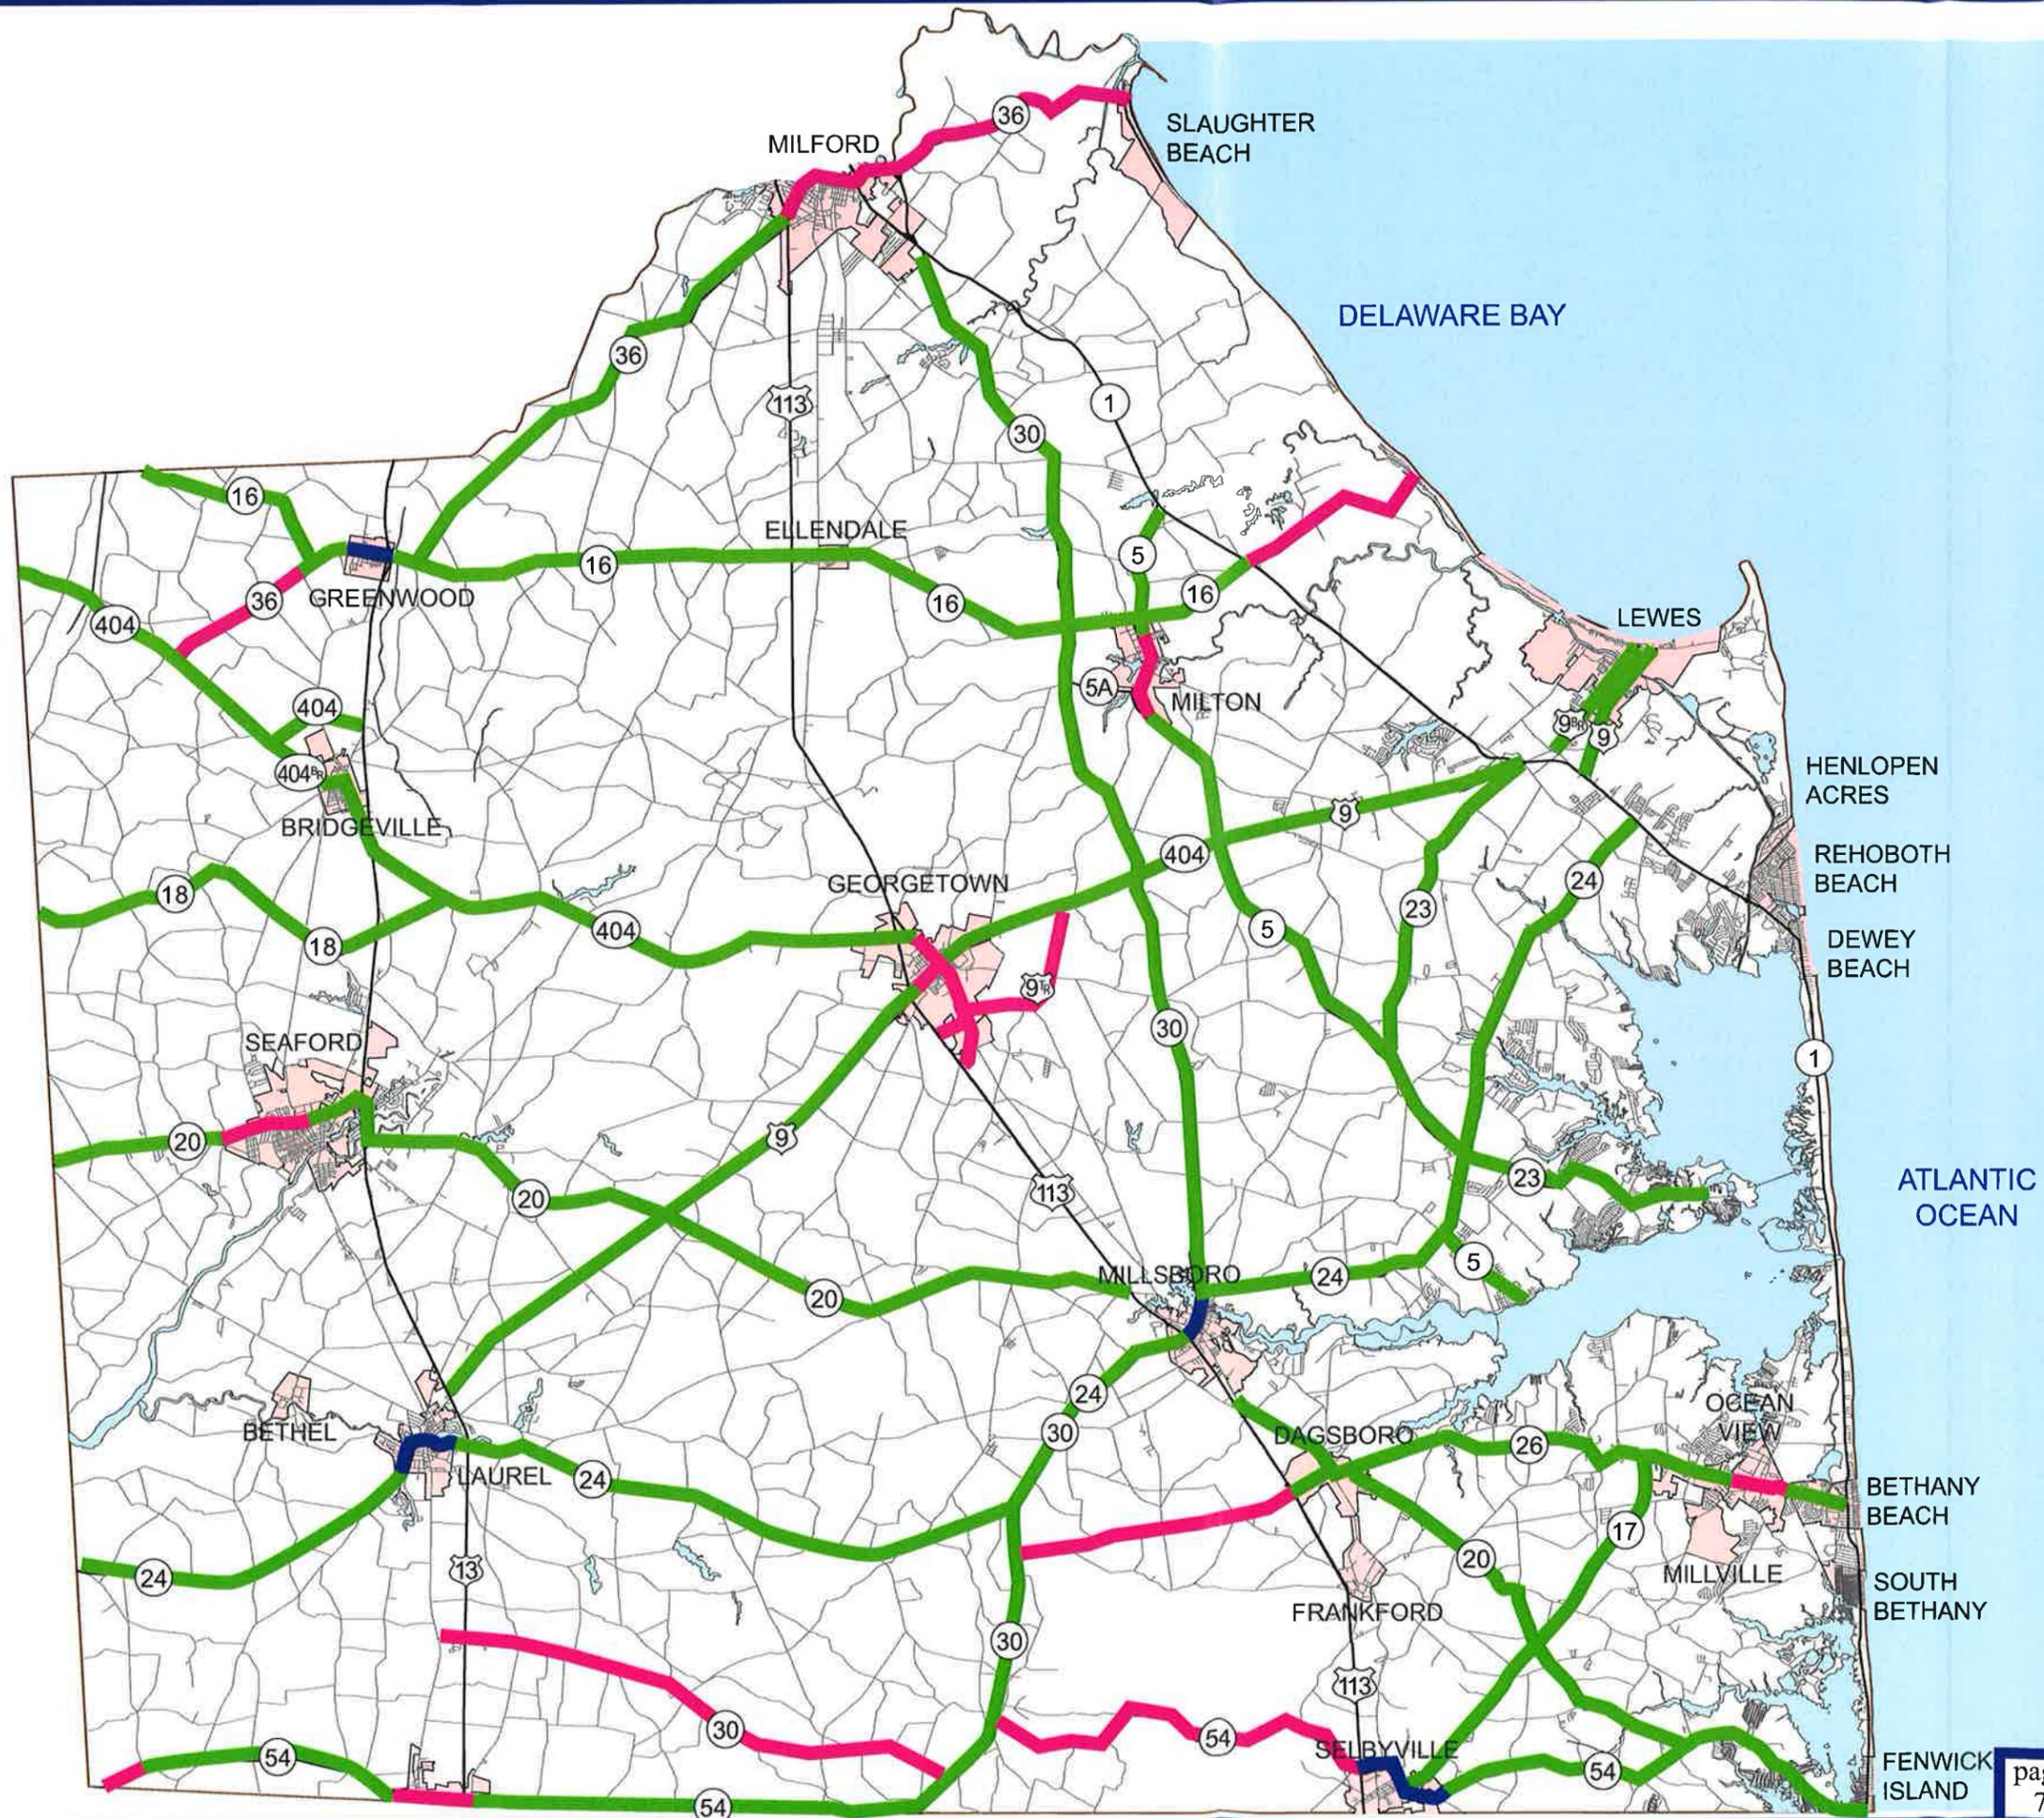
Figure 3

East-West Routes, 2004 Update Existing Shoulder Conditions

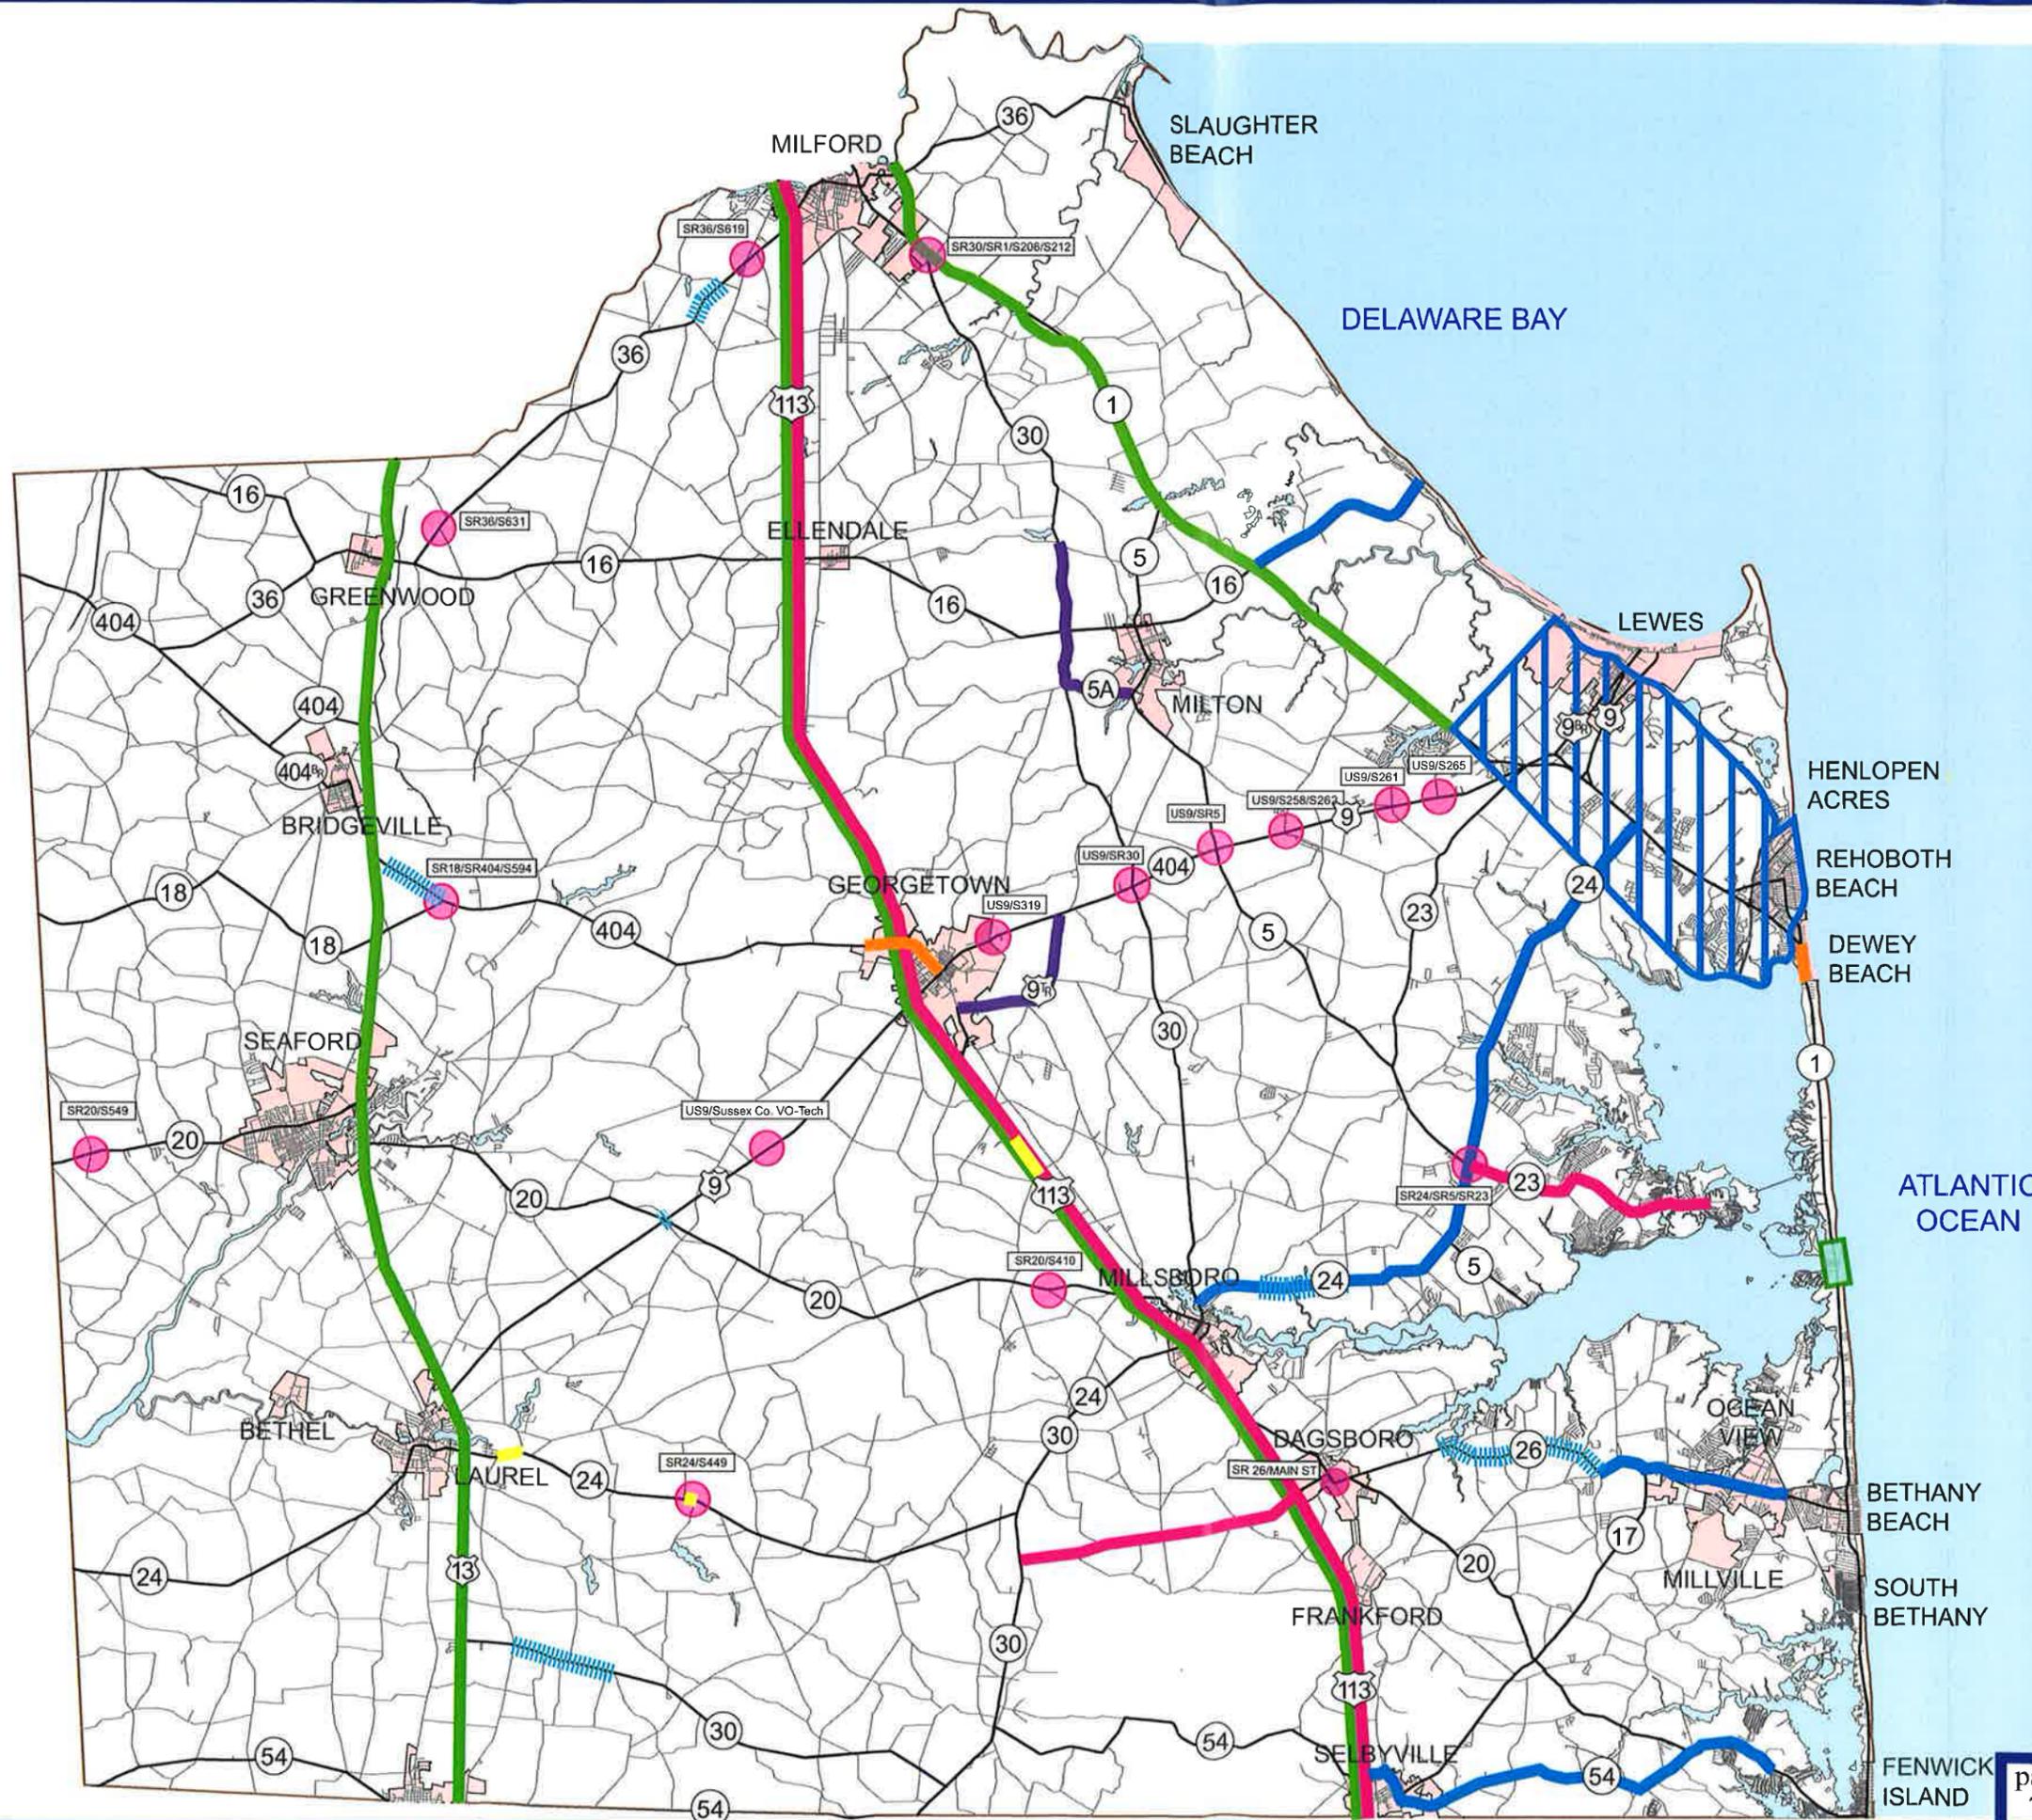
The figure shows the large number of projects currently active in Sussex County, and has been used as a reference in developing future recommendations.

Note: Other than the Indian River Bridge Replacement, Bridge Projects are not shown.

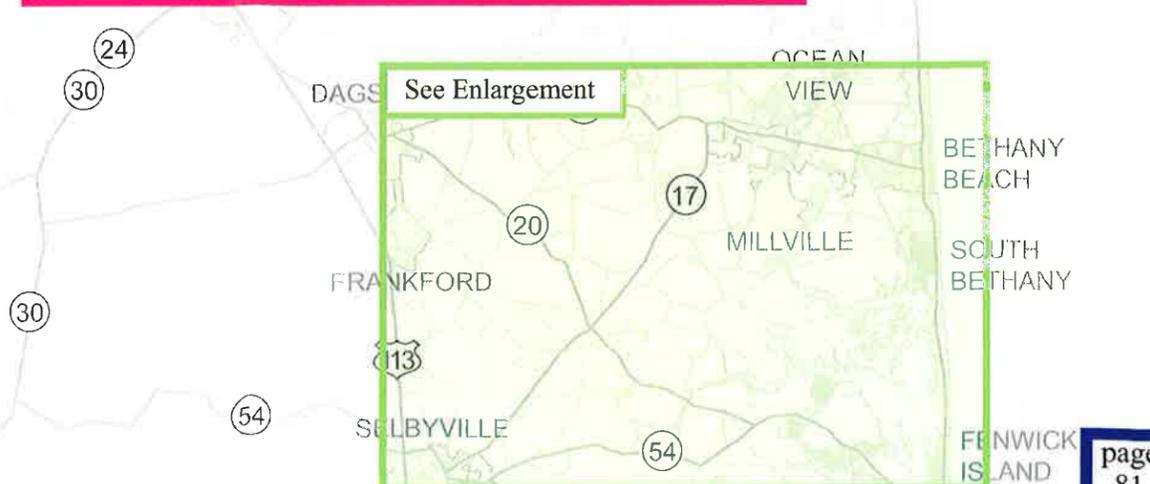
Figure 7

East-West Routes, 2004 Update 2004 Recommendations*

* Note: 2004 Recommendations include new recommendations, recommendations from previous reports that have not yet been included in the CTP, and modifications to projects currently listed in the CTP.

Based on this review, the key issues were summarized to identify and prioritize recommendations, which are shown on *Figure 7*.

The recommendations in this report include new recommendations, recommendations from previous reports that have not yet been included in the CTP, and modifications to projects currently listed on the CTP, but not yet started. A description of the recommendations (shown in *Figure 7*) include:

Overall, the roadway design characteristics of the routes examined continue to be generally good. Various issues were noted along each route, as detailed in the summary of that route in *Section II* of this report. Based on traffic volumes, development pressure, accident history, and observed conditions, several priority recommendations were developed, as discussed in *Section III* and shown on *Figure 7*.
