US 301 PROJECT
 Maryland / Delaware Line to SR1
 South of the C&D Canal
 New Castle County, Delaware

US 301 SPUR ROAD 2019 MONITORING REPORT

June 2021

DELAWARE DEPARTMENT
 OF TRANSPORTATION

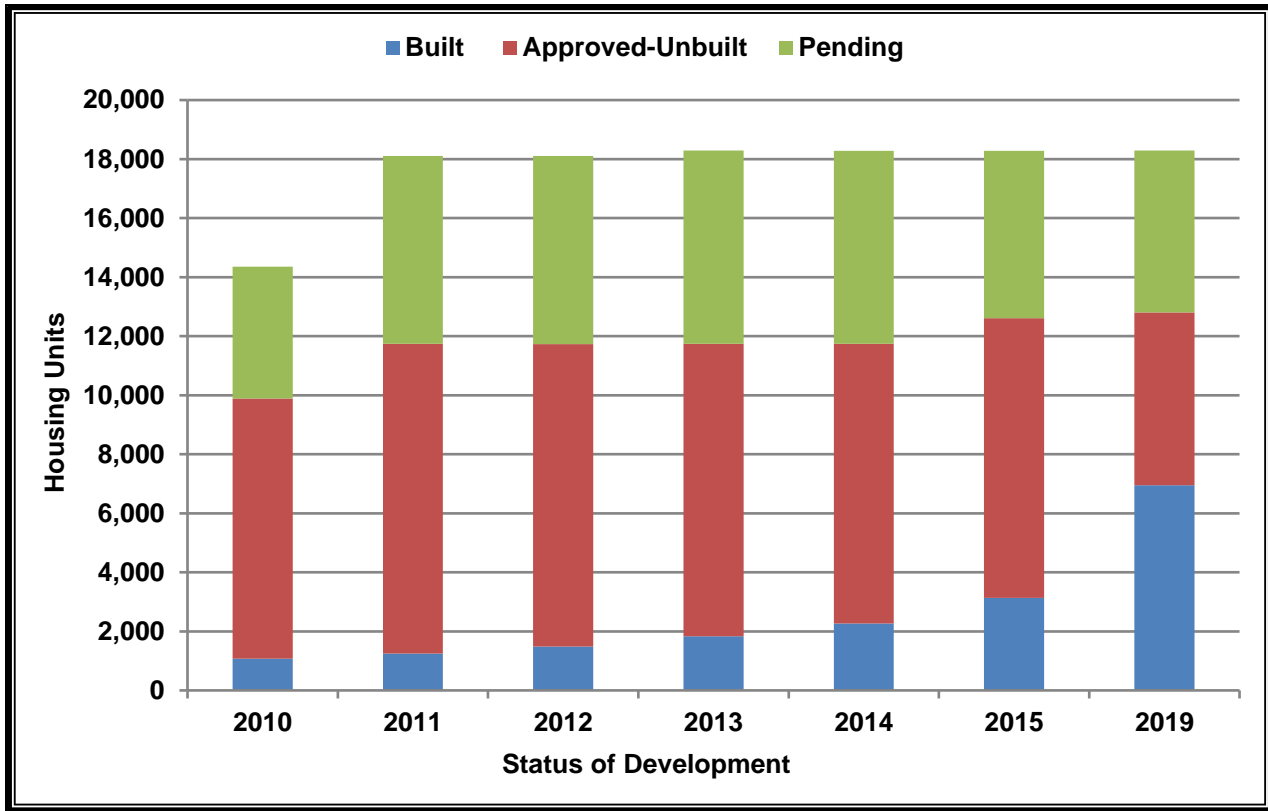
Figure 3: Residential Development in Study Area

The ongoing residential development within the study area consists of a variety of housing types, including single-family detached dwellings, townhomes, and apartments. The various residential developments were classified in differing stages of completion: Built, Approved but Unbuilt, or Pending (includes Exploratory and Expired Proposals). Figure 3 depicts the number of housing units built, approved but unbuilt, and pending at the end of 2010 to 2015 and 2019.

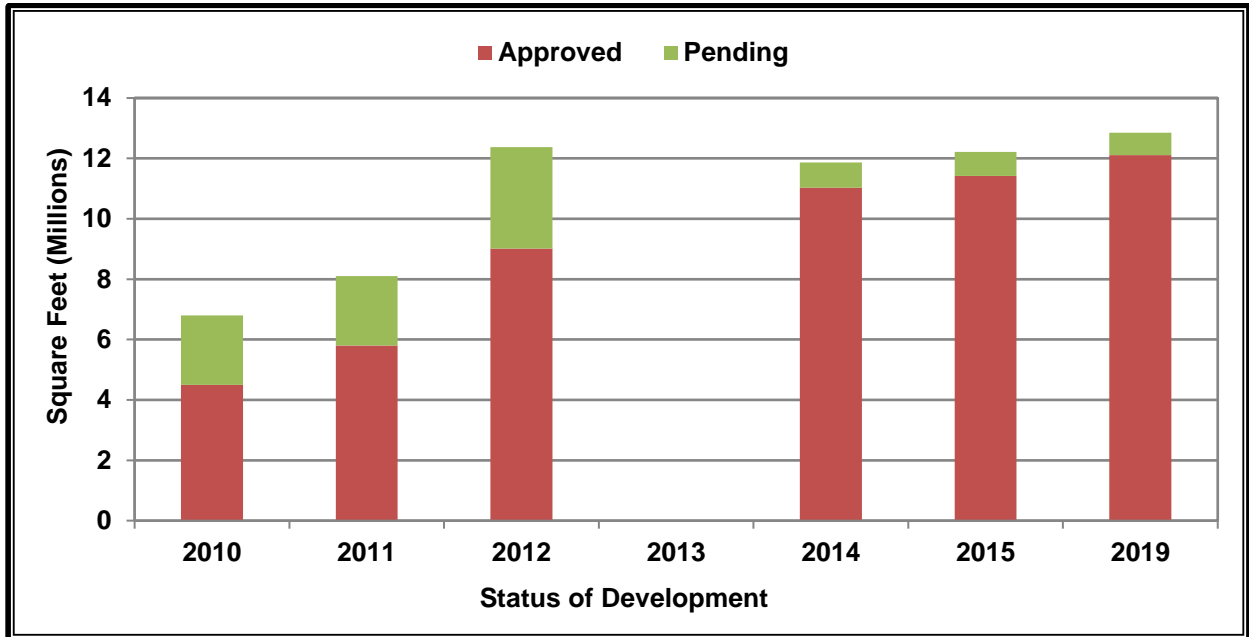
Figure 4: Non-Residential Development in Study Area

Figure 4 depicts the cumulative approved and pending commercial development in the study area since the Spur Monitoring Program commenced.

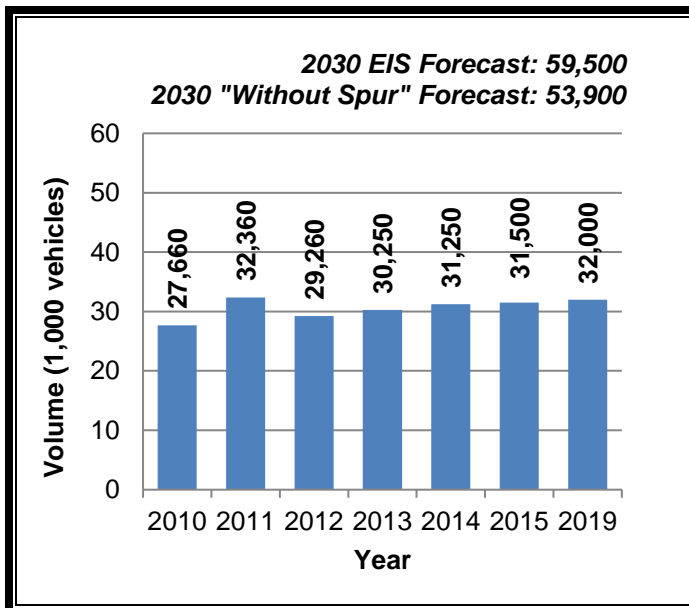
Figure 6: Average Daily Traffic (ADT) for Summit Bridge Rd at the Summit Bridge

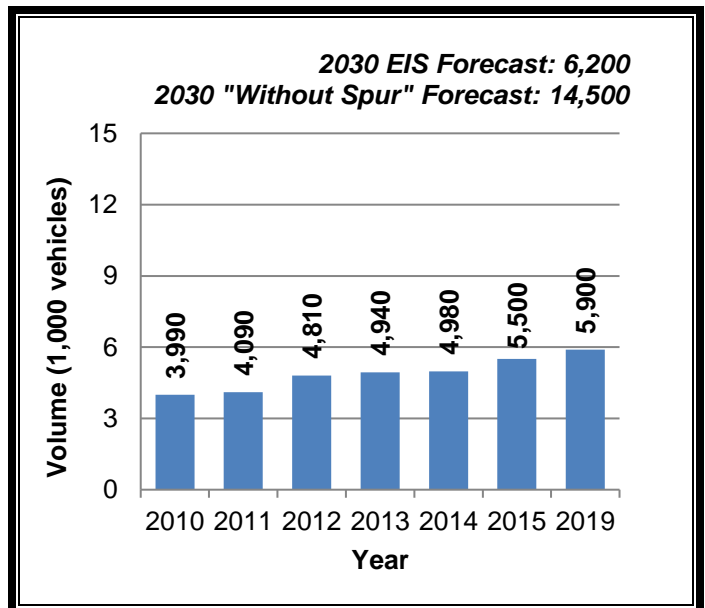
Figure 7: Average Daily Traffic (ADT) for Choptank Rd, North of Churchtown Rd

Daily traffic volumes increased on all of the roadways studied between 2010 and 2015. This included Choptank Road where the volume increased by 38%, US 13 at St. Georges Bridge where volumes increased by 23%, The Summit Bridge where volumes increased by 14%, Summit Bridge Road between Mt. Pleasant and Armstrong Corner Road where volumes increased by 9%, Summit Bridge Road north of Mt. Pleasant where volumes increased by 7%, and SR 1 at Roth Bridge which experienced an increase of 10% between 2010 and 2015.

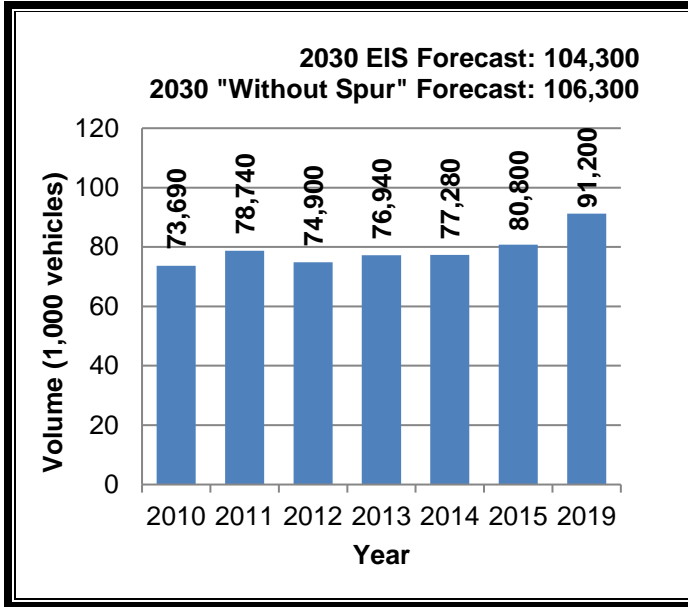
Figure 8: Average Daily Traffic (ADT) for Roth Bridge (SR 1)

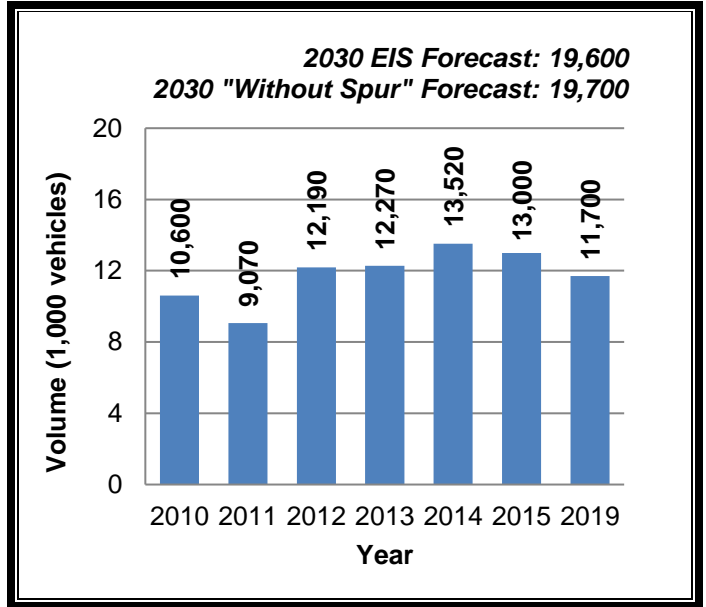
Figure 9: Average Daily Traffic (ADT) for St. George's Bridge (US 13)

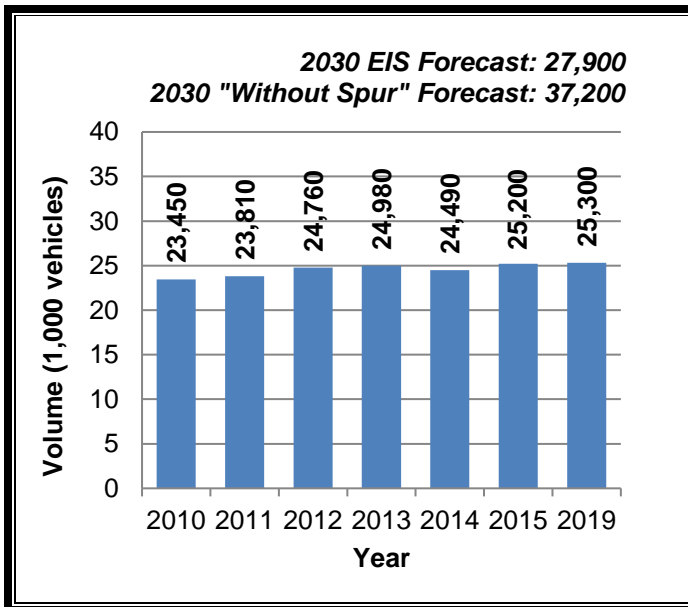
Figure 10: Average Daily Traffic (ADT) for Summit Bridge Rd North of Mt. Pleasant

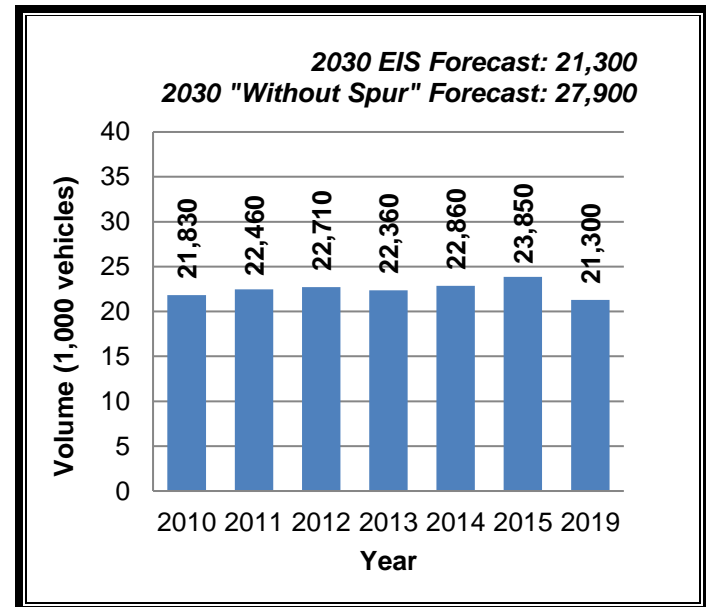
Figure 11: Average Daily Traffic (ADT) Summit Bridge Rd between Mt. Pleasant and Armstrong Corner Rd

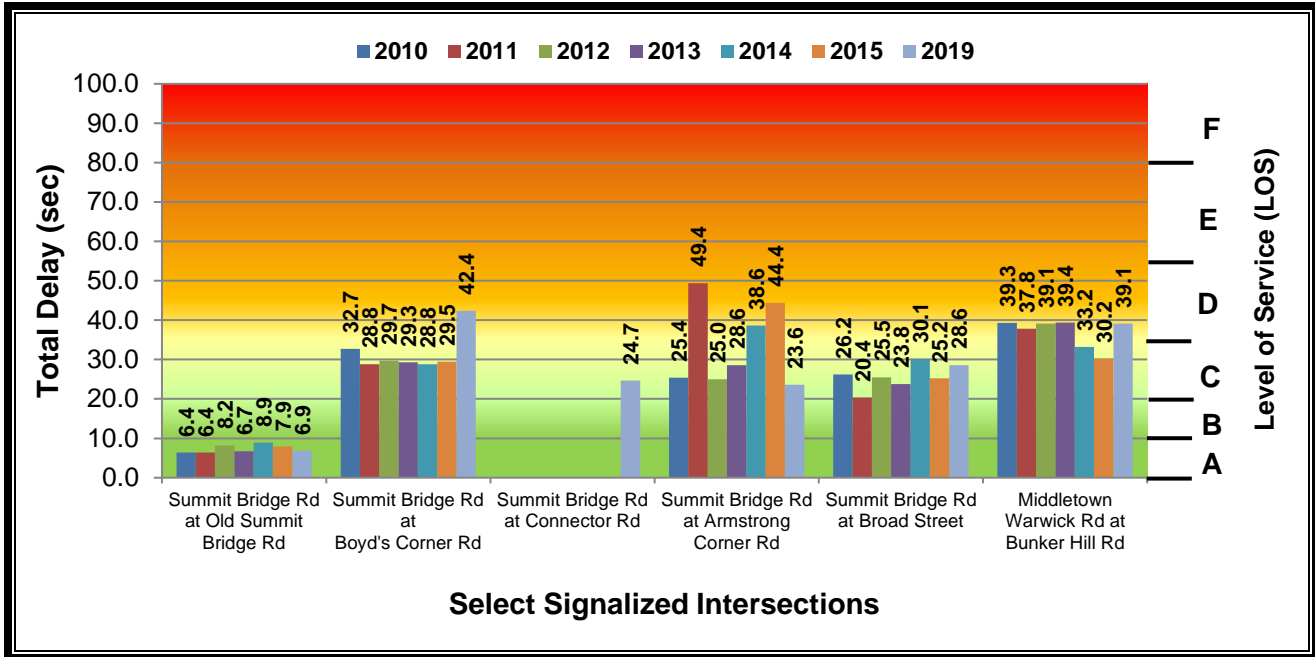
Figure 14: Total Delay and Corresponding Level of Service (LOS) at Select Signalized Intersections within US 301 Project Area during the AM Peak Hour

Peak period turning movement counts were collected on Tuesday, Wednesday, or Thursday on an annual basis at five (5) key signalized intersections in the project area. It should be noted that the connector road at the North Middletown Interchange (US 301 Toll Road) was added as an additional location in 2019. These six (6) locations, which are located along Summit Bridge Road (SR 71 and SR 896) and Middletown Warwick Road between Middletown (SR 299) and the Summit Bridge, were analyzed annually to monitor the change (degradation or improvement) in operation of each intersection. The six (6) locations, summarized in Figure 5, and Table 4, are the signalized intersections of Summit Bridge Road at Old Summit Bridge Road, Boyd's Corner Road, Connector Road, Armstrong Corner Road, North Broad Street, and Middletown Warwick Road at Bunker Hill Road. Peak hour turning movement counts were performed at these intersections during October and November 2019. This data was used to create a model of the corridor using Synchro (Version 10), a macroscopic traffic analysis software application used to evaluate the operational performance characteristics of signalized and unsignalized intersections. The results of these analyses are summarized in Table 4 and Figures 14 and 15.

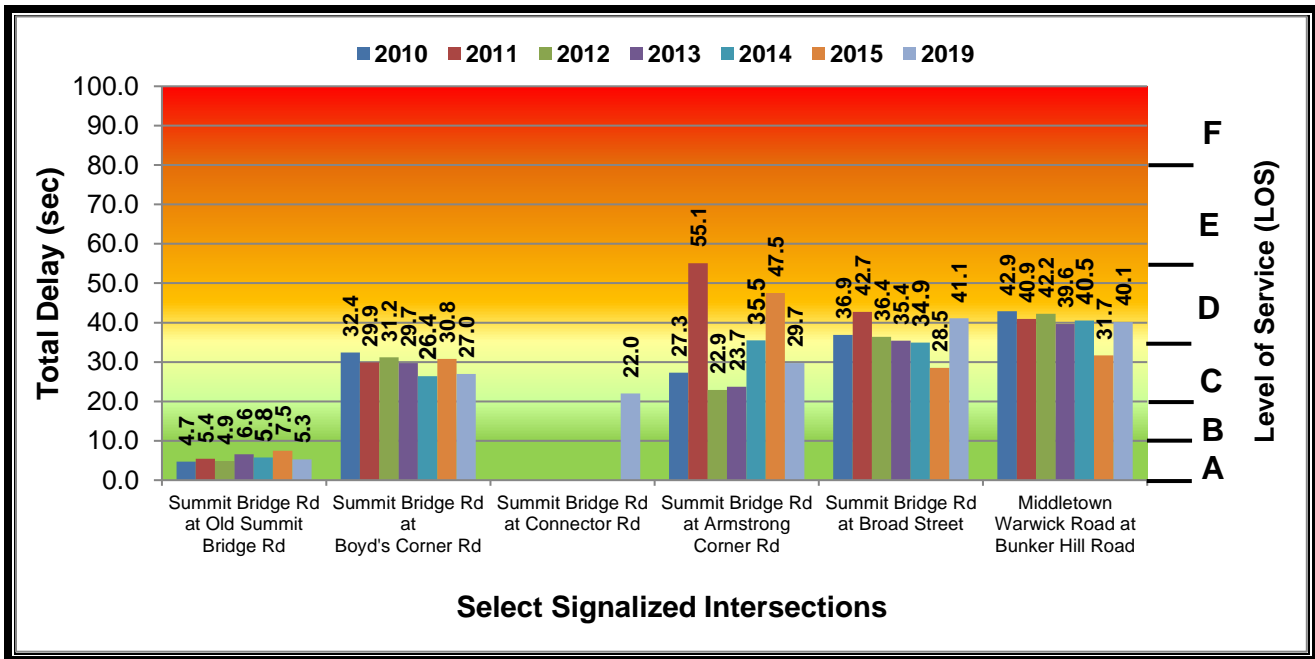
Figure 15: Total Delay and Corresponding Level of Service (LOS) at Select Signalized Intersections within US 301 Project Area during the PM Peak Hour

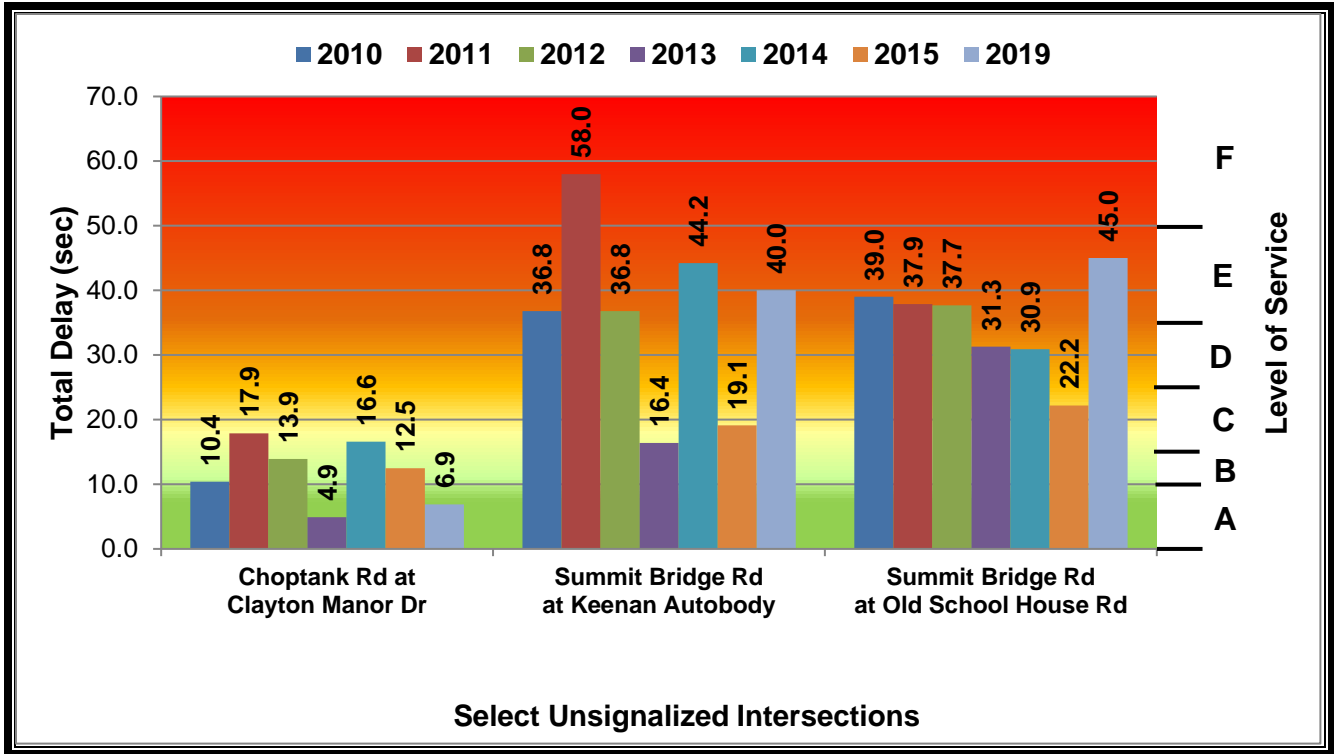
Figure 16: Total Delay and Corresponding Level of Service (LOS) at Select Unsignalized Intersections within US 301 Project Area during the PM Peak Hour

The delay at the Keenan Autobody access along Summit Bridge Road was approximately 37 sec/veh in 2010. The delay decreased significantly in 2015 (19 sec/veh) and returned to 2010 levels in 2019 (40 sec/veh).

In 2010, vehicles experienced approximately 39 sec/veh of delay at the intersection of Summit Bridge Road and Old School House Road. This decreased significantly in 2015 (22 sec/veh), but returned to 2010 levels in 2019 (45 sec/veh).

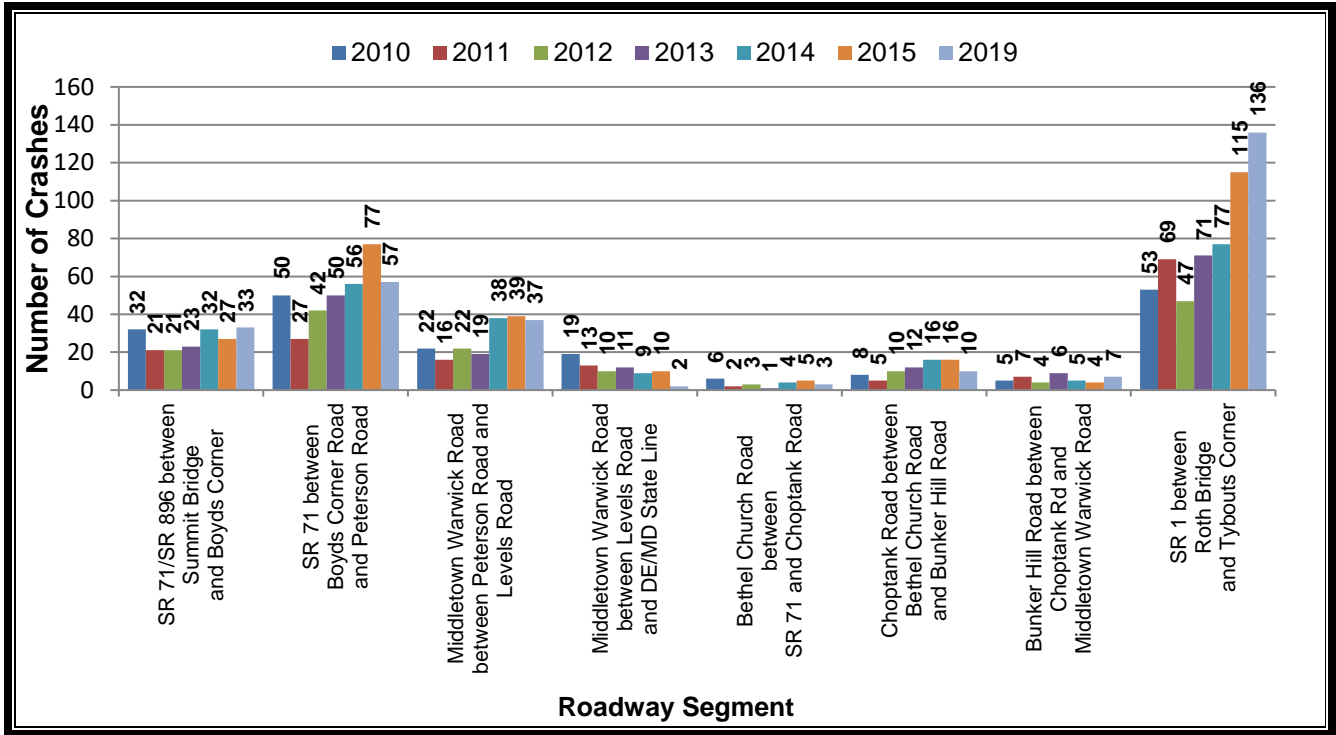
Figure 17: Comparison of Crashes for Select Roadways in the vicinity of US 301 Project Area

Looking at the crash rates, in 2010, six (6) of the eight (8) roadway segments had a higher crash rate than the Statewide and New Castle County Average Crash Rates. In 2015, five (5) of the eight roadway segments had higher crash rates than the Statewide Average Crash Rate and New Castle County Average Crash Rate. However, in 2019 only three (3) of the roadway segments had a crash rate higher than the Statewide Average Crash Rate and only one (1) roadway segment had a crash rate higher than the New Castle County Average Crash Rate. It should be noted that the Statewide and New Castle County Crash Rates were not shown for the section of Middletown Warwick Road between Levels Road and the DE/MD State Line due to the new realignment of that section. It should also be noted that in 2019, the Statewide and New Castle County Average Crash Rates went up considerably.
