Rehabilitation of Bridge 3-235

Coverdale Rd over Gravelly Fork

(DeDOT Contract T202407902)

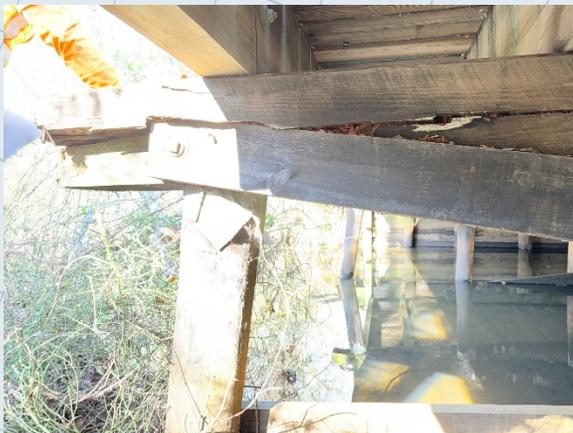
This bridge is currently closed to traffic following a crash on November 20, 2025. A truck traveling northbound on Coverdale Road crossed the southbound lane, broke through the west guardrail, struck the southwest timber wingwall that supports the abutment, and came to rest on the first pier cap supporting the bridge. This crash caused substantial damage to the timber wingwall, pier cap and sway bracings.

Severe split of the timber pier cap where the vehicle struck on November 20, 2025.

DeIDOT plans to make several emergency repairs that will enable reopening of this bridge to traffic in a more limited capacity. The pier caps will be bound with steel members on both sides to strengthen the damaged areas. The timber piles will have a steel collar placed near the top that will help support the new steel binders on the pier caps. The damaged sway braces will be removed and replaced with new timber sway braces. As mentioned above, these repairs will allow the bridge to reopen in a limited capacity. The primary loading restriction will be for large, fully loaded vehicles like dump trucks. This load restriction is out of an abundance of caution and to extend the bridge's life long enough to institute a plan for replacement.

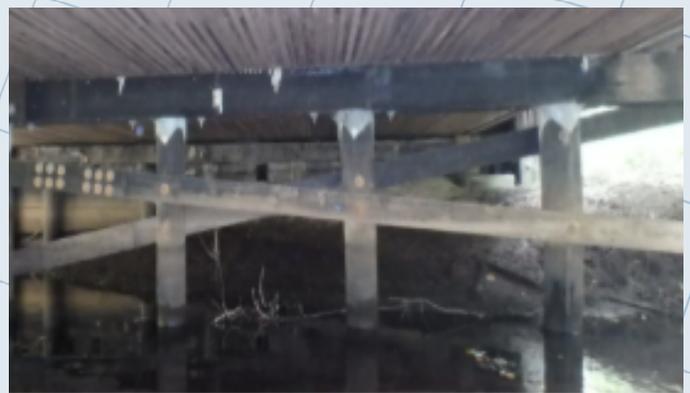
View of the same timber pier cap from a 2019 inspection. The diagonal timber pieces are sway braces that strengthen the piles.

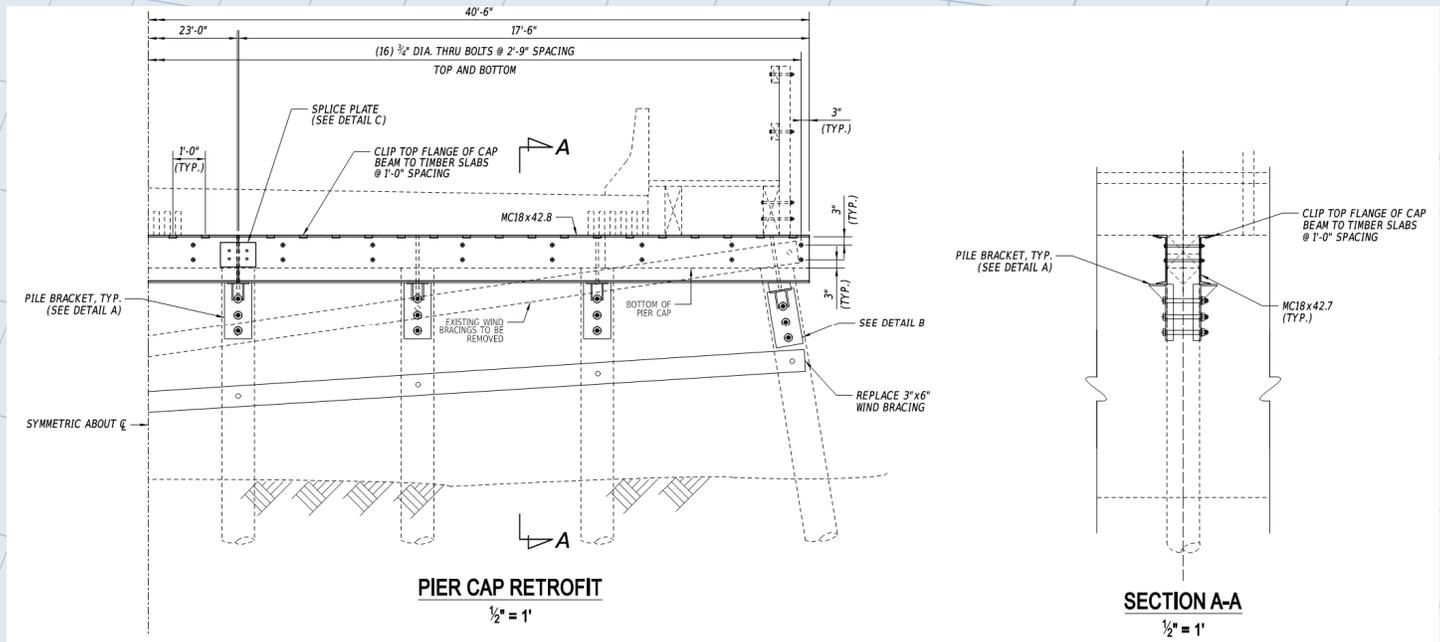
Drawings of the planned emergency repairs: installing steel binders to the pier cap and steel collars to the piles. Dashed lines indicate existing items. Solid lines identify new items.
