Gutherie-Giacomelli House (Tweed's Tavern)
CRS-#N-1101, New Castle County, Delaware

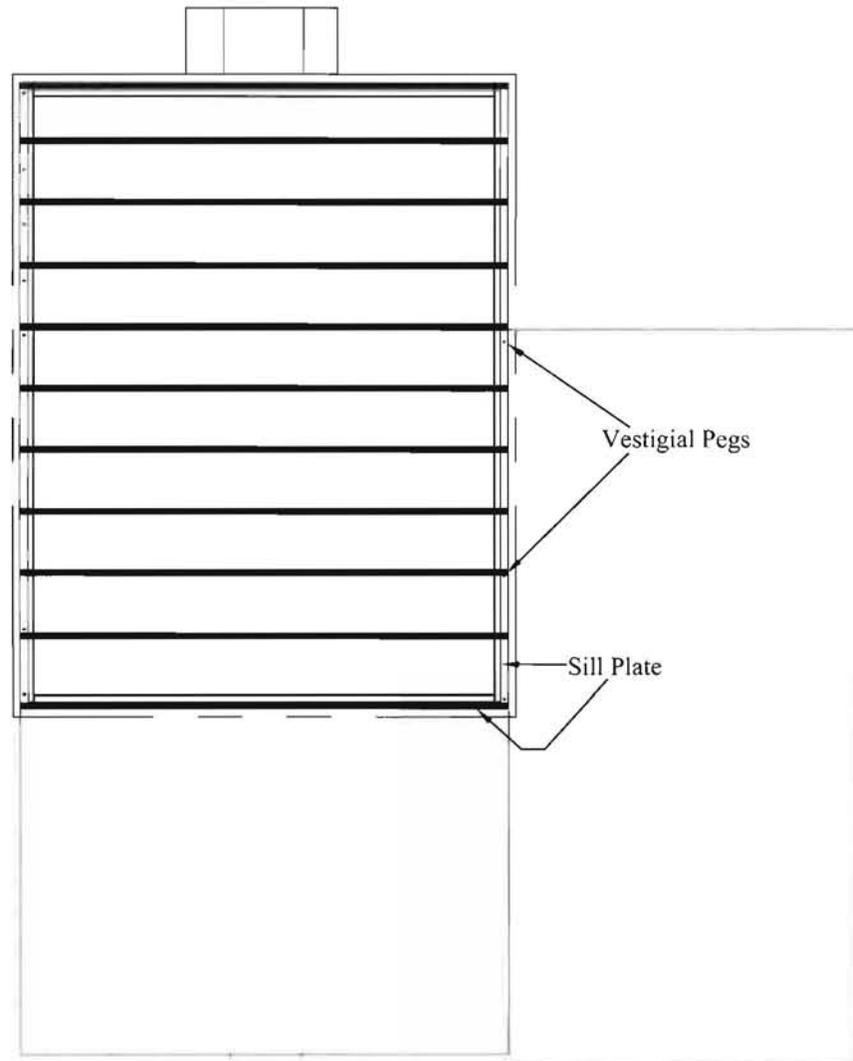
Figure 4.17. Rafter Plan.

Framing consists of eleven rafter pairs pegged at the apex. Rafter pairs are seated on plates resting on the top of the floor joists which in turn rest in pockets cut in the upper logs of the exterior walls. Pegs protrude from the plates in locations which are not associated with existing rafters suggesting that the original roof framing members have been replaced and that the present arrangement does not directly correspond with the old. Historic photographs of the building show that it retained a wood shingle roof well into the 20th century.
