2021 Edition

DELAWARE DEPARTMENT OF
TRANSPORTATION

Pipe Inspection and Remediation Guide

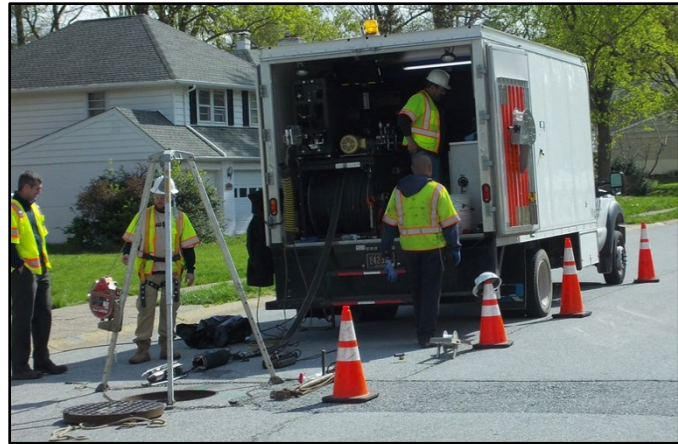
Pipe Cleaning Operation. Image Courtesy of Standard Pipe Services

Pipe cleaning is essential to a proper video inspection and should be performed in consideration with the requirements discussed in *Section 2.1.3 Cleaning for Pipe Inspections*. Selection of the equipment used shall be based on the condition of the pipe at the time work commences. The equipment shall be capable of removing debris, materials and obstructions from the storm sewer lines and structures in accordance with the requirements of Section 601 of the Standard Specifications.

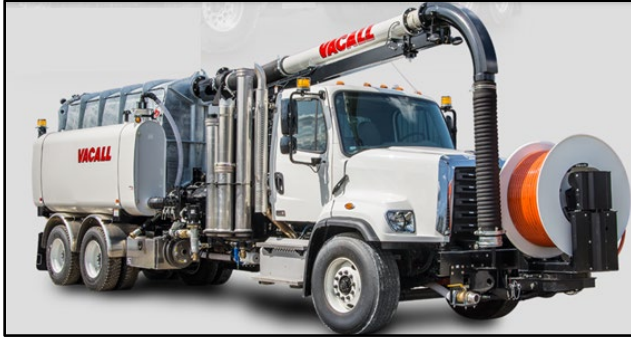
Combination Jetter and Vacuum Truck. Image Courtesy of Vacall Industries

- **Vacuum extraction** – vacuum extraction methods rely on suction to remove debris and materials from the storm drain system. Vacuum extraction is primarily utilized as a maintenance application and for structure cleaning, however, this method can be utilized for pipe cleaning in certain circumstances with the use of suitable equipment. The vacuum extraction trucks can either have a combination engine where the vacuum utilizes the same engine as the chassis or can be a dual engine where there is a separate engine for the chassis and the vacuum.

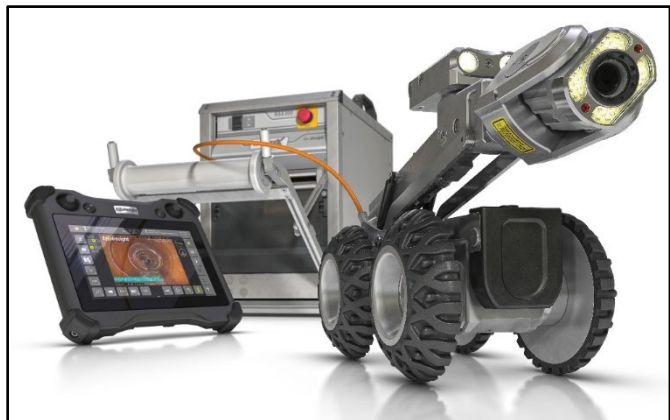
Pipe Video Rover. Image Courtesy of Envirosight

When the pipes are to be inspected through use of a video camera, the video camera and all supporting video system hardware and equipment must be capable of producing a video that is clear, focused, and relatively free from roll, static, or other image distortion qualities that would prevent the reviewer from properly evaluating the condition of a pipe to the satisfaction of the Engineer. The color television camera used for the inspection shall be one specifically designed and constructed for such inspection work.

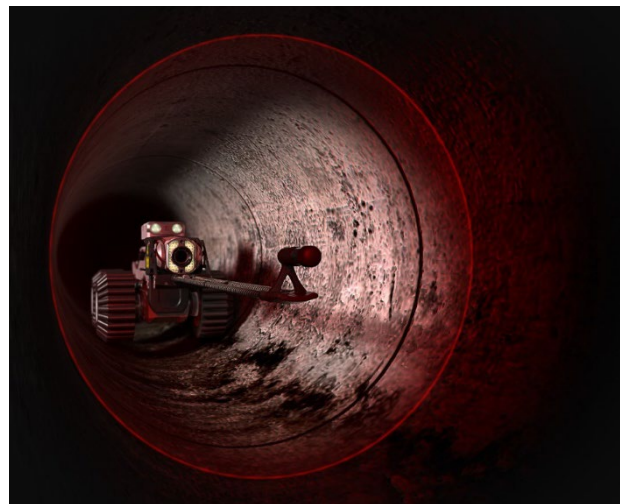
Laser Ring Profiler. Image Courtesy of Envirosight

- Capable of recording the station, milepost, distance along the invert of the pipe, or other indicators of location superimposed on the video.
- Provide a laser deflection measuring device, for use on flexible pipe, capable of measuring deflection to an accuracy of 0.5% or better and a repeatability of 0.12% or better. References of the equipment calibration are ASTM E 691 and ASTM E 177.

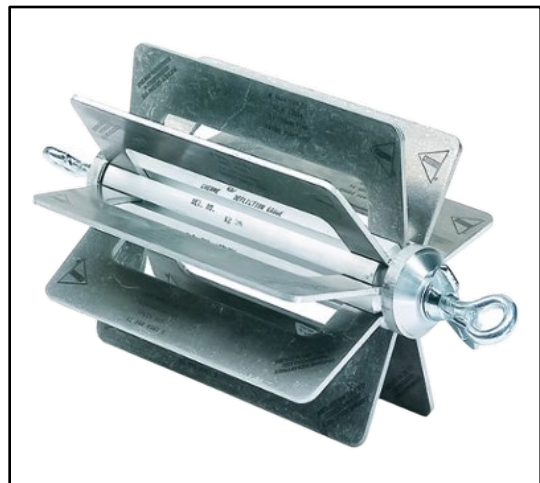
Deflection Mandrel. Image Courtesy of Cherne

The mandrel that is used for deflection tests shall be nine (or greater odd number) arm, non-adjustable, and fixed arm. The fixed arms shall be metal and fitted with pulling rings at each end, stamped or engraved on some segment other than a runner with the nominal pipe size and mandrel outside diameter. The diameter of the mandrels and matching proving rings shall be based upon the actual certified mean diameter as provided by the pipe manufacturer (0.95 x certified mean diameter for 5% deflection or 0.925 x certified mean diameter for 7.5% deflection). The Engineer shall inspect the mandrel and ensure its calibration prior to post installation pipe inspection to ensure the mandrel’s accuracy. The mandrel shall be pulled through the pipe by hand with a rope or cable. A pulley system which changes the direction of the pull may also be used so that no inspection staff be required to enter the pipe or manhole to pull the mandrel.

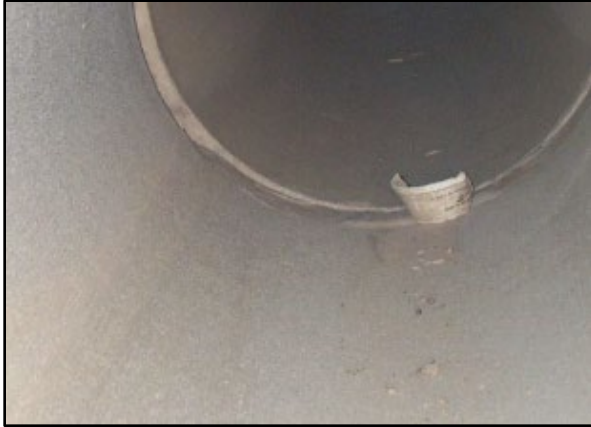
Concrete Joint Separation. Image Courtesy of Simpson, Gupertz and Hager

Pipe joints which show signs of exfiltration or infiltration are considered significant defects. Joint separations will accelerate damage caused by exfiltration and infiltration, resulting in the erosion of critical backfill material.

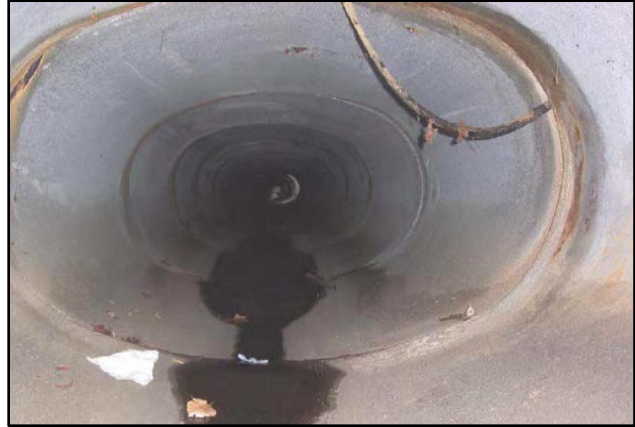
Large Concrete Joint Separation.

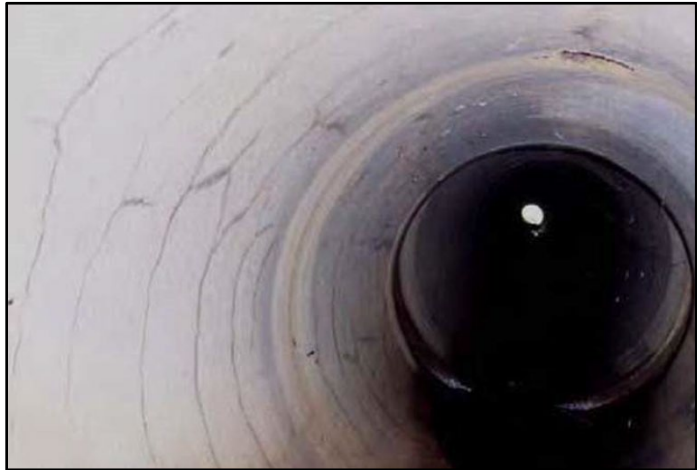
Hairline Cracking.

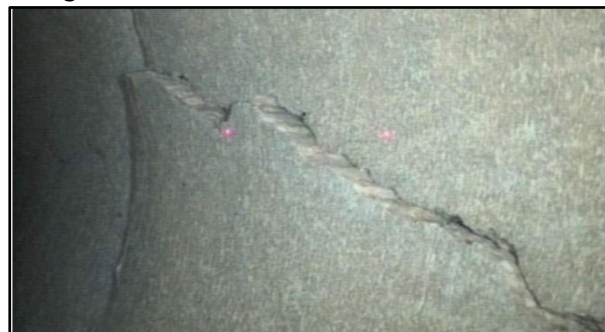
Crack with Vertical Offset. Image Courtesy of Kentucky Transportation Center

Spalling is defined as localized delamination of concrete and may develop along the edges of cracks in RCPs. Spalling along cracks is usually due to excessive shear forces and is typically the result of overloading or poor bedding support rather than simple tension cracking. Spalling can

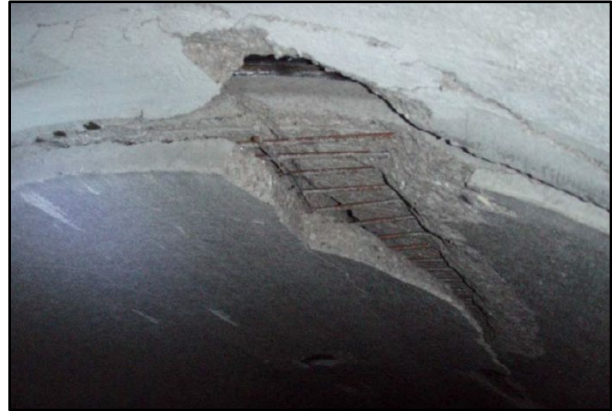
Slabbing. Image Courtesy of Kentucky Transportation Center

Slabbing is a radial failure of the concrete reinforcement cage due to excessive tension and usually occurs in pipes located in deep fills which creates a high shearing stress on the pipe. This defect results in excessive deflection which forces the concrete cover away from the reinforcement. Slabbing can be identified by offset across the face of the crack as well as large slabs of concrete “peeling” away from the sides of the pipe. Slabbing is a serious defect and pipes in this condition shall be repaired or replaced.

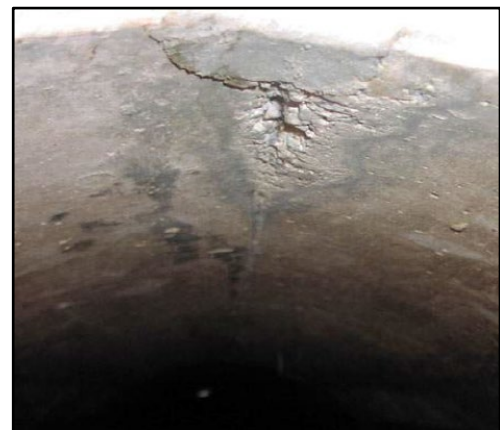
Spalling. Image Courtesy of Simpson, Gupertz & Hager

Spalling is defined as localized delamination of concrete and can occur for numerous reasons. Spalling with no other defect present is considered minor in nature. Excessive spalling can be a symptom of a more serious defect and should be investigated to determine the cause and the associated severity. *Section 5.1.2.2 Crack Spalling* provides considerations for spalling occurring at crack locations and *Section 5.1.1.2 Joint Spalling* provides consideration for spalling occurring at joint locations.

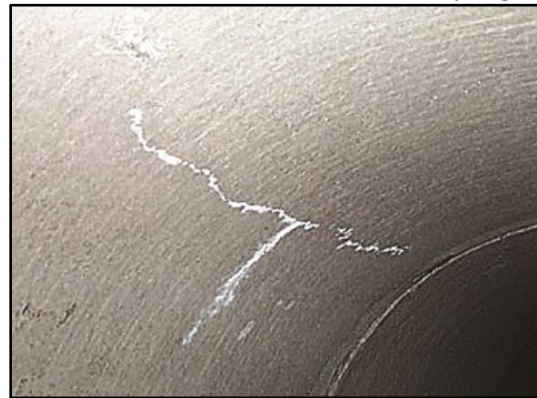
Autogenous Healing. Image Courtesy of American Concrete Pipe Association

Autogenous healing is a process where certain size cracks can heal themselves as a result of a chemical reaction that takes place in the presence of moisture and air. In this process, calcium carbonate (a hard, white, crystalline substance) can form when unhydrated cement in the pipe wall reacts with moisture and oxygen. This process typically can occur in hairline and design cracks as defined in *Section 5.1.2 Cracking* of this guide.

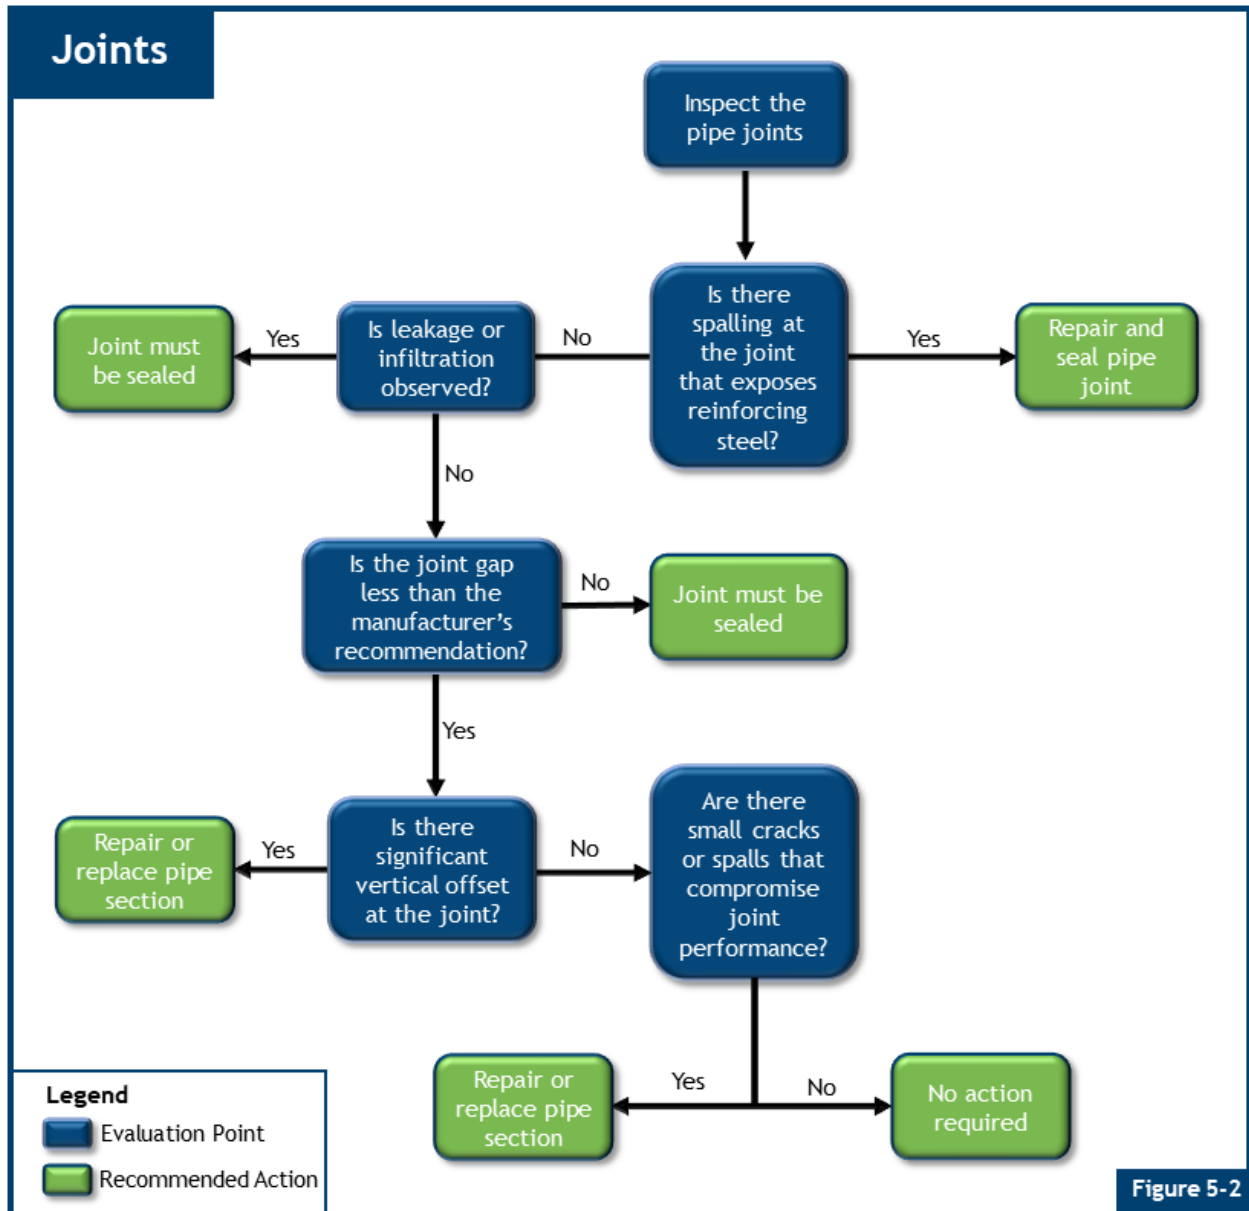
5.3.2 Joint Defects

Joints must be leak-resistant in accordance with the contract documents to prevent infiltration or exfiltration which can lead to loss of backfill material.

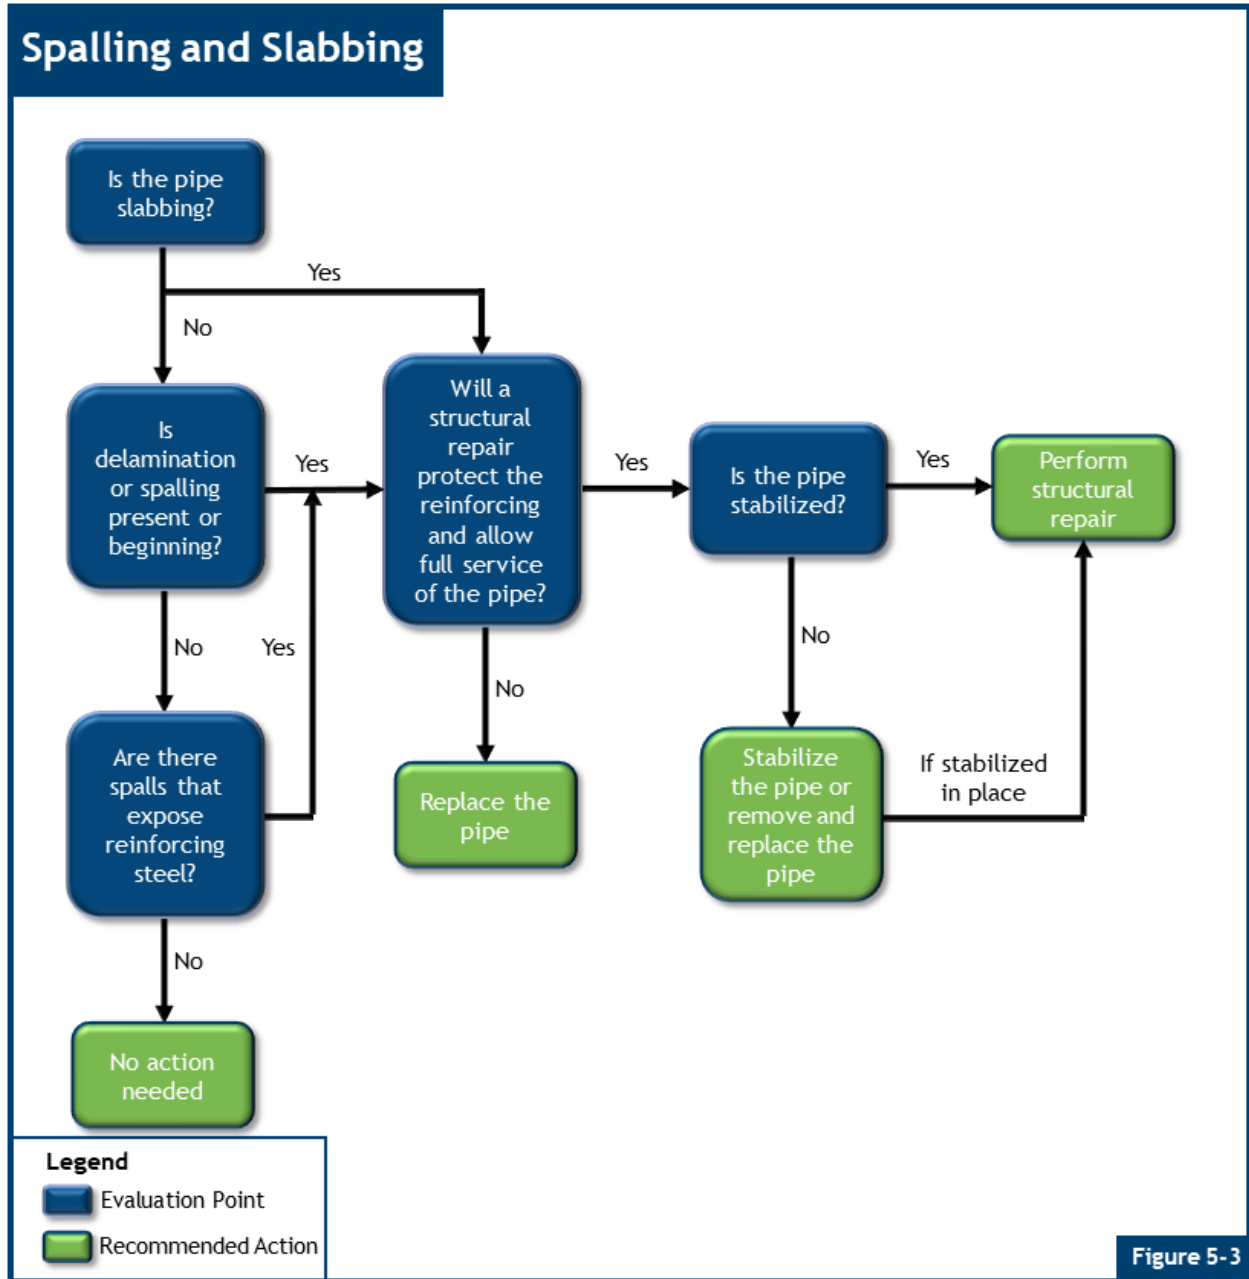
5.3.3 Spalling and Slabbing

If spalling occurs along crack planes, or if the pipe is exhibiting slabbing, it is important to remove all delaminated and/or loose concrete from above the reinforcing steel. If the pipe is stabilized and equilibrium has been achieved, then the exposed reinforcement can be cleaned and protected, and the pipe can maintain an appropriate service life.

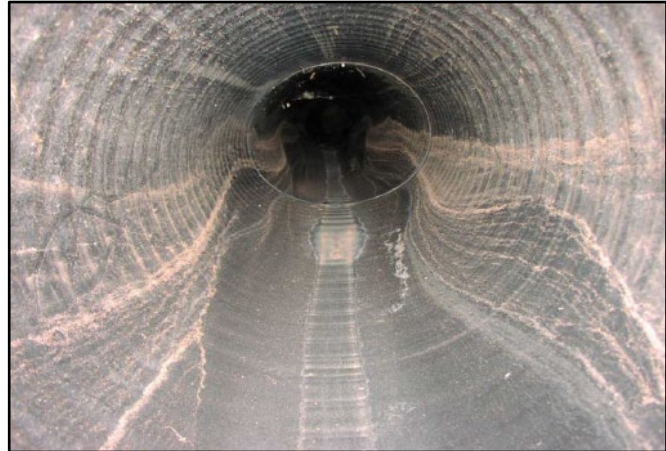
Pipe with Over 10% Deflection. Image Courtesy of Simpson, Gupertz & Hager

Where percent deflection exceeds 5% but is 7.5% or less, the contractor must perform an evaluation to determine the severity of the defect. The evaluation shall consider the severity of the defect, the structural integrity of the installation (using Section 12 “Buried Structures and Tunnel Liners” of the AASHTO LRFD Bridge Design Specifications), the existing environmental conditions, and the design service life of the installation. The contractor’s evaluation must result in a recommendation to the Engineer as to the need for remediation as well as the remediation alternative selected by the contractor, if required. In all cases, the Engineer must approve the recommendation provided.

Where pipe diameter deflection exceeds 7.5%, remediation or removal is required.

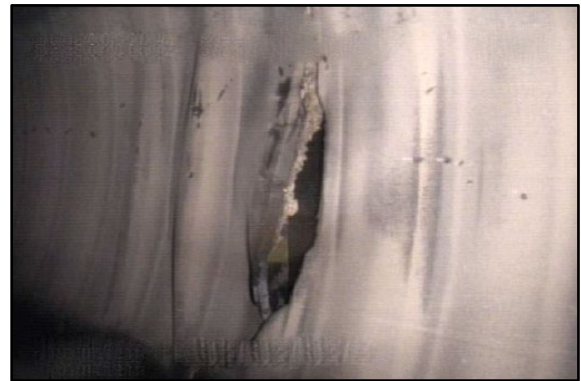
Hole in Pipe. Image Courtesy of Kentucky Transportation Center

Cracking, tearing, or holes can develop in thermoplastic pipe and can impair either the integrity of the barrel in ring compression or permit infiltration of groundwater or backfill. All instances of cracks, tears or holes discovered during post installation inspection must be either repaired or replaced.

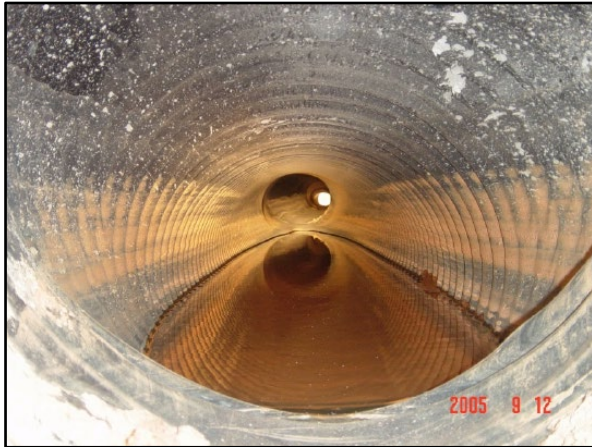
Misalignment. Image Courtesy of California Department of Transportation

The barrel of the pipe shall be checked by sighting along the crown, invert, and sides of the culvert to assure it is aligned properly. Barrel alignment can indicate barrel structural distress, joint distress, or loss of support through soil infiltration or exfiltration. In some cases, misalignment can impact the design flow. The vertical alignment shall be checked for sagging, faulting, and invert heaving. The horizontal alignment shall be checked for straightness or smooth curvature. When performing an inspection, the inspector must take into account pipes laid with camber or a grade change in accordance with the contract plans or

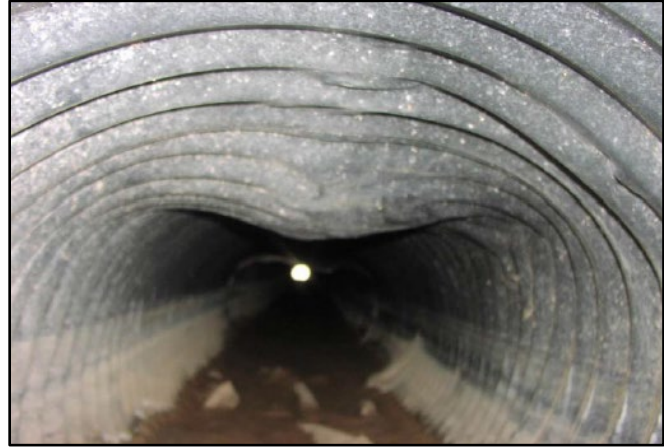
Buckling. Image Courtesy of Simpson, Gupertz & Hager

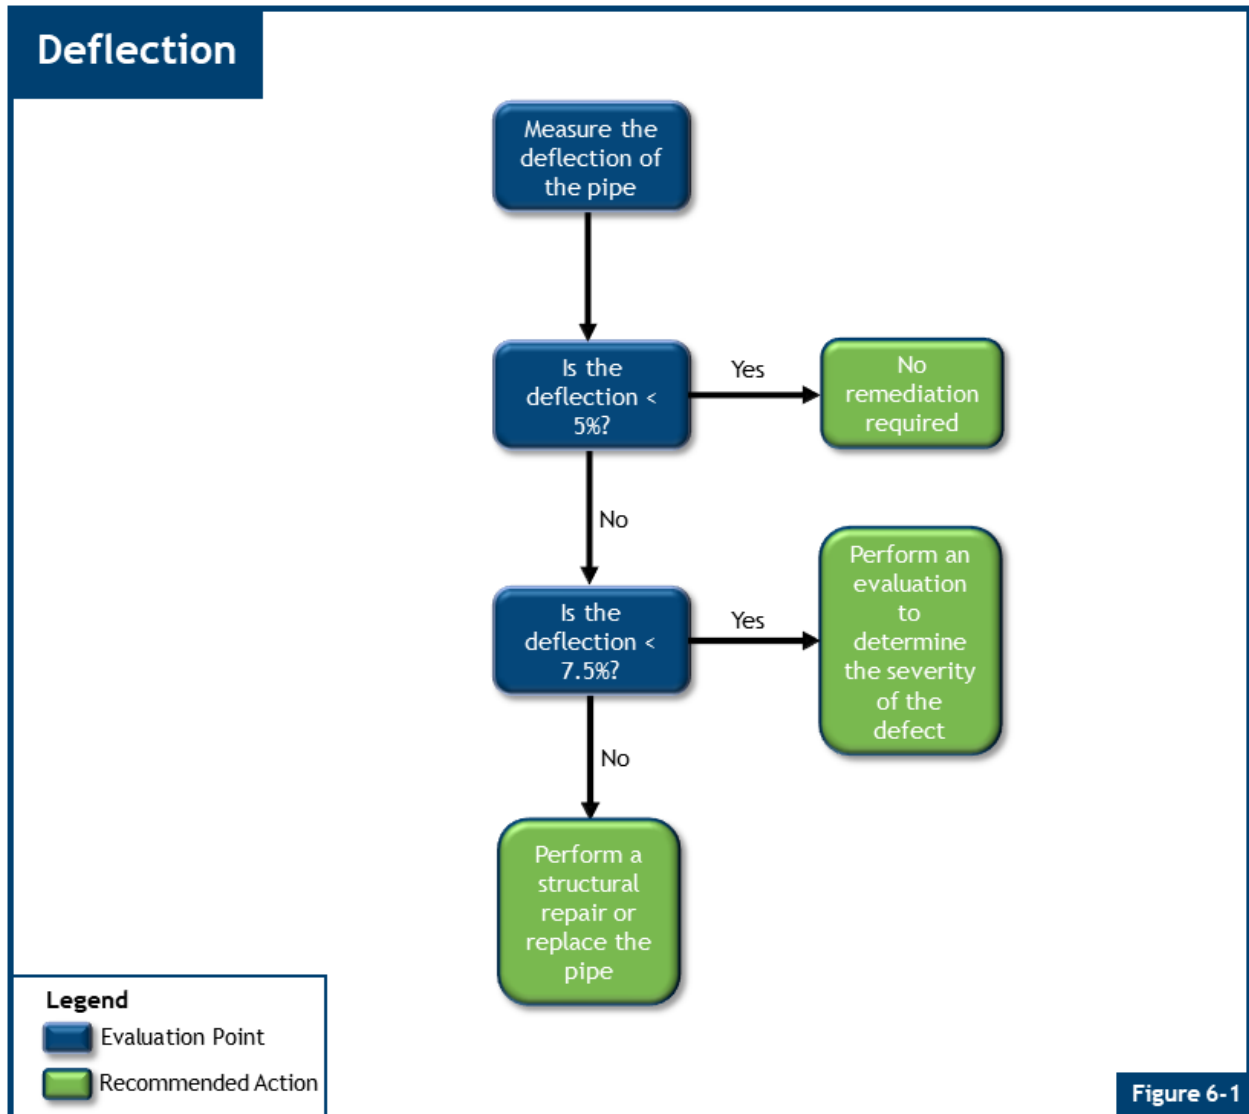
6.3.1 Installation Deflection

Pipe installations may deflect post installation. It is critical to measure the percent deflection to determine if the defect requires remediation.

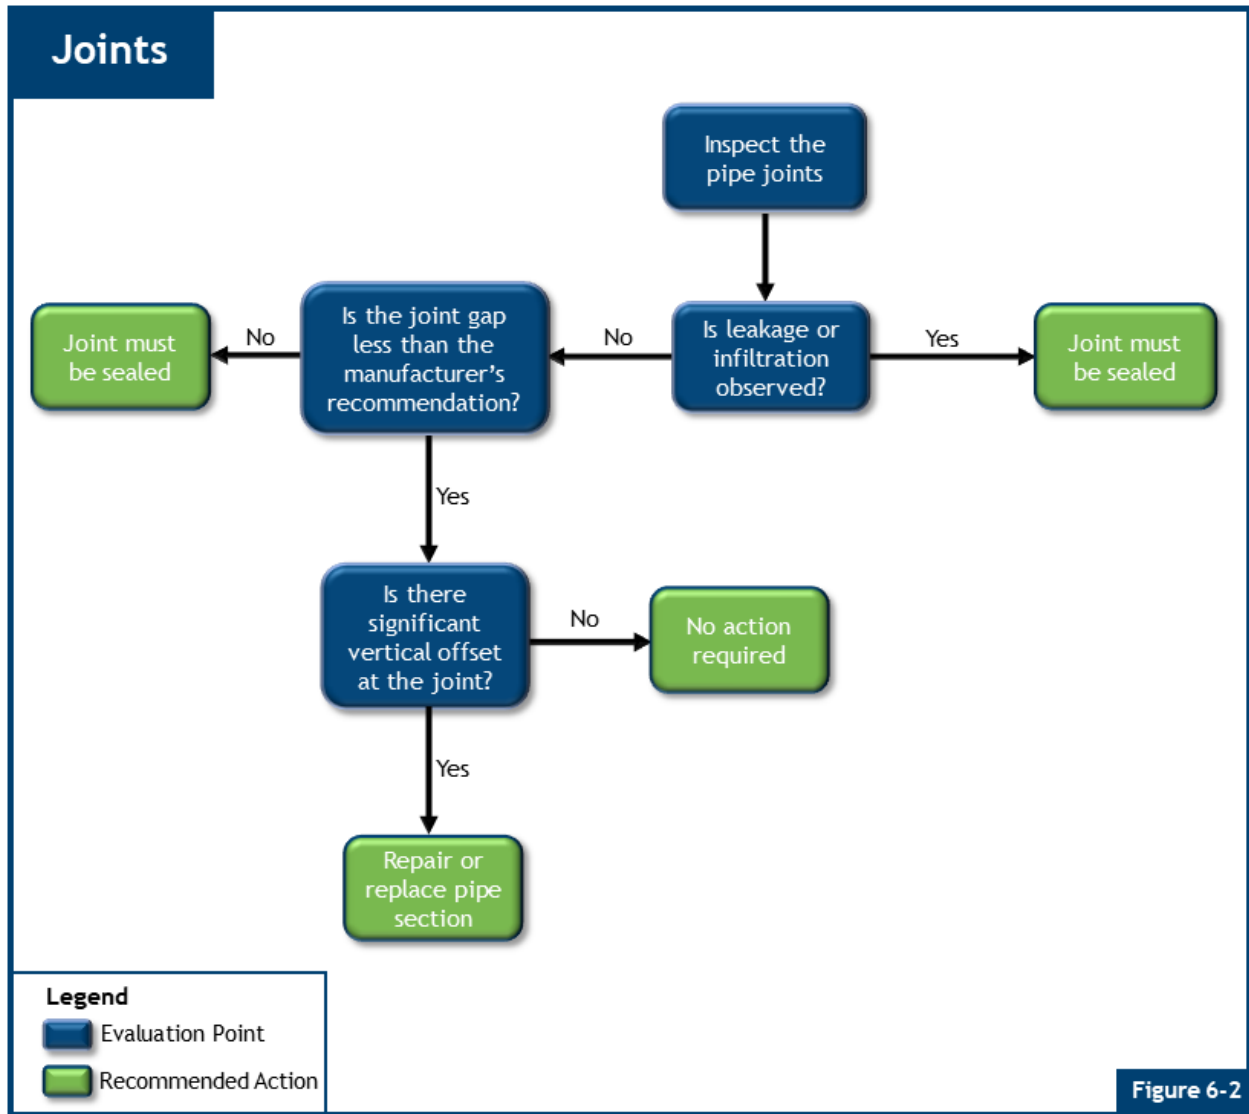
6.3.2 Joint Defects

Joints must be leak-resistant in accordance with the contract documents to prevent infiltration or exfiltration which can lead to loss of backfill material.

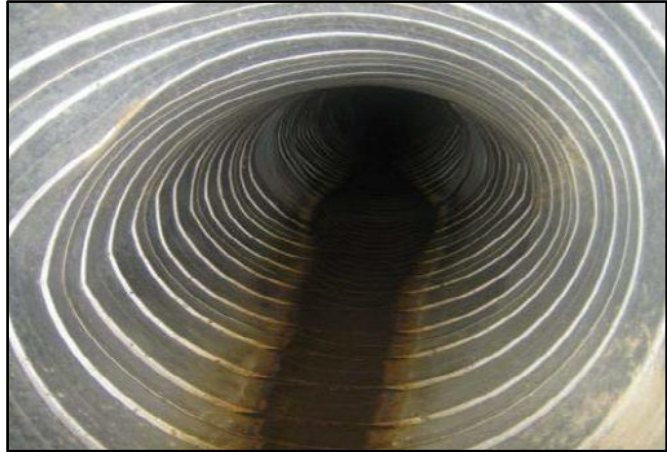
Deflected Pipe. Image Courtesy of Simpson, Gupertz & Hager

Recorded deflections that exceed 5% of the nominal inside diameter are an indication of substandard installation and are required to be documented in the Storm Drain Report.

Where percent deflection exceeds 5% but is less than 7.5% plus a manufacturing tolerance of either 1 percent of the nominal diameter or 0.5", whichever is greater, the contractor must perform an evaluation to determine the severity of the defect. The evaluation shall consider the severity of the defect, the structural integrity of the installation (using Section 12 "Buried Structures and Tunnel Liners" of the AASHTO LRFD Bridge Design Specifications), the existing environmental conditions, and the design service life of the installation. The contractor's evaluation must result in a recommendation to the Engineer as to the need for remediation as well as the remediation alternative selected by the contractor, if required. In all cases, the Engineer must approve the recommendation provided.

Where pipe diameter deflection exceeds 7.5% plus a manufacturing tolerance of either 1 percent of the nominal diameter or 0.5", whichever is greater, remediation or removal is required.

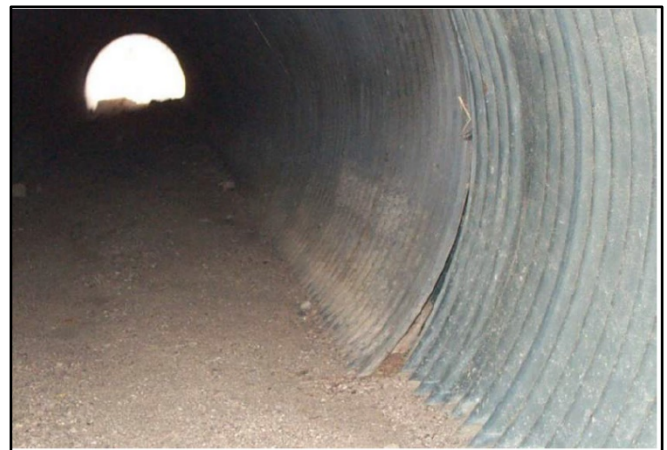
Joint Gap. Image Courtesy of Simpson, Gupertz & Hager

Joints in pipe segments are a critical evaluation area. CMPs commonly use a gasketed, banded and bolted restrained joint. This restrained joint requires a spacing in between the two ends of the pipes at a joint to allow the gasket and band to seat into and engage the annular CMP ends. The gap between the two pipe ends will vary due to the manufacturing process. Joint gaps that allow for infiltration or exfiltration are considered significant defects and must be documented in the Storm Drain Report. Table 7-1 shown below provides the maximum allowable gap for CMP with gasketed, banded and bolted restrained joints.

Pipe Diameter (in.)	Allowable Gap between Pipe Ends
15" to 24"	1 ½"
30" and larger	3"

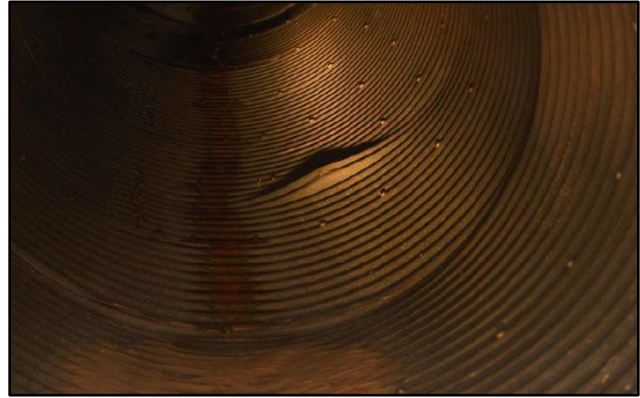
Dent in Pipe. Image Courtesy of Simpson, Gupertz & Hager

Cracking, tearing, holes or dents can develop in CMPs and can impair either the integrity of the barrel in ring compression or permit infiltration of groundwater or backfill. All instances of cracks, tears, holes or dents discovered during post installation inspection must be either repaired or replaced.

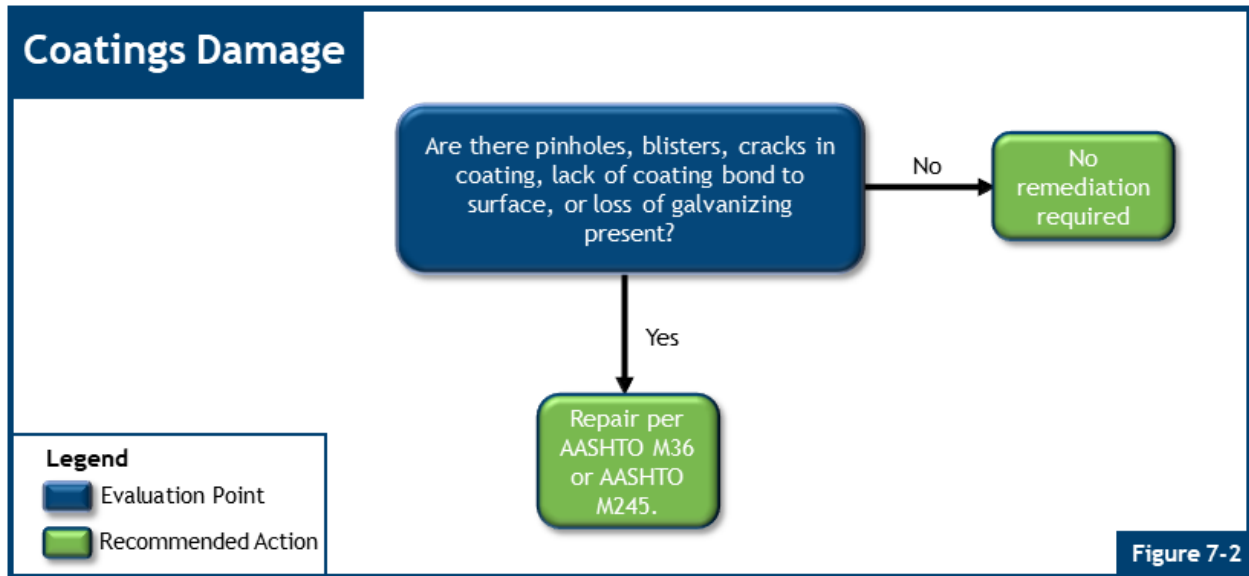
7.3.2 Coatings Damage

Metal pipes are coated to protect the metal pipe from their surrounding environment. Damages to the coating may affect the long-term performance of the installation.

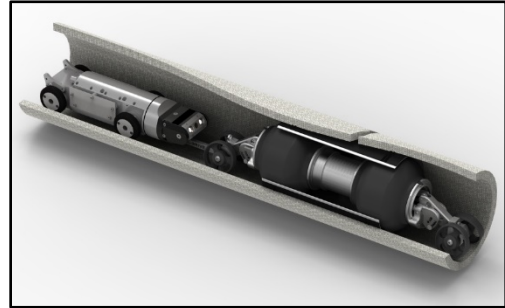
Robotic Packer. Image Courtesy of Sewer Robotics

Mechanical spot repair is used to rehabilitate pipes that have localized damage and have not been structurally compromised. When structural damage is observed, mechanical spot repair can be used in combination with other structural repair methods to repair and seal the pipe. Mechanical spot repair is performed by using machines which enter the pipe to perform grouting, patching, or other sealing operations.

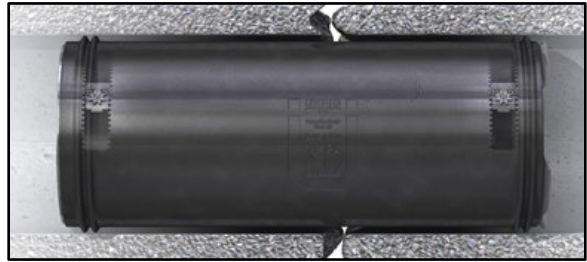
Internal Compression Seal. Image Courtesy of EnviroSight

Utilizing an internal compression seal is another common localized point repair option. Typically, a flexible rubber seal is inserted at the location exhibiting infiltration or exfiltration and then compressed to the pipe wall to prevent the movement of water. The service life for these repairs generally varies based on manufacturer as well as environmental condition.

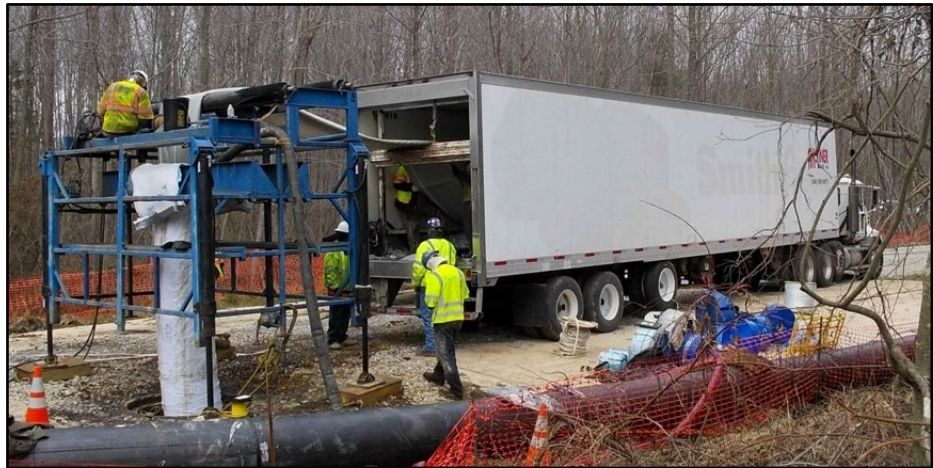
Pipe Liner Installation. Image Courtesy of Standard Pipe Services

Pipe lining is a trenchless pipe repair process where an existing pipe is lined with a foreign material to create a new flow surface. The new continuous pipe lining eliminates infiltration and exfiltration at pipe joints and along the pipe walls. The liner may provide additional structural support depending upon the liner material and the liner's thickness. The new liner will have a smaller diameter than the host pipe; however, the resulting liner is typically smoother than the material of the host pipe to offset the resulting smaller pipe diameter's effect on flow capacity. Pipe linings attach to the existing pipe walls; therefore, this remediation method will not correct any misalignment issues present in the existing installation. There are multiple materials and techniques used to accomplish pipe linings.

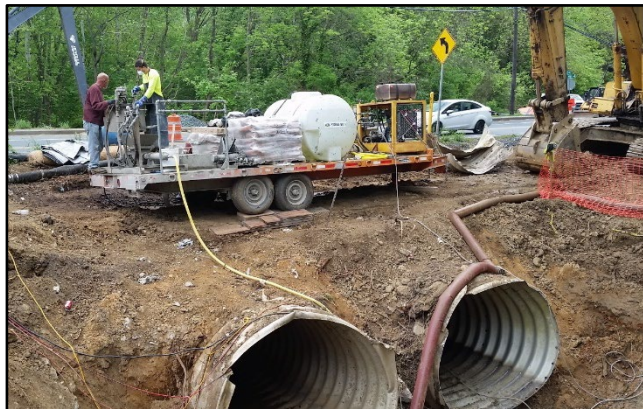
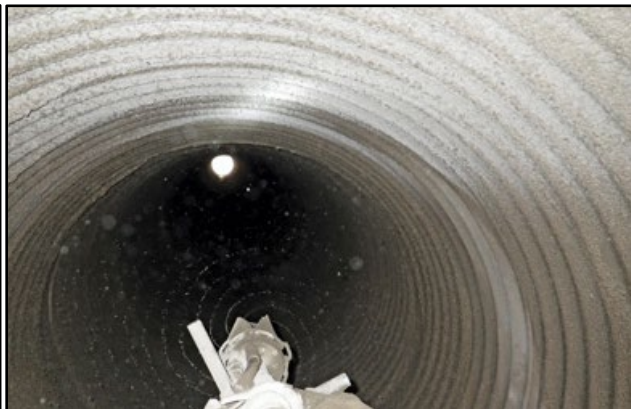
Centrifugally Installed Liner. Image Courtesy of Standard Pipe Services

Centrifugally Installed Liner. Image Courtesy of Centi-Lining

This liner technique utilizes a high-pressure nozzle on a pneumatic hose to shoot the new liner material onto the existing pipe wall. The liner material can vary based on manufacturer. The hydraulics of the system must be considered when utilizing this application as the liner will reduce the conduit diameter conduit. As a result, pipe capacity should be considered when utilizing this remediation method.

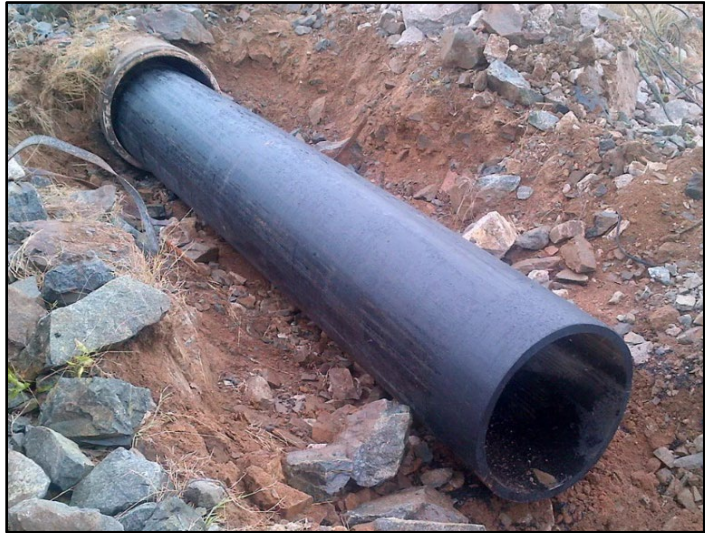
Pipe Sliplining. Image Courtesy of Downer PipeTech

“Sliplining” is a trenchless method of installing a new pipe inside of an existing pipe. There are a wide variety of individual techniques that may be employed to perform a slipline; however, the process generally involves pulling a new liner pipe into the existing pipe with a winch cable or pushing into place with a choker strap and mechanical equipment. Once the new liner pipe is installed, the void space between the new and old pipe is filled by grouting.

Sliplining a pipe eliminates infiltration and exfiltration at pipe joints and along pipe walls. The liner may provide additional structural support depending upon the slipliner material and associated thickness. The new liner will have a smaller diameter than the host pipe; however, the resulting liner is typically smoother than the material of the host pipe to offset the resulting smaller pipe diameter's effect on flow capacity.
