Delaware Department
of Transportation

HAWK Pedestrian Signal Compliance Review

December 2017

RK&K

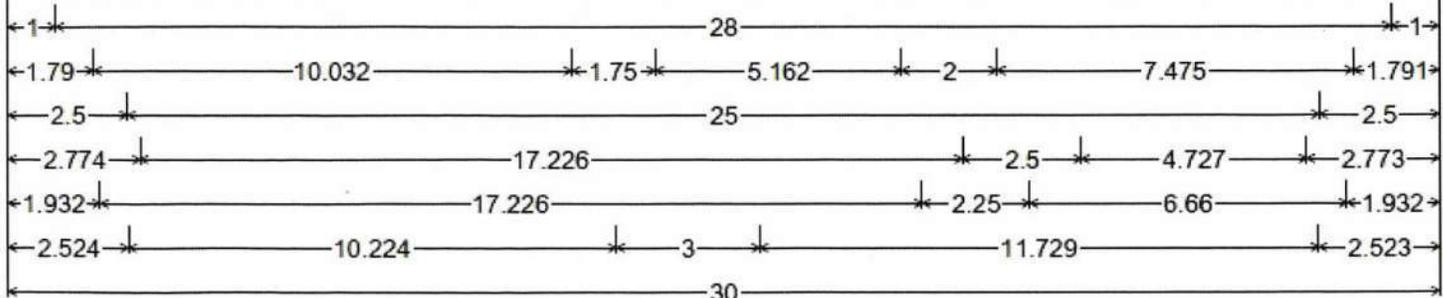
STOP ON RED

**PROCEED ON
FLASHING RED
WHEN CLEAR**

1.875" Radius, 0.625" Border, 0.375" Indent, Black on White;
"STOP" C specified length; "ON" C specified length; "RED" C specified length; "PROCEED" C specified length;
