Historic American Buildings Survey (HABS) Documentation

HISTORIC AMERICAN BUILDINGS SURVEY

LOCUST GROVE (Meldrum Farm)

HABS No. DE-266

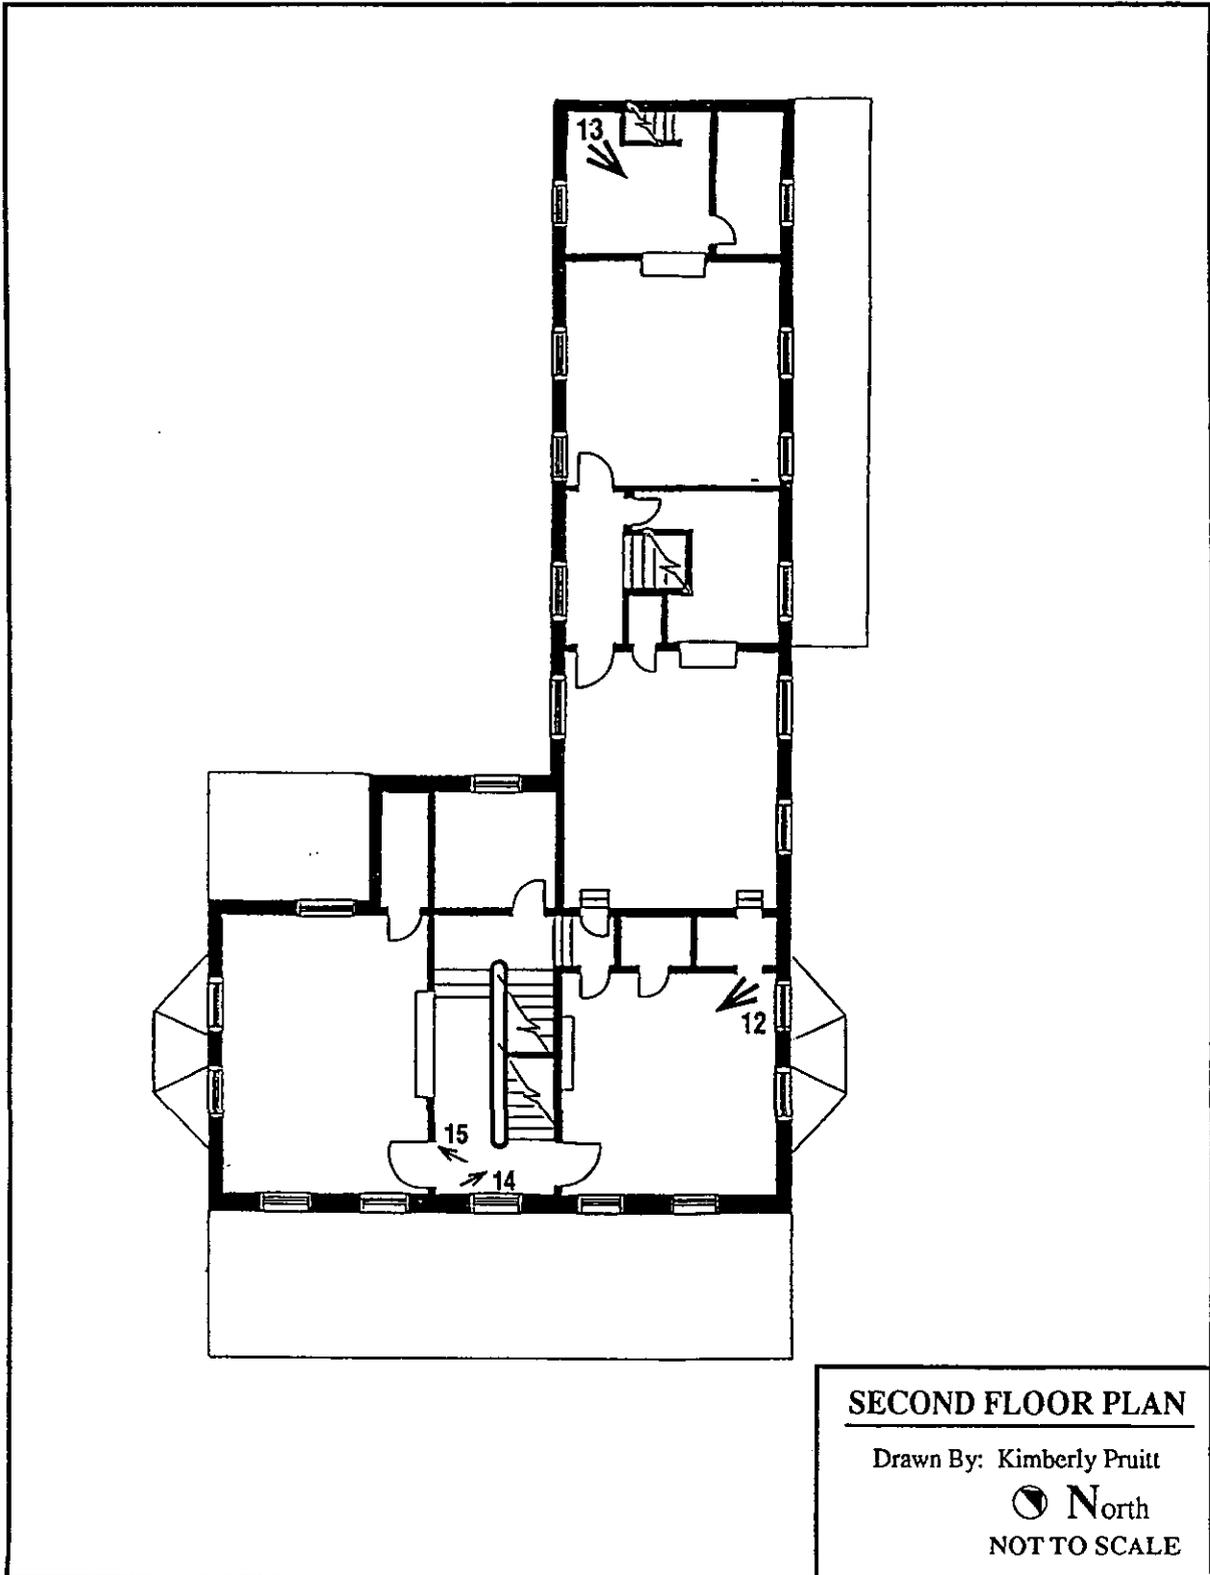
SECOND FLOOR PLAN

North
NOT TO SCALE

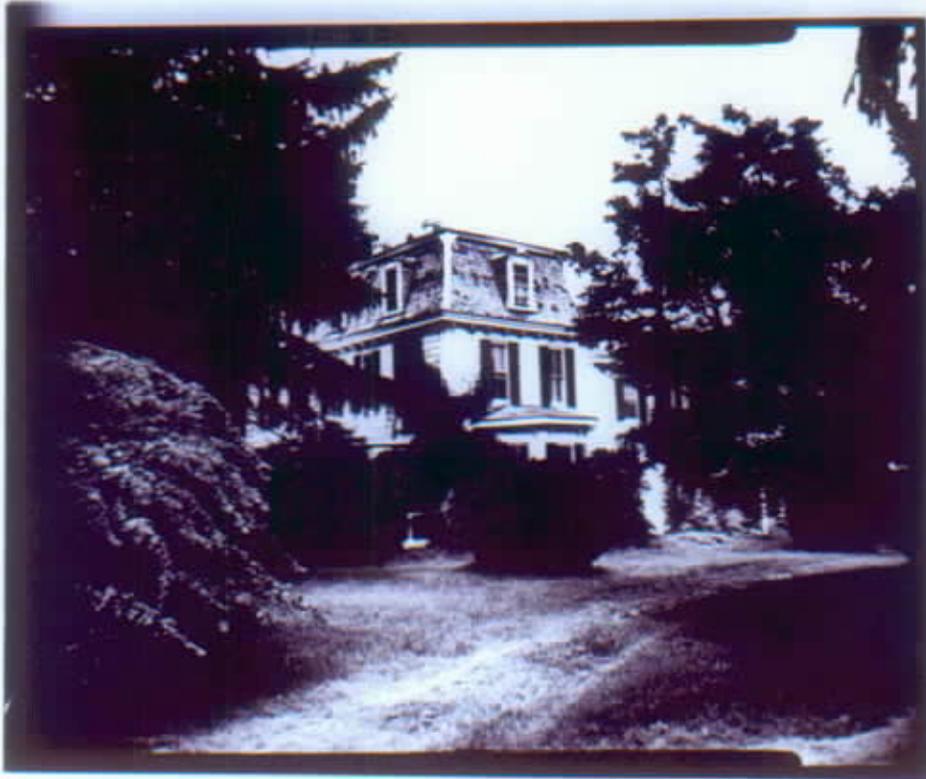
HABS No. DE-266-1

- DE- 266 -1 VIEW WEST, NORTHEAST AND SOUTHEAST ELEVATIONS
- DE- 266 -2 VIEW NORTHWEST, SOUTHEAST FRONT
- DE- 266 -3 VIEW SOUTH, EAST SIDE
- DE- 266 -4 VIEW EAST, WEST AND NORTHWEST SIDES

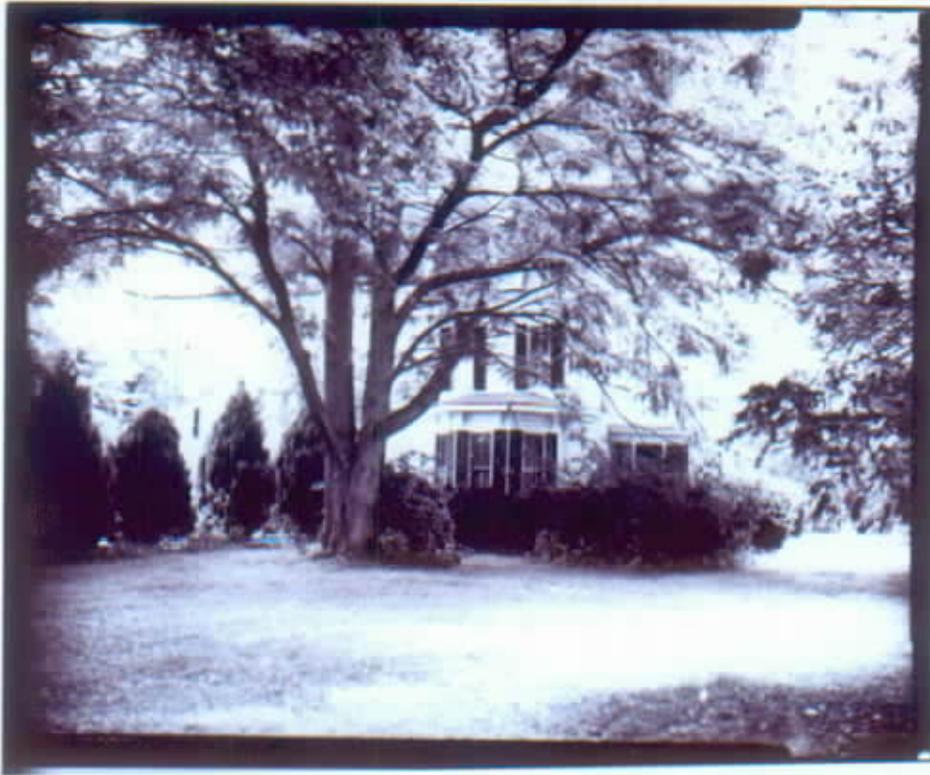
HABS No. DE-266-5

- DE- 266 -5 VIEW NORTHEAST, SOUTHWEST SIDE
- DE- 266 -6 VIEW WEST, DETAIL OF SOUTHEAST SIDE
- DE- 266 -7 VIEW SOUTH, DETAIL OF EAST BAY
- DE- 266 -8 FIRST FLOOR, CENTRAL HALL LOOKING SOUTHEAST

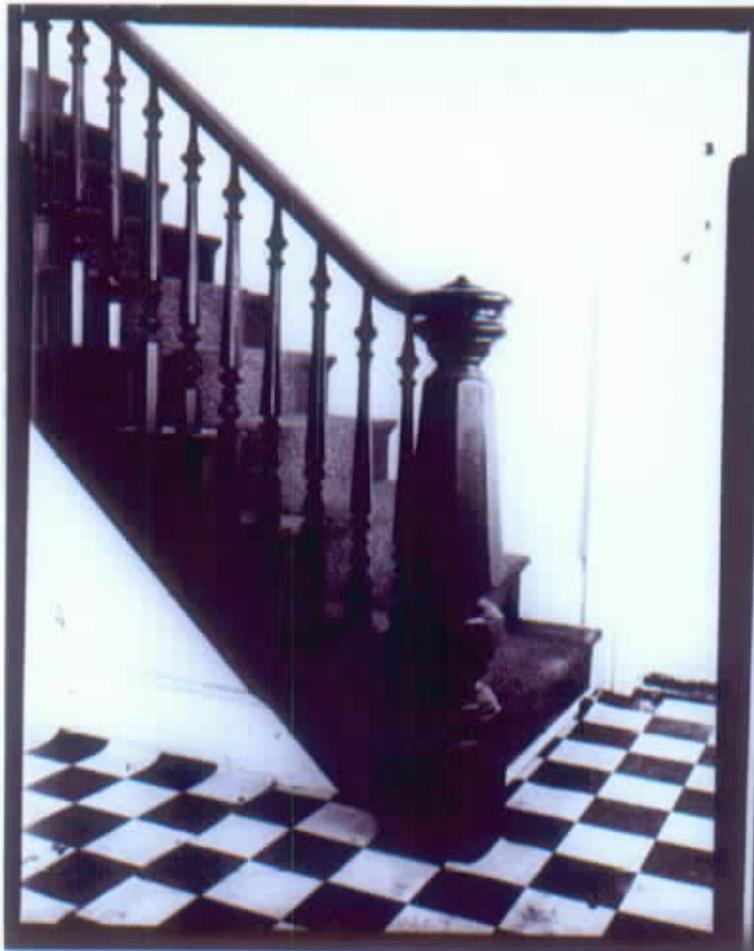
HABS No. DE-266-9

- DE- 266 -9 FIRST FLOOR, DETAIL OF NEWEL POST
- DE- 266 -10 FIRST FLOOR, SOUTHWEST ROOM, WEST BAY
- DE- 266 -11 FIRST FLOOR, SOUTHEAST ROOM FROM ADJACENT ROOM

The stairway in the center of the Second Empire block of the house has an open, simply articulated stringer, and a stained wood balustrade composed of turned balusters and a rounded handrail. The balustrade terminates at a heavy, turned newel post that includes a rounded newel cap. The stairway in the Greek Revival section of the house is completely enclosed from the first to the second story.

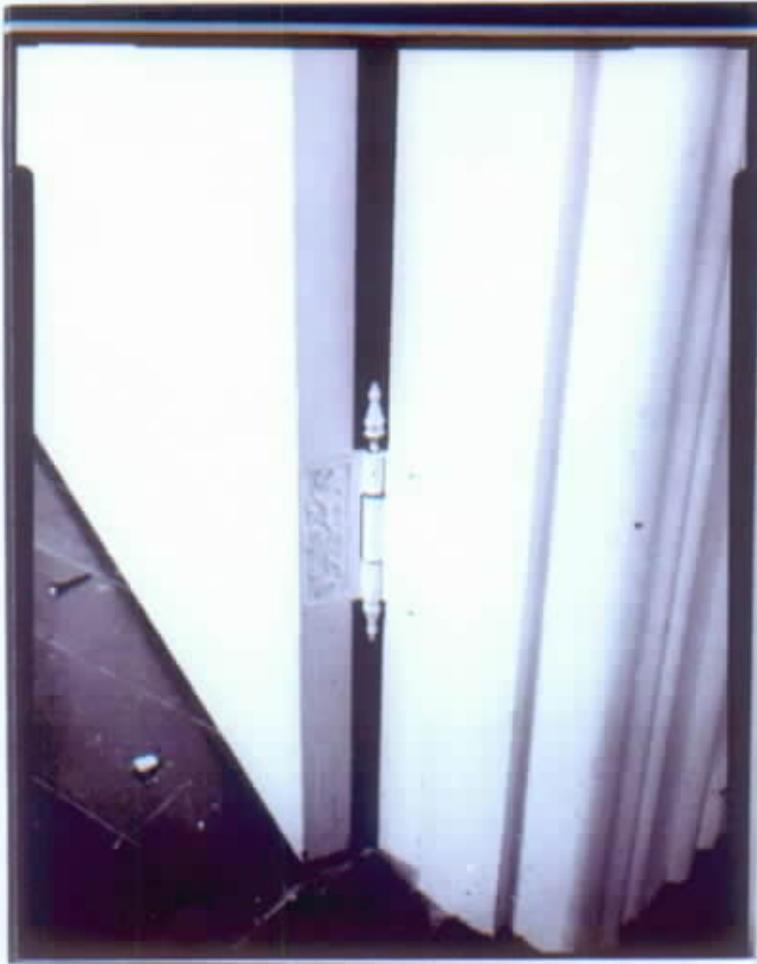
Habs No. DE-266-15

- DE- 266 -15 SECOND FLOOR, SOUTHWEST ROOM, DETAIL OF DOOR HINGE
- DE- 266 -16 THIRD FLOOR, SOUTHWEST ROOM, SOUTH AND EAST WALLS
- DE- 266 -17 SMOKE HOUSE, VIEW WEST, SOUTH AND EAST SIDES

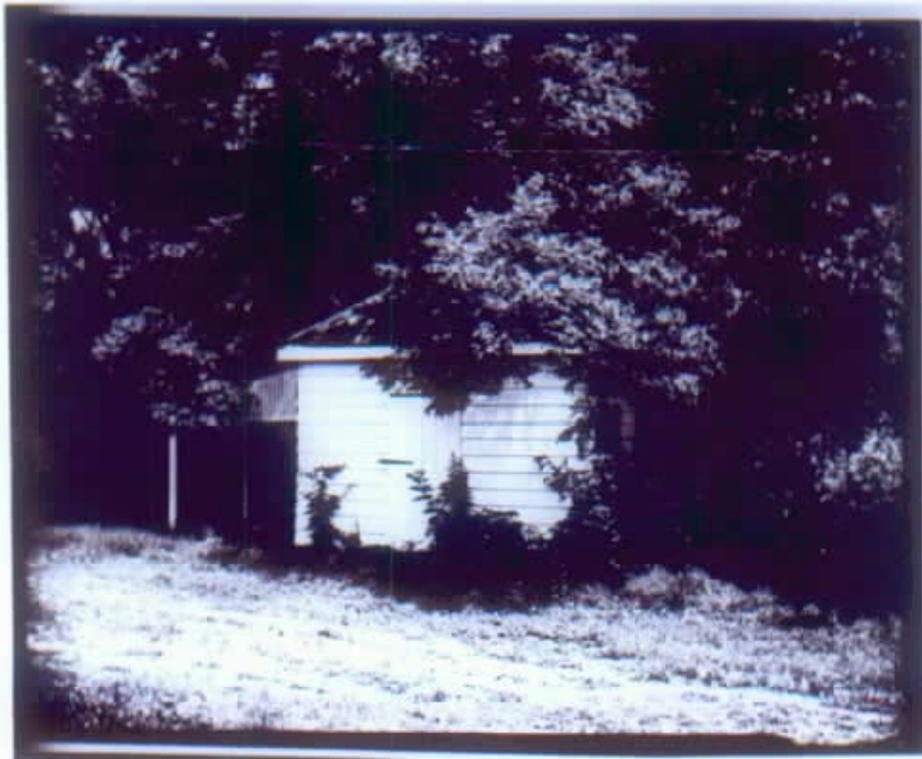
HABS No. DE-266-18

- DE- 266 -18 SMOKE HOUSE, VIEW NORTH, WEST AND SOUTH SIDES
- DE- 266 -19 SMOKE HOUSE INTERIOR, NORTH AND WEST WALLS

A single-story, wood-framed, square-plan smoke house (ca. 1830) is located immediately northeast of the dwelling. The building measures 12'-4" on each side and has a brick foundation and a standing seam metal, pyramidal roof. The walls are covered with aluminum siding. An open, shed-roofed porch extends from the smoke house's west side and is supported on cedar posts. The porch roof is constructed of corrugated fiberglass. The building's east and west elevations contain six-light hopper sash flanked by mid-twentieth-century applied shutters. A vertical wood-planked door with strap hinges and Norfolk latch is located on the south elevation. The interior has plank floors and exposed heavy timber framing. Hewn vertical clapboards are nailed to the outside of the timber framing.
