## CHAPTER 10

### SITE

### INTERPRETATIONS

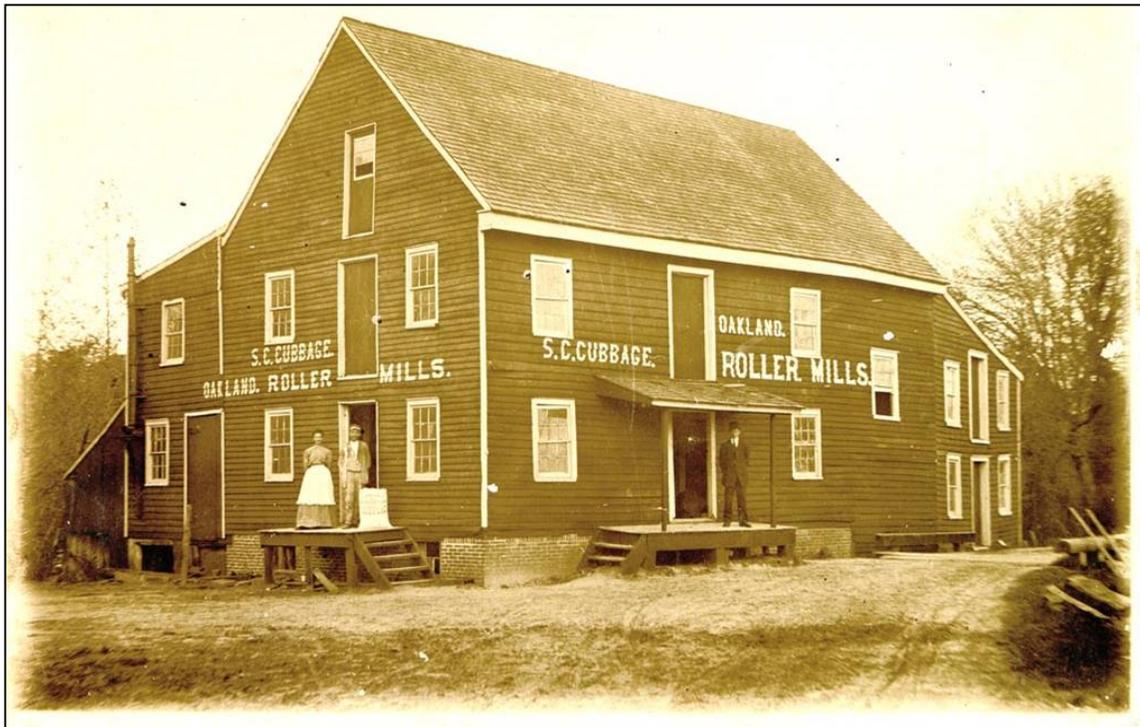
***Photograph 10.1***

By the turn of the 20<sup>th</sup> century, the mill concentrated singularly on meal production (Photograph 10.1).

***Oakland Roller Mills of Samuel Cubbage. Looking Southeast. Photograph ca. 1910-1915.***

Samuel Cabbage purchased the mill from the Davis Family in 1908, long after the time when most local mills ceased operations because of competition from larger commercial roller mills. A Photograph from this period illustrates a well-maintained mill (see Photograph 10.1). Cabbage and his son were both listed in the Milford Directory (Polk 1908-1909) as farmers, poultry keepers, and fruit growers, perhaps indicating that multiple sources of income were needed to supplement mill income.

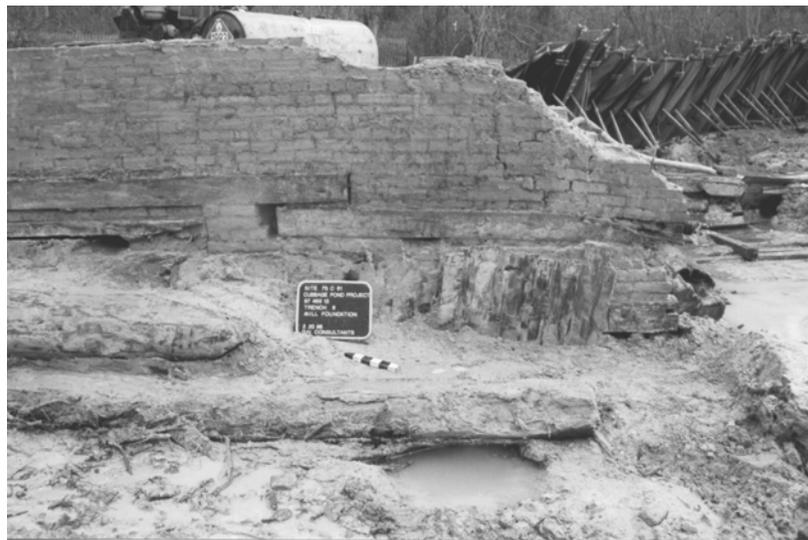
*Photograph 10.2*

*Vertical cribbing placed to protect the south end of the west foundation wall from water.*

Archeologists observed numerous wooden stakes underpinning the foundation, confirming the tenuous nature of construction on saturated soils. Vertical cribbing was in place to keep water from undermining the western and southern foundation walls and portions of the penstock and wheelpit (Photographs 10.2 and 10.3). Clearly, there were ongoing efforts to stabilize the foundation, such as the addition of wood blocks to support wooden sills (brick foundation) and brick nogging between the piers.

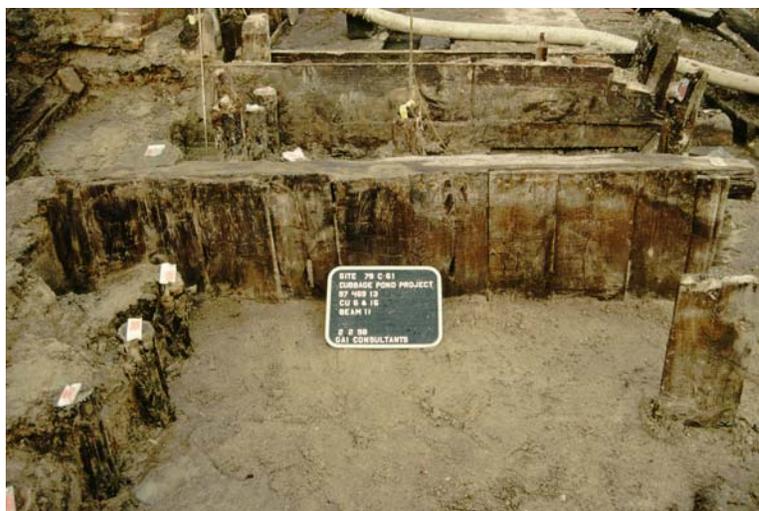
*Photograph 10.3*

*Vertical Cribbing around the Penstock and Wheelpit.*
