ARCHITECTURAL RESOURCES: DESCRIPTION AND EVALUATION

Jonathan Davis Farmstead (N-11711)

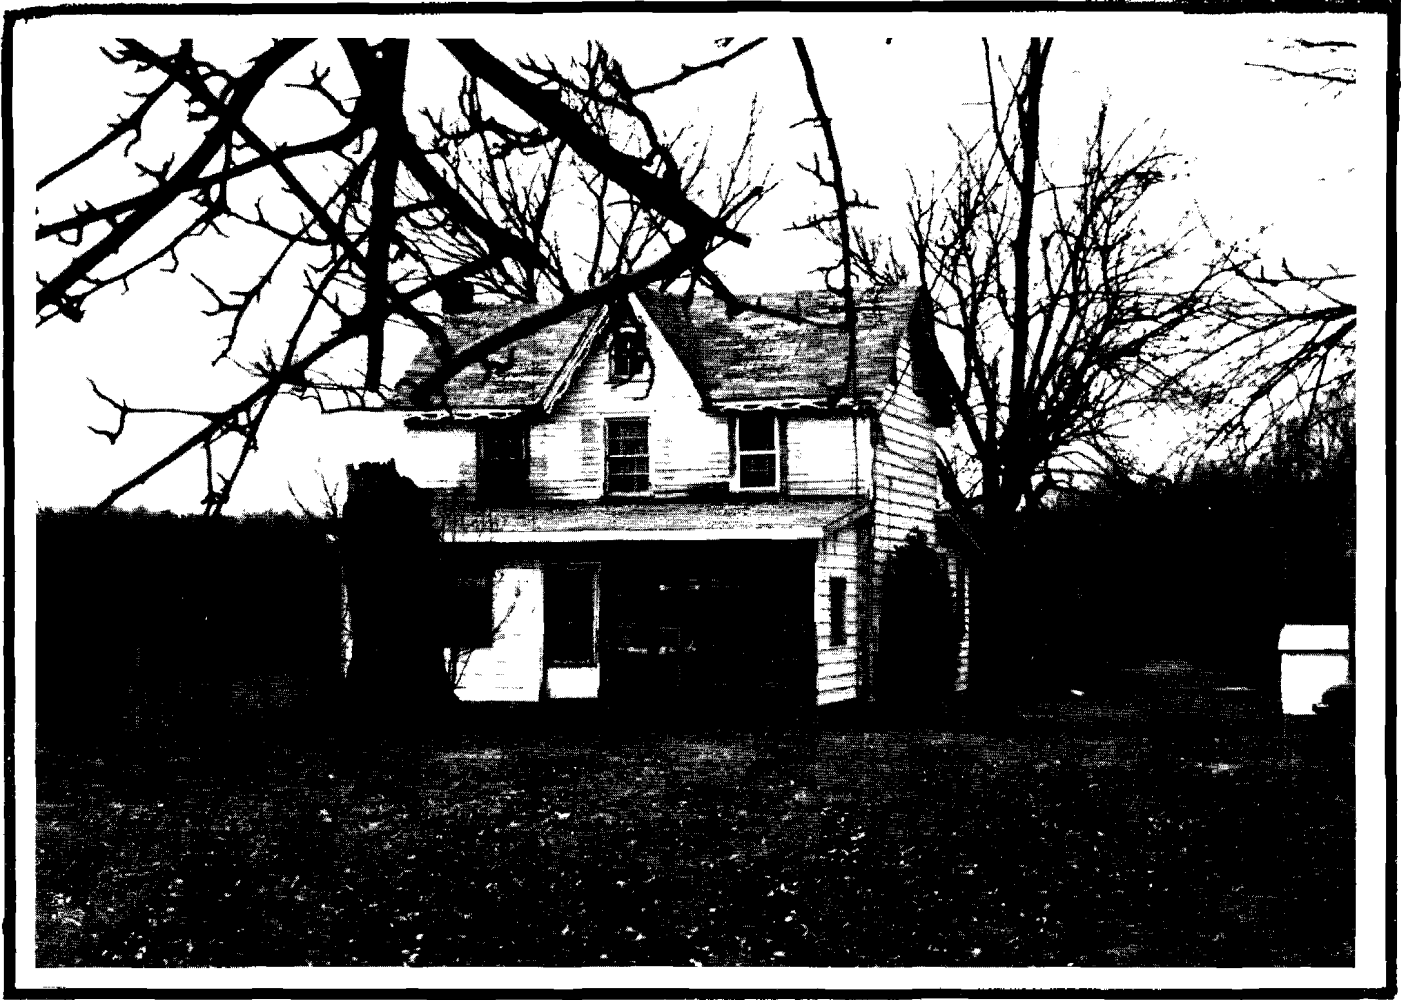
PLATE 3: Jonathan Davis House, View to West

The Davis farmstead consists of a dwelling, barn and several sheds, most in very dilapidated condition (Appendix A). The house is set back several hundred feet from the road, with a few mature shade trees nearby. The house is a two-story single-pile side-gable dwelling of wood frame construction on a low fieldstone basement (Plate 3). The exterior of the main block is variously clad in wood clapboards and vinyl siding. An enclosed shed-roofed porch extends across the facade; two fully-enclosed units of similar form and proportions, clad in vinyl siding, have been built across the rear.

The main elevation is symmetrically arranged with three bays and a gabled wall dormer rising at center. The rear of the main block is divided into two bays. Most window openings are fitted with 6/6 wooden double hung sash and trimmed with half-round applied molding strips. The front and rear eaves of the composition-shingle roof are embellished with narrow fascia boards scroll-cut with a "vine" motif. An exterior concrete block chimney is present at the south gable end.

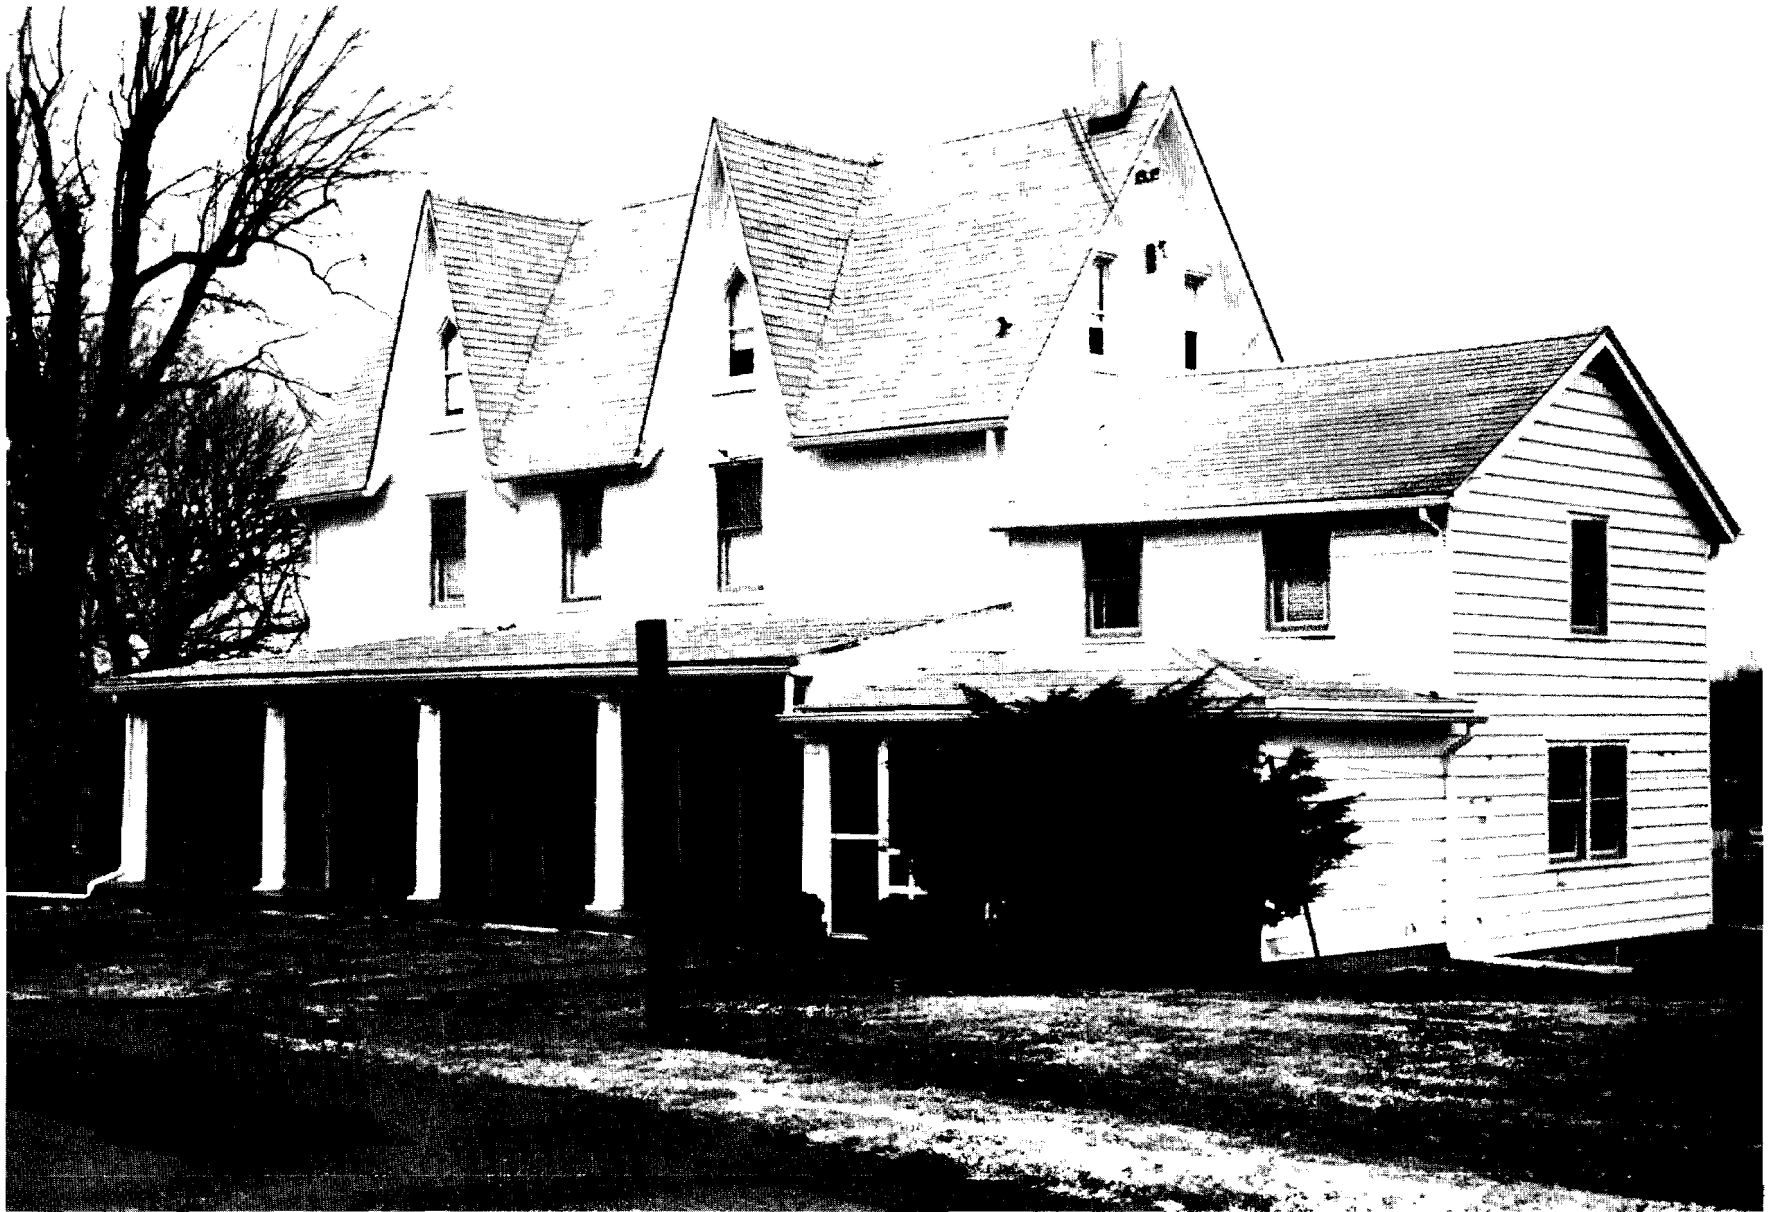
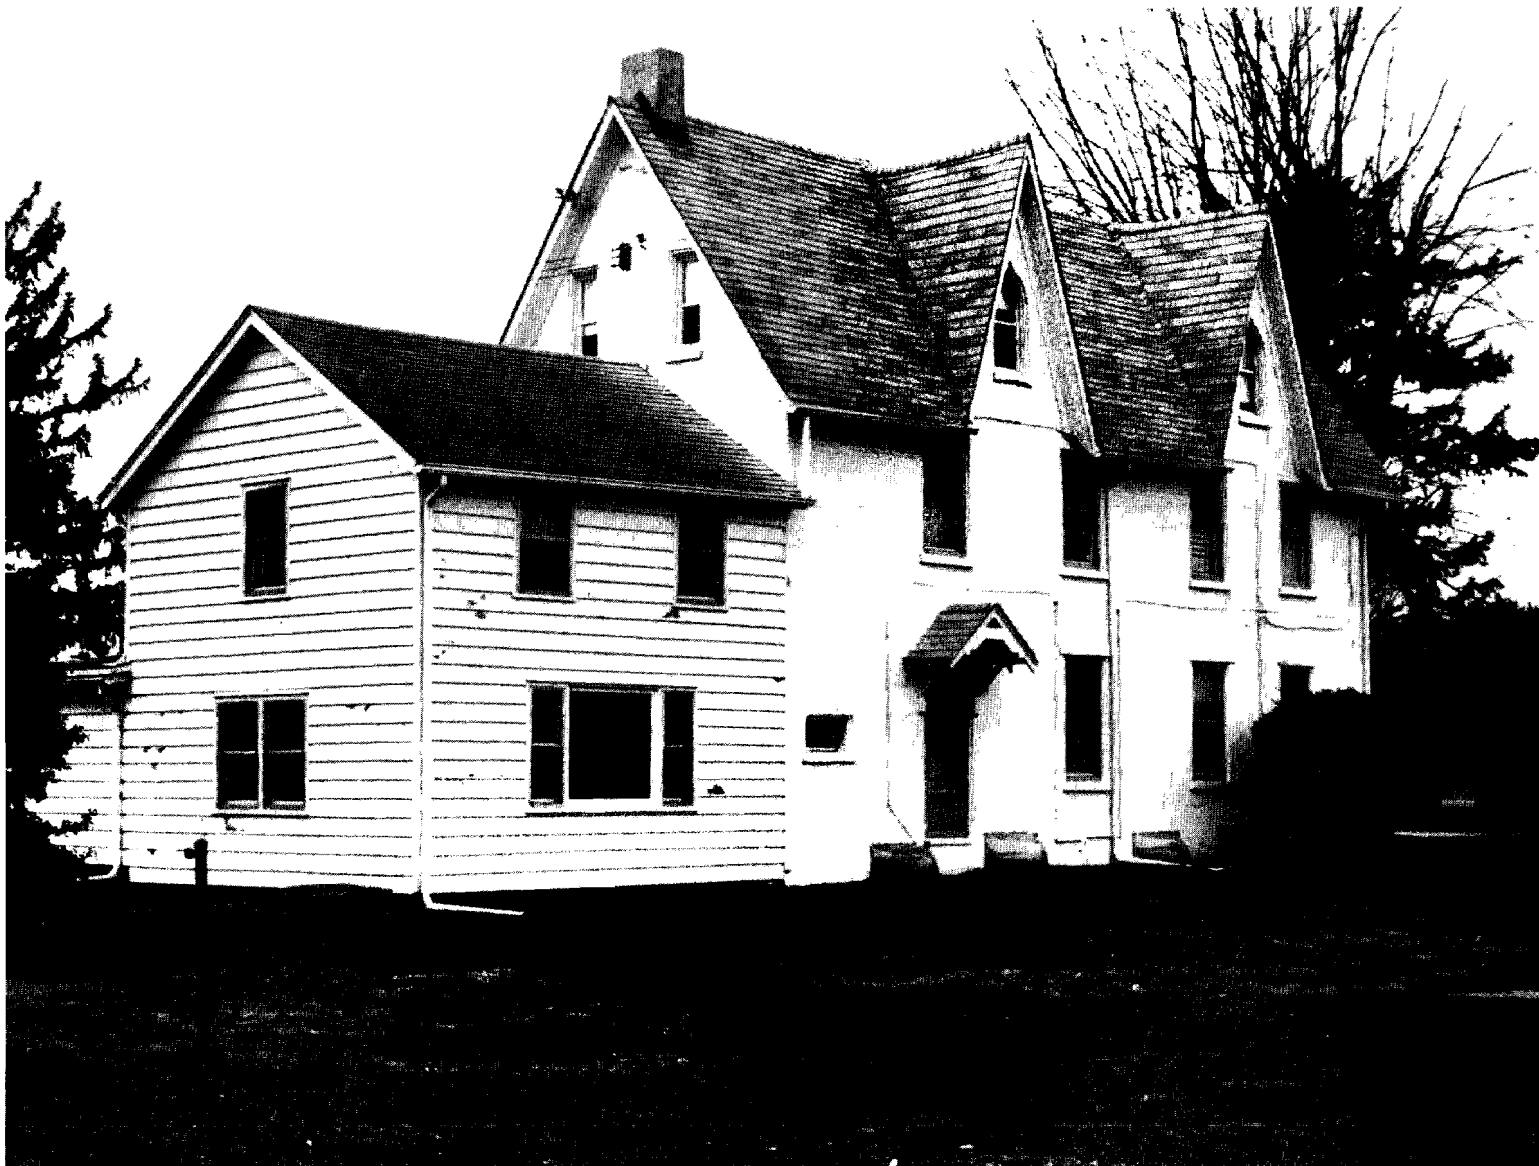
The house is massed in linear fashion with a 2-1/2 story main block and two-story wing at the east end (Plates 6 and 7). Both sections have side-gable orientation, one-room depth, and first stories set essentially at grade. The main block is of masonry construction on a stone foundation. The first stories of the main (south) and north elevations, as well as the entire west side, are stuccoed. On the main and north sides, the stucco is scored to resemble cut ashlar, while the second story walls are painted white but still reveal lines of common bond brickwork.

PLATE 6: Silver Hill Farm, Farmhouse, View to Northwest

PLATE 7: Silver Hill Farm, Farmhouse, View to Southwest

The facade of the main block is arranged with three bays over four, the openings in each story symmetrically arranged but not aligned vertically, while the north elevation is divided into four bays on each story. All window openings have wood lintels and sills, and are fitted with 1/1 replacement sash. The structure is surmounted by a steeply-pitched roof, on each slope of which are two tall, even more sharply-pitched gable wall dormers, each featuring a small window with ogee-arched brick head. The ogee is repeated in the attic windows of the west gable end, but not on the east end. The roof was originally clad in patterned red and green hexagonal slates, replaced ca. 1982 with composition shingling. The date "1882" is featured as part of an Eastlake-style wooden vergeboard on the west gable end.

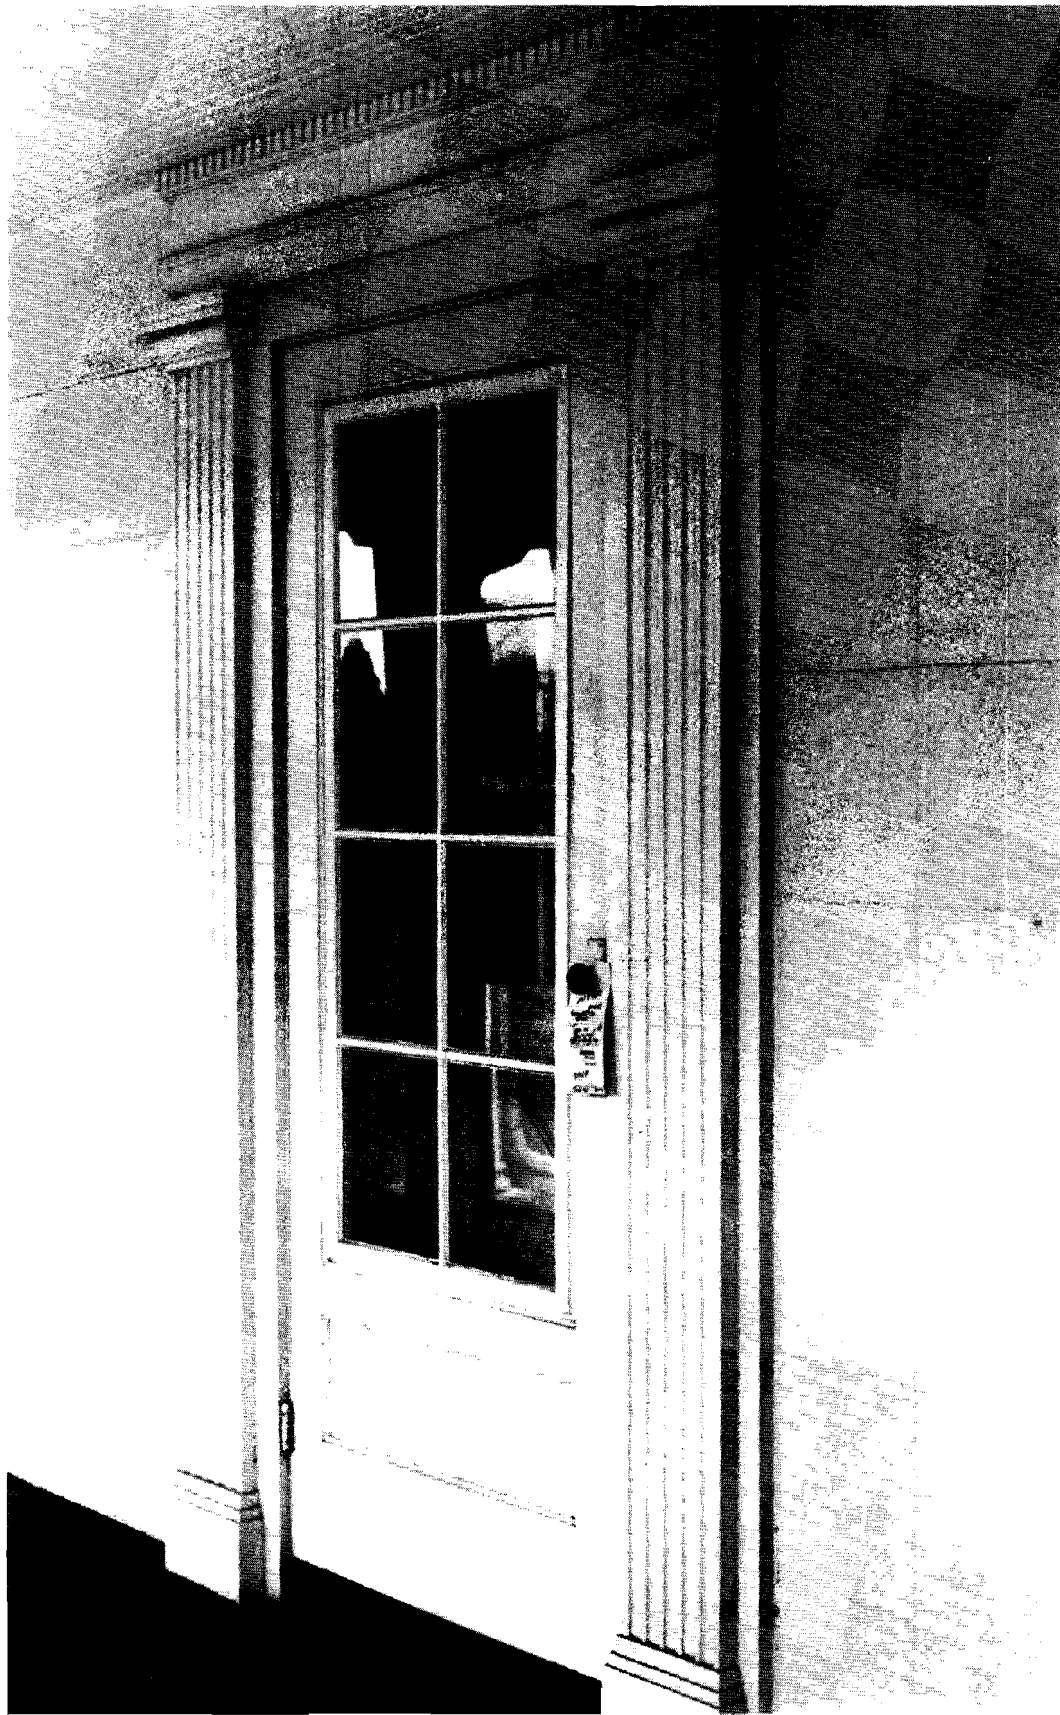
PLATE 8: Silver Hill Farm, Farmhouse, Main Entrance

The main entrance is located in the second bay from the west end, has a surround with fluted pilasters and narrow dentil molding (Plate 8). The deep reveals and soffit are embellished with a 3-inch wide reeded band. A shed-roofed porch across the full width of the facade has thick Tuscan Doric columns set on a concrete slab floor that is extended beyond the facade around the west side of the house. The rear entry, in the easternmost bay, is sheltered by a small gable roof with scroll-cut vergeboard.

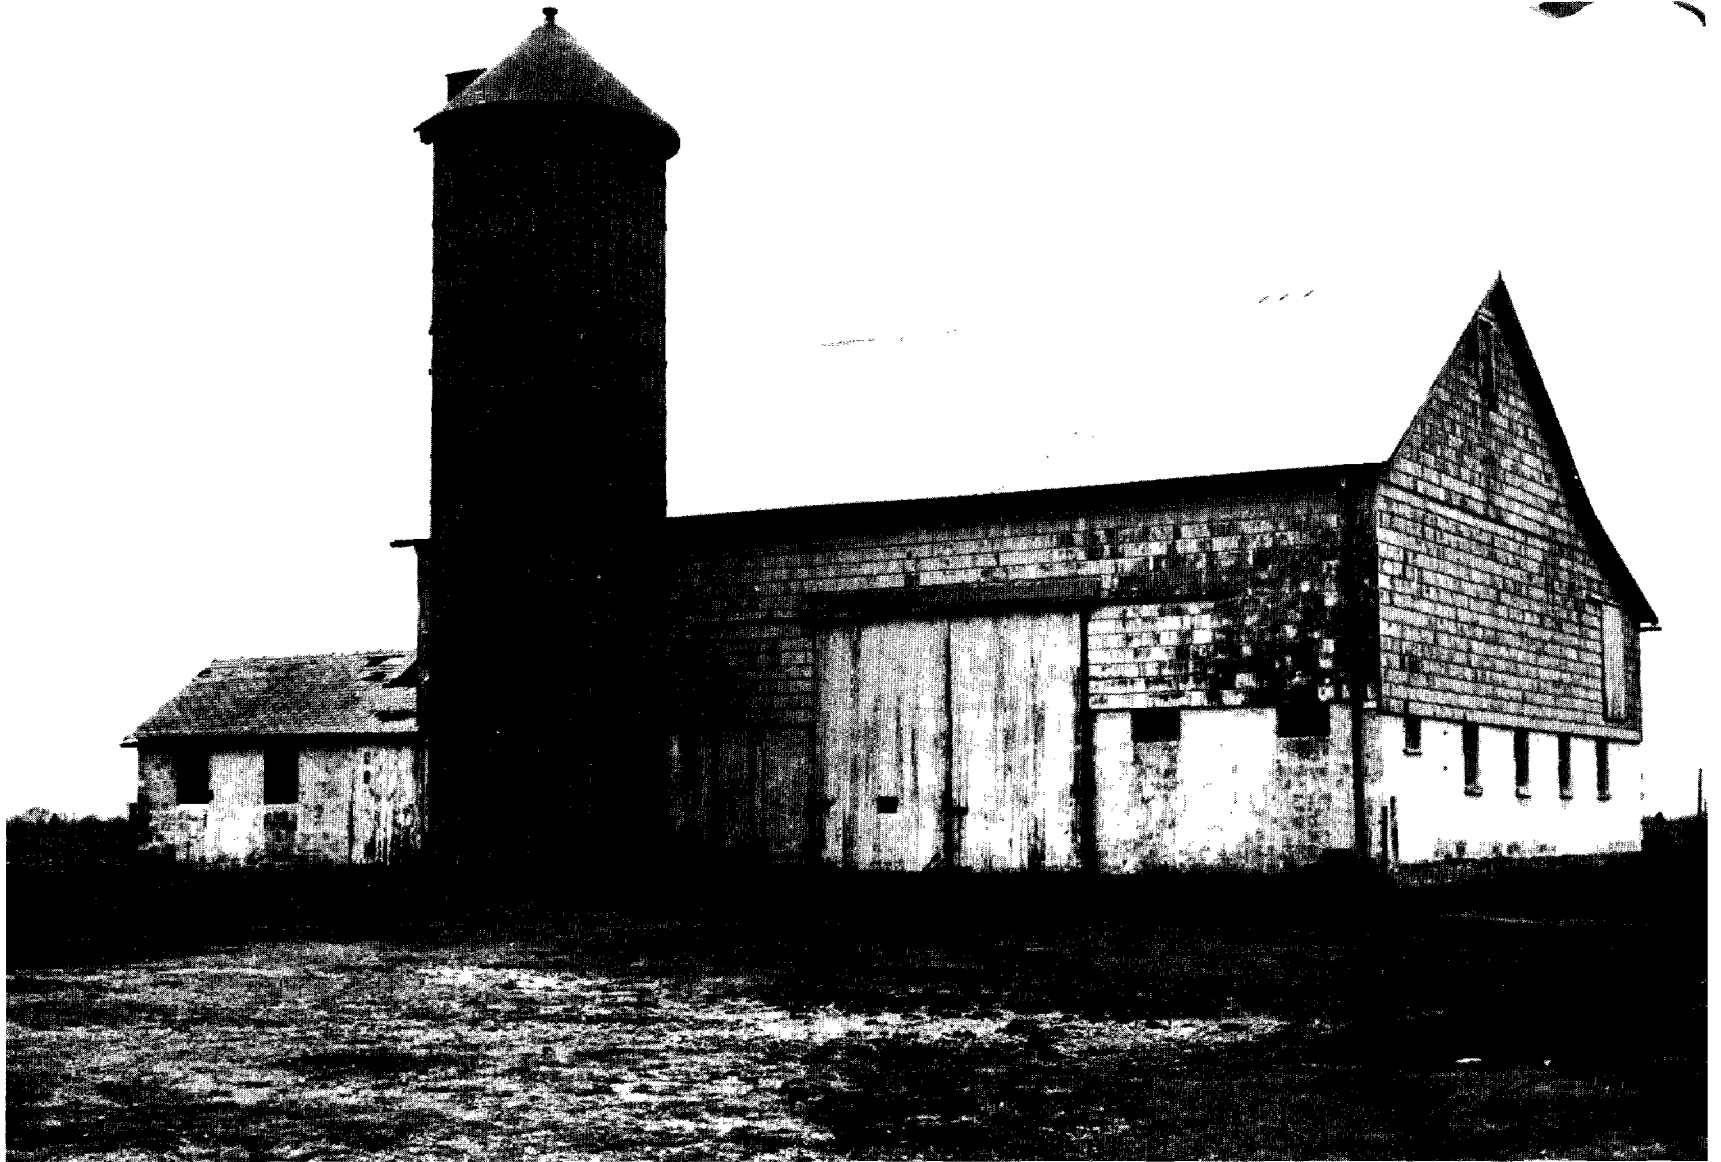
PLATE 9. Silver Hill Farm, Dairy Barn, View to Southeast

Prior to demolition, the principal outbuilding in the complex was a large side-gable barn with concrete block ground level and a timber framed loft level clad with shingles (Plate 9). The south roof slope was extended, on concrete block walls, as a "forebay" over what was once a cattle shed. A very tall wooden sliding door was centered in the north elevation, and the ground floor interior was fitted with metal milking stanchions. The adjacent silo was of poured concrete strengthened with metal rods. Other structures in the complex included a concrete block garage with aluminum overhead roll door, a frame garage with double-leaf hinged wooden doors and shingle siding, a concrete block and beaded-board machine shed, and a small "barn", possibly for poultry or sheep, with concrete block ground level and shingled frame loft (Plate 10).

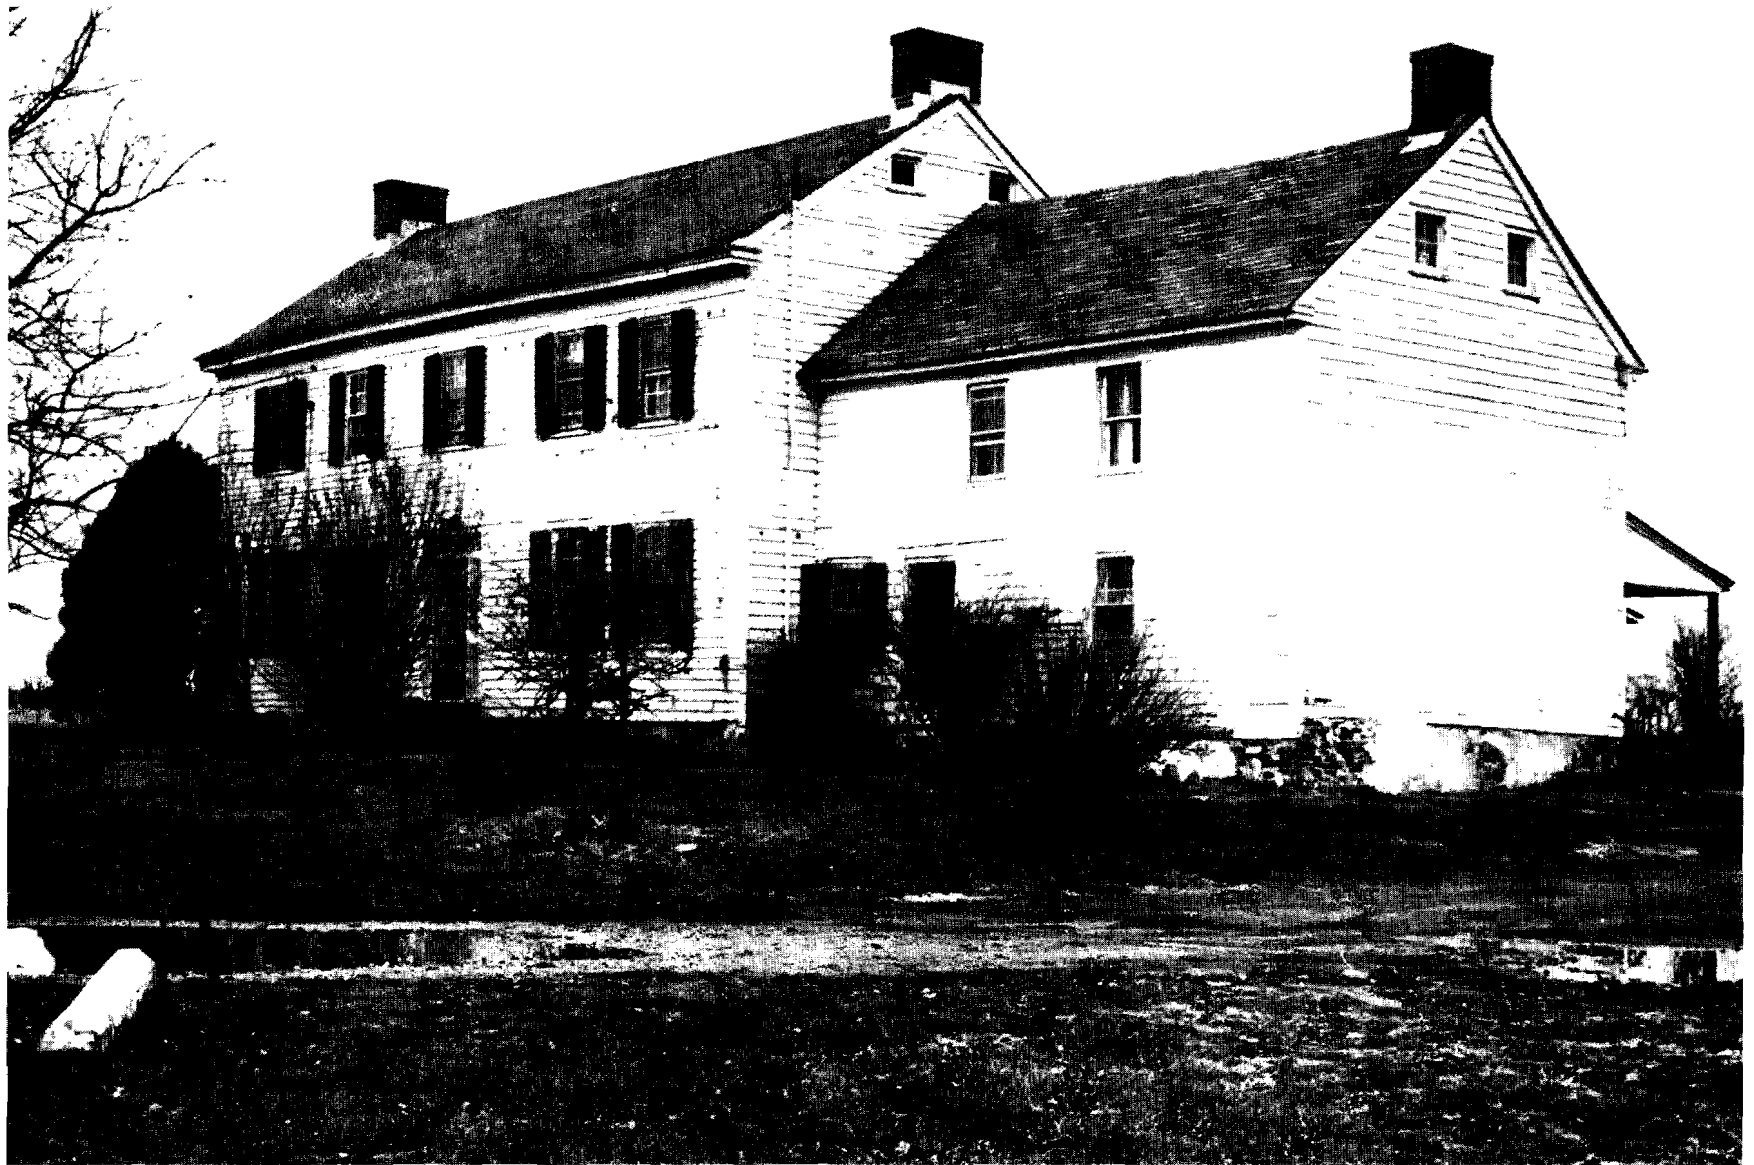
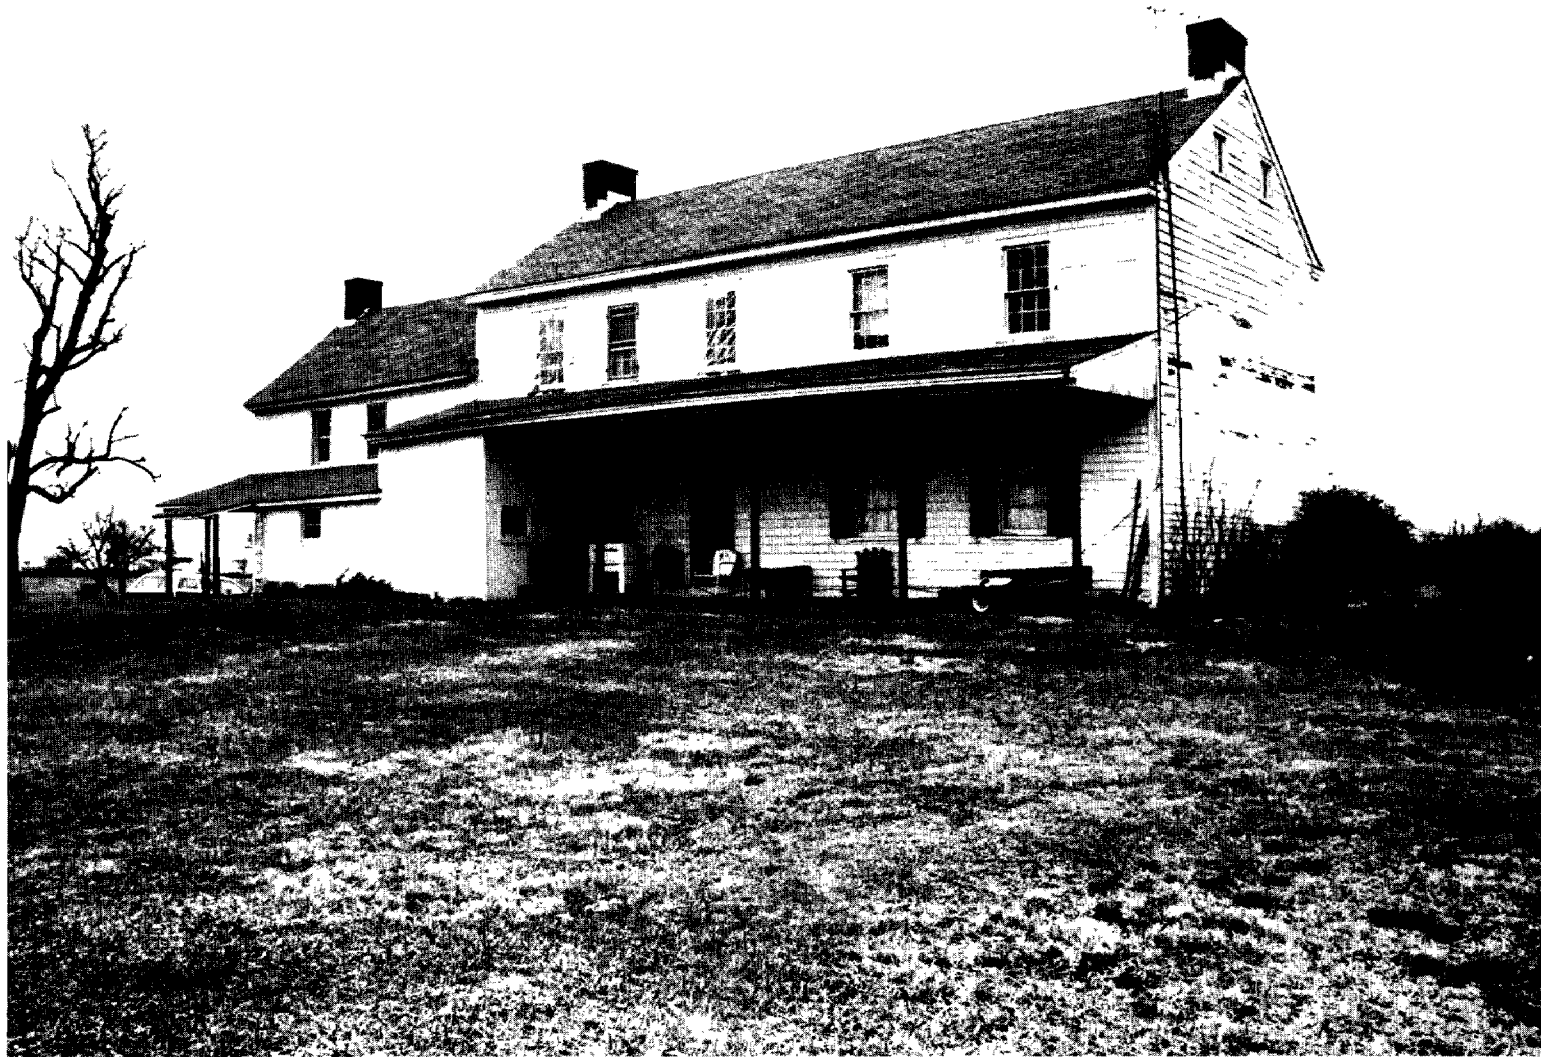
The farmhouse, which faces west, consists of two side-gable units massed in linear fashion that are the products of two separate building episodes, the later of which is estimated to have occurred ca. 1850-1860 (Plates 11 and 12). The earlier section, containing the kitchen, is a two-story, single-pile unit on a low rubble fieldstone foundation. According to the occupants, this section is constructed of logs measuring approximately 9" x 9", and is covered with wooden clapboards of varying width. Window openings (two at each story on the west side, one on first and two on second on the east (rear)), are fitted with 6/6 double hung sash and flat, unmolded surrounds. An interior chimney in the south gable end features the inscription "AJW 1860" in the mortar (visible from within the attic). (Since none of the recorded owners of this farm had those initials, the inscription may have been the work of a tenant or mason.)

The later, larger section that now constitutes the main block of the house, is a timber-framed clapboarded center-hall I-house on a low fieldstone foundation, with a brick-floored basement under the south end. The symmetrical five-bay facade contains a

PLATE 11. John T. Simmons House, View to Northeast

PLATE 12. John T. Simmons House, View to Southwest

center entry framed with sidelights and multi-light transom. Windows have 6/6 double hung sash; those on the facade have paneled shutters on the first story, louvred shutters on the second. The narrow front eave is edged with a simple dentil molding. Interior brick chimneys (the stacks of which appear to have been rebuilt) are present at each of the gable ends, which apart from small attic windows have blind walls.

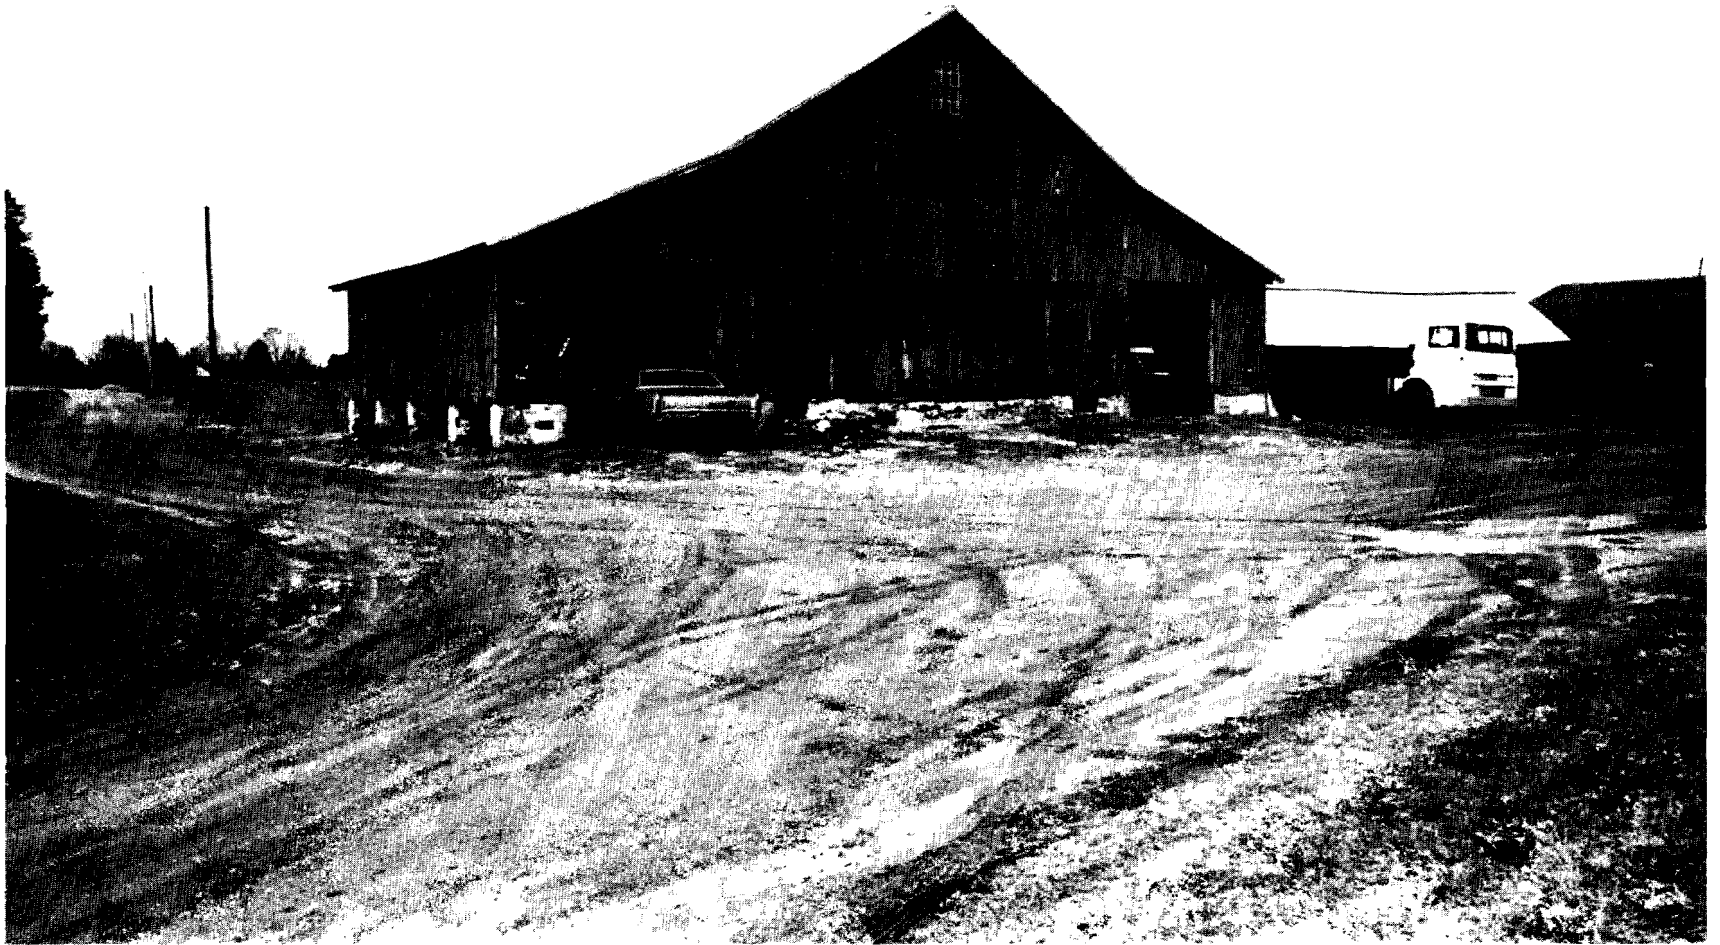
PLATE 15. John T. Simmons Farmstead, Granary, View to West

Most of the outbuildings in the complex are located north of the house, the exceptions being a row of three poultry houses with shed roofs and rough plank siding, and the foundations of an ice house located east of the dwelling. One of the principal structures is a large, six-bay granary constructed of nailed dimensioned lumber on fieldstone foundations and footings, clad in vertical plank siding, and featuring a winding stair to the upper level (Plate 15). A machine shed constructed of wood posts with sheet metal walls and gable roof, open on the east side, extends off the north wall of the granary. Perpendicular to the machine shed is another frame shed, partly open on the south side for machinery, with the east end fully enclosed. This shed also forms the south "wall" of a cattle yard, which is bounded by an open metal-clad shed on the west and by the dairy barn on the north (Plate 16). The dairy barn is a large structure with concrete block ground story and wood-framed loft area covered with a high arched "rainbow" roof. Two concrete silos are located at the northwest corner of the barn. On the east edge of the cattle yard are two closed gable-roofed frame sheds and a tall steel windmill.

The agricultural structures in the complex, the granary in particular, contribute to the significance of the property as architectural expressions of the evolution of agriculture in the area in the later 19th and early 20th centuries. The large granary is a very good example of this structure type, which appeared in association with agrarian reform in the region during the middle decades of the 19th century, and in addition is a prominent visual element in the complex. The early 20th century dairy barn, with extensive use of concrete and its arched "rainbow" roof, illustrates the erection of new structures on

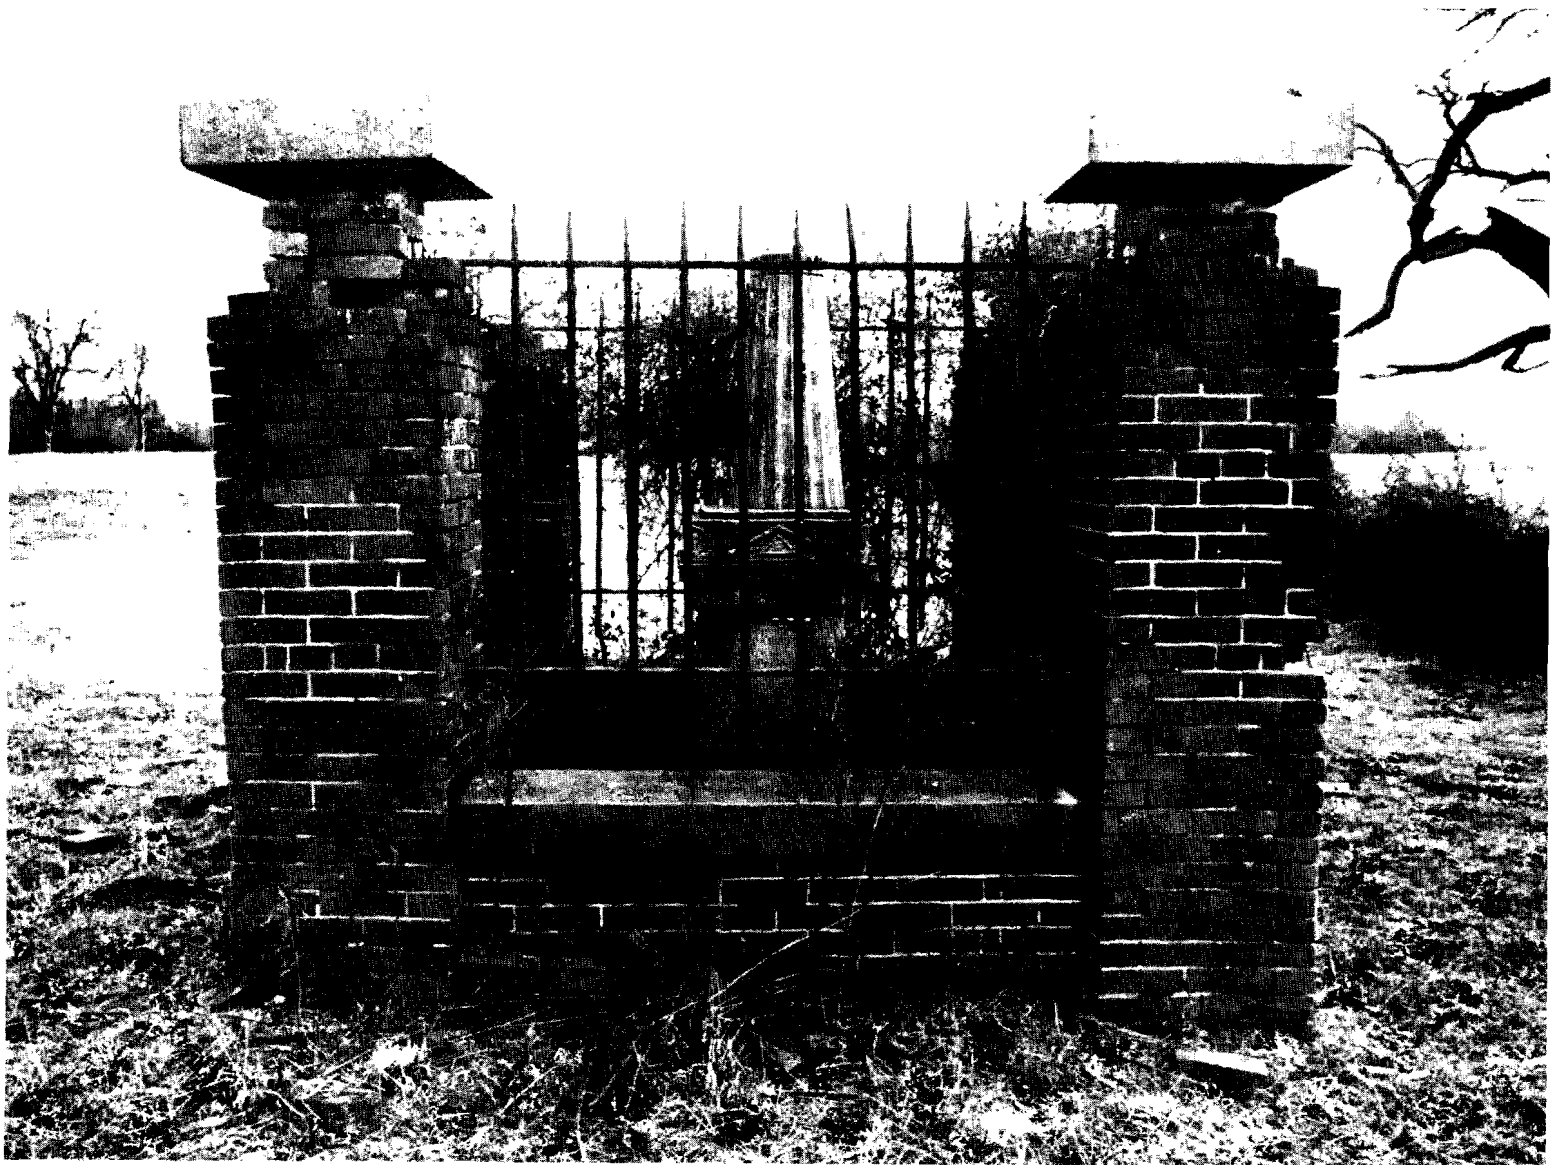
PLATE 17: John T. Simmons Farmstead, Partridge Memorial, View to East

Approximately 400 feet southwest of the house, at one end of a small fenced pasture, is a stone monument enclosed within barred cage with tall brick corner piers (Plate 17). The inscription of the monument dedicates the object to the four children of James and Margaret Partridge, who owned large tracts of land in

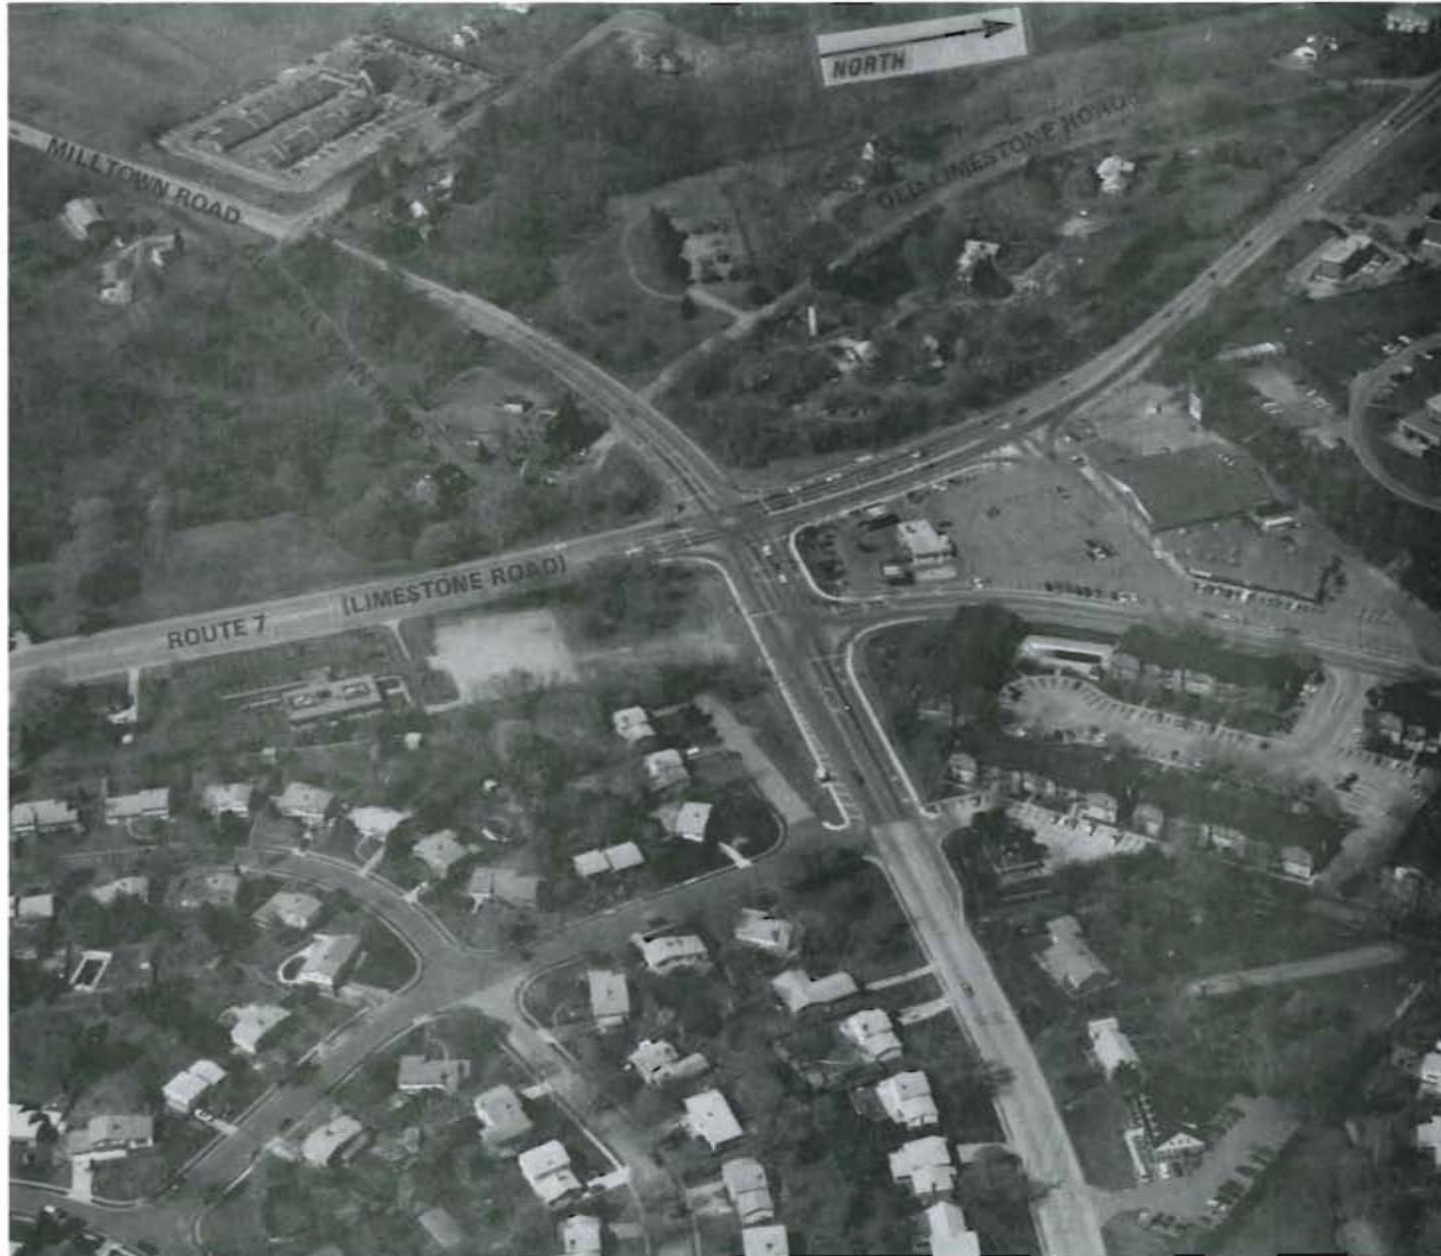
PLATE 18: Harlan—Chandler Mill Complex, Aerial View of Milltown Intersection

Description: The Harlan-Chandler Mill Complex is located at the southwest corner of the intersection of Limestone Road (Del. Route 7) and Milltown Road, in Mill Creek Hundred (Plate 18). The complex includes four structures: a stone mill built in 1815, a brick dwelling built in the late 1860s, and a garage and stable, associated with the dwelling, built in the 1930s. Although presently under separate ownership, the mill and house properties were part of a single mill tract from at least the mid-18th century until 1945. For this historical reason, and because the area in which they are located remains an identifiable whole, the mill and house are discussed and evaluated as a complex.

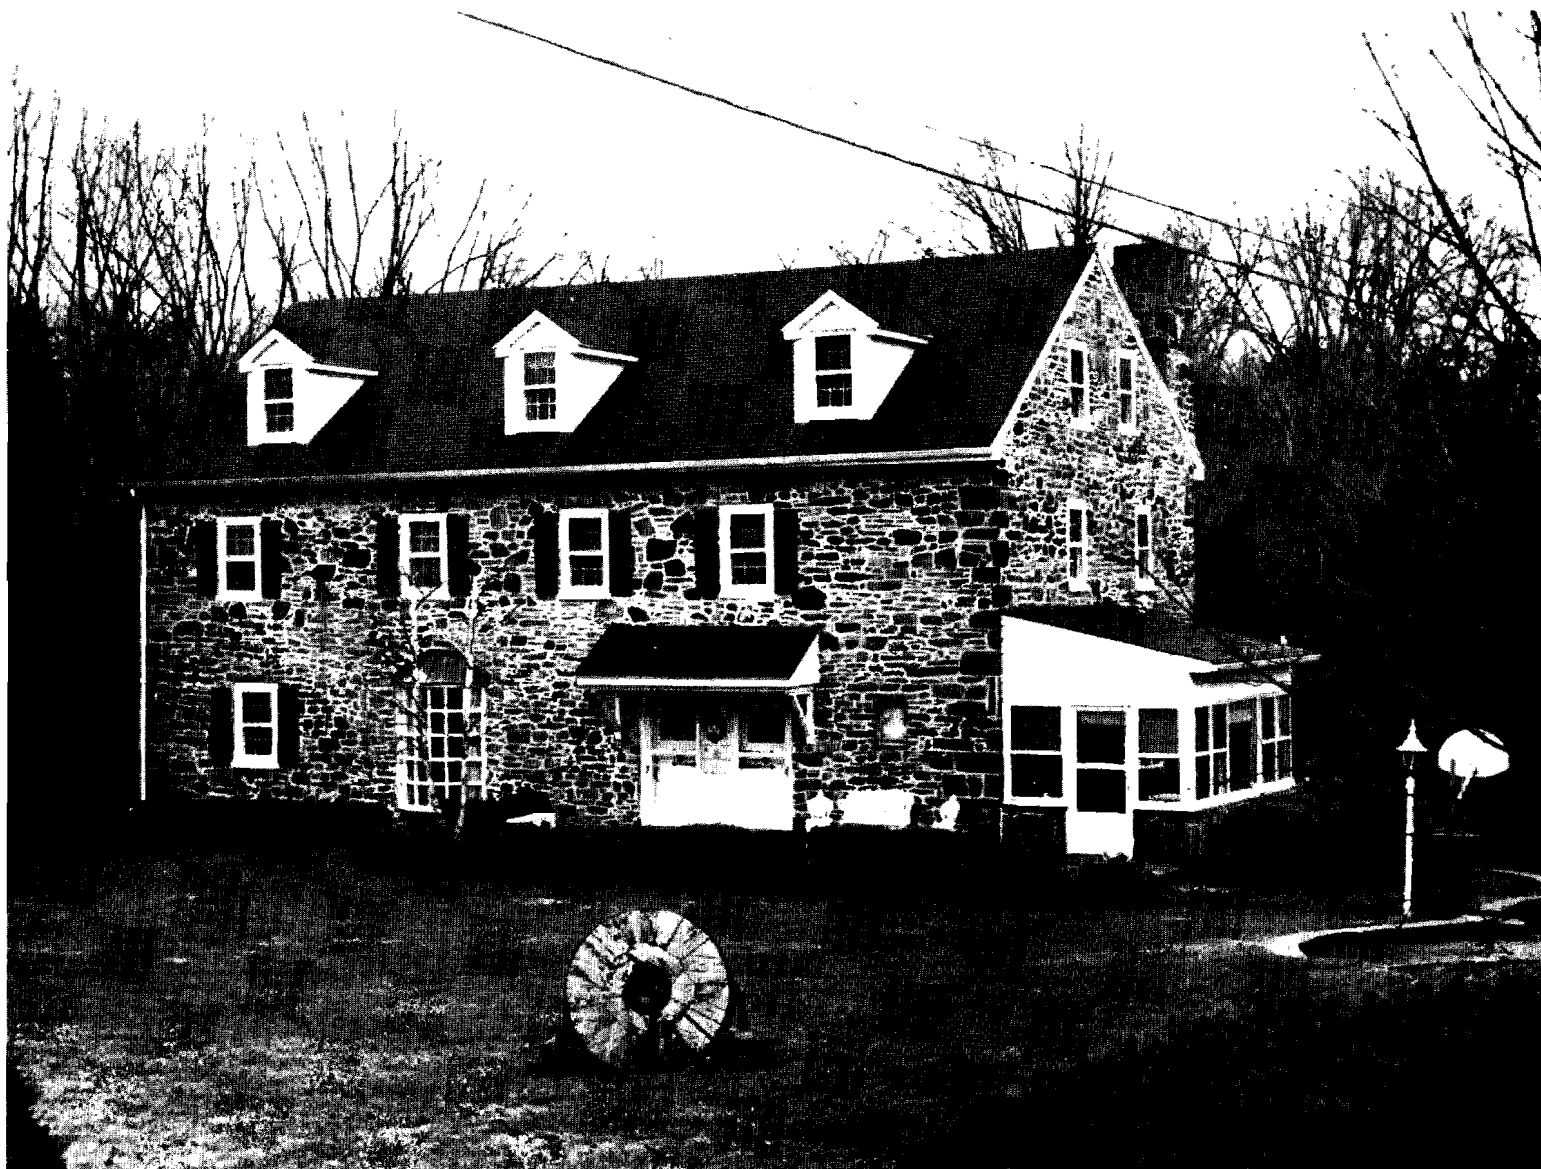
The Harlan Mill (N-251) is a 3-1/2 story side-gable rectilinear structure built of local fieldstone (Plates 19 and 20). Gutted by fire in the 1940s, the mill has been remodelled as a dwelling with a separate apartment in the rebuilt attic story. A two-level aluminum-sided frame unit with projecting garage has been built across the south elevation, and a slant-roofed porch has been added at the west end. In general, the exterior stone shell is essentially all that remains of the original structure. The roof has aluminum boxed eaves and is covered with composition shingling. A large shed dormer is built across the south roof slope. On the north slope are three symmetrically placed gabled

PLATE 19: Harlan Mill, View to South

PLATE 20: Harlan Mill, View to Northeast

dormers sided with aluminum. A large stone chimney stack rises from within the southwest corner of the structure.

Fenestration is somewhat irregular in the four-bay north and south elevations. On the north are two entrances side-by-side, and an opening to the east of these which has been enlarged to accommodate a curved "bay" window. With the exception of a second "bay" window on the west end, all other window openings have 6/6 replacement sash: east and west gable ends feature two regularly-spaced openings at second, third and attic story levels.
