ARCHITECTURAL RESOURCES: DESCRIPTION AND EVALUATION

Jonathan Davis Farmstead (N-11711)

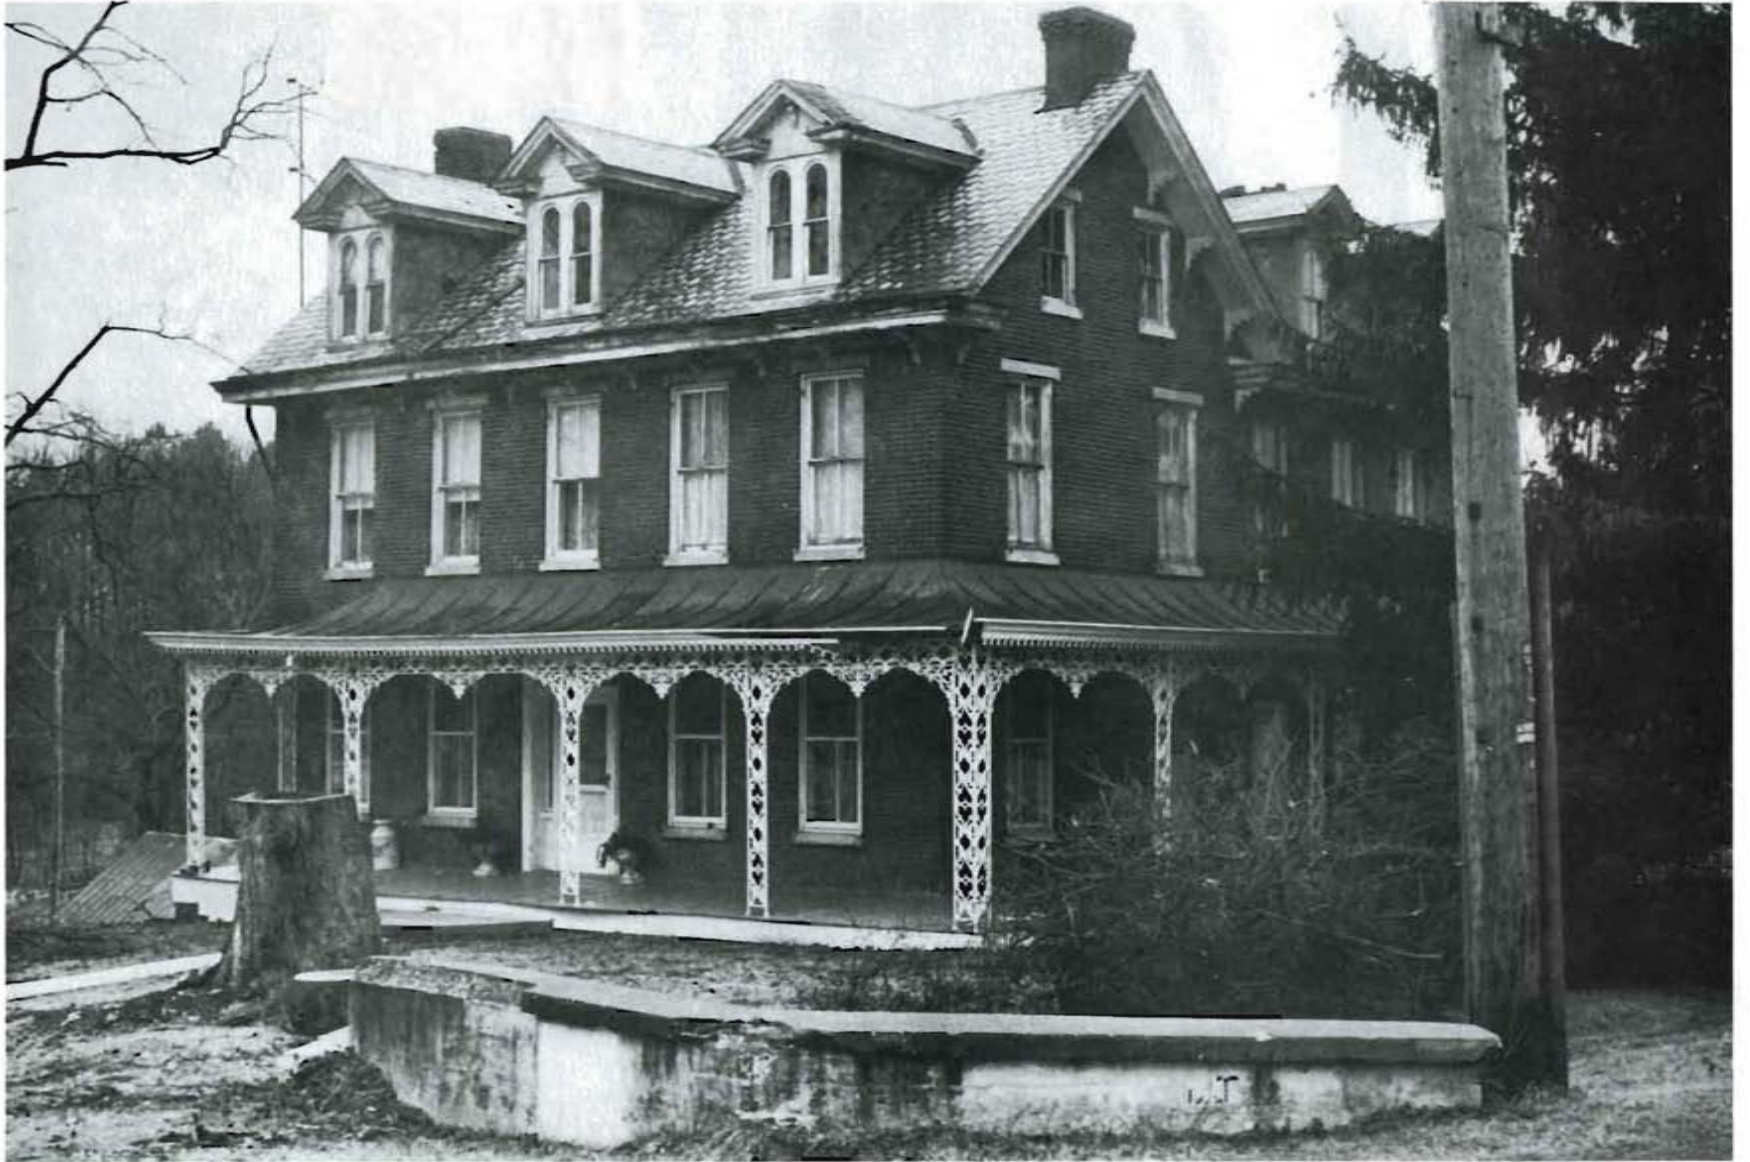
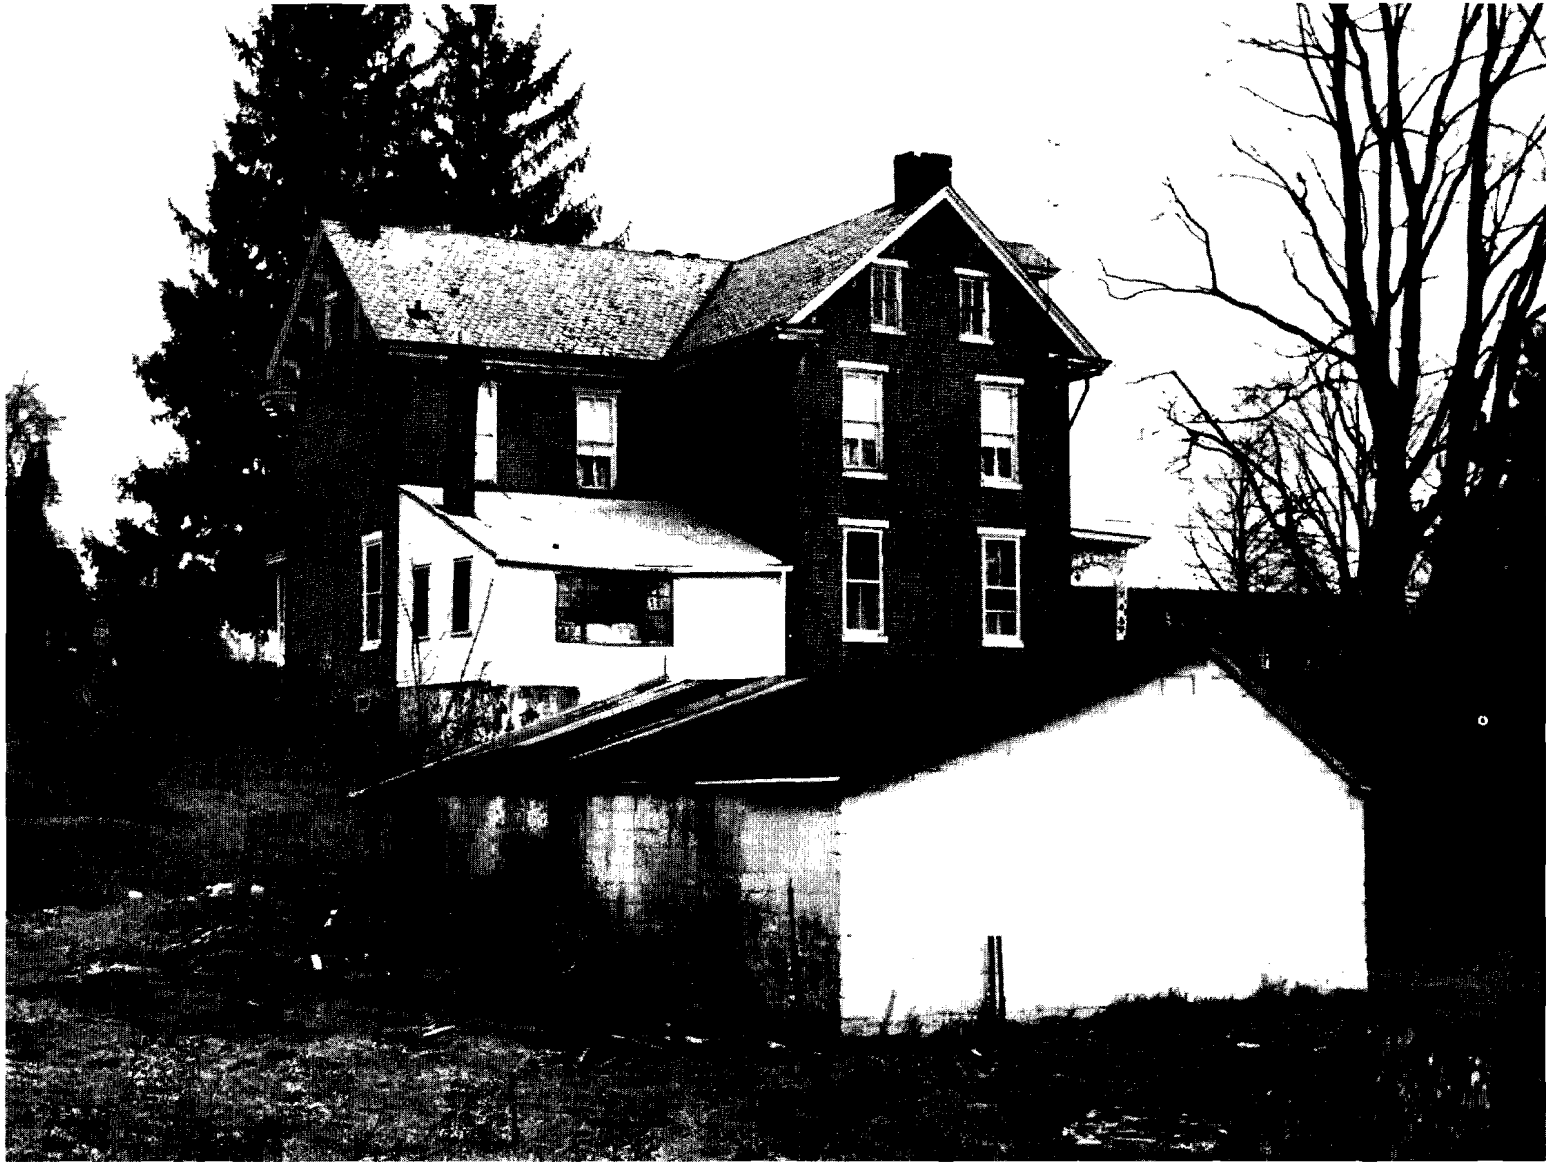
The Abram Chandler House (N-250) is a 2-1/2 story dwelling constructed of brick on a rubble fieldstone basement (Plates 21 and 22). The form of the house is that of a gable-roofed center-hall I with full-height rear ell. The gable roofs have partial cornice returns and bracketed eaves, and are covered with shaped slate shingles. Gabled, slate-shingled dormers, fitted with round-arched windows, are located on the east slope of the main

PLATE 21: Abram Chandler House, View to Southwest

PLATE 22. Abram Chandler House, View to North

roof and the north slope of the roof of the ell. The main block has a five-bay symmetrical facade and a center entrance with three-light transom and sidelights in which original glass has been replaced. Extending across the facade and the full length of the north side is a wood-floored veranda with concave standing-seam metal roof and mid-20th century ornamental ironwork posts. All windows in the principal floors have 2/2 double hung sash, and slab stone lintels and sills. Off the south wall of the rear ell is a one-room, slant-roofed aluminum-sided unit erected on a high masonry foundation, a portion of which, of rubble stone, may represent an earlier structure at this site.

The stable and garage structures located south of and below the Chandler house are constructed primarily of concrete block (Plates 22 and 23). The garage has a shallow "saltbox" roof while that of the stable is gabled. The stable has an upper loft area clad in vertical plank siding with a double-leaf door in the north end.
