Rehabilitation of Bridge 3-146

Main Street (US 13 Business) over Bridgeville Branch

(DeDOT Contract T202407902)

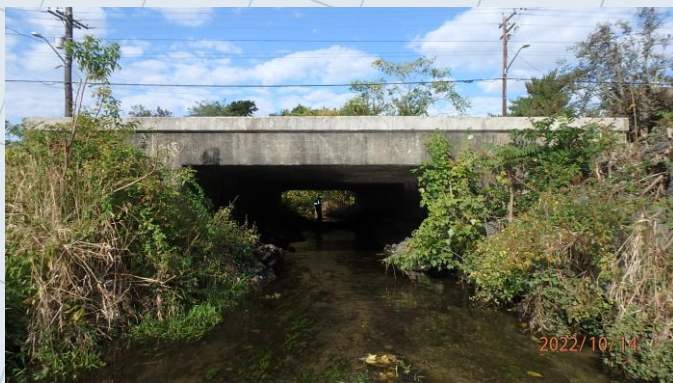
North elevation view of the culvert

Bridge 3-146 is owned and maintained by DeDOT and lies in Bridgeville spanning the Bridgeville Branch. The existing structure consists of a culvert originally built in 1934. The culvert was extended in 1962 to carry two lanes of traffic along with shoulders.

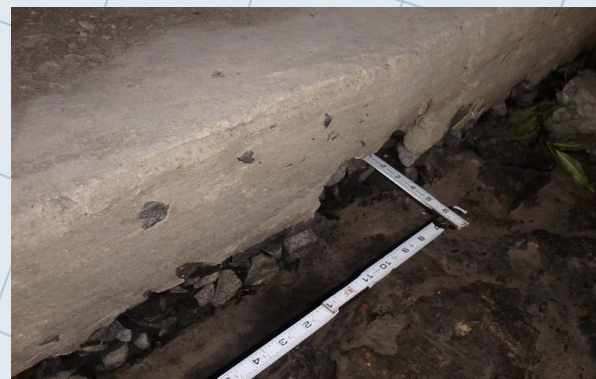
Scour exposing the culvert footer. Note the deep abrasion in the culvert footer as shown by the ruler probing it.

This culvert carries the water flow for the Bridgeville Branch towards the Nanticoke River to the east, covering a drainage basin of over 7 square miles. The water flow picks up sediments of various types and will etch into the concrete walls, creating abrasions on the surfaces of the interior culvert walls. Additionally, the water flow carrying sediments is striking the toe floor of the culvert and eroding the culvert itself. These erosive forces have exposed the culverts footers (known as scour) and cause a condition known as abrasion which is where the concrete and aggregate inside of it begin to wash away with the water flows.

The bridge substructure, the part of the bridge that carries the weight of the bridge and everything passing on the bridge, was rated as “Fair” condition. A “Fair” condition rating is defined by Federal standard as “all primary structural elements are sound but may have minor section loss, cracking, spalling, or scour.” While the bridge is currently safe, unremedied scour and abrasion could destabilize the bridge’s foundation and force the Department to implement weight restrictions on the structure.

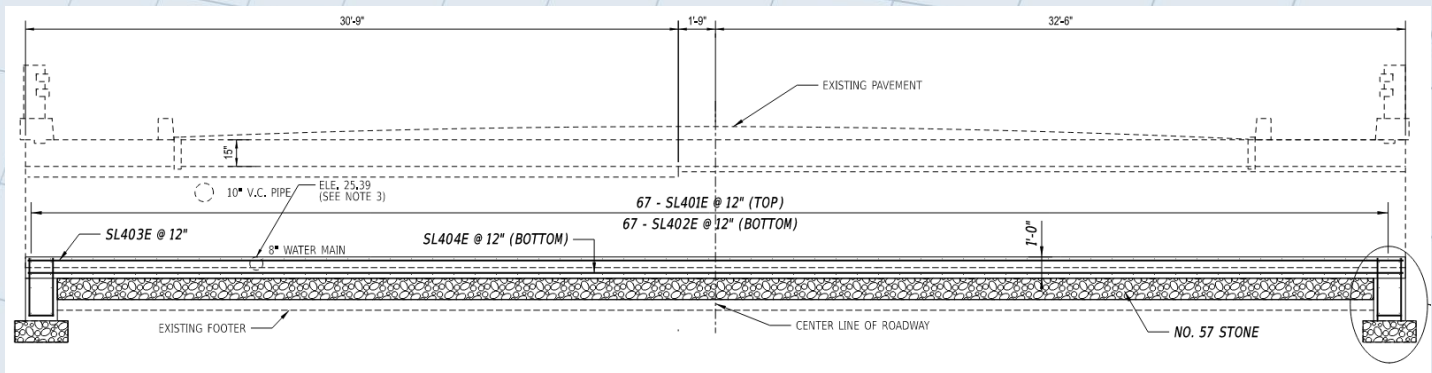
Drawings of the planned repairs: installing steel reinforced floor to the culvert. Dashed lines indicate existing items. Solid lines identify new items.

DeIDOT plans to extend the lifespan of this vital bridge by constructing a concrete floor through the culvert. The existing abrasion in the footer of the culvert will be encapsulated and protected by the new culvert floor. This floor will remediate the scour issue below the bridge and protect the structure against scour for years to come. New toe walls at each end of the floor will withstand the force of the water and sediments striking the face of the culvert. Lastly, the floor will secure a water main pipe that is currently partly buried in the culvert floor. By placing the reconstructed floor that embeds the water main, the water main will be protected from the effects of water erosion that could damage or rupture the water main itself.

This project will be conducted in the stream bed by installing a pump that will carry steam-diverted water through pipes mounted on the wall of the culvert itself. This will create a dry work area where concrete can be poured over the steel rebar reinforcements and allowed to cure to the needed strength.
