PHASE I SURVEY RESULTS

STUDY PARCELS FOR PHASE I ARCHAEOLOGICAL SURVEY OF U.S. 13 RELIEF ROUTE, SOUTH TO NORTH ALONG PROPOSED RIGHT-OF-WAY, STAS 1779-2060

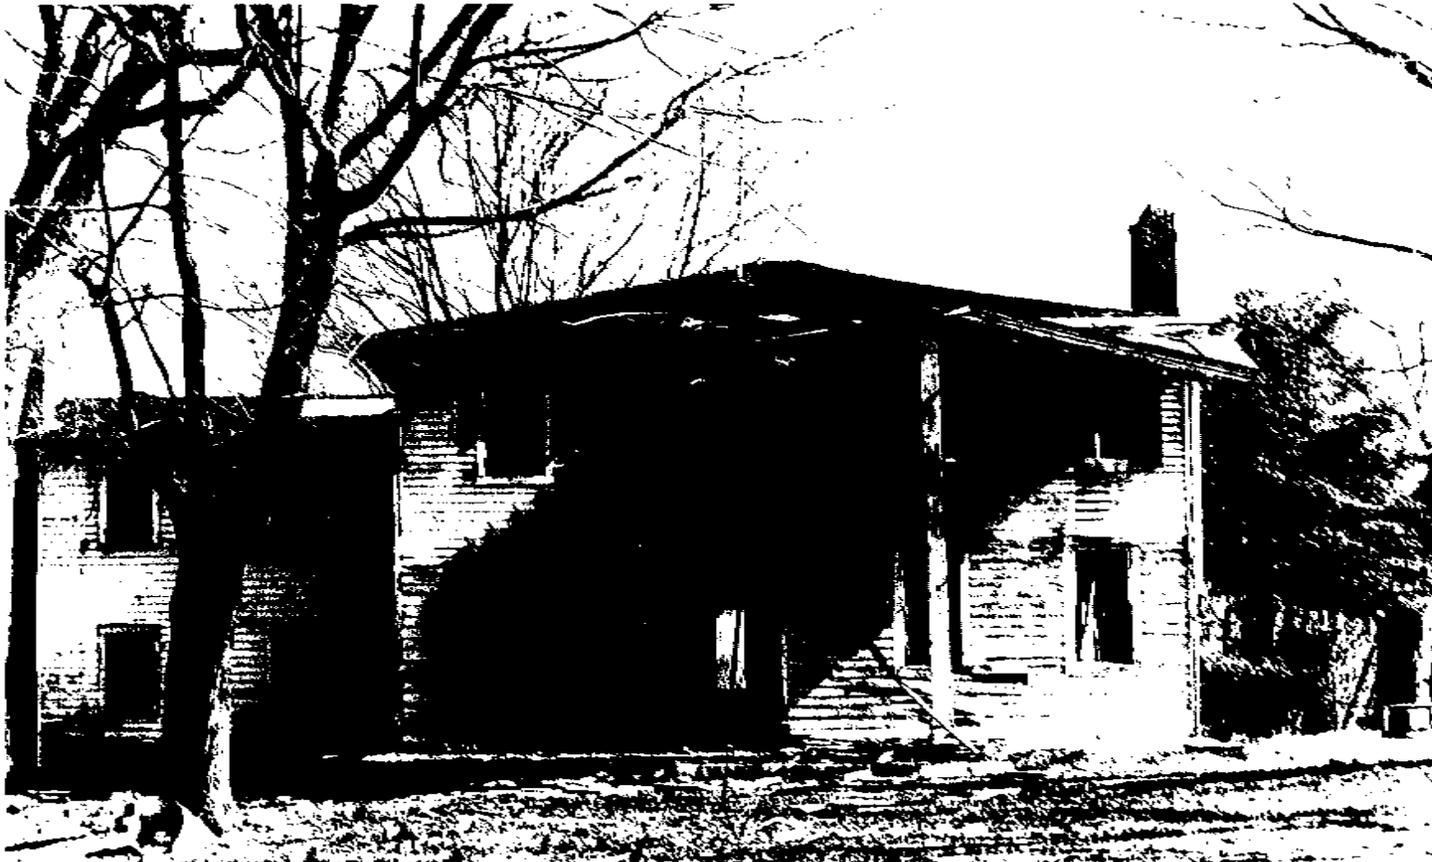
PLATE 2

7NC-E-98, N-5053, South Elevation;
Structure Razed about 1980

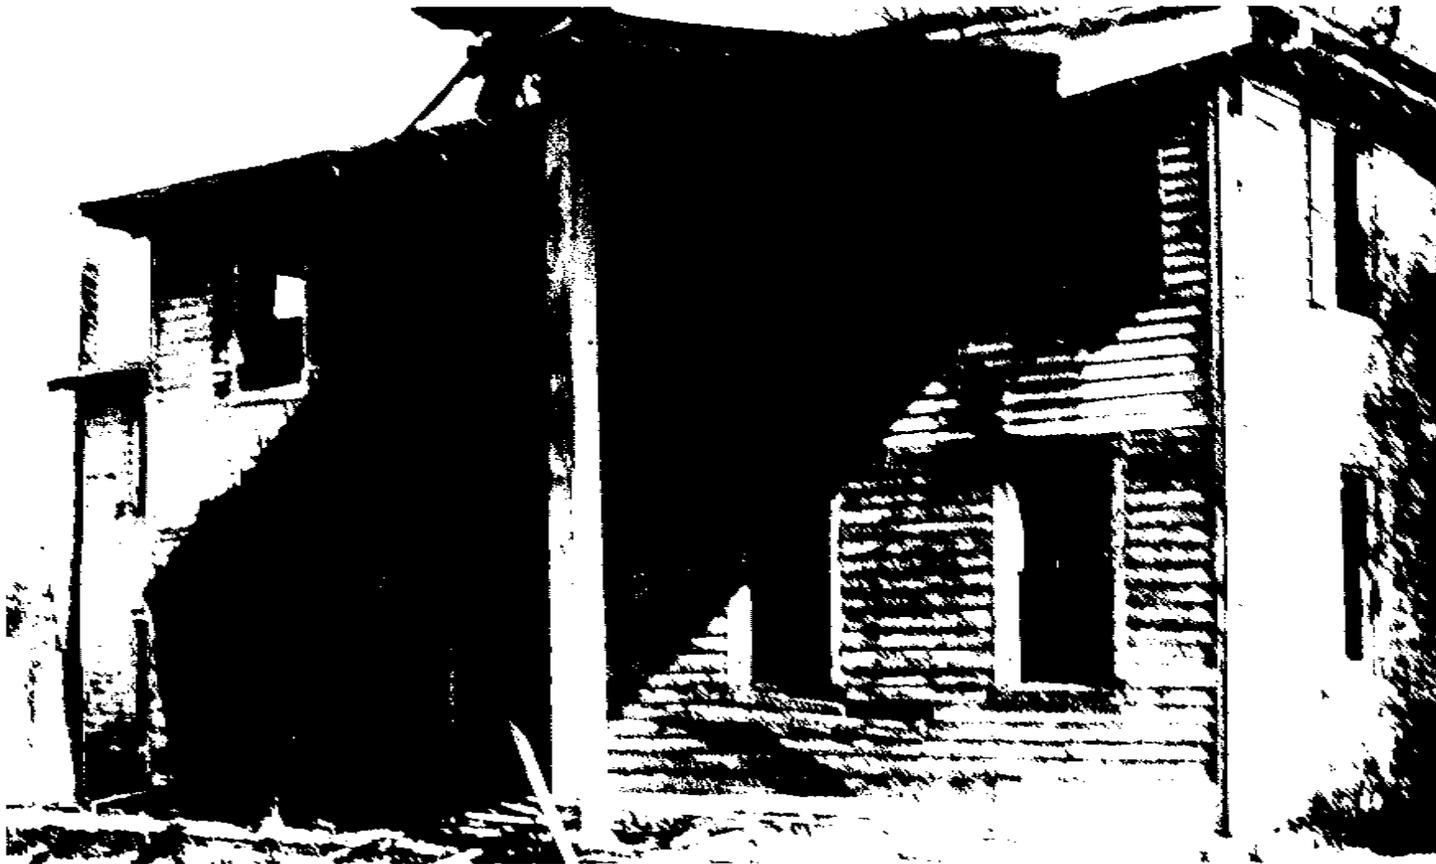
PLATE 3

7NC-E-98, N-5053, South Elevation;
Structure Razed about 1980

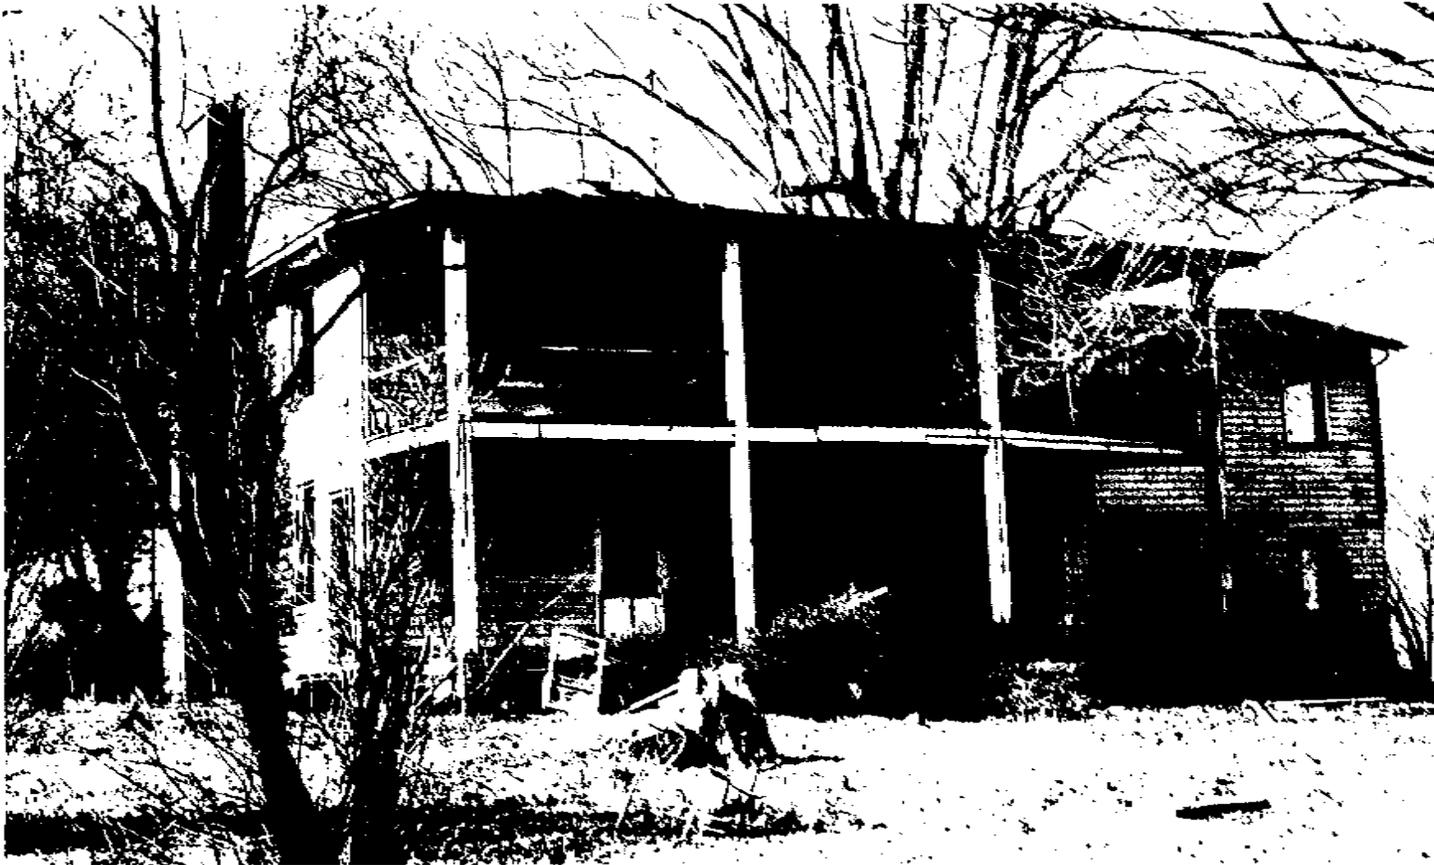
PLATE 4

7NC-E-98, N-5053, North Elevation;
Structure Razed about 1980
