State Bridge Number 300

HABS/HAER INVENTORY

Porter Station Road over Red Lion Creek
Porter, New Castle, Delaware

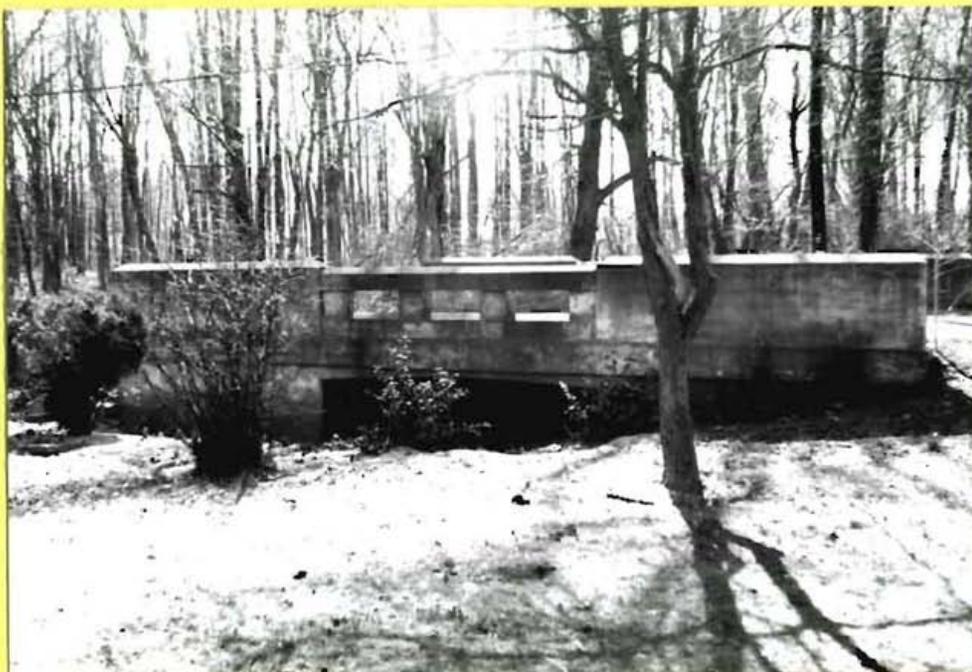
37B:23

Good

State Highway Bridge 300 is a 10'-10" concrete rigid frame bridge with concrete abutments and U-shaped concrete wing walls. It carries two lanes of traffic on a deck 24'-0" wide. A corbeled band defines the top of the fascia and wing walls. The fascia is shaped as a segmental arch. The concrete parapet consists of two large end blocks, each 10'-0" long. The wall between the end blocks is lower and is comprised of concrete posts as an oversized balustrade and beveled rail.
