# HABS/HAER INVENTORY

State Bridge Number 707

Road 50 over Silver Lake  
Rehoboth Beach, Sussex County, Delaware

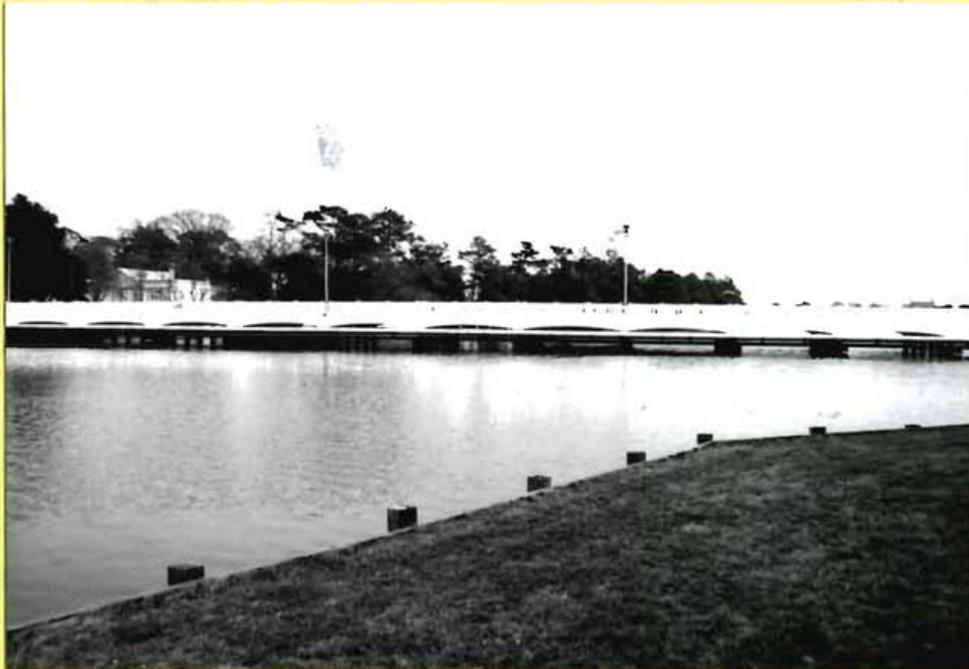
12B:6-25

Delaware State Highway Bridge 707, "Lake Bridge", is a thirteen span combination timber and concrete bridge 260'-2" long. The spans are equally spaced at 20'-0". The deck is a composite slab structure and the parapet is concrete. The parapet is decorated with rectangular shaped arched pointed openings between columns. These columns are spaced 6'-4" apart. A concrete fascia, with a broad segmental arch curve, also ornaments the bridge. The fascia is 1'-8" wide at the crown of the arch and 4'-0" above the water level. The concrete deck, parapet and fascia are supported by timber members. The substructure is timber with timber bents comprising 12" x 12" beams on pilings, and U-shaped timber wing walls. The bridge's timber bents are laterally braced with horizontal struts. Two joints and double piers support the structure at the fourth and ninth pier. The bridge is 30'-8" wide and carries two lanes of traffic and two sidewalks. There are four decorative lamps on the bridge's west elevation.
