New Castle Pedestrian Study
 New Castle, Delaware
 Proposed Short & Long Term Improvements
 US Route 13 From DE Route 273 To Buena Vista Drive
 June 2008
 Figure 11C

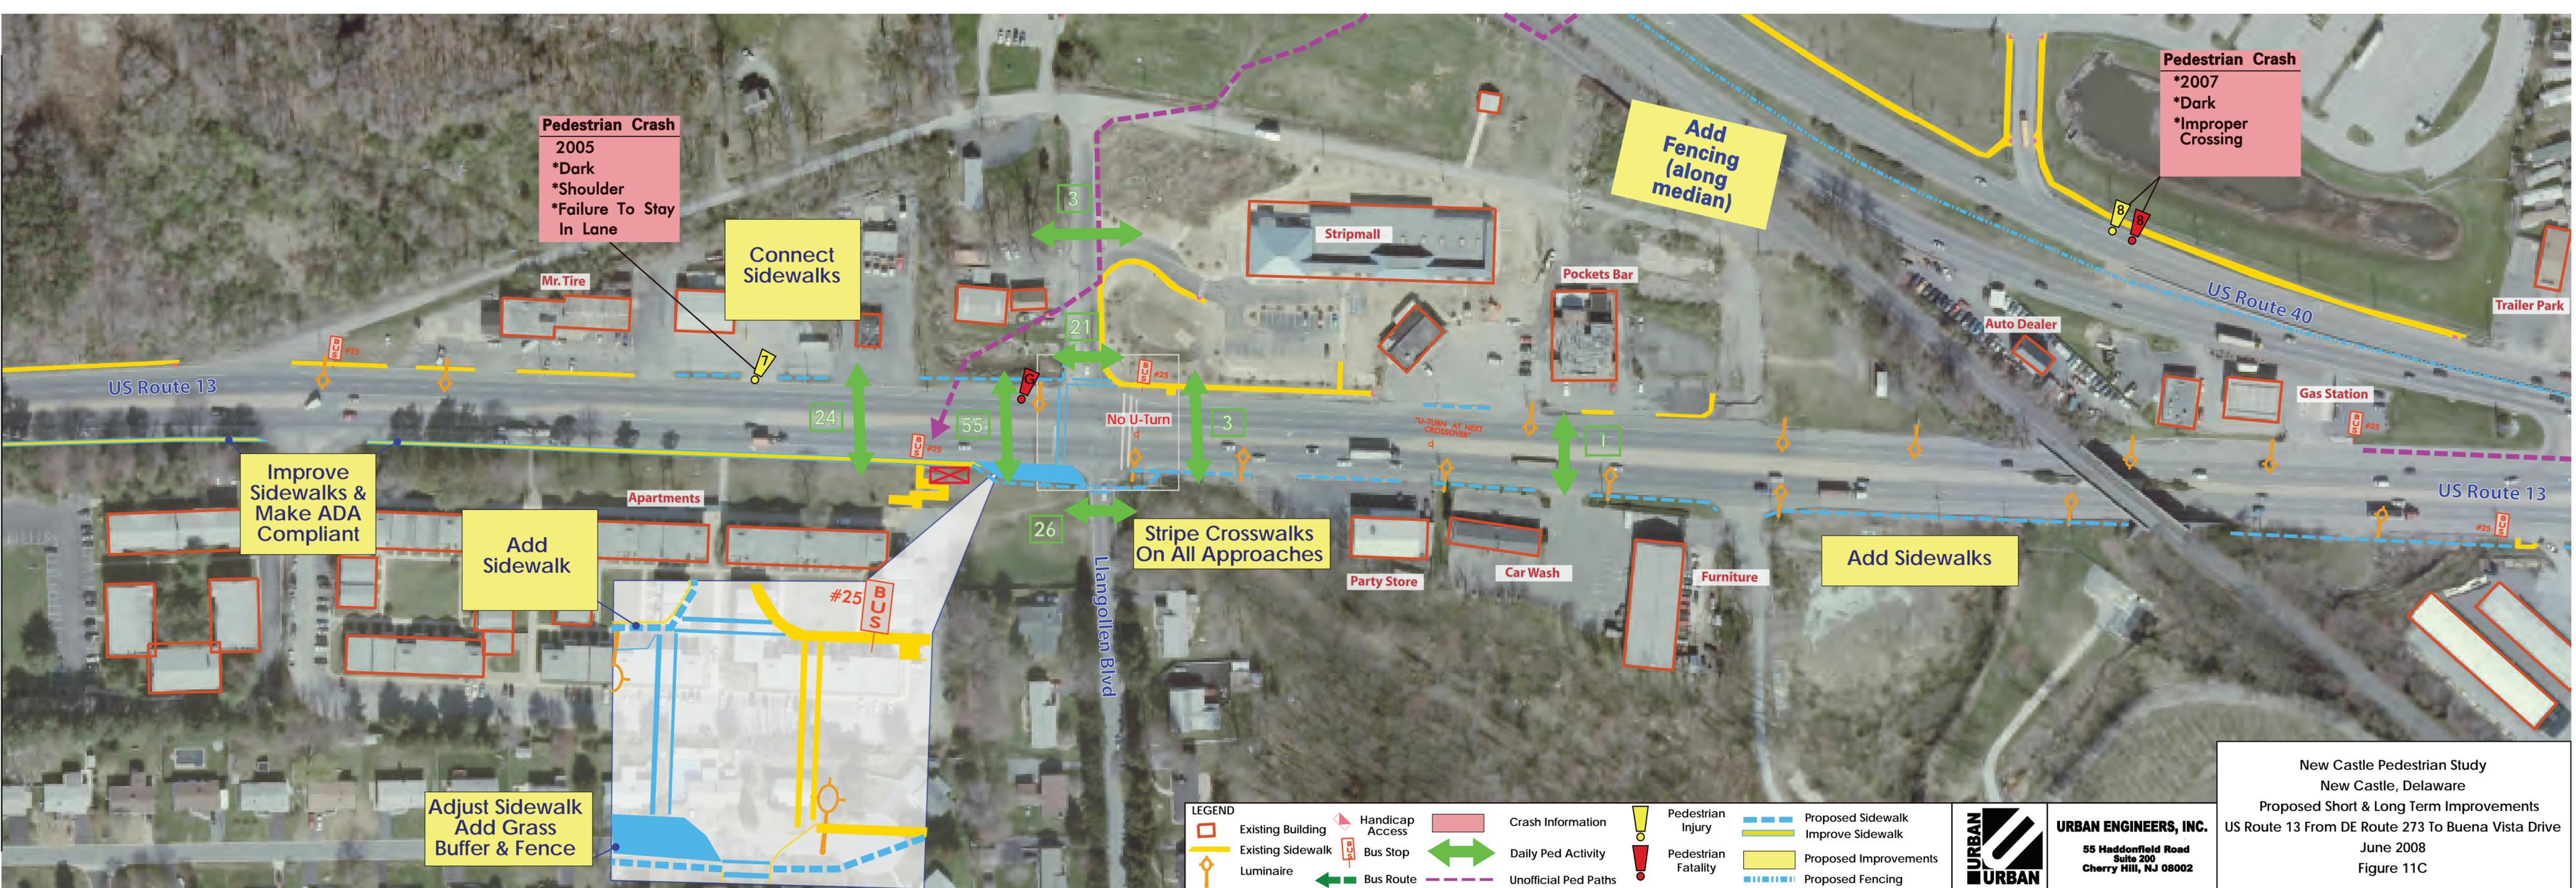
Pedestrian Crash
 2005
 *Dark
 *Shoulder
 *Failure To Stay In Lane

Pedestrian Crash
 *2007
 *Dark
 *Improper Crossing

Improve Sidewalks & Make ADA Compliant

Add Sidewalk

Adjust Sidewalk Add Grass Buffer & Fence

Connect Sidewalks

Stripe Crosswalks On All Approaches

Add Fencing (along median)

Add Sidewalks
